AMANDA GATES
CONSULTING ARBORIST
ISA CERTIFIED #WE-11839A

April 22nd, 2021

1125 Spyglass Woods Drive
Pebble Beach, CA 93953

RE: Huff Residence

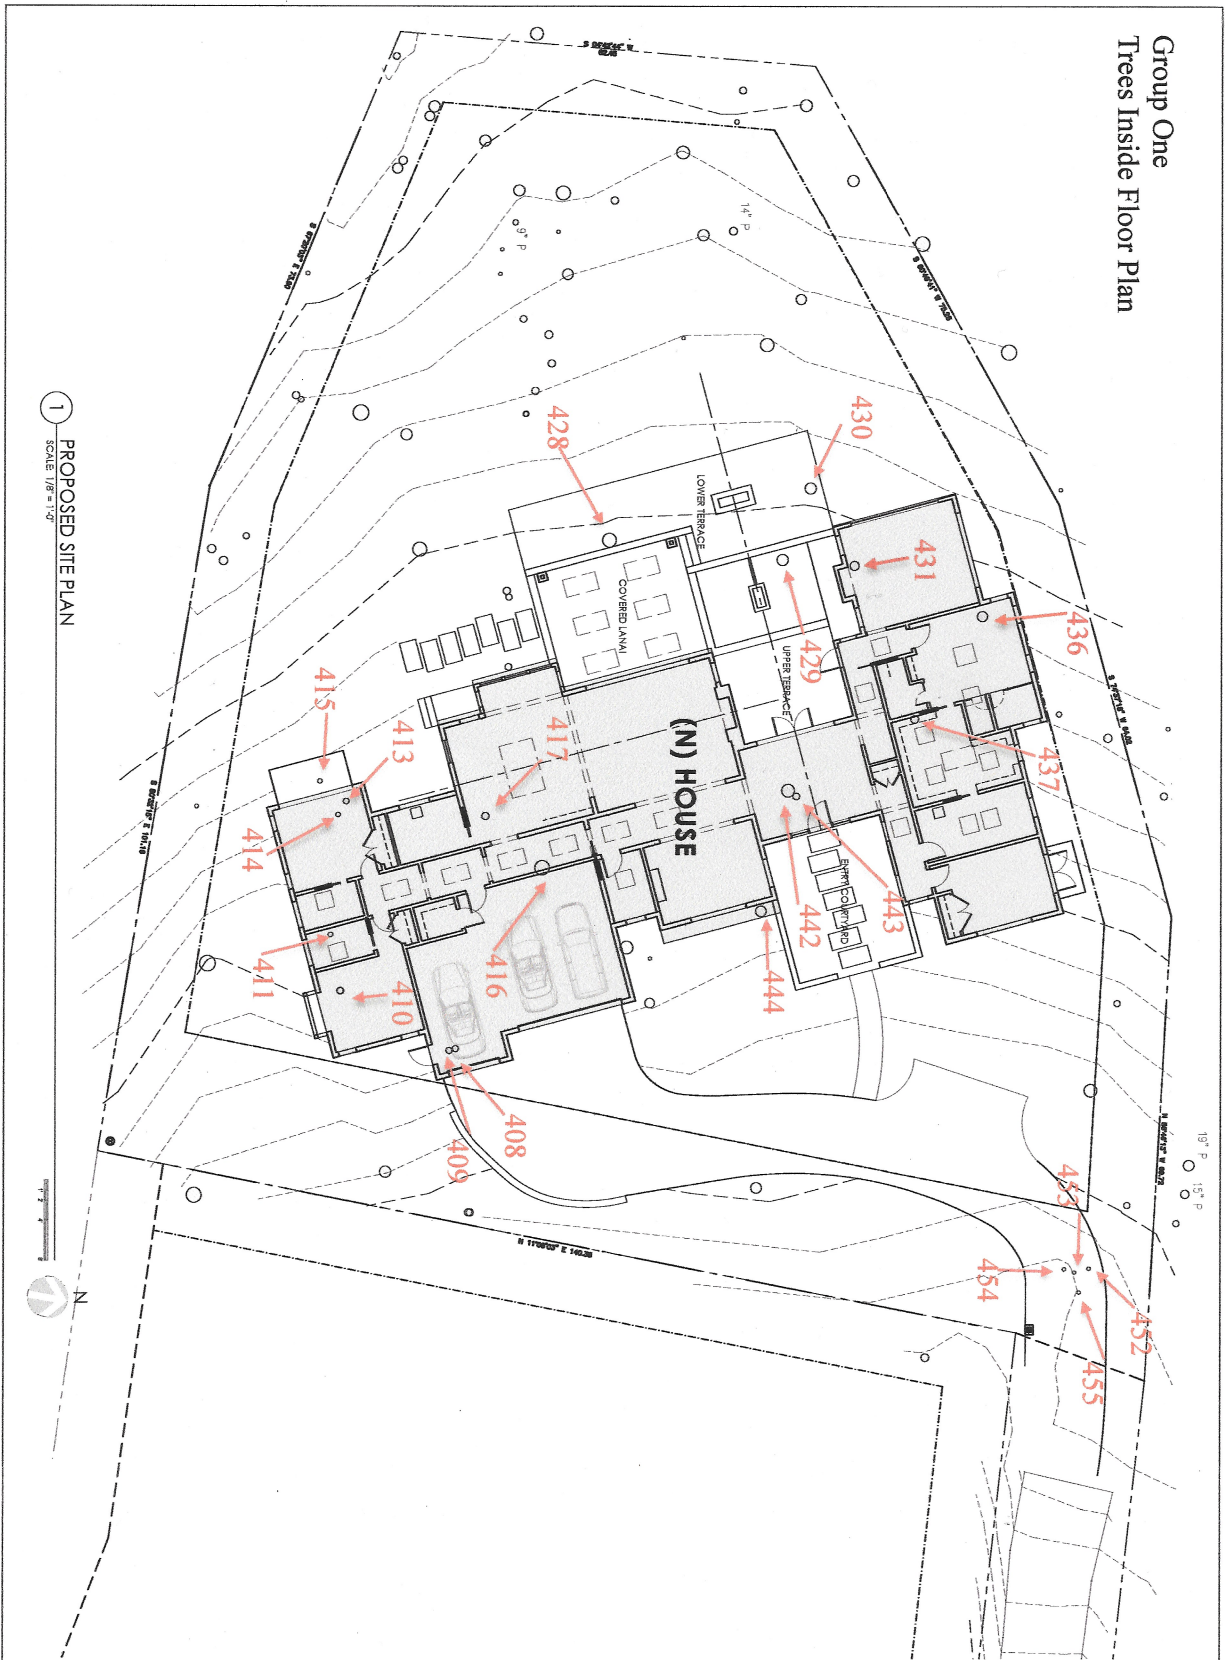
Group One
Trees Inside Floor Plan

These trees will be necessary for removal for the proposed building project. Most of these trees display poor structural growth due to growing in a stand of trees, tightly grouped together. Trees that grow in close proximity commonly compete for sunlight and develop undesirable structural issues that could become hazardous. These trees conditions are as follows.

Tree #	Species	Approx Height	DBH	Condition	Action
430	<i>Pinus radiata</i>	64ft	20"	Fair- This tree has about a 90% live crown ratio, but appears to have western gall rust and dwarf mistletoe and a lean towards the project. This trees root system is too close to the floor plan.	Removal
428	<i>Pinus radiata</i>	60ft	25"	Fair- This tree has slight swelling of the trunk and dwarf mistletoe, which could indicate internal decay. This tree is too close to floor plan.	Removal
415	<i>Quercus agrifolia</i>	11ft	8"	Poor condition and too close to the floor plan.	Removal
408	<i>Quercus agrifolia</i>	24ft	11"	Fair- This oak tree has a live crown ratio of about 90%. This tree is within the floor plan.	Removal
409	<i>Quercus agrifolia</i>	26ft	11"	Fair- This oak tree has a live crown ratio of about 90%. This tree is within the floor plan.	Removal
410	<i>Quercus agrifolia</i>	22ft	22"	Fair- This tree has a green crown but has extensive decay within a split up the main trunk. This tree is within the floor plan.	Removal

411	<i>Quercus agrifolia</i>	12ft	8"	Poor. Coast live oak that is within the floor plan.	Removal
413	<i>Quercus agrifolia</i>	11ft	8"	Poor. Low live crown ratio and root plate lifting. Tree within floor plan.	Removal

414	<i>Quercus agrifolia</i>	13ft	10''	Poor. Sparse crown with root plate lifting. This tree is within the floor plan.	Removal
416	<i>Pinus radiata</i>	12ft	26''	Dead. Tall dead stump. Within floor plan.	Removal
417	<i>Pinus radiata</i>	30ft	15''	Poor. Low live crown ratio with excessive lean (bow) western gall rust. Within floor plan.	Removal
429	<i>Pinus radiata</i>	70ft	20''	Poor. Structural issues, several limbs have failed. Shrunken bark from western gall rust, signs of internal decay. This tree is within the floor plan.	Removal
431	<i>Pinus radiata</i>	68ft	16''	Dead. This tree is within the floor plan.	Removal
436	<i>Pinus radiata</i>	71ft	18''	Poor. This tree has a bow as well as large amounts of dwarf mistletoe and western gall rust. Signs of internal defect. This tree is within the floor plan.	Removal
437	<i>Pinus radiata</i>	33ft	14''	Poor. Crown has failed and only one lateral limb remains. This tree is within the floor plan.	Removal

442	<i>Pinus radiata</i>	75ft	23''	Fair. Structural issues were observed exhibited with a lean (Bow). Bark Beetle frass and western gall rust also present.	Removal
443	<i>Pinus radiata</i>	15ft	12''	Fair- 90% live crown ratio. Within floor plan of project.	Removal
444	<i>Pinus radiata</i>	70ft	19''	Dead. Fallen tree, stump still standing. Within floor plan.	Removal
452	<i>Pinus radiata</i>	24ft	6''	Fair condition. In driveway	Removal
453	<i>Pinus radiata</i>	25ft	6''	Fair condition. In driveway	Removal
454	<i>Pinus radiata</i>	24ft	6''	Fair condition. In driveway	Removal
455	<i>Pinus radiata</i>	22ft	6''	Fair condition. In driveway	Removal

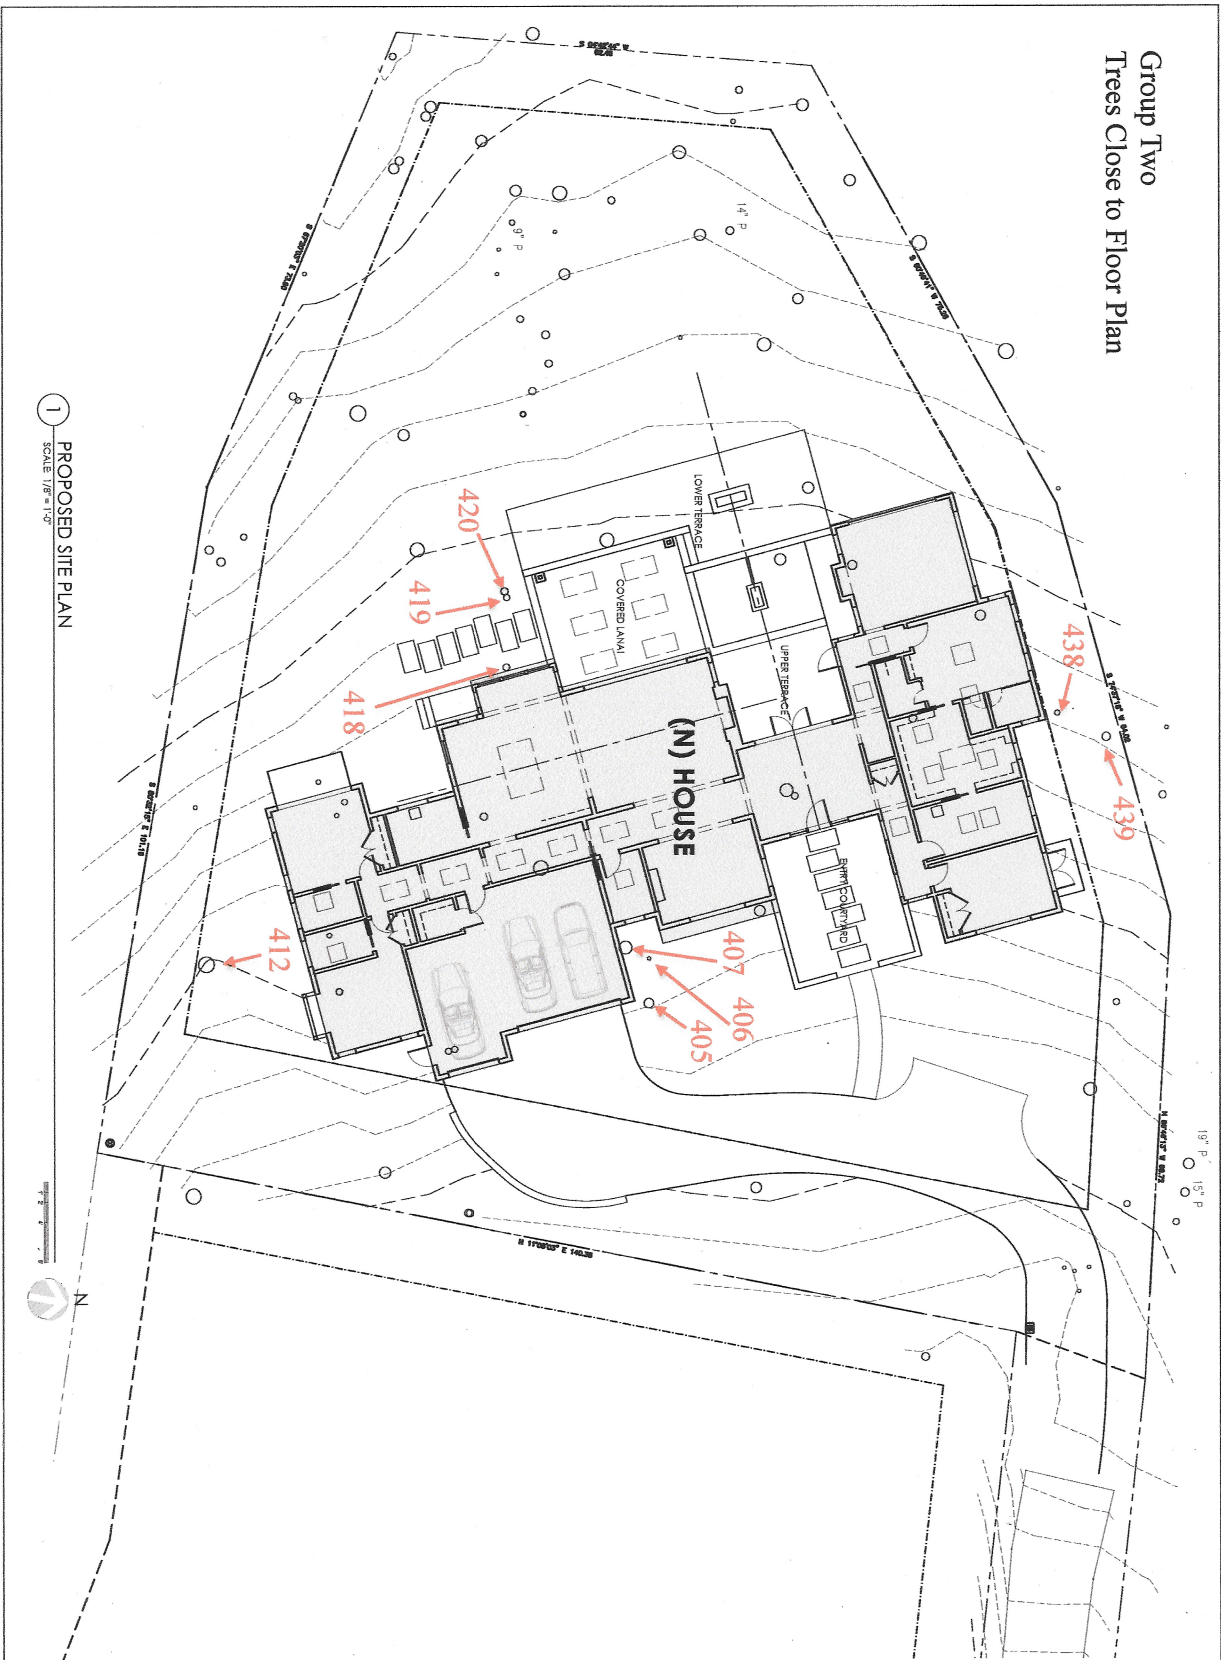
Group Two
Trees Close to Floor Plan

This group of trees are outside the floor plan proposal. However, when construction occurs too close to a tree and its root system, this can alter their structural integrity. Any site alterations can be stressful and damaging to trees, and to eliminate the risk, these trees should be removed to accommodate the project.

Tree #	Species	Approx Height	DBH	Condition	Action
412	<i>Pinus radiata</i>	64ft	28"	Average. This tree exhibits a straight lean, which would lean towards the new build. The base of the tree is also too close to the floor plan.	Removal
407	<i>Pinus radiata</i>	60ft	23"	Average. This Monterey pine has a 90% live crown ratio, but is too close to floor plan. This tree also exhibits structural issues up the trunk that appear to indicate internal decay. Western gall rust and dwarf mistletoe.	Removal
406	<i>Pinus radiata</i>	30ft	6"	Dead. Too close to floor plan.	Removal
405	<i>Pinus radiata</i>	70ft	17"	Fair. This tree has a symmetrical crown and an exhibited bow lean. This tree could be a hazard to the project and the root system is too close to floor plan.	Removal
439	<i>Pinus radiata</i>	44ft	15"	Poor. The live crown ratio is only about 10% and has evidence of western gall rust and dwarf mistletoe up the stem.	Removal

418	<i>Pinus radiata</i>	35ft	12"	Average condition. This tree appears healthy, but is too close to the floor plan. This puts the roots at risk during the construction.	Removal
420	<i>Quercus agrifolia</i>	12ft	13"	Fair. This tree appears to be too close to the overall project and should be removed.	Removal

419	<i>Quercus agrifolia</i>	18ft	11''	Fair. This oak tree is too close to the floor plan, and should be removed.	Removal
438	<i>Pinus radiata</i>	38ft	9''	Fair. Roots will likely be damaged due to close proximity. This could alter the anchorage of the roots and could become a hazard.	Removal

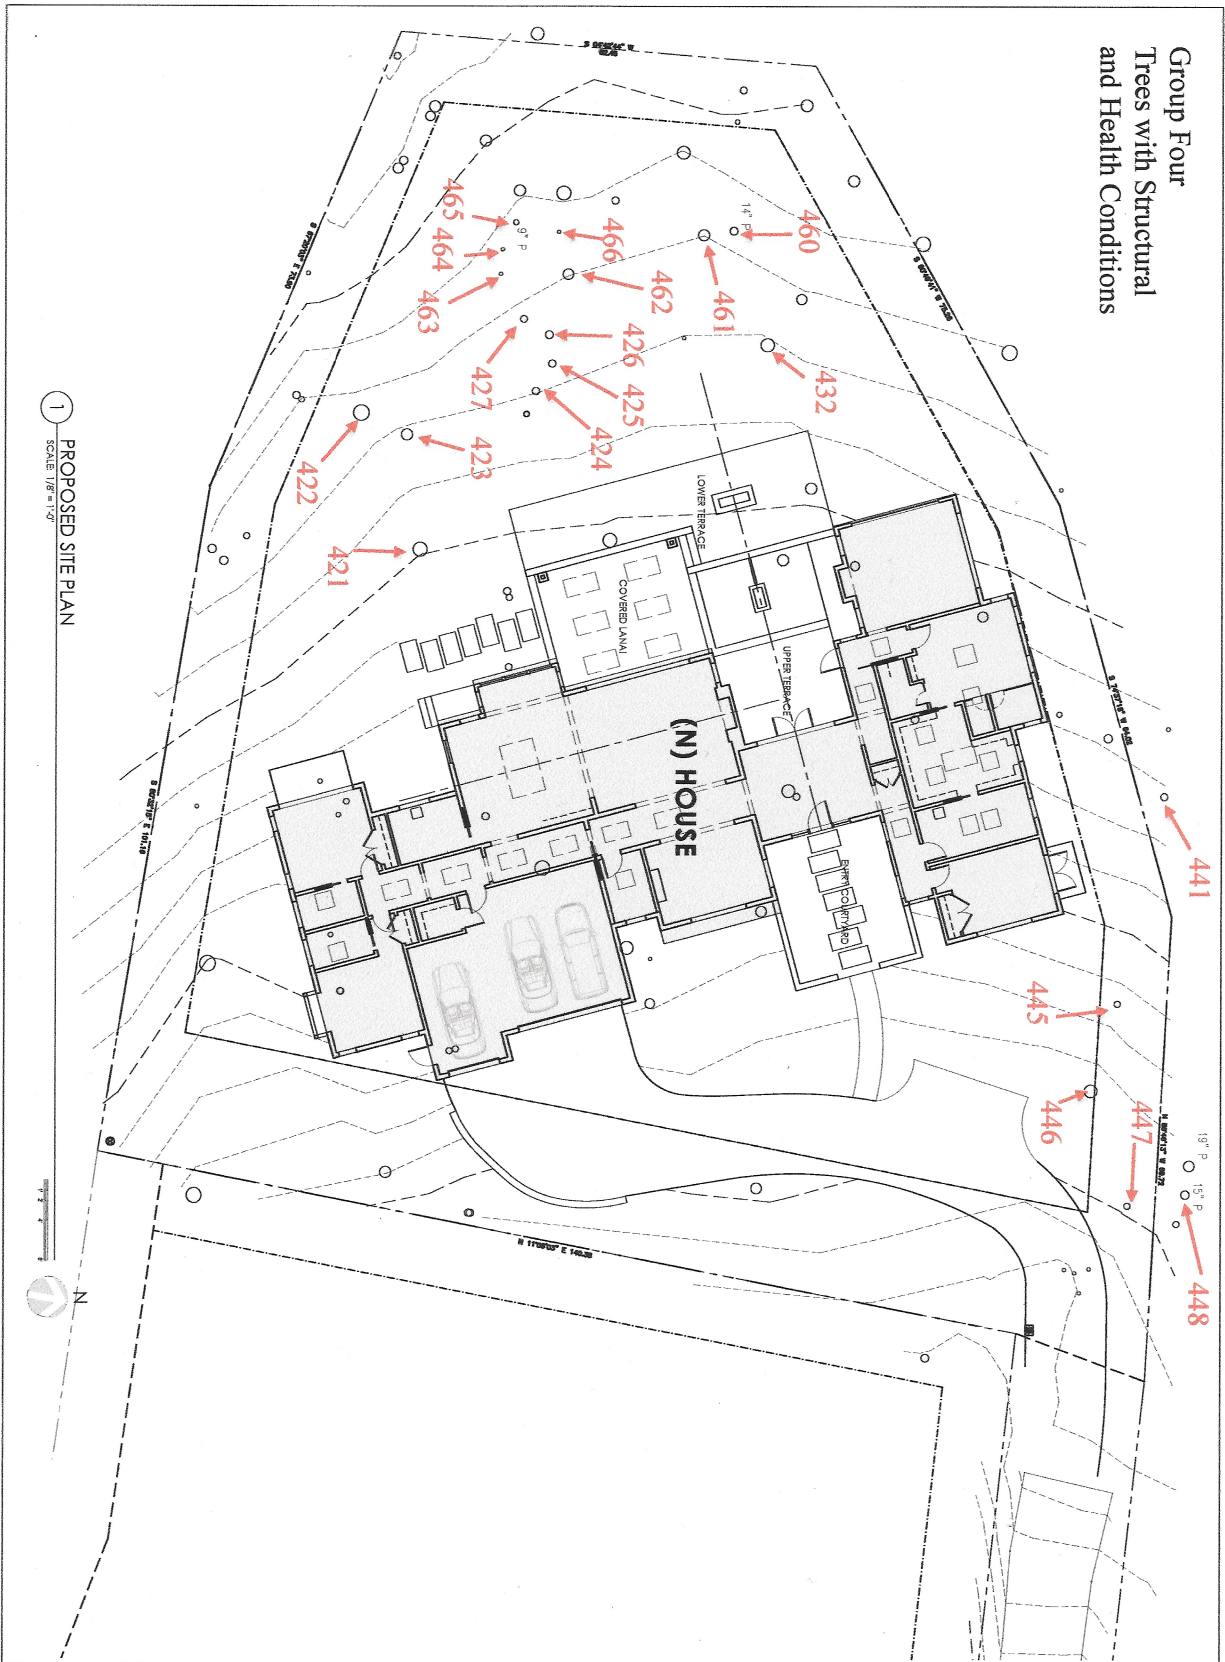
Group Four
Trees with Structural
and Health Conditions

These trees appear to have structural issues and possible decay that can commonly lead to failure. Additionally, the construction on site could potentially cause root alterations, leading to anchorage issues. These trees should be removed to mitigate potential risk to the new project.

Tree #	Species	Height	DBH	Condition	Action
421	<i>Pinus radiata</i>	68ft	25"	Poor condition, but has an excessive lean and western gall rust. The tension side of the lean has what appears to be western gall rust up the entire stem, which could lead to snapping.	Removal
422	<i>Pinus radiata</i>	76ft	28"	Poor condition. This tree has no remaining crown, which appears to have broken out in the past. The stem has an abundance of bleeding/sap flow, which most likely indicates decay or an internal defect.	Removal
423	<i>Pinus radiata</i>	39ft	20"	Poor. This tree has a 20% live crown ratio and has swelling around the trunk. The apparent decline and swelling provides evidence that this tree may have potential structural issues.	Removal
424	<i>Pinus radiata</i>	31ft	13"	Dead tree	Removal
425	<i>Pinus radiata</i>	46ft	13"	This tree has a 5% live crown ratio with no remaining lateral limbs. Dwarf mistletoe is abundant which may indicate poor health conditions.	Removal

426	<i>Pinus radiata</i>	52ft	14"	Dead tree	Removal
427	<i>Pinus radiata</i>	36ft	12"	The live crown ratio of this tree is about 30% and is asymmetrical. The trunk appears to have swelling which may indicate decay. This tree may be prone to snapping.	Removal
432	<i>Pinus radiata</i>	61ft	24"	Poor. Crown has failed and the laterals have grown very large. When laterals grow large from the loss of the crown, they are more at risk of breakage.	Removal
441	<i>Pinus radiata</i>	32ft	13"	Fair condition but has possible structural issues. The base of the tree has some loose bark that appears to be decayed. This tree also leans towards the project.	Removal
445	<i>Pinus radiata</i>	32ft	11"	Poor condition. A neighboring tree that had completely failed damaged this tree. The crown is unequally distributed over the root system and is heavy on the leaning side. The live crown ratio is low. This tree could be prone to failure and could cause damage to the future targets.	Removal

446	<i>Pinus radiata</i>	67ft	23''	Dead tree	Removal
447	<i>Pinus radiata</i>	36ft	11''	Poor condition. 10% live crown ratio. The main concern is the western gall rust that has affected more than 40% of the circumference of the stem. Decay more than 40% can be a high-risk tree for snapping.	Removal
448	<i>Pinus radiata</i>	58ft	15''	Fair condition with a live crown ratio of about 40%. The hazardous condition is the bow lean. This lean appears to have been a result of partial failure of the wood fibers of the stem.	Removal
460	<i>Pinus radiata</i>	40ft	14''	Poor condition. The crown has failed and only a few branches remain. This tree leans excessively and may be prone to failure.	Removal
461	<i>Pinus radiata</i>	12ft	20''	Poor. Failed tree, only the stump remains.	Removal
462	<i>Pinus radiata</i>	19ft	19''	Poor condition. Masses of Sequoia pitch moth and swelling around the trees base. The swelling could suggest a root defect. There was also evidence of decay up the main stem.	Removal

463	<i>Pinus radiata</i>	30ft	6''	Dead tree	Removal
464	<i>Pinus radiata</i>	30ft	6''	Dead tree	Removal
465	<i>Pinus radiata</i>	30ft	9''	Dead tree	Removal
466	<i>Pinus radiata</i>	35ft	19''	Dead tree	Removal
