Arborist Report

*33 Potrero Trail
Carmel, CA 93923
APN# 239-111-013*

*Inspection Date:
February 21, 2022*

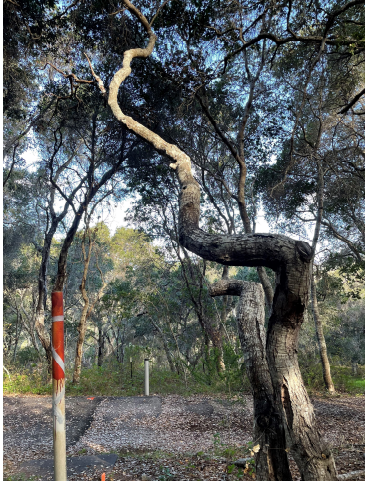
Tree #1 is a Coast live oak (*Quercus agrifolia*) with a DBH's of 14" & 13.5"

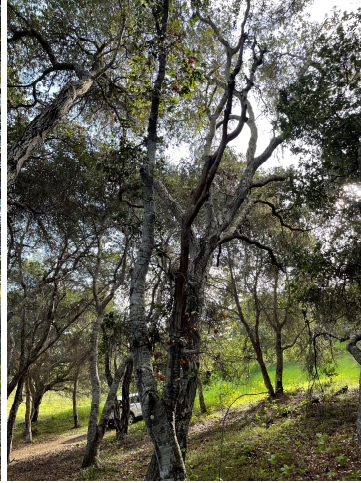
Tree #3 is a Coast live oak (*Quercus agrifolia*) with a DBH of 8.5"

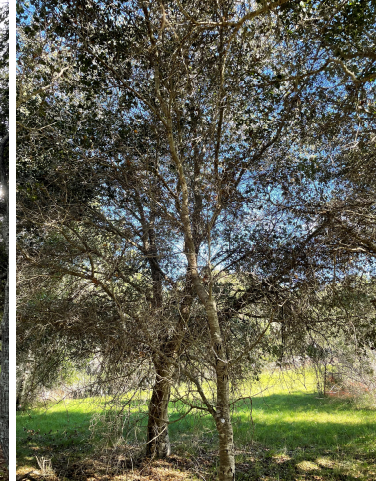
Tree #17 is a Coast live oak (*Quercus agrifolia*) with a DBH of 4.5"

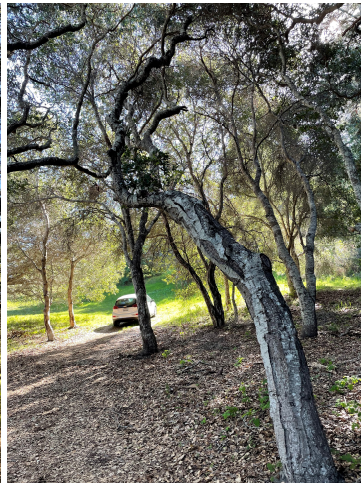
Tree #31 is a Coast live oak (*Quercus agrifolia*) with a DBH of 15"

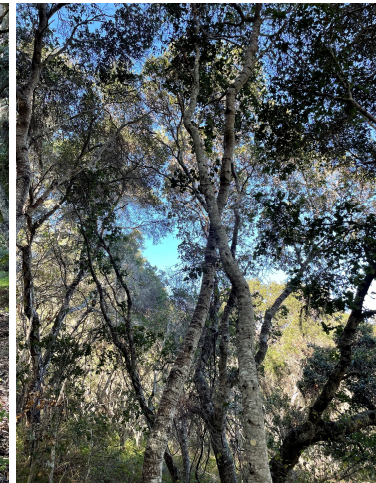
Tree #35 is a Coast live oak (*Quercus agrifolia*) with a DBH of 4.5"

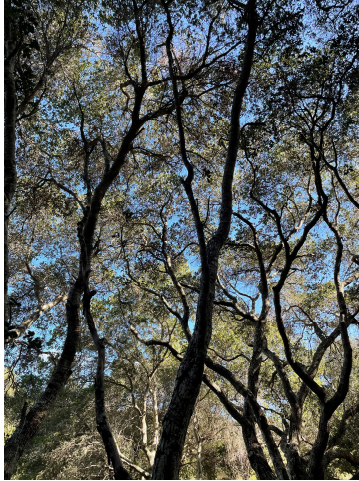
Tree #36 is a Coast live oak (*Quercus agrifolia*) with a DBH of 9.5"

36	Coast live oak	9.5	35'/12'	fp	fp	x	C	Removal, little new foliage, no hope for recovery
37	Coast live oak	5	18'/6'	f	fp		B	EWR, DWR, SP, RCE, leaning
38	Coast live oak	27.5	40'/40'	fg	fp	x	B	EWR, DWR, SP, RCE, codominant leaders at 4'
39	Coast redwood	20	38'/25'	fg	g	x	A	EWR, DWR
40	Coast live oak	11.5	18'/18'	fg	fp	x	B	EWR, DWR, SP, RCE, codominant leaders at 4'
41	Coast live oak	11.8	15'/16'	fg	fp	x	B	EWR, DWR, SP, RCE, codominant leaders at 3'
42	Scrub oak?	10 @ 1'	8'/10'	fg	fp	x	B	EWR, DWR, SP, RCE
