## Arborist Report

Santa Lucia Preserve Lot #189  
16 Potrero Trail  
Carmel, CA 93923  
APN# 239-111-003

Inspection Date:  
June 29, 2021

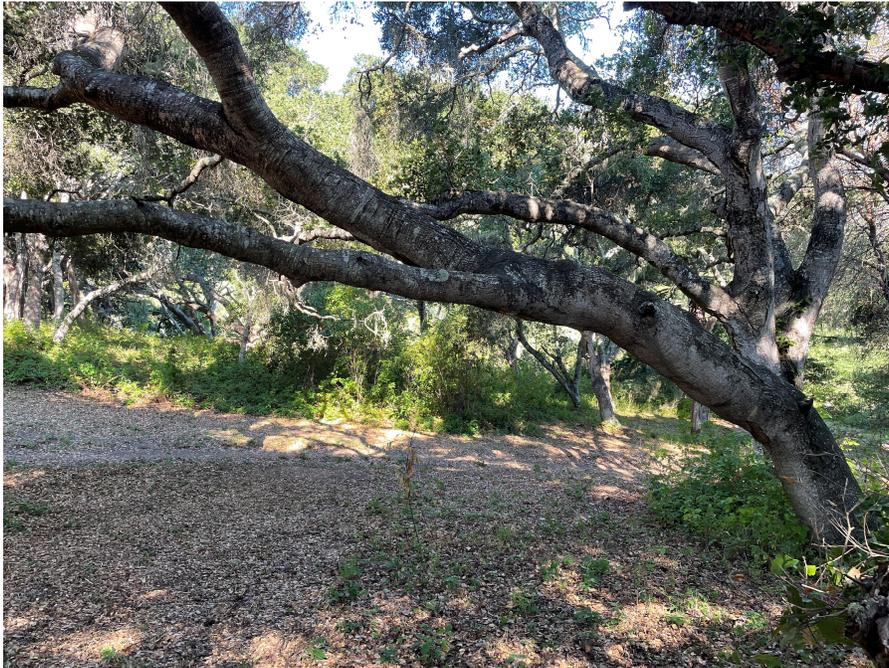
**Tree #1**

- Tree #1 is a Coast live oak (*Quercus agrifolia*) with a DBH of 26.5"
- Tree #16 is a Coast live oak (*Quercus agrifolia*) with a DBH of 15" at 3.5'
- Tree #40 is a Coast live oak (*Quercus agrifolia*) with a DBH of 7"
- Tree #43 is a Coast live oak (*Quercus agrifolia*) with a DBH of 6.5"
- Tree #47 is a Coast live oak (*Quercus agrifolia*) with a DBH of 8"
- Tree #48 is a Coast live oak (*Quercus agrifolia*) with a DBH of 14.5" at 3'
- Tree #49 is a Coast live oak (*Quercus agrifolia*) with a DBH of 8"

TAG NO.	COMMON NAME	DIAMETER AT BREAST HEIGHT"	H'/W'	HEALTH	STRUCTURE	PROTECTED (X)	TREE DISPOSITION	NOTES, RECOMMENDATIONS
1	Coast live oak	26.5	20'/40'	fg	p	x	C	Recommend removal, heavy lean, no hope for recovery
2	Coast live oak	14.0	25'/18'	fg	fp	x	B	Recommend EWR, DWR, SP, RCE, codominant leaders at 10'
3	Coast live oak	12.0	25'/20'	fg	fp	x	B	Recommend EWR, DWR, SP, RCE, codominant leaders at 7'
4	Coast live oak	21.5	40'/45'	fg	fp	x	B	Recommend EWR, DWR, SP, RCE, multiple leaders at 8'
5	Coast live oak	14.5	25'/18'	fg	fp	x	A	Recommend EWR, DWR, SP, RCE, codominant leaders at 13'
6	Coast live oak	24.0	48'/45'	fg	fp	x	A	Recommend EWR, DWR, SP, RCE, codominant leaders at 15'
7	Madrone	13.5	48'/20'	f	fp	x	B	Recommend EWR, DWR, SP, RCE, multiple leaders at 13'
8	Coast live oak	20.0	48'/30'	fg	f	x	A	Recommend EWR, DWR, SP, RCE, multiple leaders at 20'
9	Coast live oak	32.0	45'/55'	fg	f	x	A	Recommend EWR, DWR, SP, RCE, multiple leaders at 16', cabling

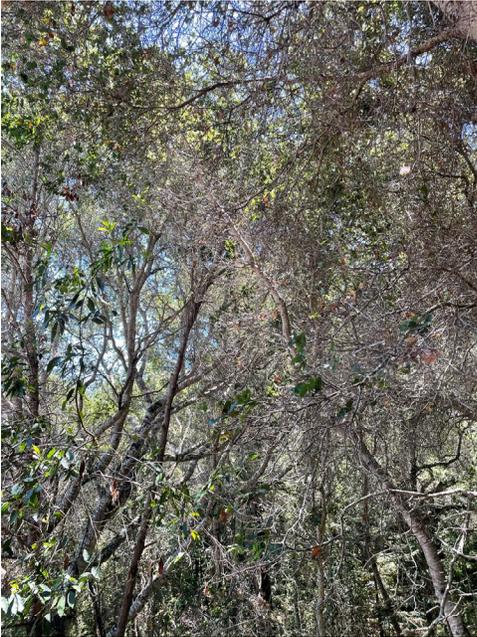
**Tree #43**

TAG NO.	COMMON NAME	DIAMETER AT BREAST HEIGHT"	H'/W'	HEALTH	STRUCTURE	PROTECTED (X)	TREE DISPOSITION	NOTES, RECOMMENDATIONS
43	Coast live oak	6.5	23'/7'	f	fp	x	C	Recommend removal, leaning, good forestry practice
44	Coast live oak	12.0	32'/17'	fg	fp	x	B	Recommend EWR, DWR, SP, RCE, slight lean
45	Coast live oak	17.0	35'/28'	fg	fp	x	B	Recommend EWR, DWR, SP, RCE, codominant leaders at 5'
46	Coast live oak	16.0	35'/20'	fg	fp	x	B	Recommend EWR, DWR, SP, RCE, codominant leaders at 13'
47	Coast live oak	8.0	25'/6'	f	fp	x	C	Recommend removal, leaning low live crown ratio
48	Coast live oak	14.5 @ 3'	16'/8'	fp	p	x	C	Recommend removal, severe lean, no hope for recovery
49	Coast live oak	8.0	18'/12'	f	fp	x	C	Recommend removal, leaning, good forestry practice
50	Coast live oak	11.0	32'/16'	fg	f	x	B	Recommend EWR, DWR, SP, RCE, slight lean
51	Coast live oak	9/6.5	28'/15'	p	fp	x	C	Recommend removal, rotten leader, thin canopy, no hope for recovery

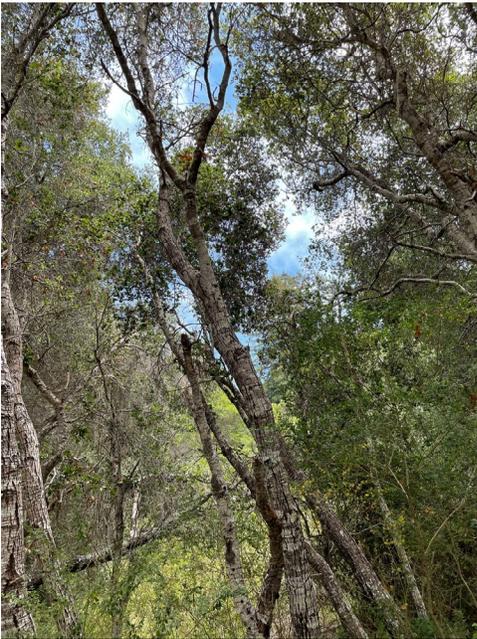
**Tree #51** is a Coast live oak (*Quercus agrifolia*) with a DBH of 9" & 6.5"  
**Tree #55** is a Coast redwood (*Sequoia sempervirens*) with a DBH of 7"  
**Tree #56** is a Coast live oak (*Quercus agrifolia*) with a DBH of 34"  
**Tree #58** is a Coast live oak (*Quercus agrifolia*) with a DBH of 18"  
**Tree #60** is a Coast live oak (*Quercus agrifolia*) with a DBH of 16"

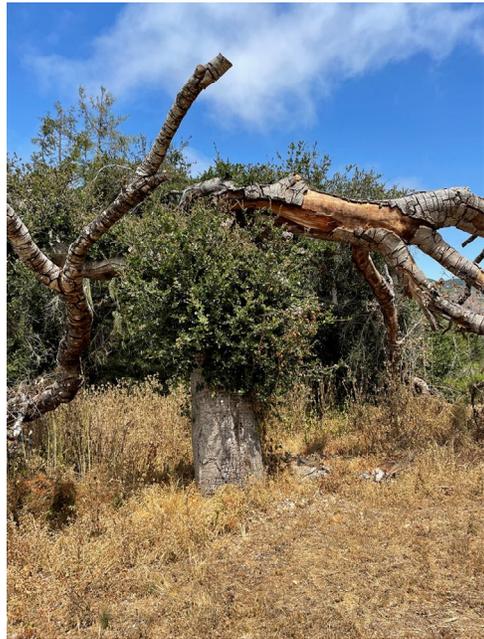
**Tree #55**

52	Coast live oak	13.5	28'/18'	fg	fp	x	B	Recommend EWR, DWR, SP, RCE, slight lean
53	Coast redwood	18.0	40'/30'	fg	fg	x	A	Recommend EWR, DWR, RCE
54	Coast redwood	17.0	38'/30'	fg	fg	x	A	Recommend EWR, DWR, RCE
55	Coast redwood	7.5	18'/16'	f	f	x	C	Recommend removal, good forestry practice
56	Coast live oak	34.0	12'/50'	p	p	x	C	tree is dead, top broke off
57	Coast live oak	8.4/7	18'/20'	fg	fp	x	B	Recommend EWR, DWR, SP, RCE, codominant leaders at base, thin canopy
58	Coast live oak	18.0	30'/40'	fg	f	x	C	Remove for construction limits
59	Coast live oak	29.0	50'/45'	fg	fp	x	B	Recommend EWR, DWR, SP, RCE, codominant leaders at 6', leaning
60	Coast live oak	16.0	50'/30'	fg	p	x	C	Recommend removal, severe lean, no hope for recovery
61	Coast live oak	40.0	55'/75'	fg	fp	x	B	Recommend EWR, DWR, SP, RCE, codominant leaders at 5'
62	Coast redwood	6.0					B	Dense brush with poison oak, unable to accurately survey at time of inspection
