THOMPSON
WILDLAND MANAGEMENT

September 14, 2020

Spanos Residence
 3347 17 Mile Drive
 Pebble Beach, CA. 93953
 APN: 008-351-008-000

Subject: 3347 17 Mile Drive pre-construction tree impact assessment

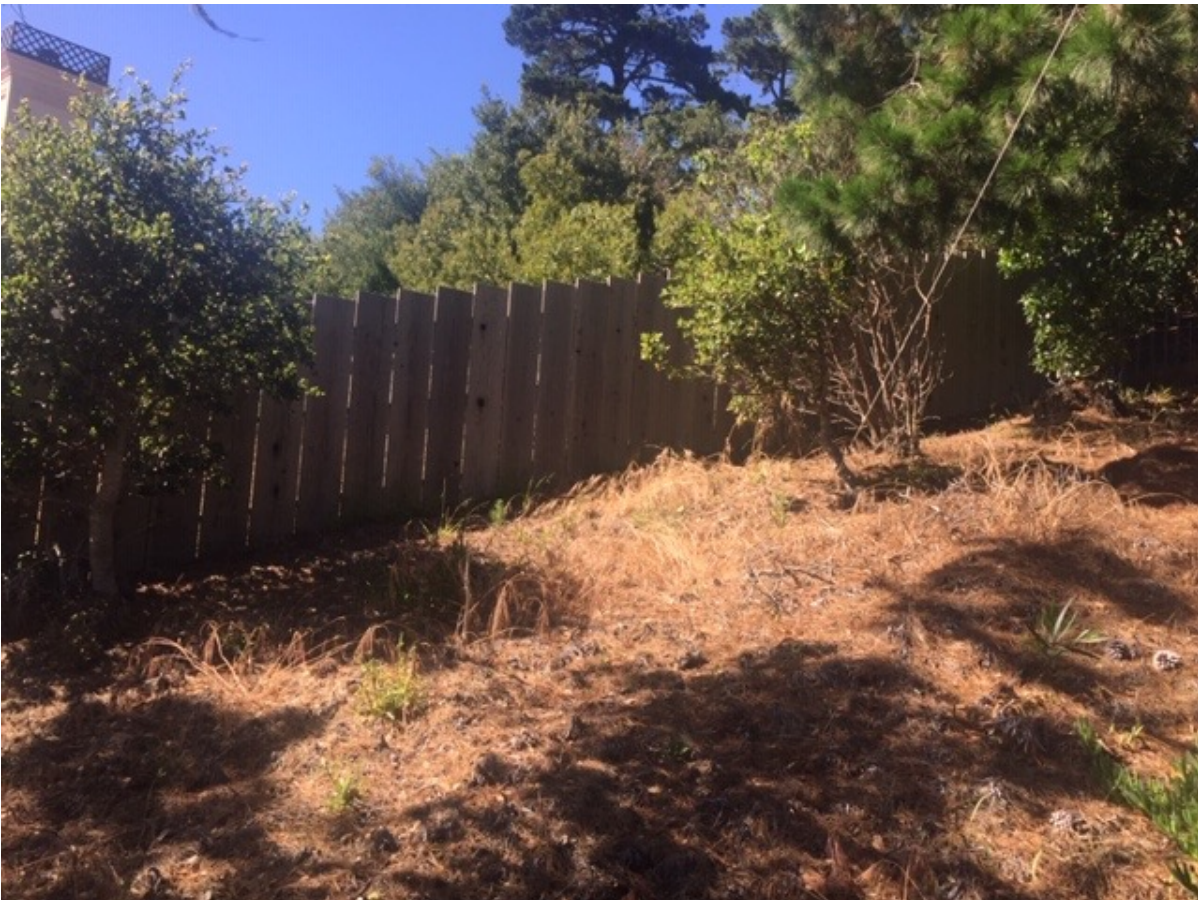
Figure 4. Example of clearing where replacement planting oaks and pines can be planted.

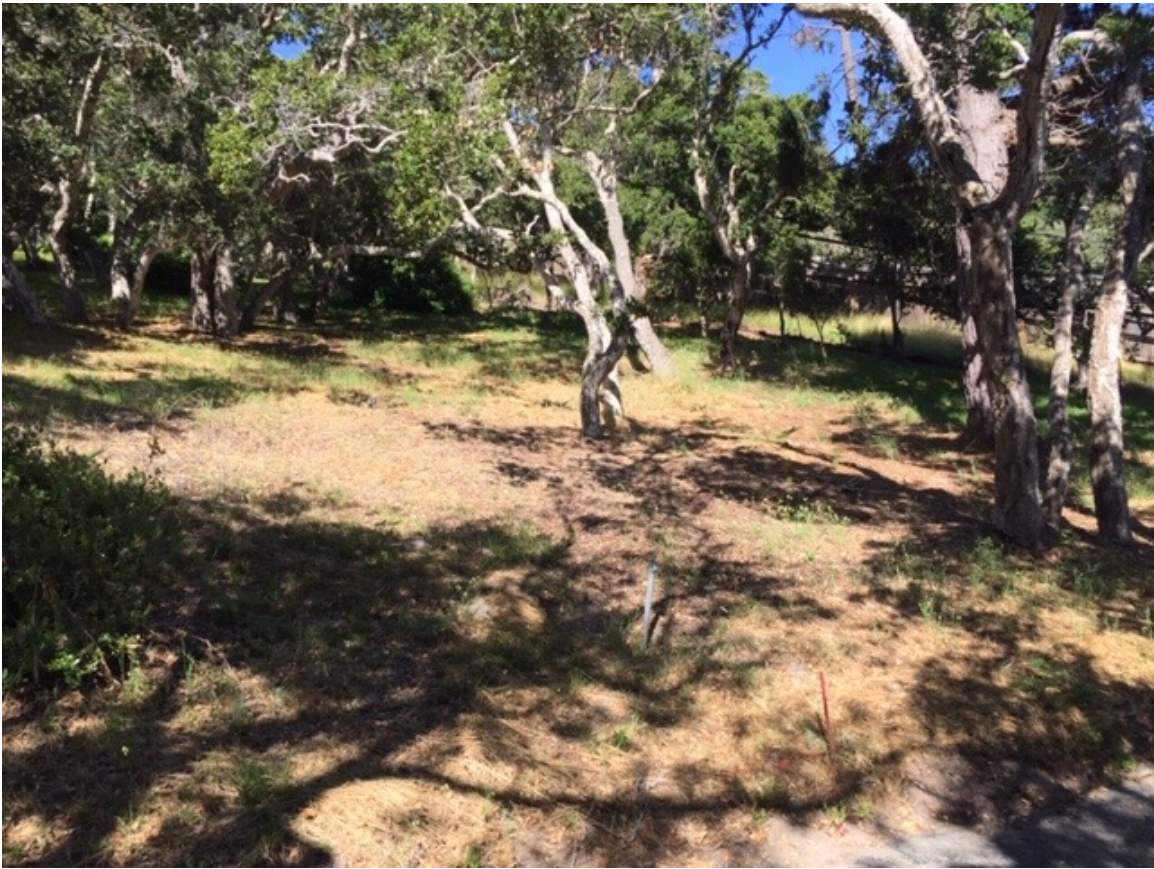
Figure 5. Another woodland clearing where replacement plantings can be planted.

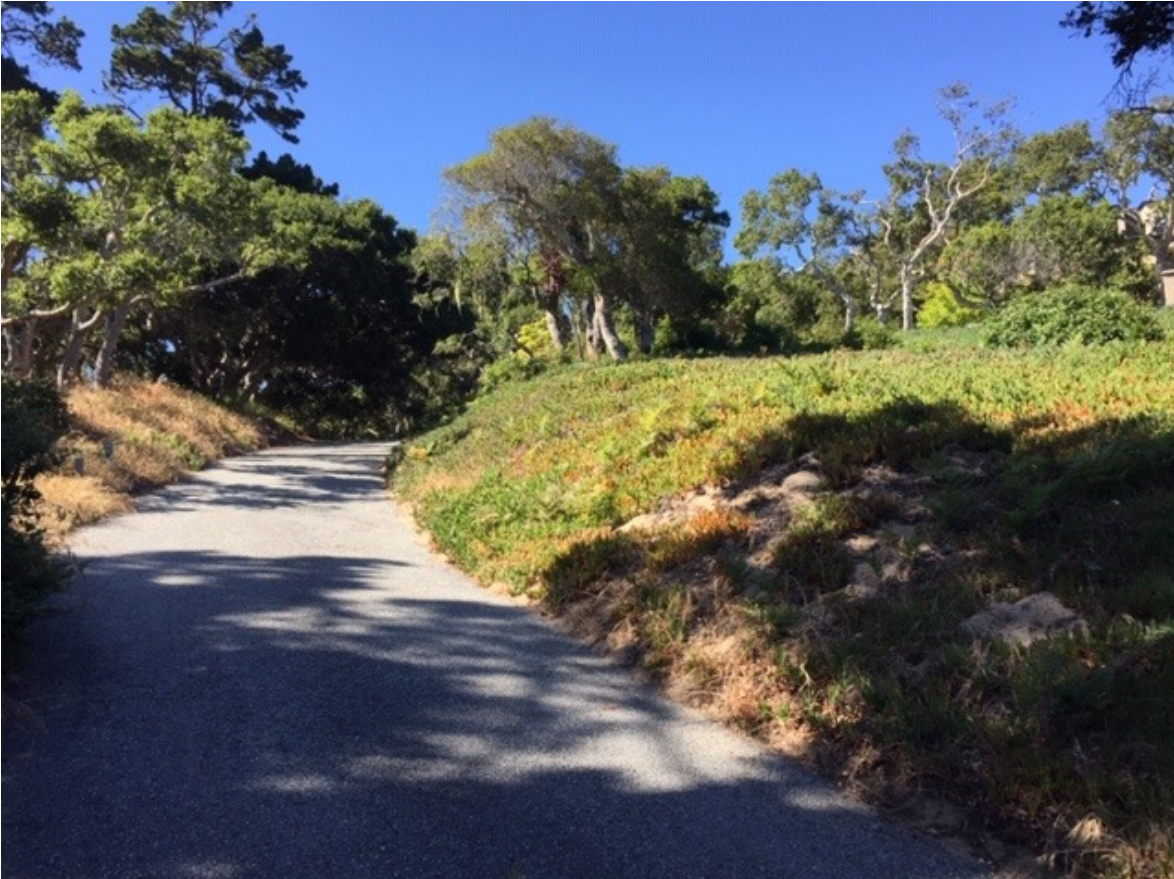
Figure 6. This upper section of driveway will be removed and this area restored. Several replacement plantings can be planted in this clearing, but non-native invasive Ice Plant will need to be removed, controlled and managed.

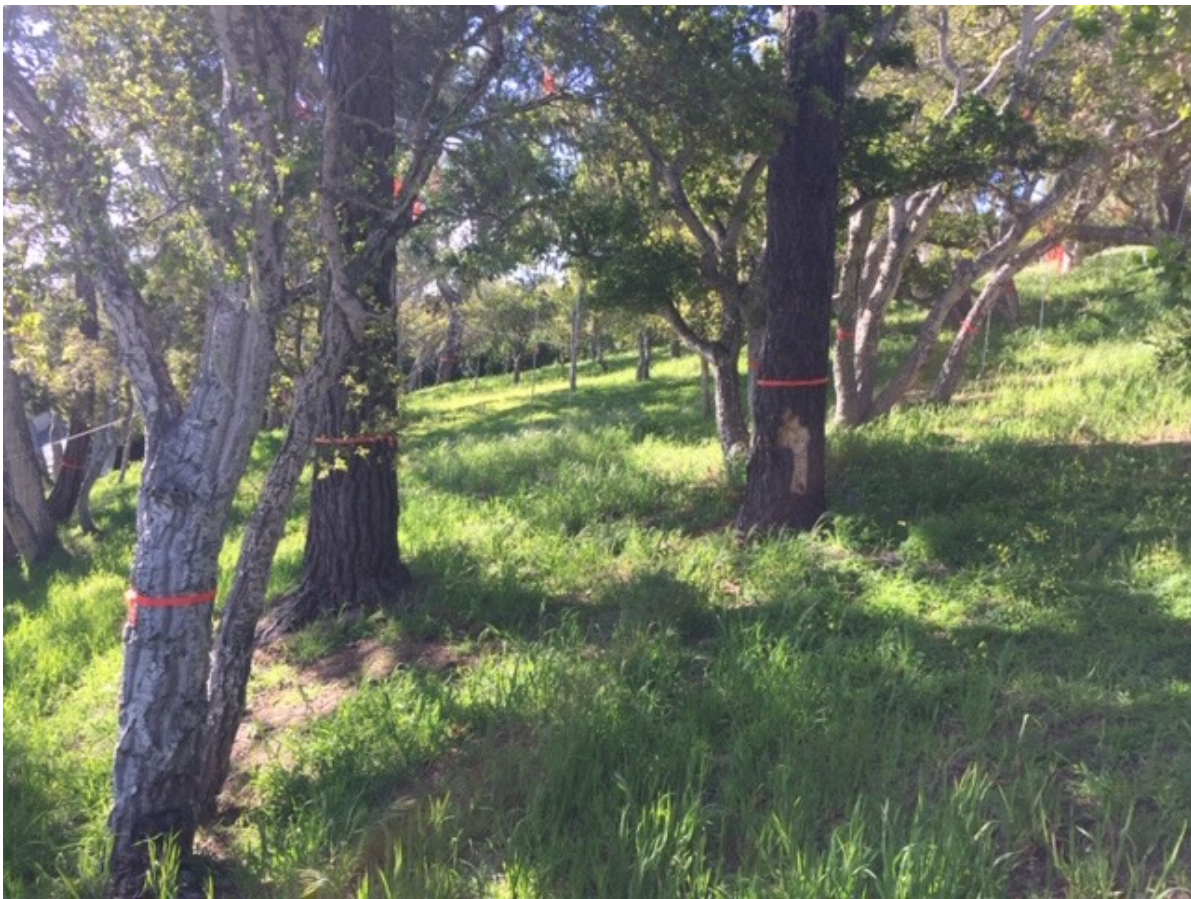
Figure 1. Combination of oaks and pines in foreground and background (marked with orange flagging tape) in proposed driveway parking area that are planned for removal due to construction impacts.

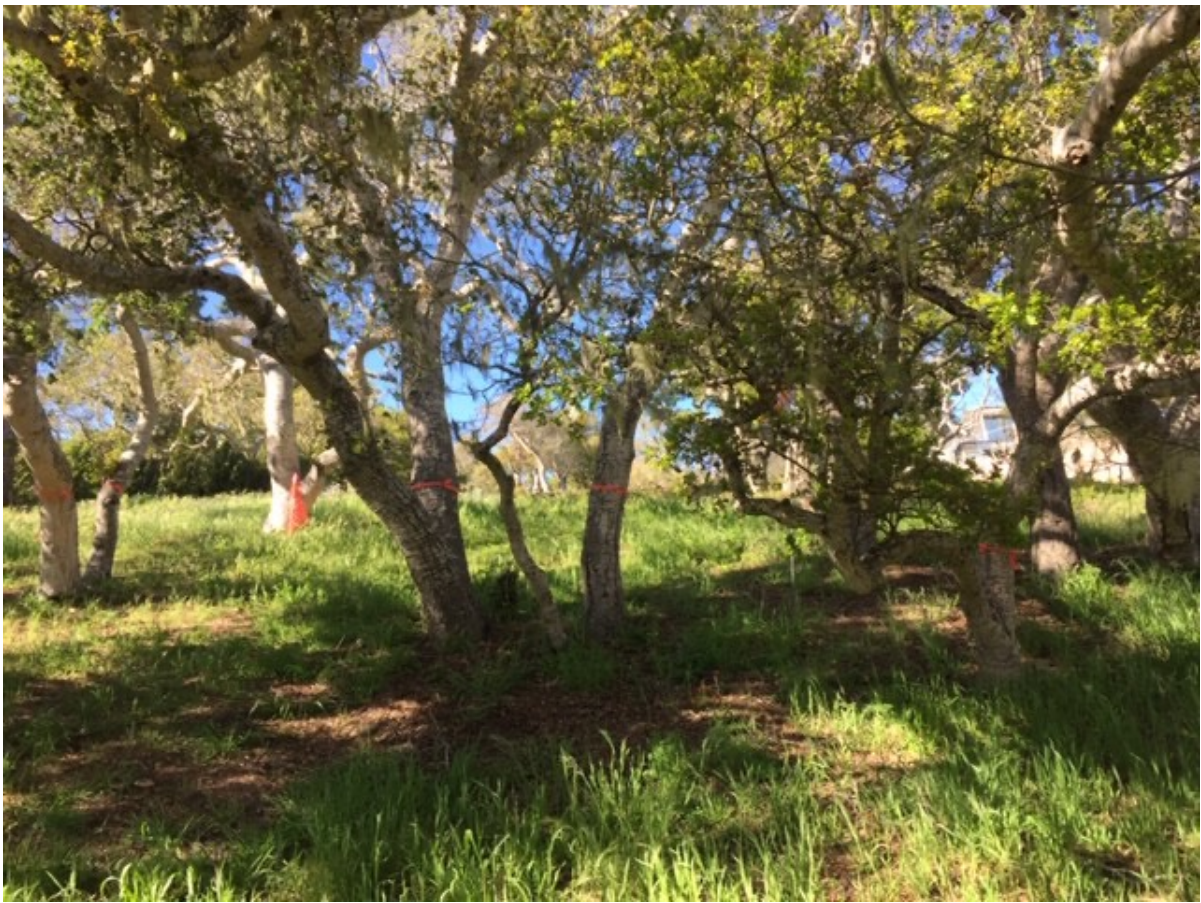
Figure 3. Several additional small to medium size oaks that will need to be removed due to location within proposed construction footprint.

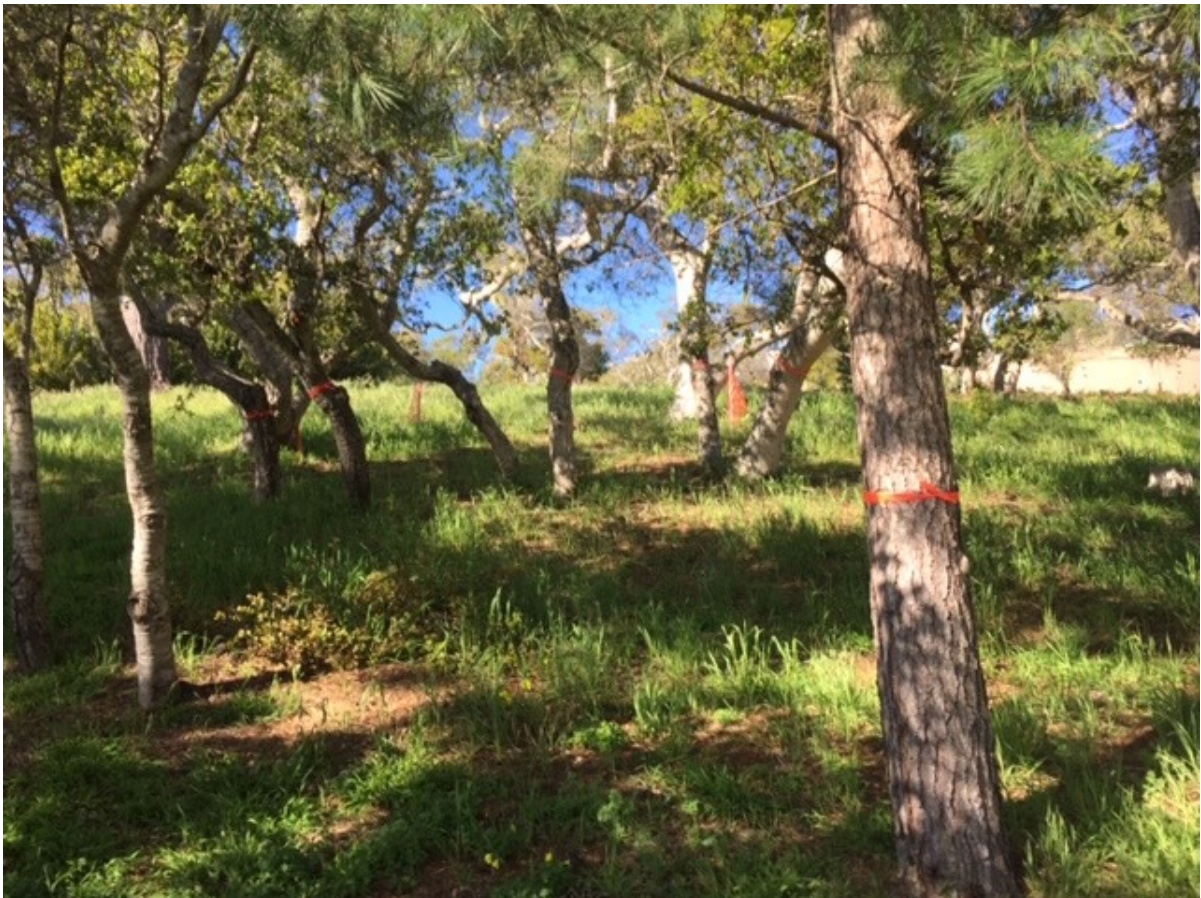
Figure 4. Small pine and several small to medium sized oaks proposed for removal due to construction impacts.

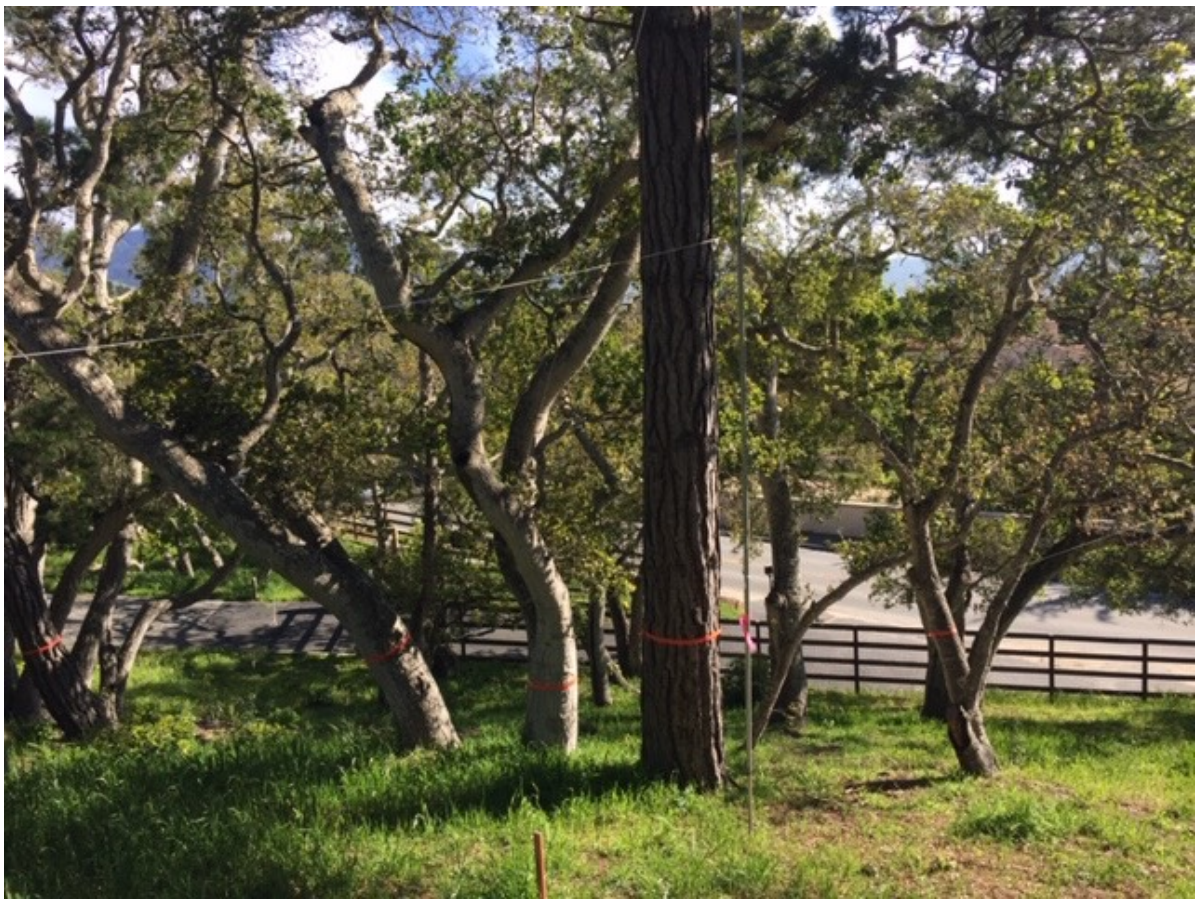
Figure 5. Additional trees in proposed pool deck area are planned for removal due to construction impacts. 17 Mile Drive is in background.

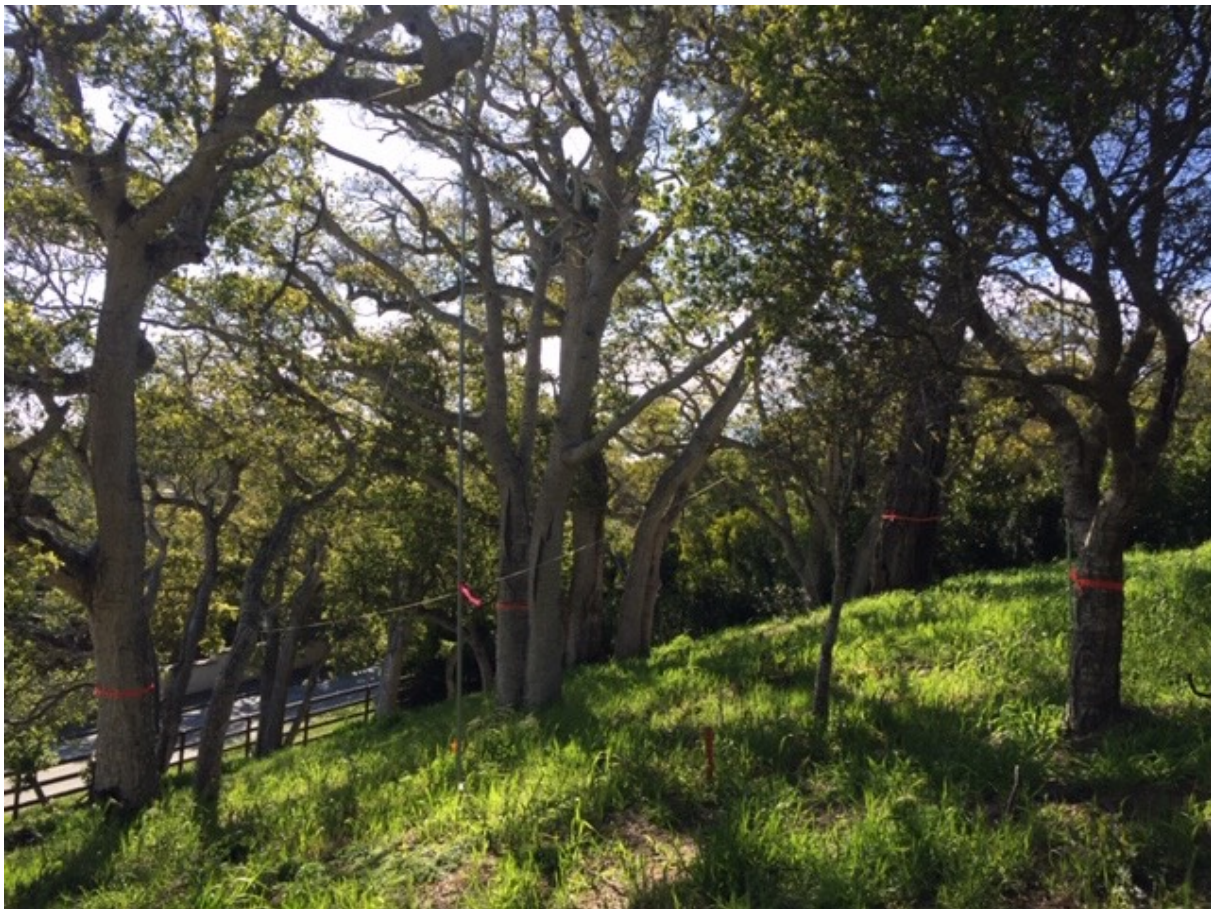
Figure 6. A few more trees in proposed pool area that are planned for removal.

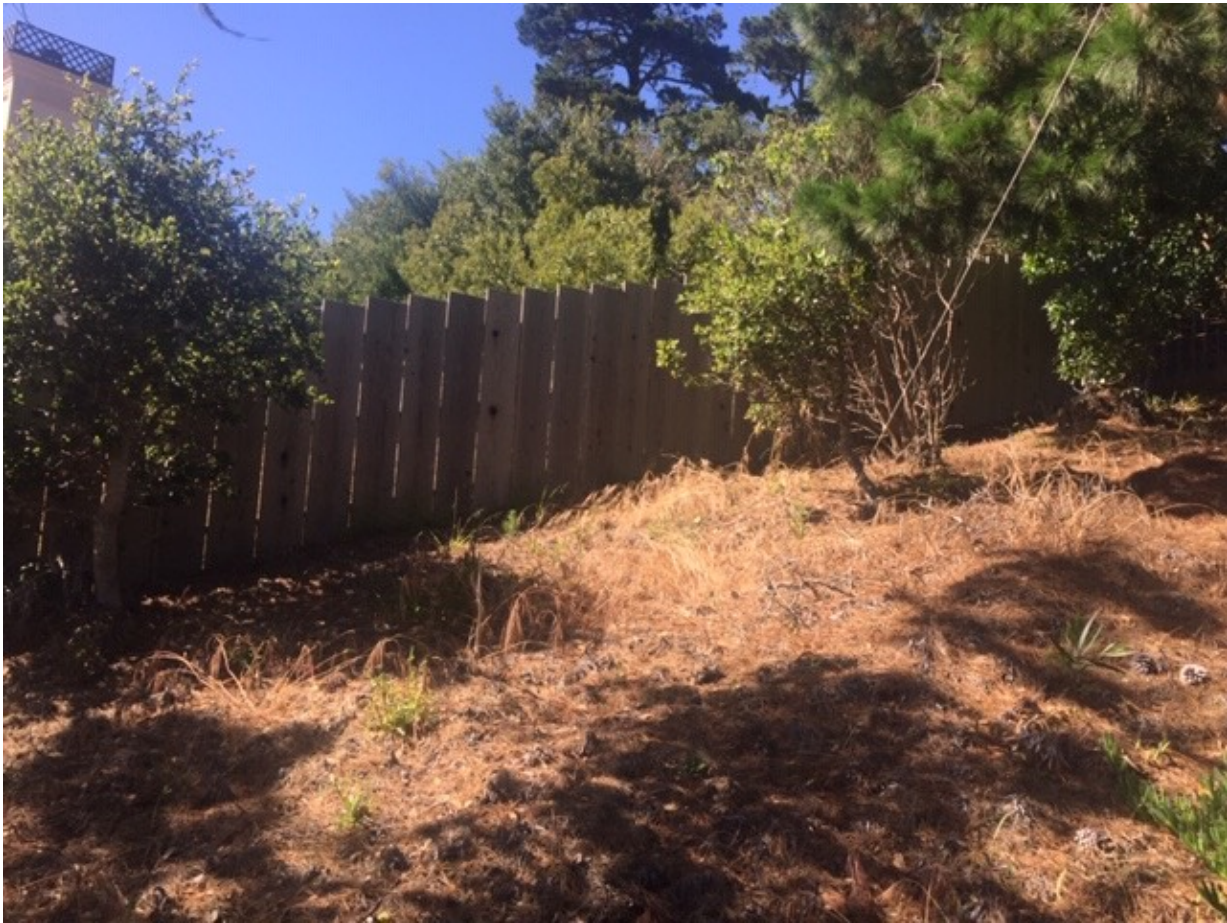
Figure 7. Example of clearing where replacement planting oaks and pines can be planted.

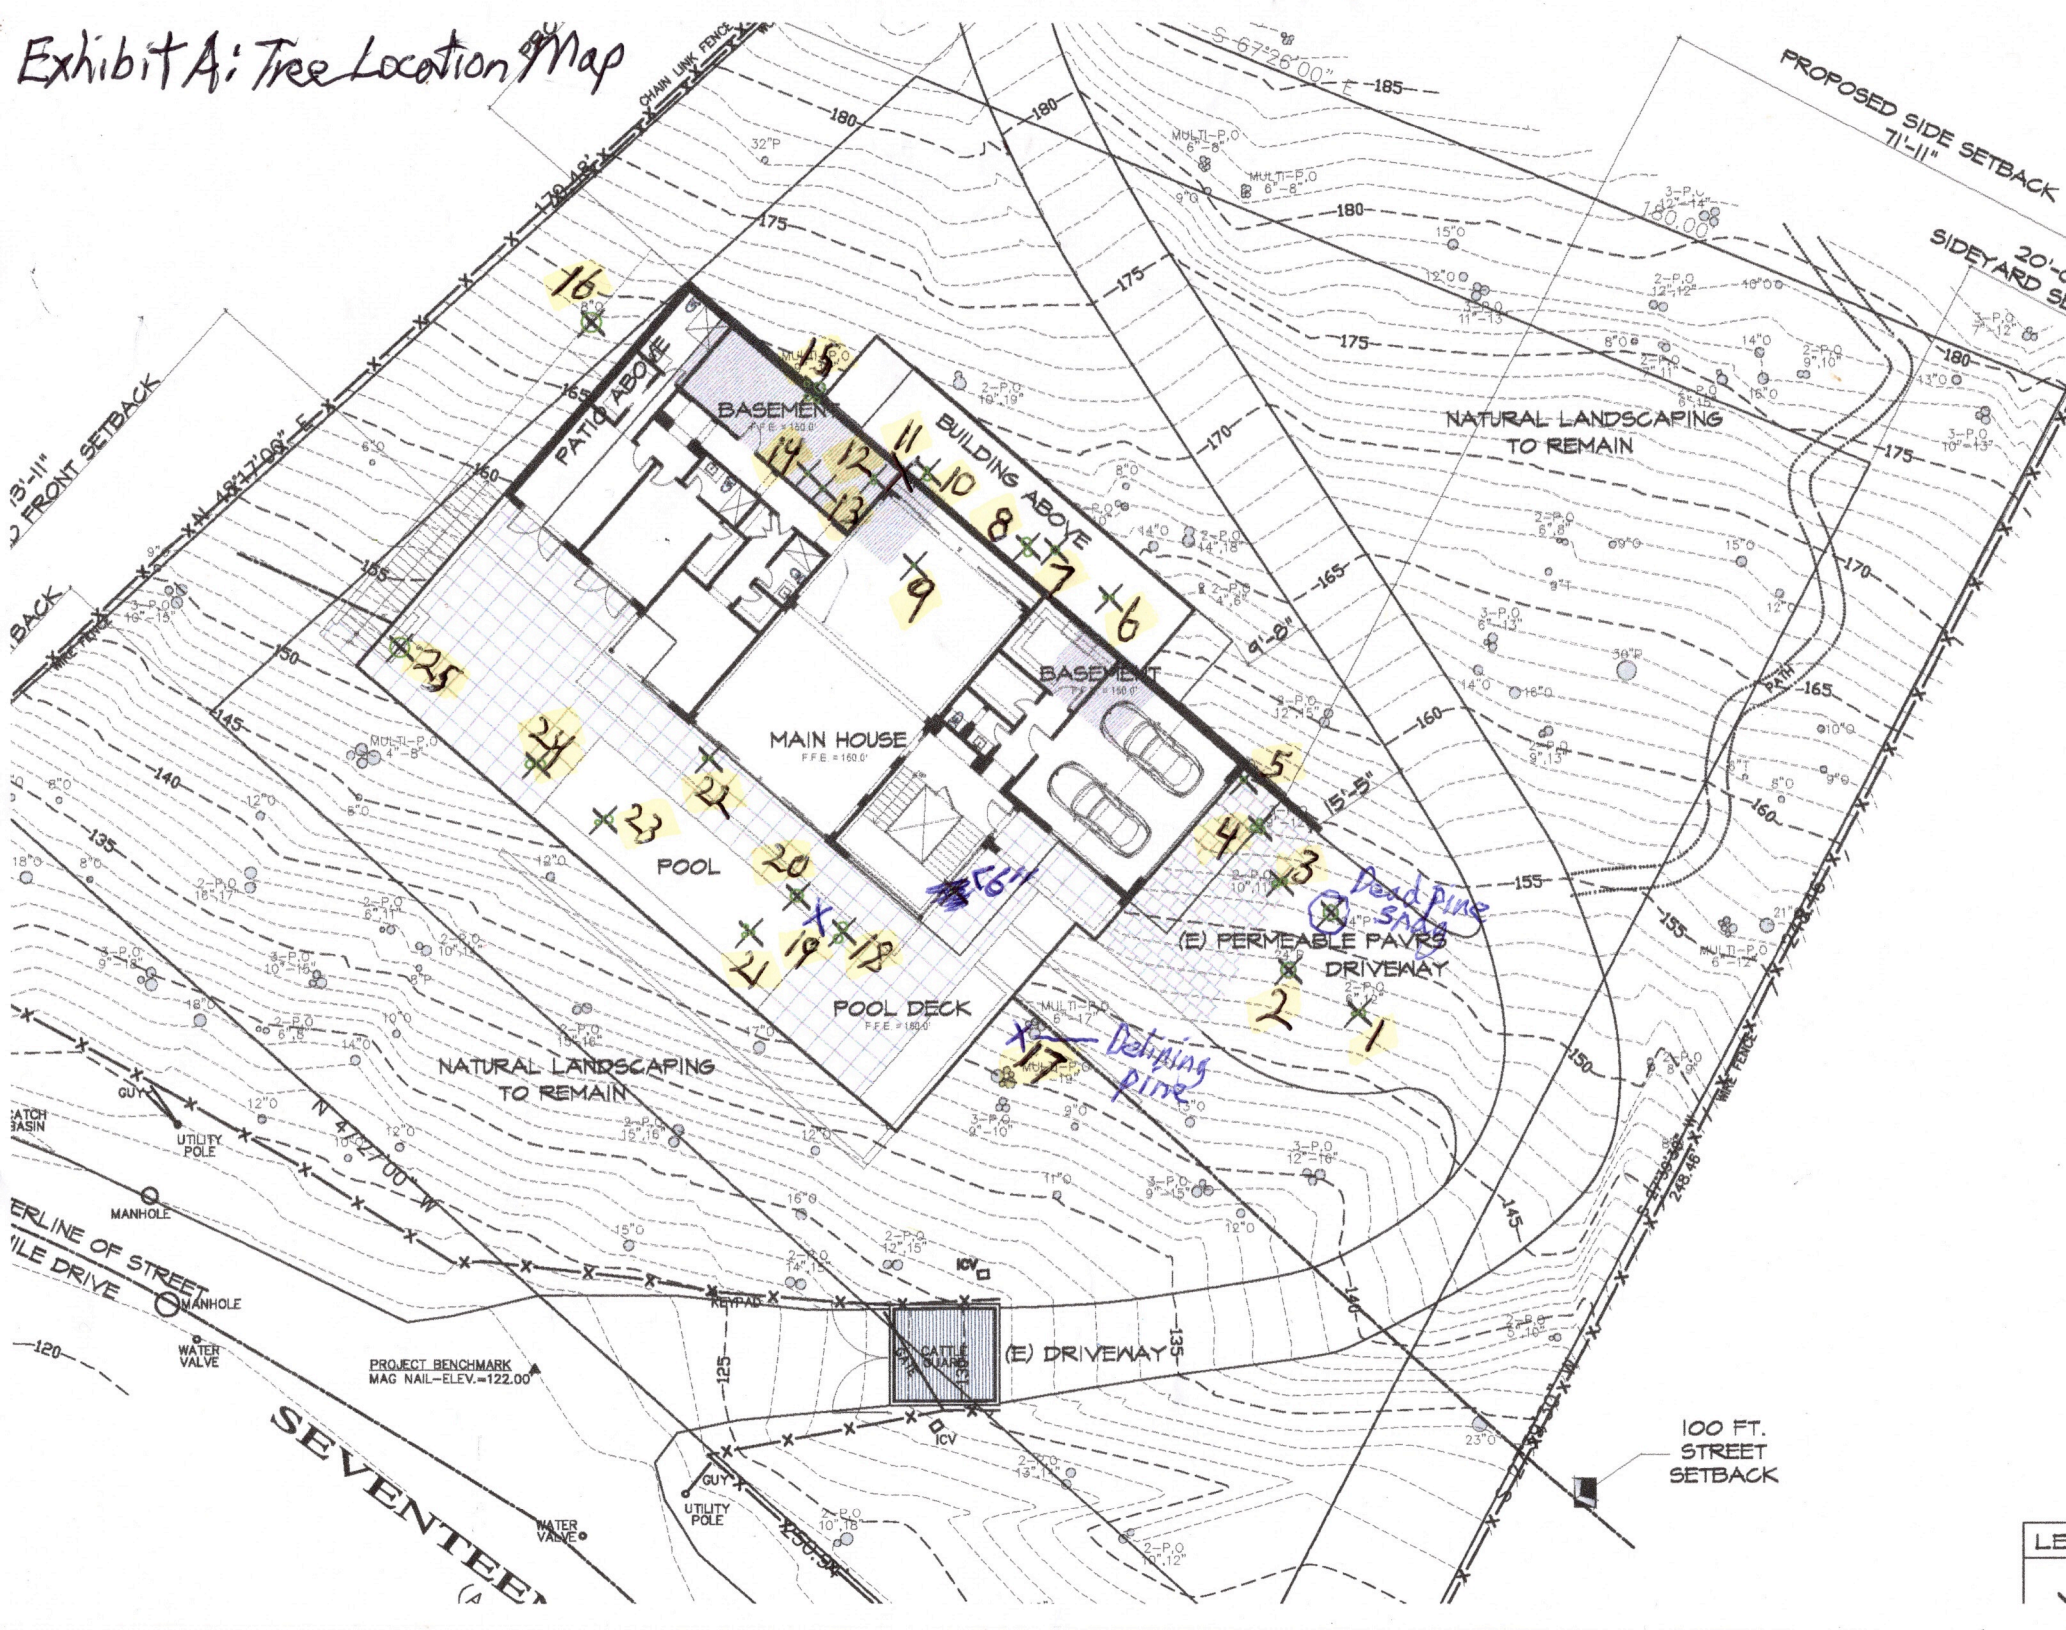
Exhibit A: Tree Location Map

These 25 trees are identified on the property with orange flagging tape and have been assigned tag numbers 1-25 (refer to the corresponding *Exhibit A: Tree Location Map*). All of these trees (exception being one unhealthy and declining pine tree [identified as Tree#17 in *Exhibit A*] located in close proximity to the building envelope that should be removed due to construction impacts and hazard concerns) will require removal due to their location within or directly adjacent to the proposed construction footprint (refer to *Figures 1-6*). Trees located directly adjacent to construction and grading operations frequently require removal due to significant and unavoidable root system impacts that will compromise the health and structural integrity of trees.

As previously noted, tree removal is due to the subject trees being located within or directly adjacent to the proposed construction footprint, exception being the one previously mentioned large and rapidly declining pine tree (Tree#17) located in close proximity to the construction footprint that should be removed due to hazard concerns.
