CONSULTING GEOTECHNICAL & COASTAL ENGINEERS

Subject: Geologic and Coastal Bluff Recession Assessment Report

Reference: 35700 Highway 1, Big Sur, CA 93920
Monterey County APN 418-111-012

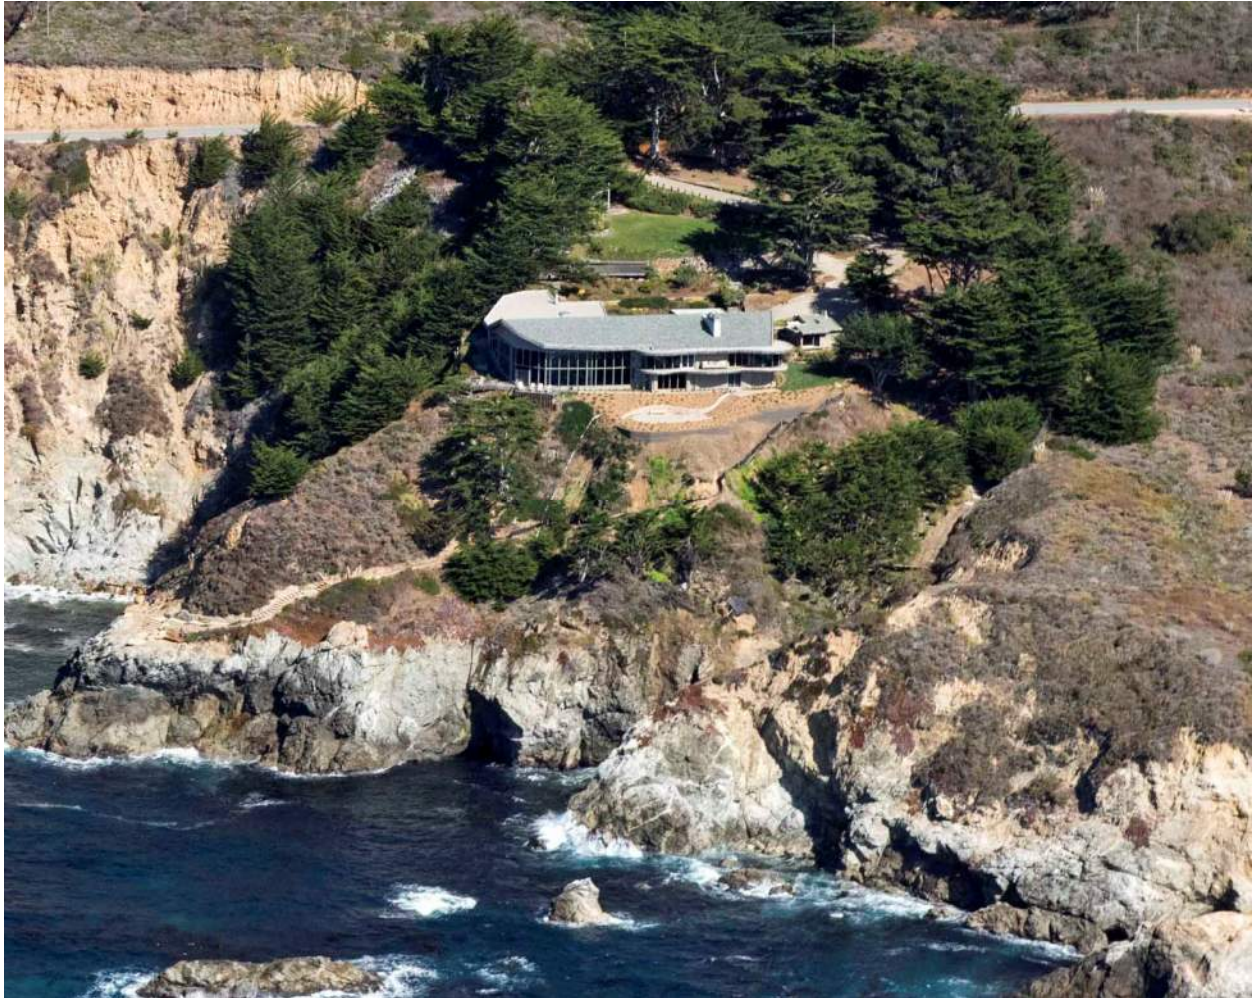
**Photograph 5: Aerial Photograph from October 2, 2019
(courtesy of www.californiacoastline.org)**

We examined the bluff face in October 2021 and find the geologic and geomorphic conditions to be virtually identical to those in the October 2019 photograph below:

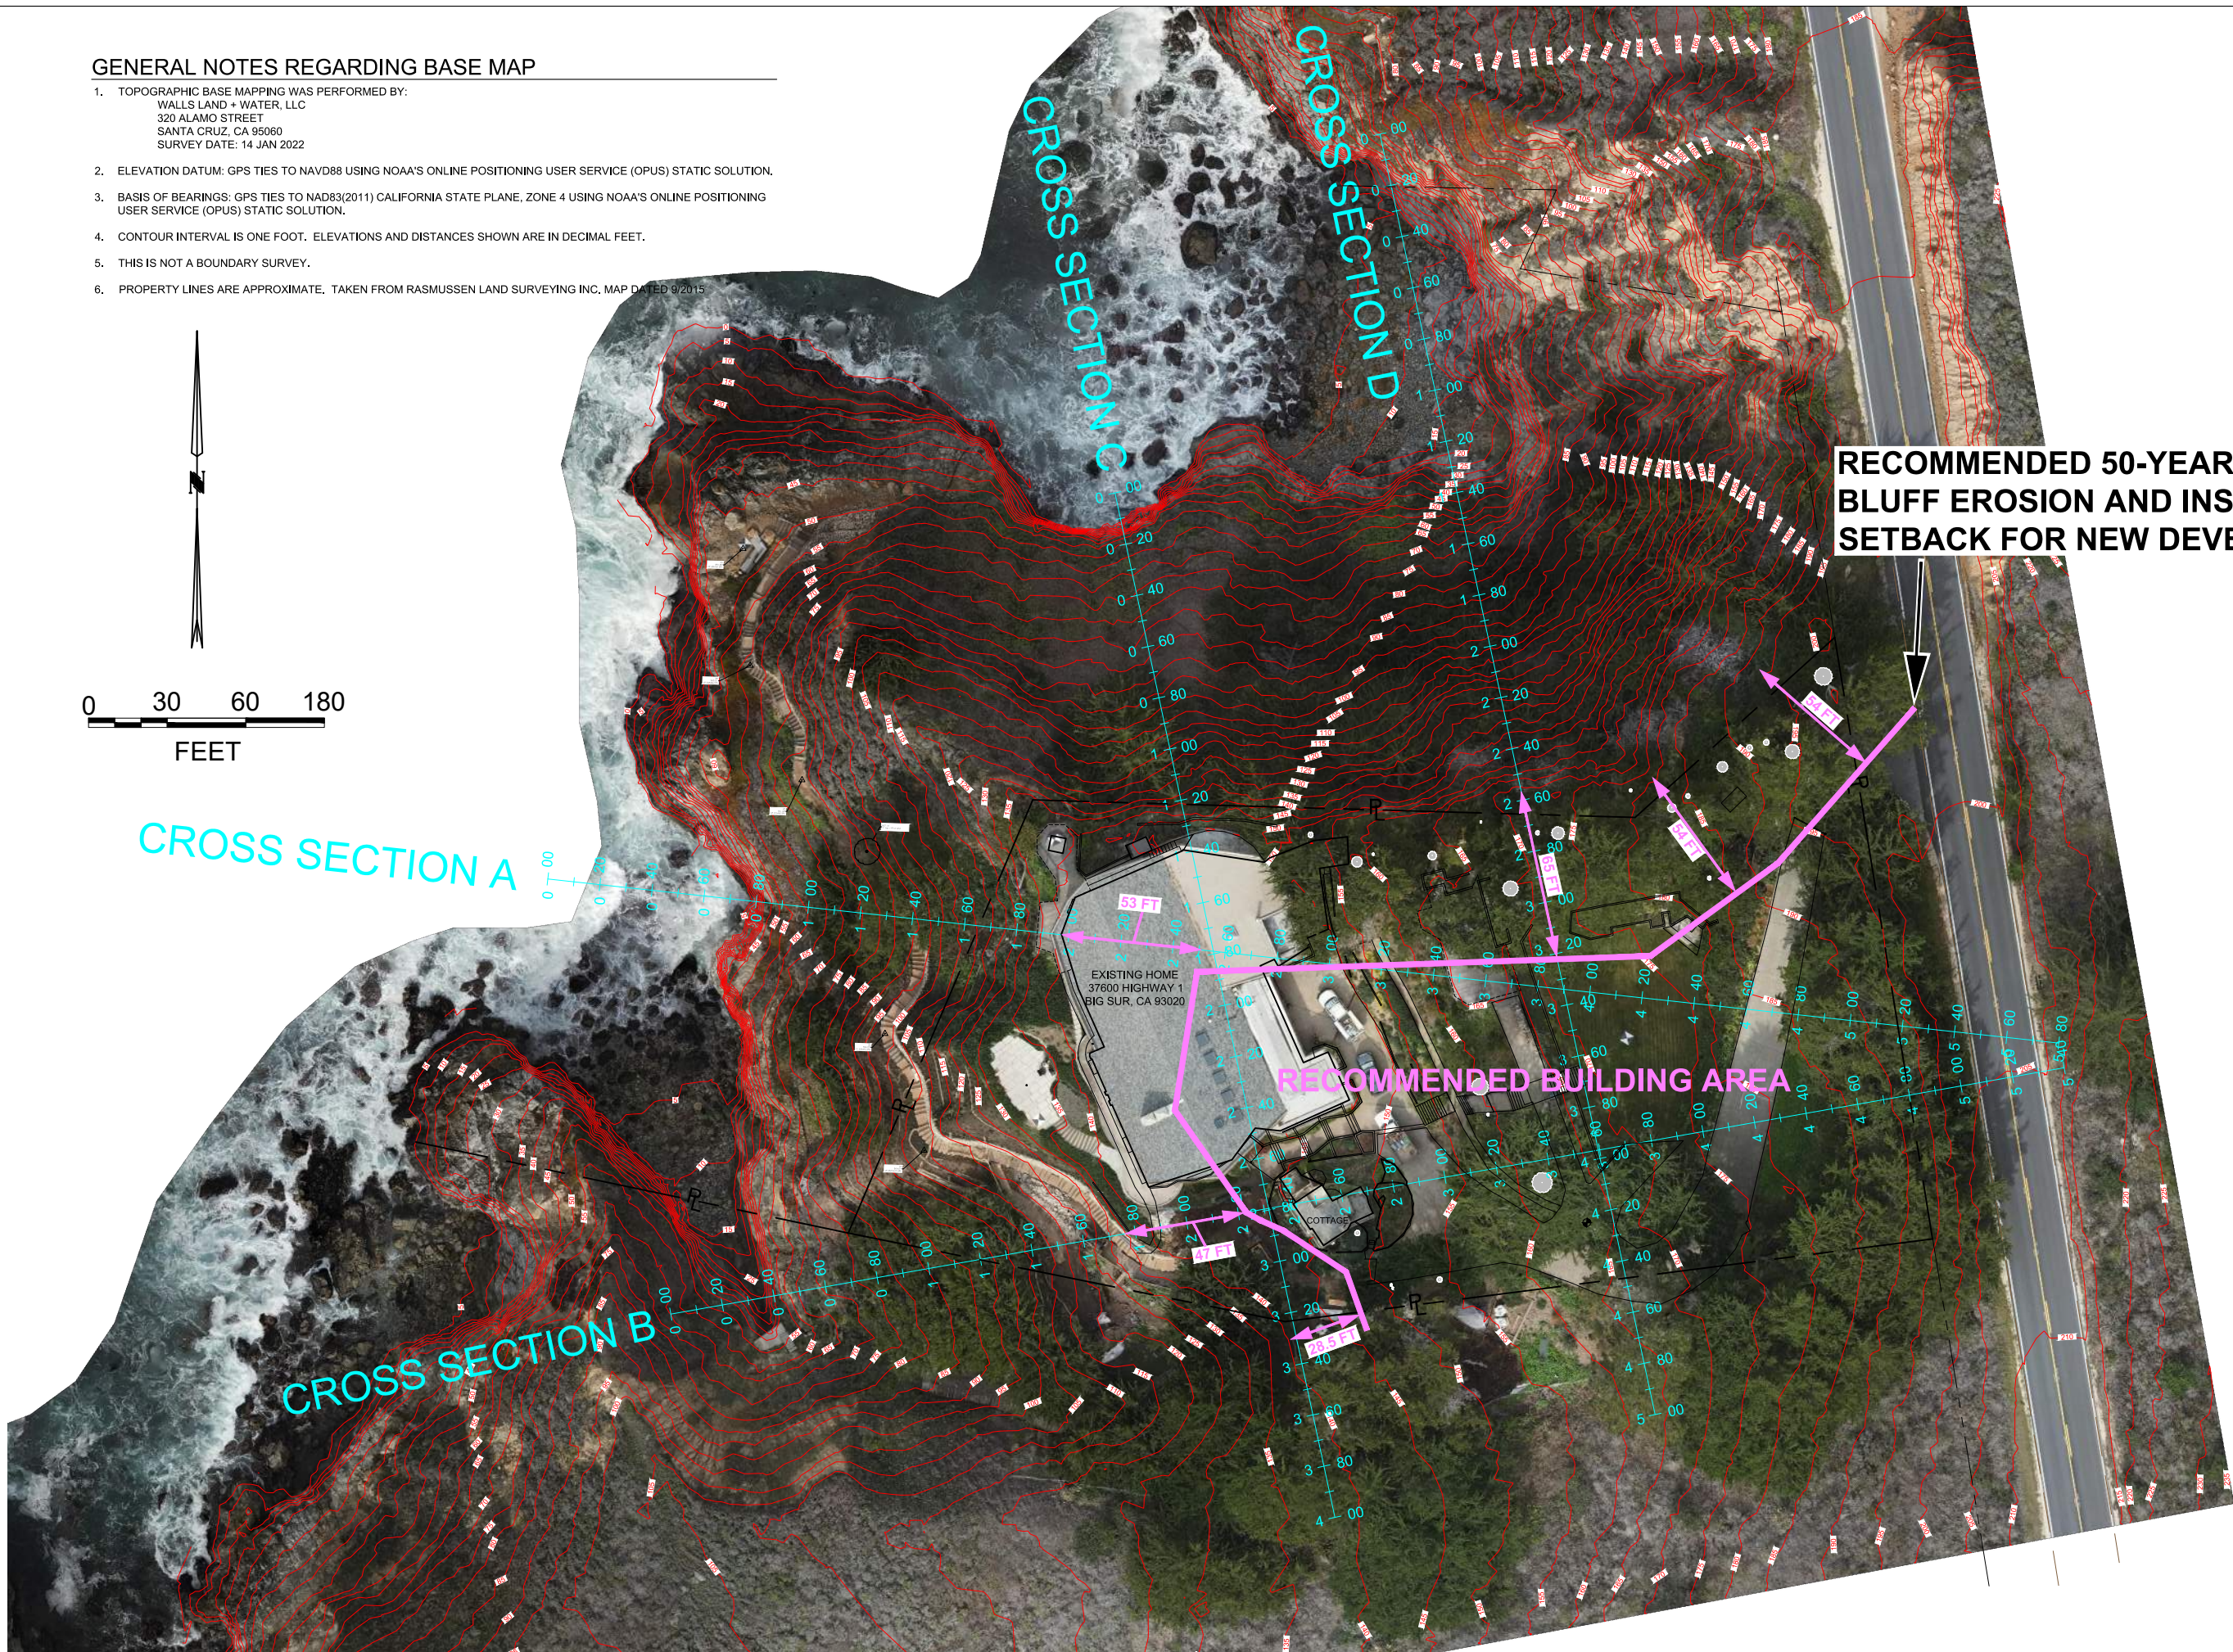
We transferred the results of that slope stability analysis (which is presented in an accompanying report from our firm) onto the geologic Cross Sections that are included in Appendix B to show what portion of the property is likely to remain stable for 50 years (until at least 2073) and show our RECOMMENDED 50-YEAR BLUFF EROSION AND INSTABILITY SETBACK LINE on two maps (Sheets 2 and 3 in Appendix B).

4. At the subject property, we recommend that areas seaward of the RECOMMENDED 50-YEAR BLUFF EROSION AND INSTABILITY SETBACK MAPS (Seven 11 X 17 inch sheets dated 4-28-2022) shown in Appendix B be considered to be at potential risk in the next 50 years (by 2073). This is derived as follows: 50 years of debris fan recession at the estimated

long term historical average annual erosion rate (4 feet), plus flattening of the overlying surficial soil slopes from potential slope instability, which varies in additional distance (43 to 61 feet) depending upon the location on the site. Appendix B contains RECOMMENDED 50-YEAR BLUFF EROSION AND INSTABILITY SETBACK MAPS (Seven 11 X 17 inch sheets dated 4-28-2022) which shows our recommended 50 year setback in relation to both the existing development and proposed new structures.

- 1) At the subject property, we recommend that areas seaward of the RECOMMENDED 50-YEAR BLUFF EROSION AND INSTABILITY SETBACK MAPS (Seven 11 X 17 inch sheets dated 4-28-2022) shown in Appendix B be considered to be at potential risk in the next 50 years (by 2073). We recommend that new habitable development only be constructed inland of this setback. It is possible that any development or improvements seaward of this setback may be damaged by coastal erosion, bluff retreat and/or bluff instability during the next 50 years.

- 3) We should review any plans that are submitted for permit purposes prior to submittal.
- 4) Prior to construction of any new foundations, coastal bluff recession should be considered. The location of the proposed new foundations should be verified to insure that they are landward of the recommended 50 year coastal recession setback line shown on the map in Appendix B prior to reinforcing steel being placed and concrete being poured. Improvements seaward of the recommended 50 year coastal recession setback line should be considered sacrificial.
