**THOMPSON
WILDLAND MANAGEMENT**

August 4, 2022

Maxwell Residence
21 Pronghorn Run
Carmel, CA. 93923
APN: 239-091-044-000

Subject: 21 Pronghorn Run Pre-construction Tree Impact Assessment

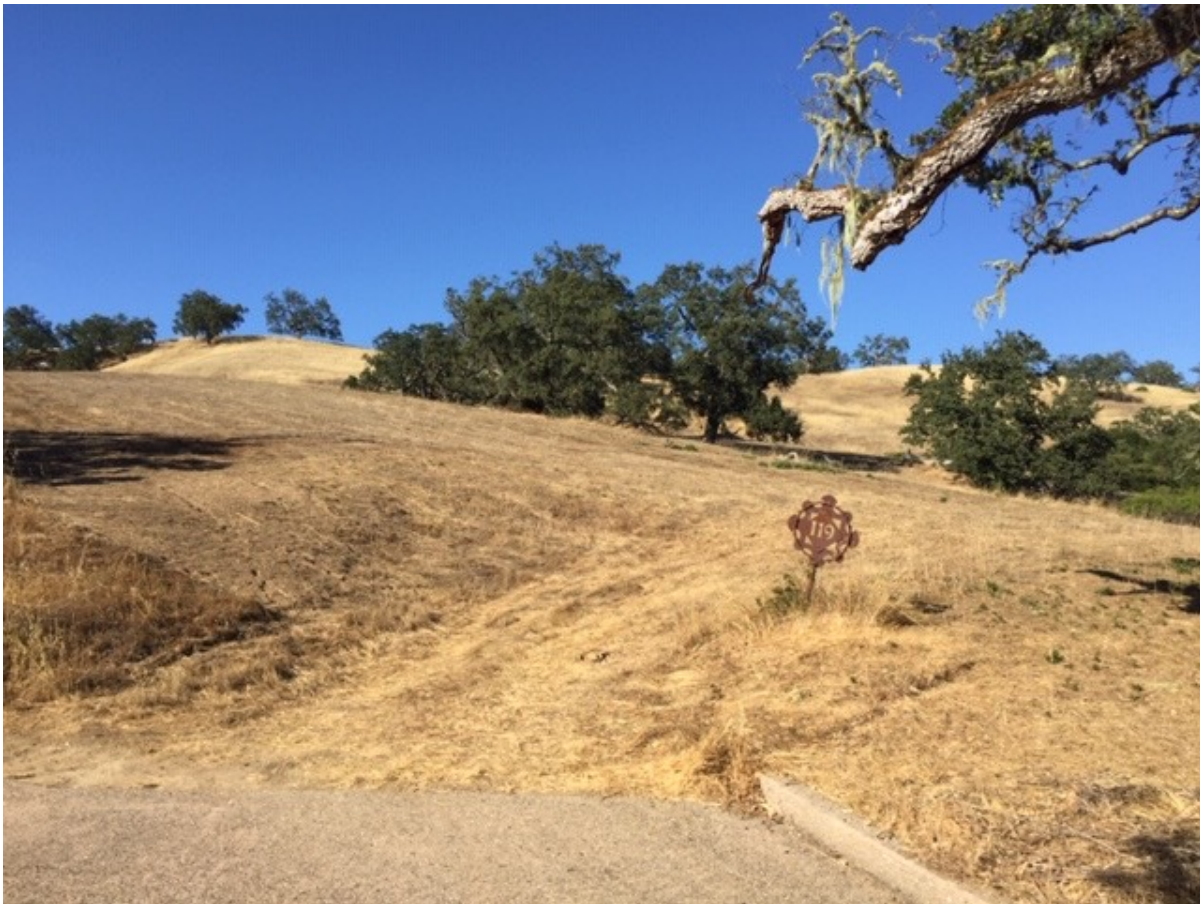
Figure 1. Entrance to Lot 119 located in oak savanna habitat. No trees are planned for removal.

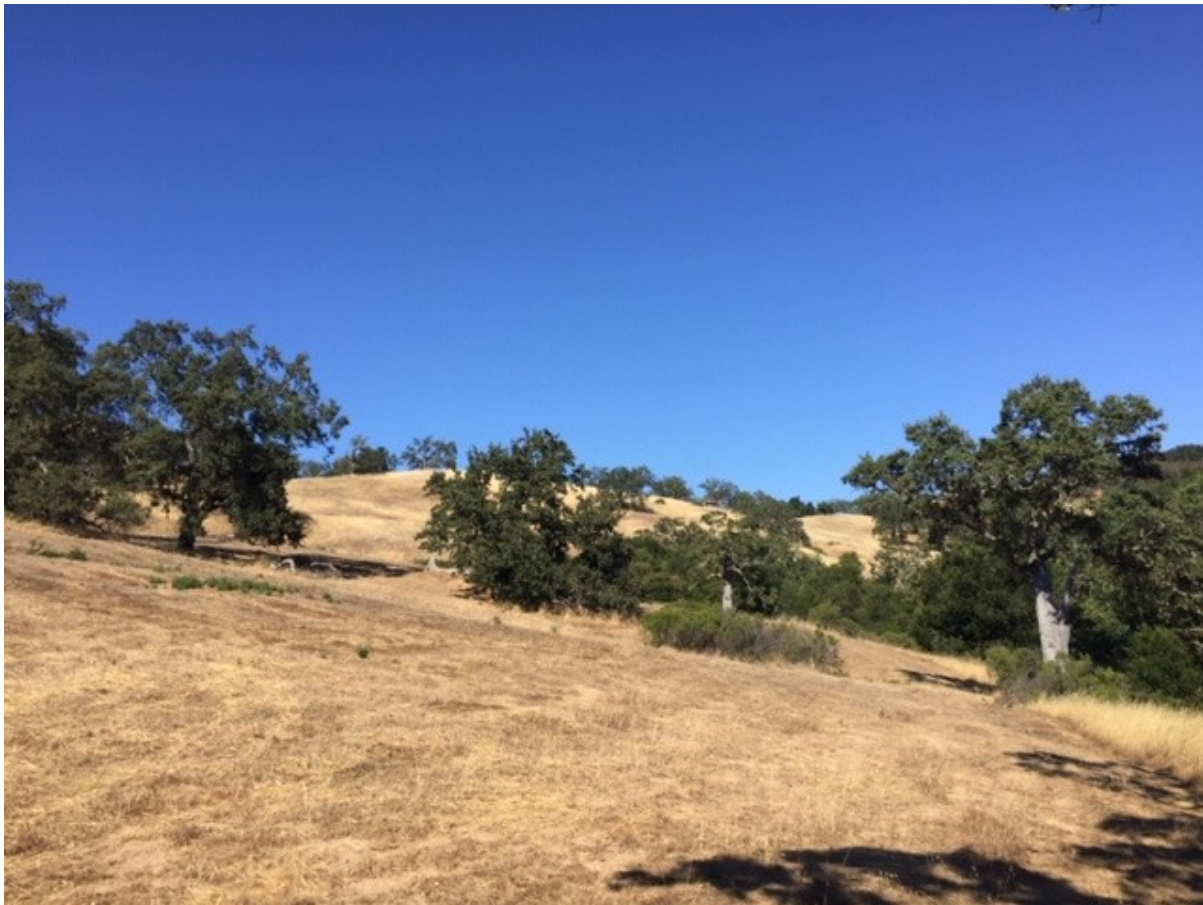
Figure 2. View of oak savanna Homeland from entrance to lot. Valley oak identified as *Tree#270* is at right edge of photo. Oaks identified as *Tree#s 271-273* are also visible in background of photo. All oaks will be retained and protected.

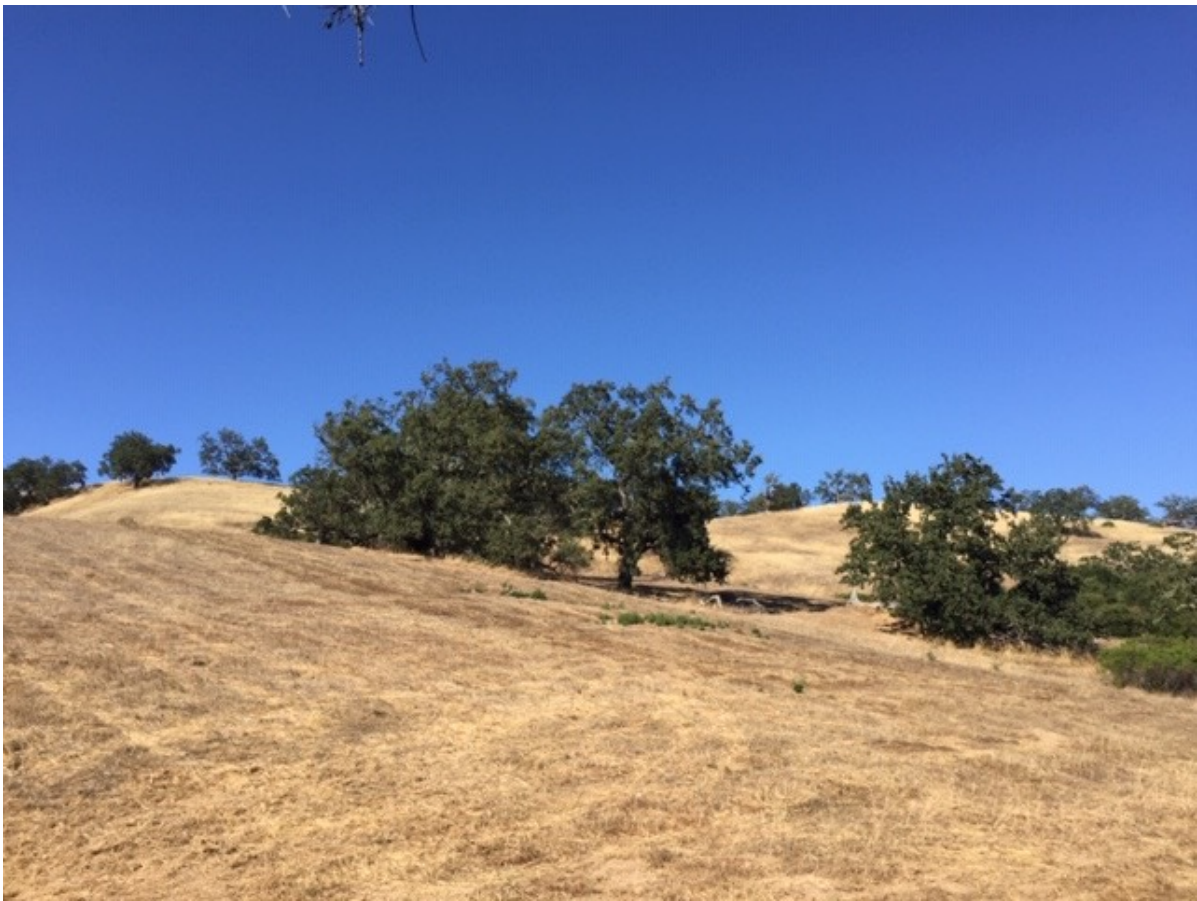
Figure 3. Another view of Homeland from entrance looking up towards proposed homesite. Valley oaks identified as *Tree#s 272-275* are visible in photo.

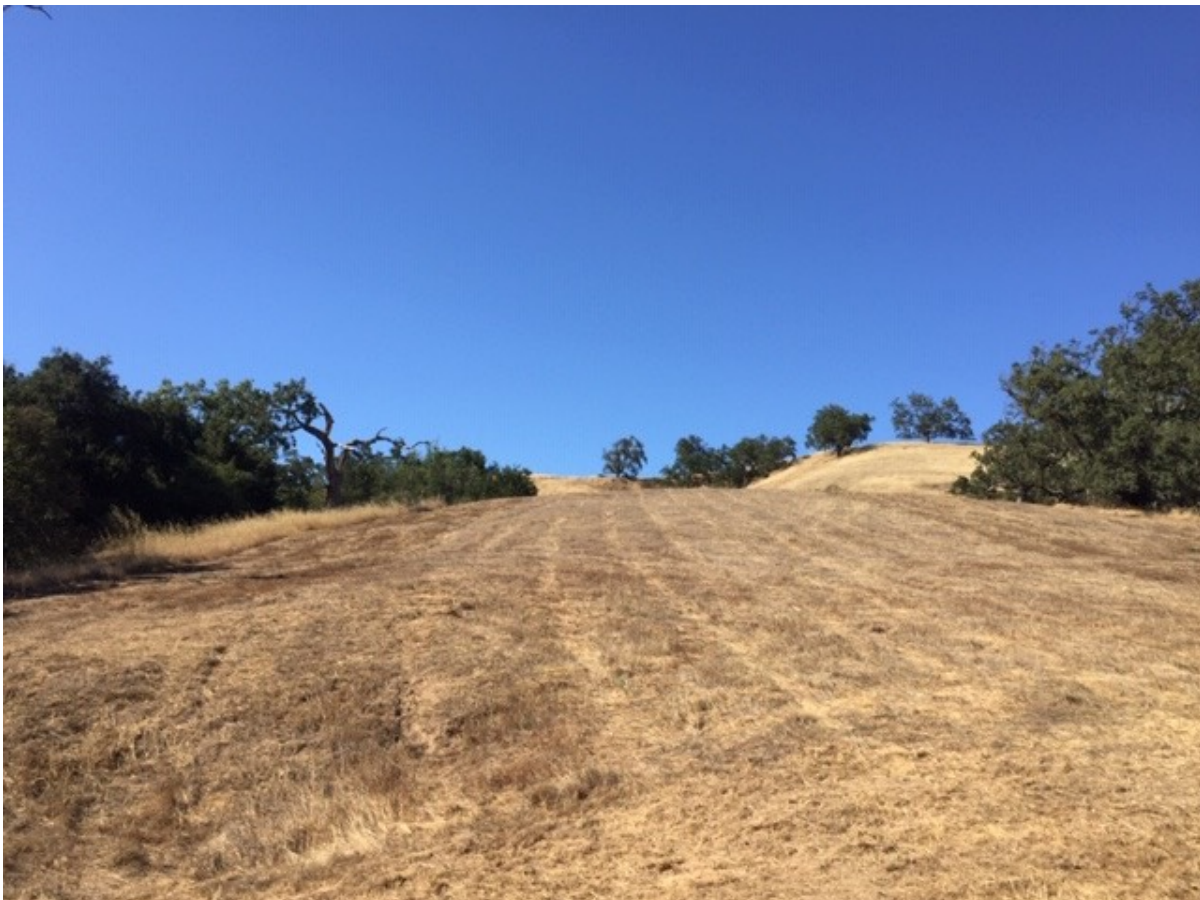
Figure 4. Another view of Homeland from entrance looking up towards homesite area.

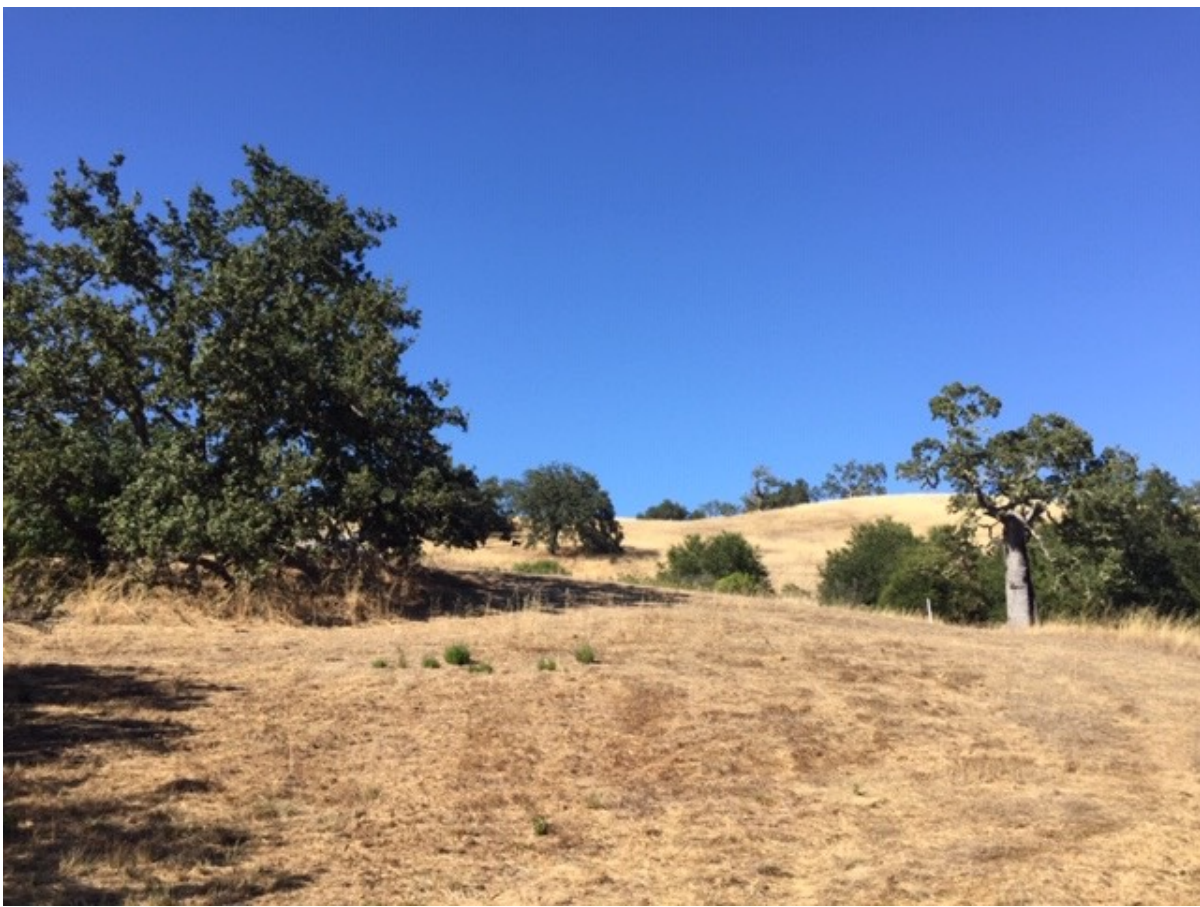
Figure 5. Valley oak identified as *Tree#271* is at right edge of photo and valley oak identified as *Tree#272* is to the left.

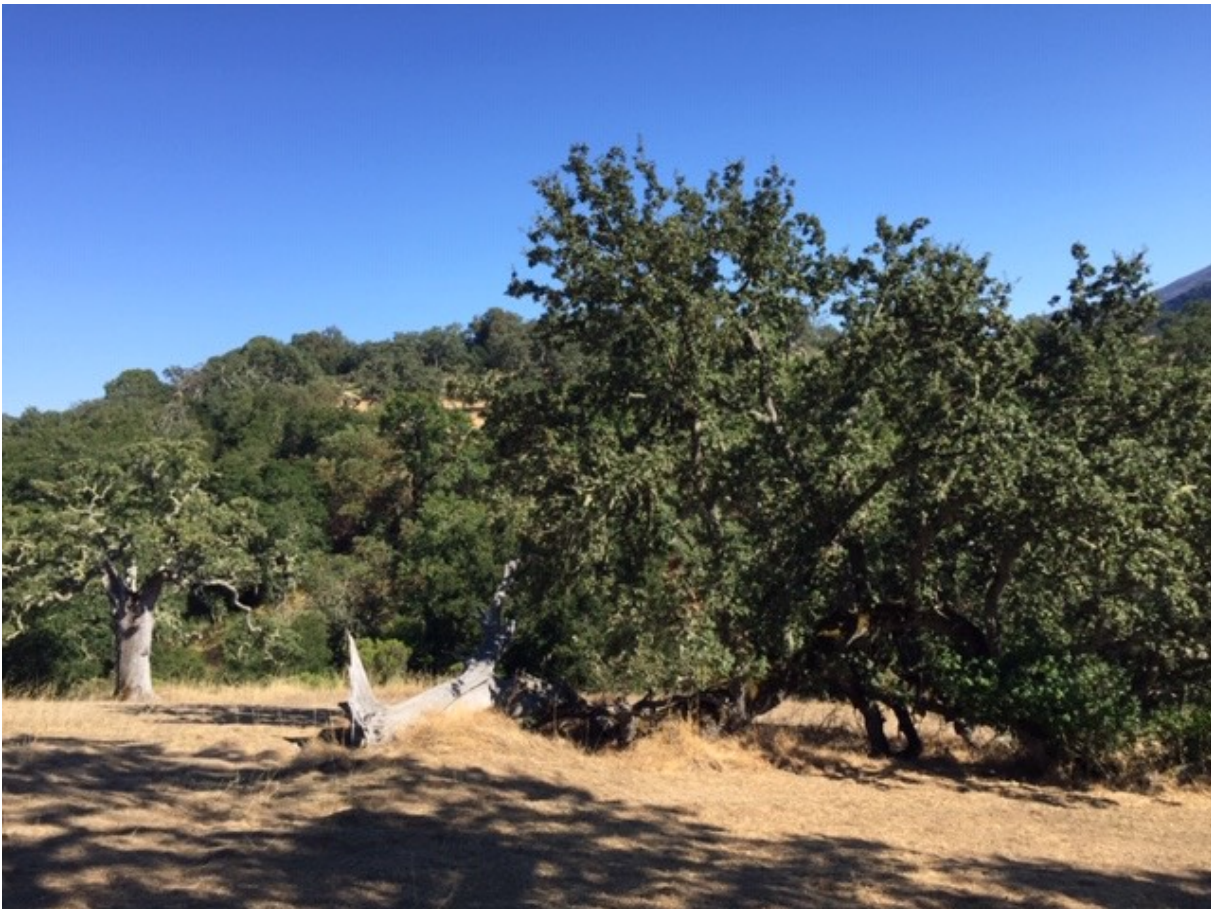
Figure 6. *Tree#272* is in center foreground and *Tree#271* is in left background of photo. Fairly dense mixed oak woodland is occurring in background just outside of Homeland.

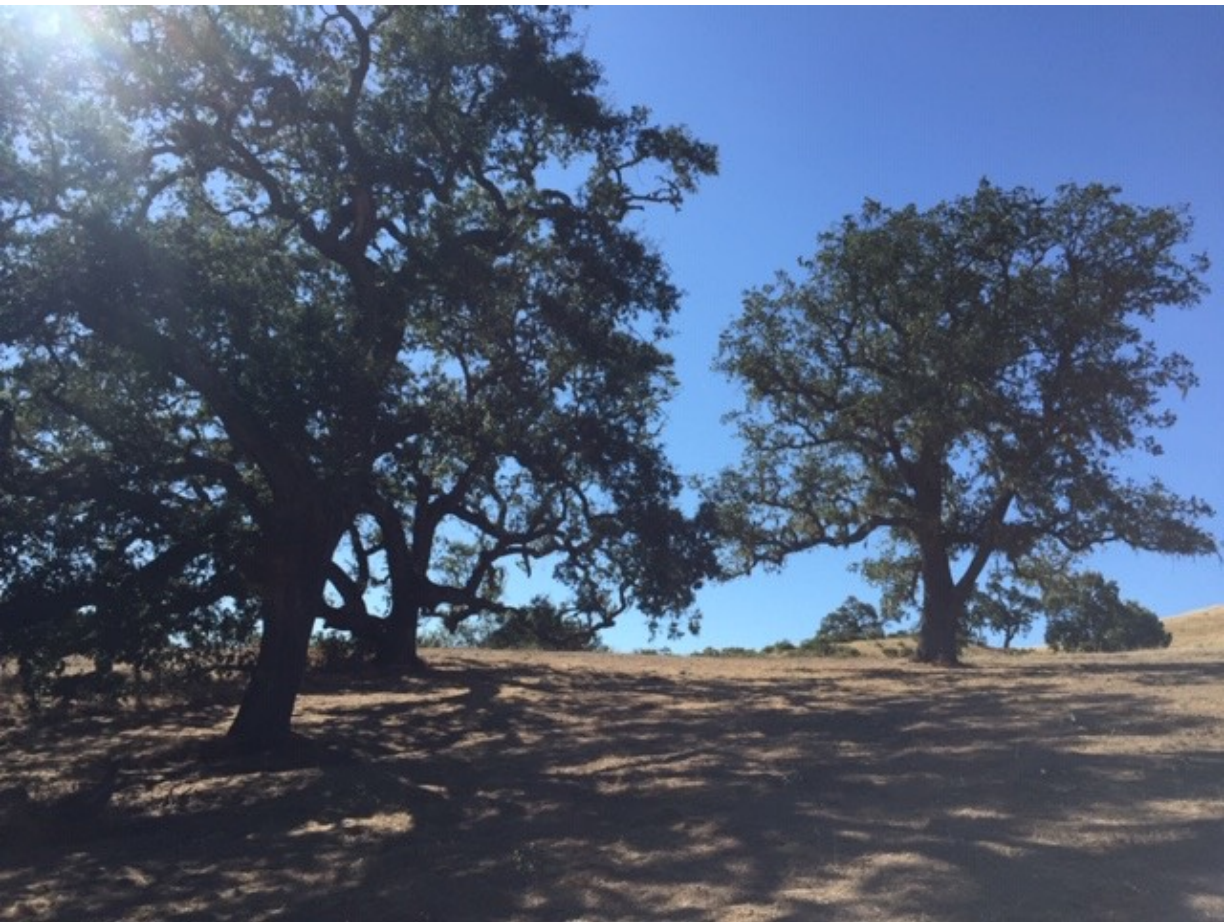
Figure 7. Large and senescing valley oaks identified as *Tree#s* 273-275 (going left to right) will be retained and protected.

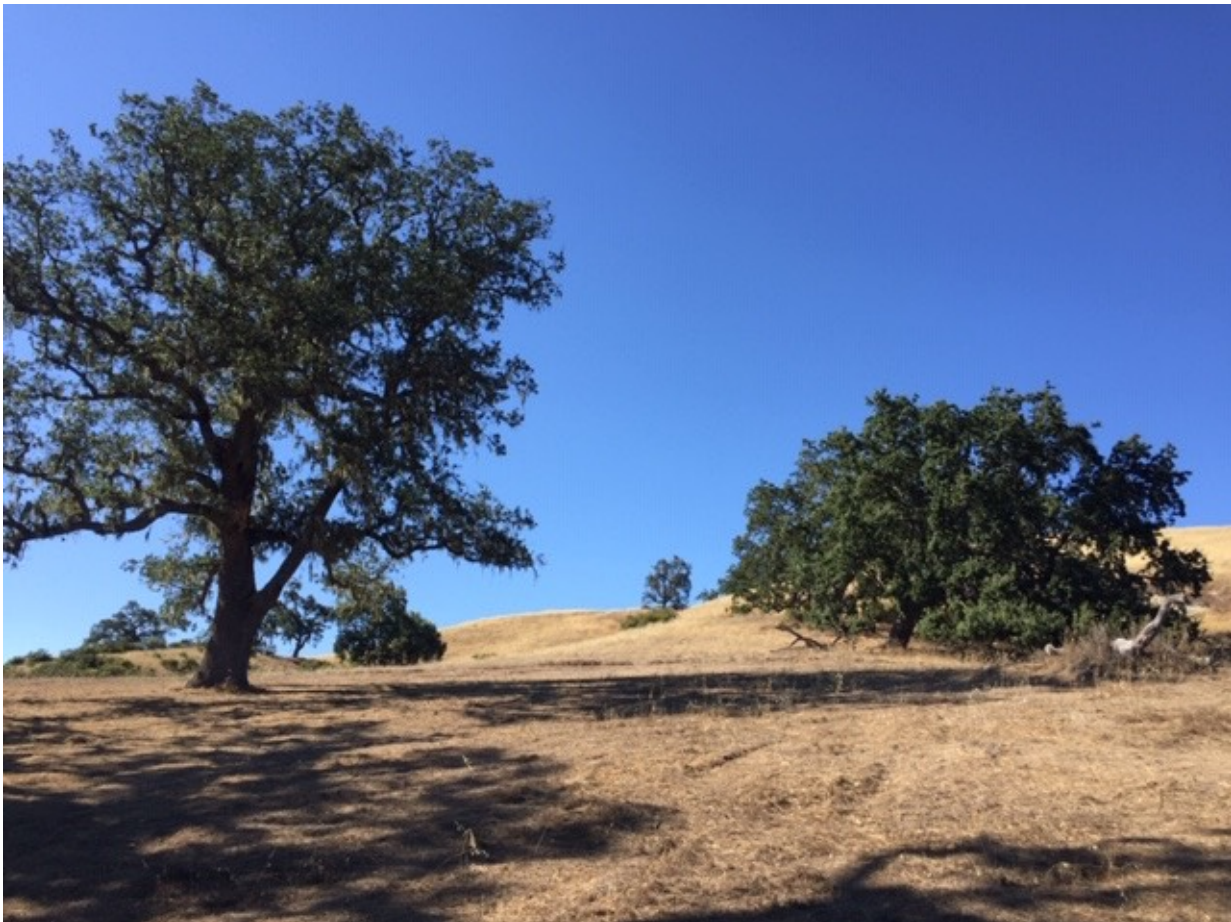
Figure 8. Valley oaks identified as *Tree#s* 275 (left of center) & 276 (background right of center) are visible in photo.

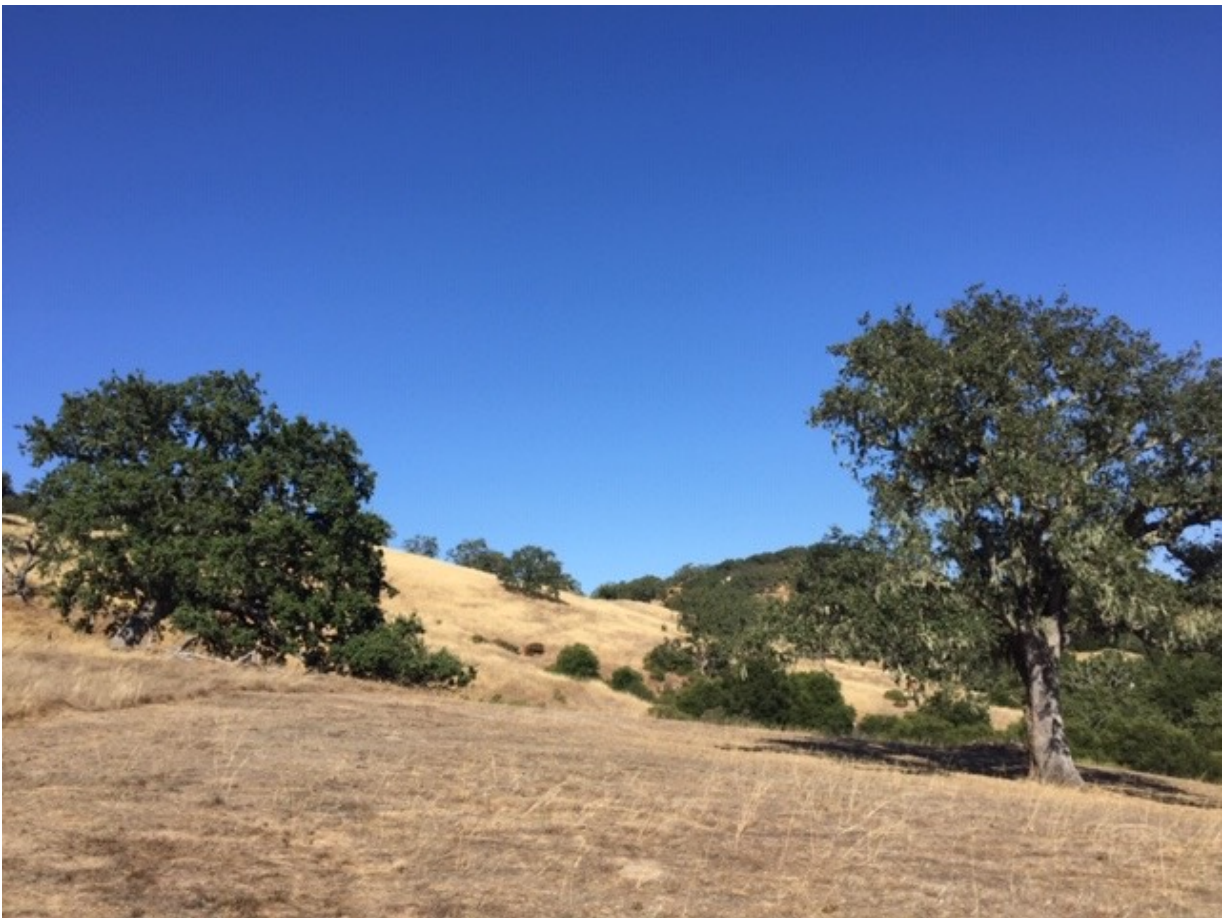
Figure 9. Another view of *Tree#s* 275 (right edge of photo) & 276 (left edge of photo).

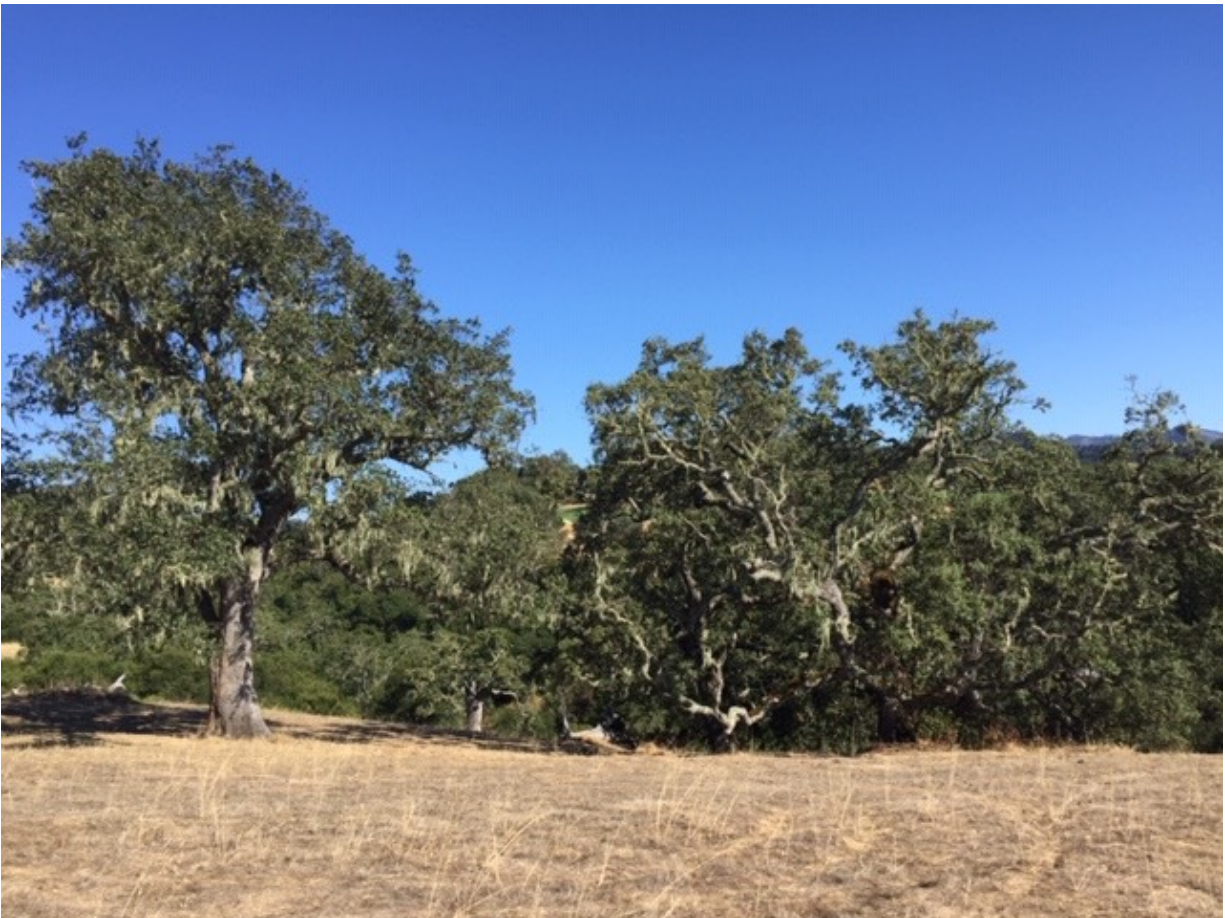
Figure 10. View of *Tree#274* is located in center of photo and *Tree#275* is left of center.

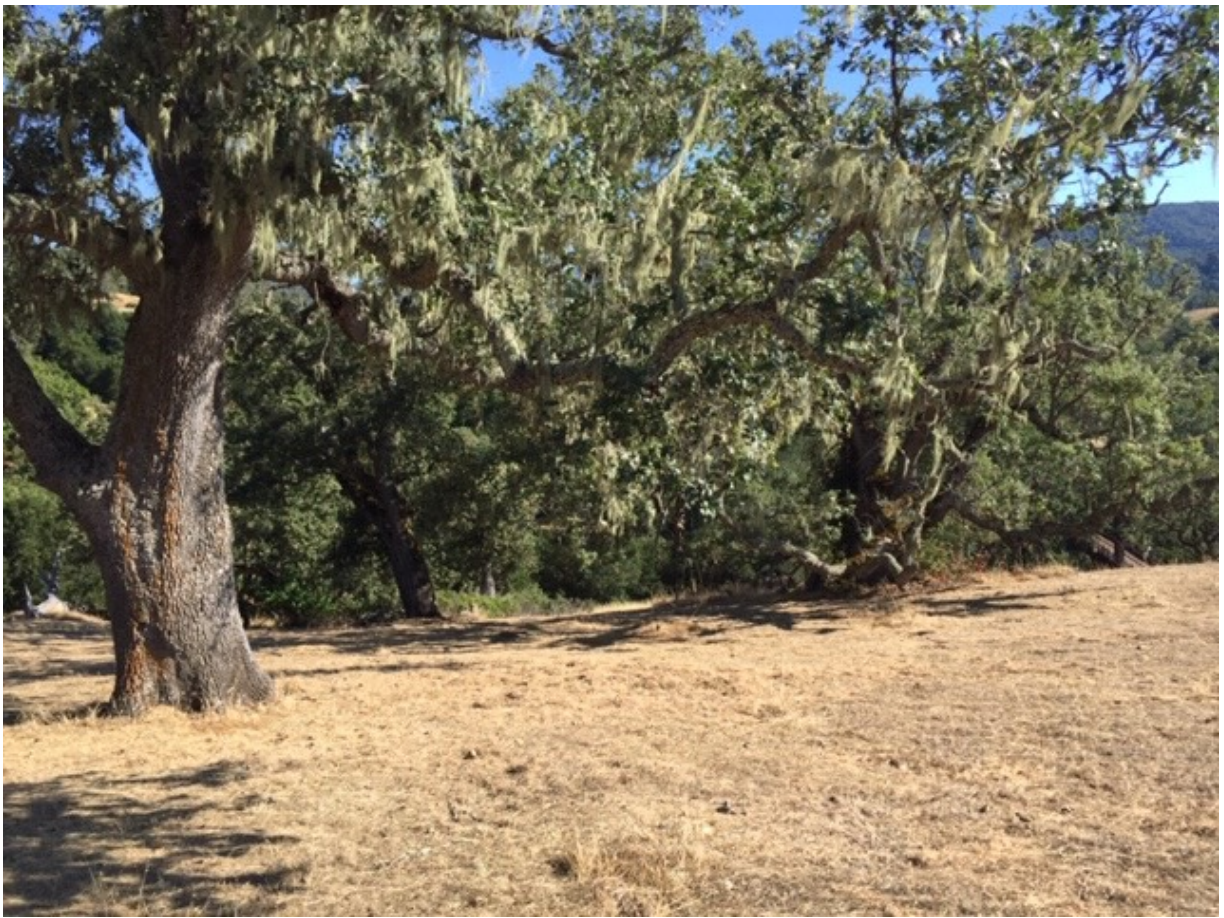
Figure 11. View of *Tree#273* (background left of center), *Tree#274* (right of center) and *Tree#275* (foreground left).

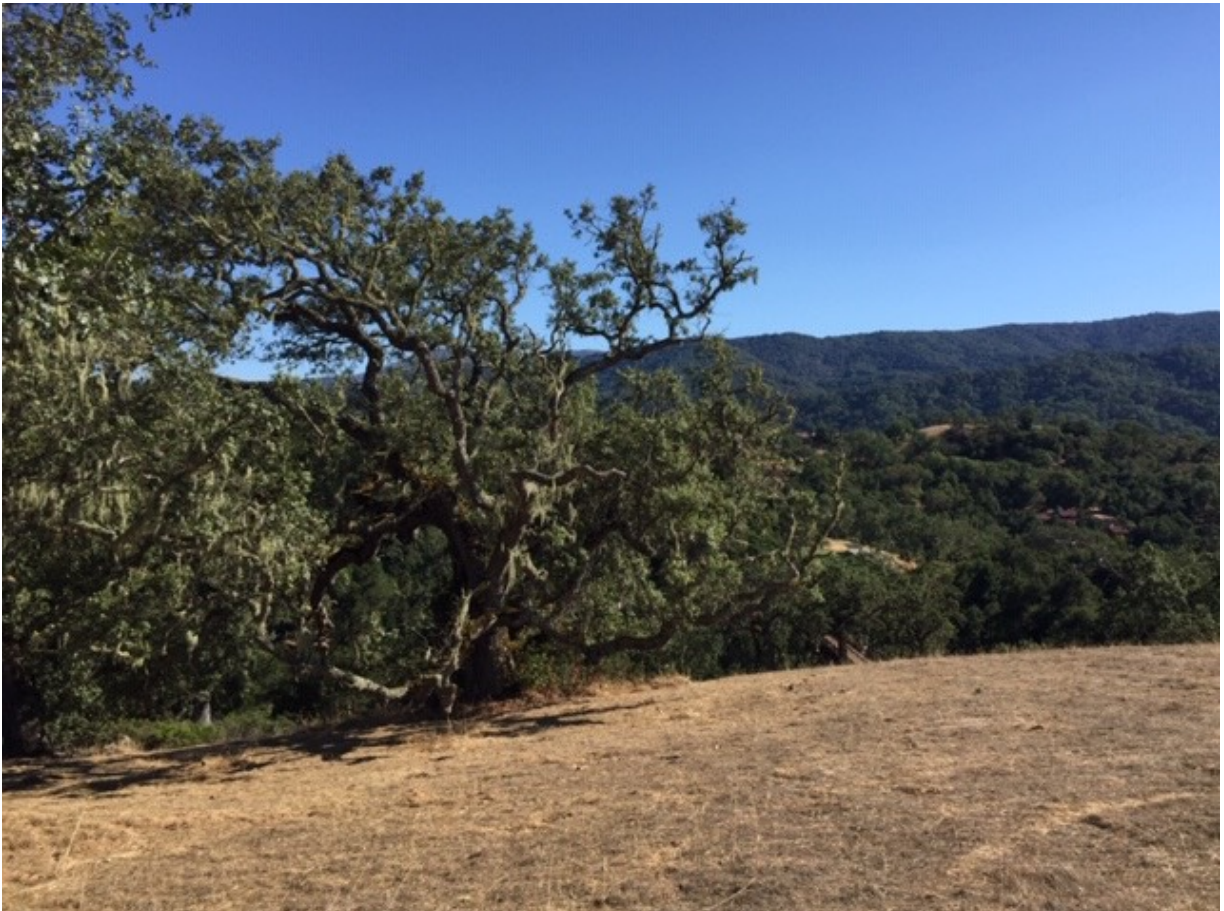
Figure 12. View of valley oak identified as *Tree#274* next to proposed homesite. All oaks will be retained and protected.

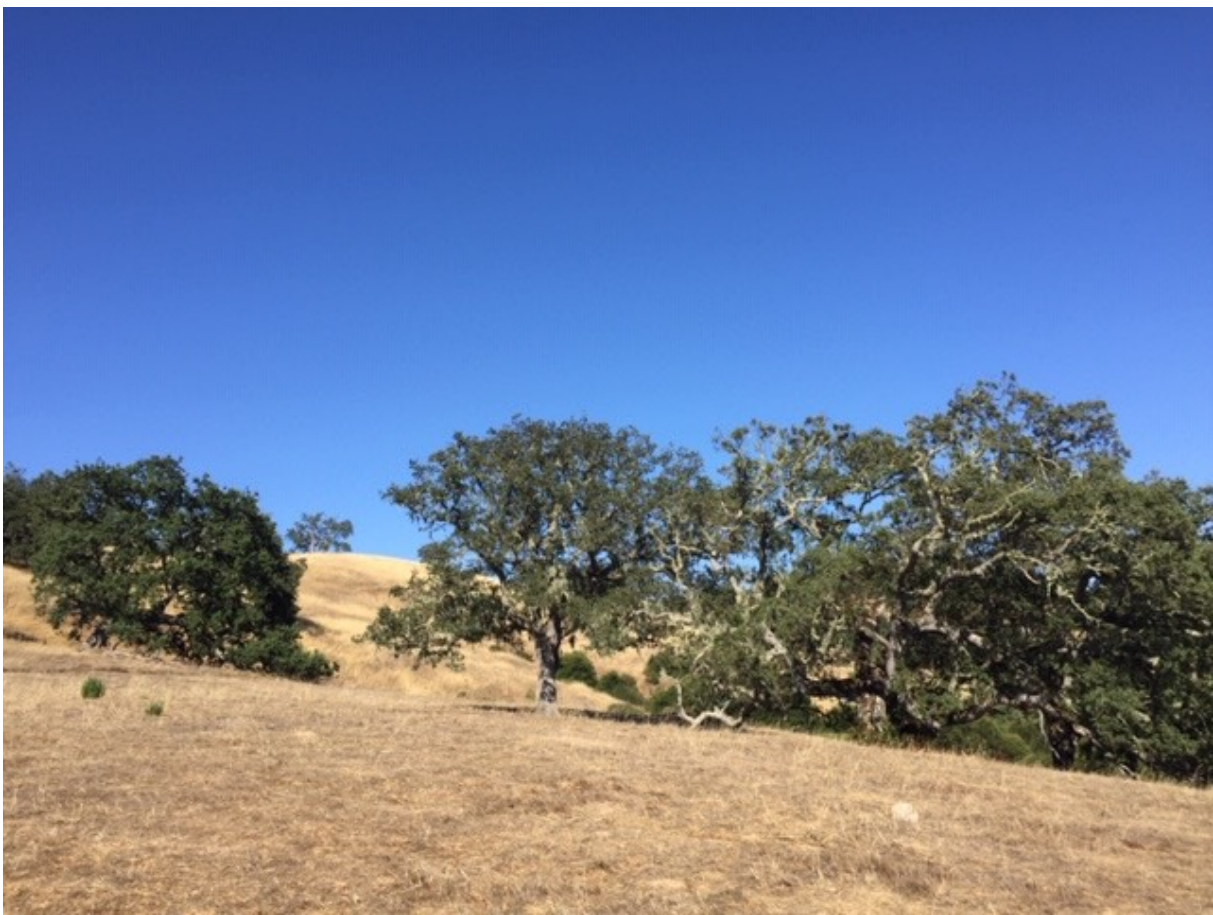
Figure 13. *Tree#s* 274-276 (right to left) viewed from proposed homesite located in oak savanna environment.

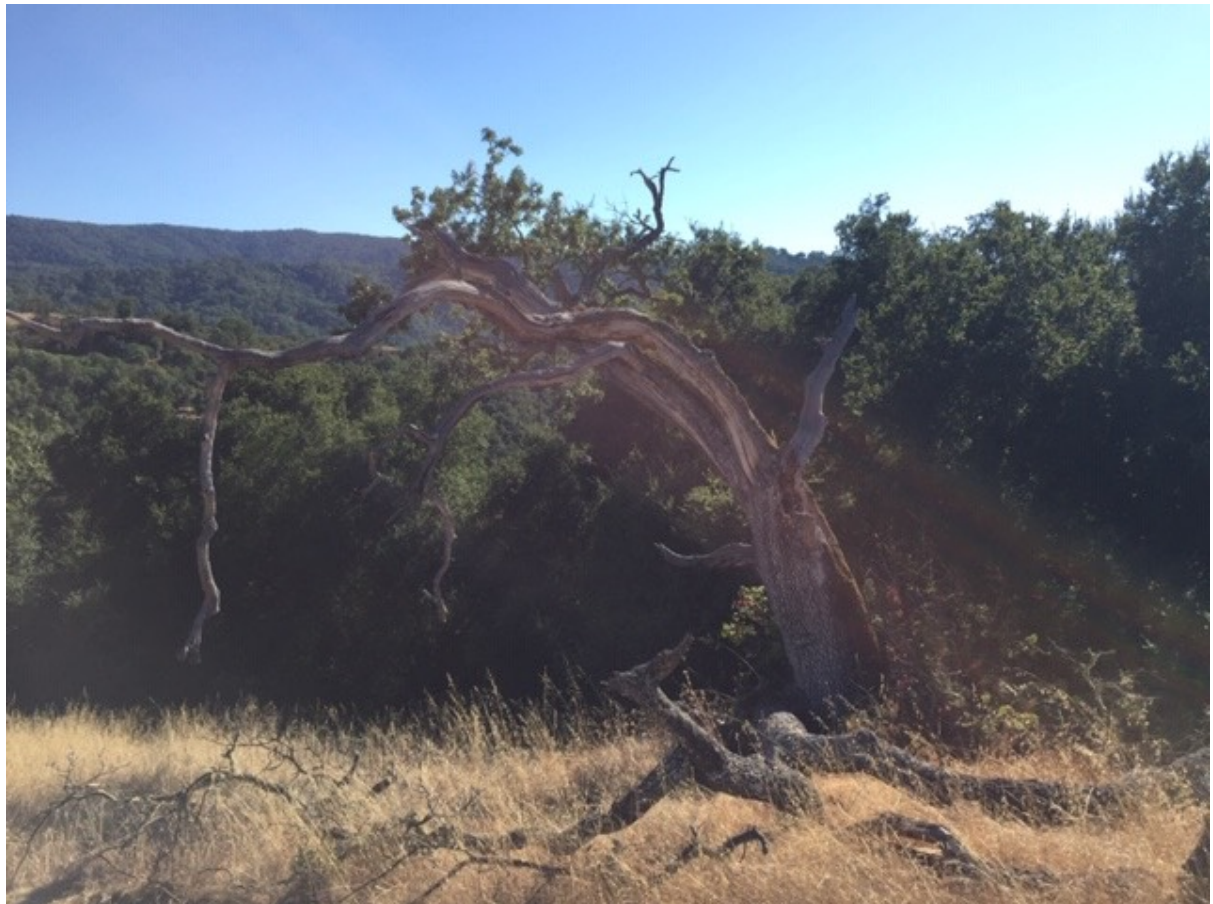
These 8 valley oaks range from being in poor to good overall health and condition, with a majority of these aging oaks being in fair physiological health and structural condition. It should be noted that the oak identified as *Tree#277* is nearly dead and not considered a viable tree (refer to *Figure 14*) due to it only having one living limb as well as severe deadwood, decay and structural degradation. This deteriorating oak can be characterized as a snag and will be retained for habitat value.

Figure 14. Nearly dead valley oak identified as *Tree#277* does not pose a hazard concern and will be retained for habitat. Fairly dense mixed oak woodland is occurring just outside of Homeland.
