Original September 14, 2020 Pre-
Construction Tree Impact Assessment

(April 3, 2023 Revised Pre-Construction
Tree Impact Assessment and supplemental
correspondence attached below)

Spanos Residence
3347 17 Mile Drive
Pebble Beach, CA. 93953
APN: 008-351-008-000

Subject: 3347 17 Mile Drive pre-construction tree impact assessment

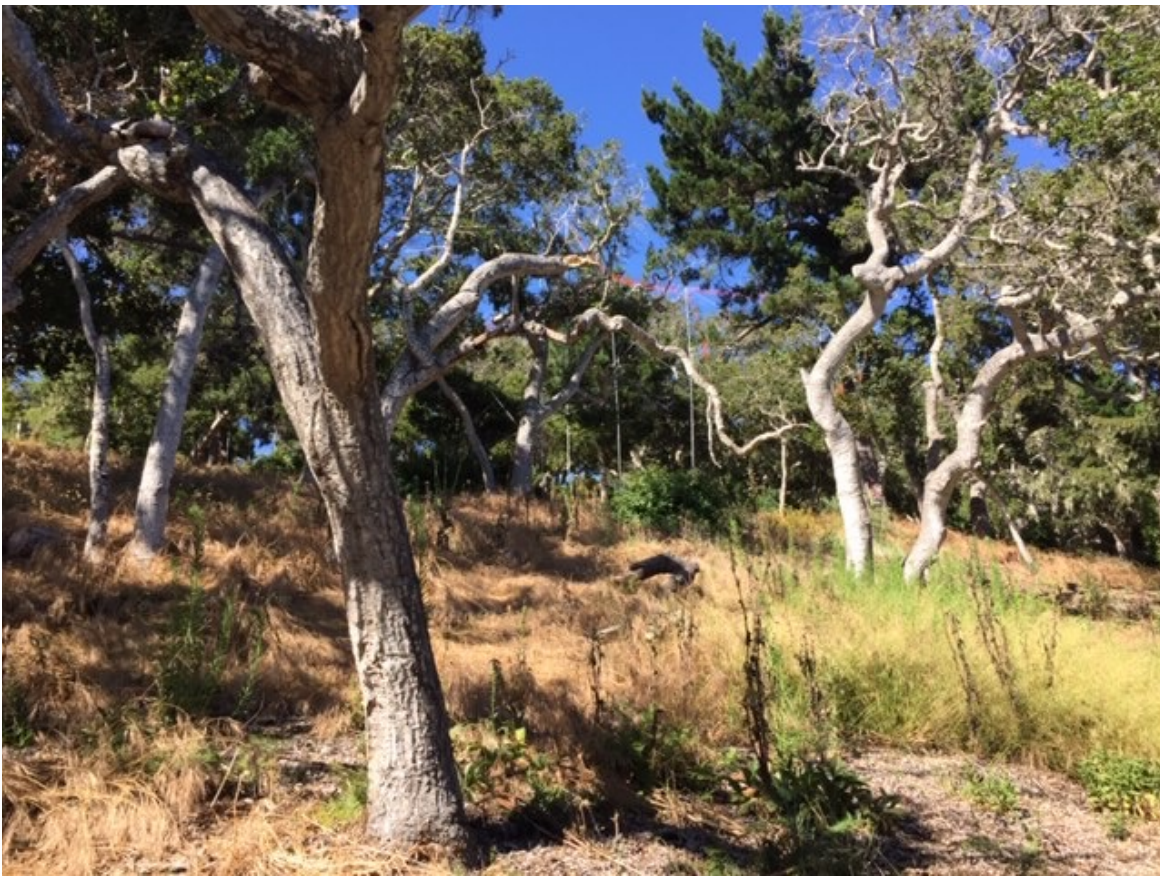
Figure 1. Proposed construction site is located in a natural clearing of this oak dominated woodland.

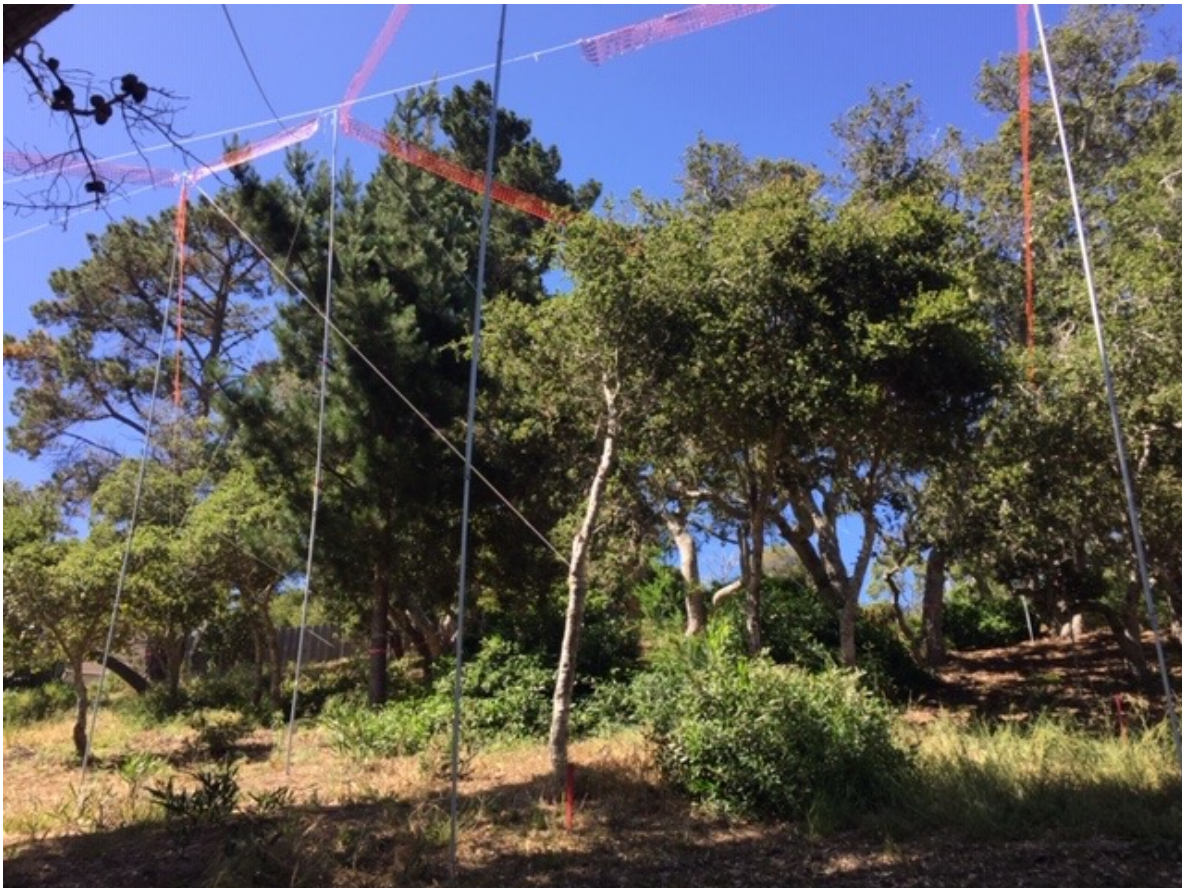
Figure 2. Another view of proposed construction site in oak dominated woodland. Several coffeeberry shrubs are occurring in woodland understory.

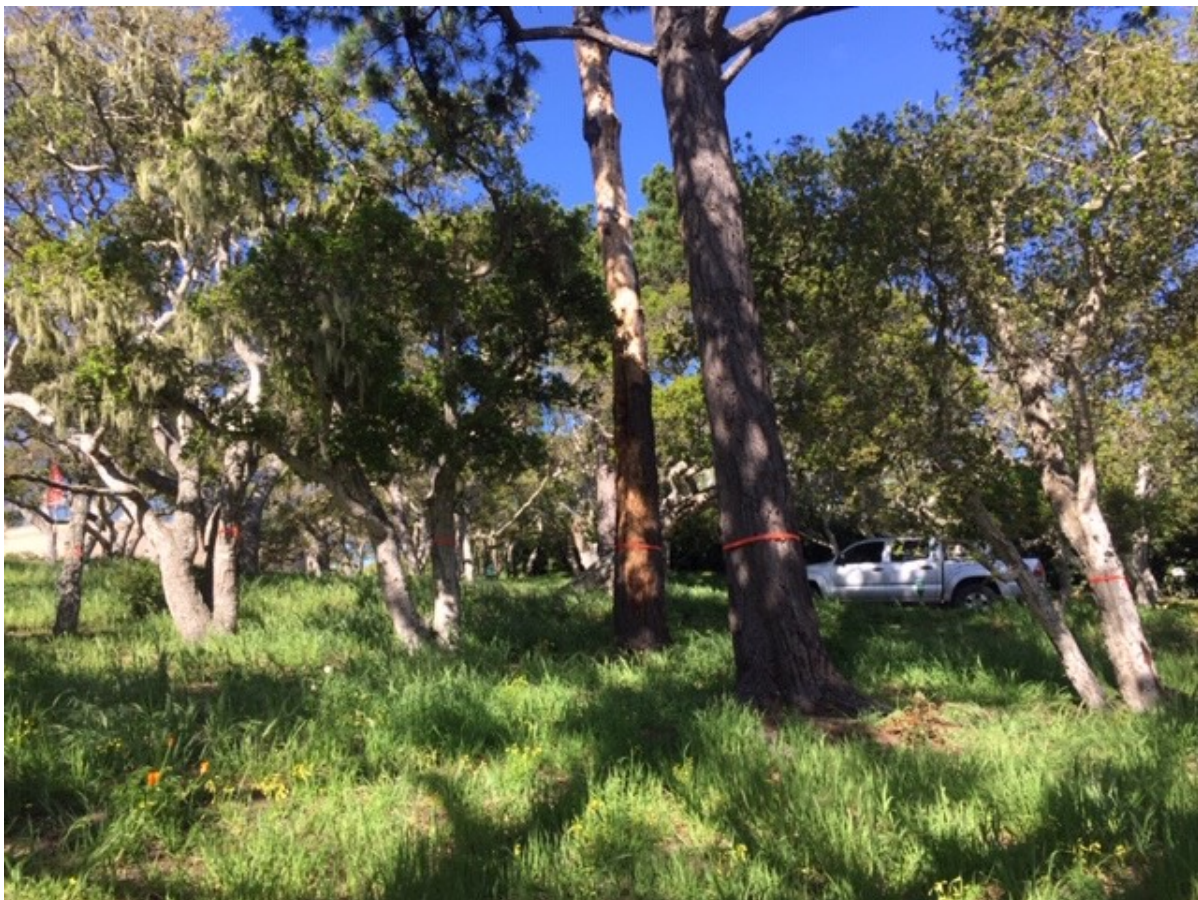
Figure 2. Another view of several trees proposed for removal due to construction impacts. Pine in center of photo is a dead snag.

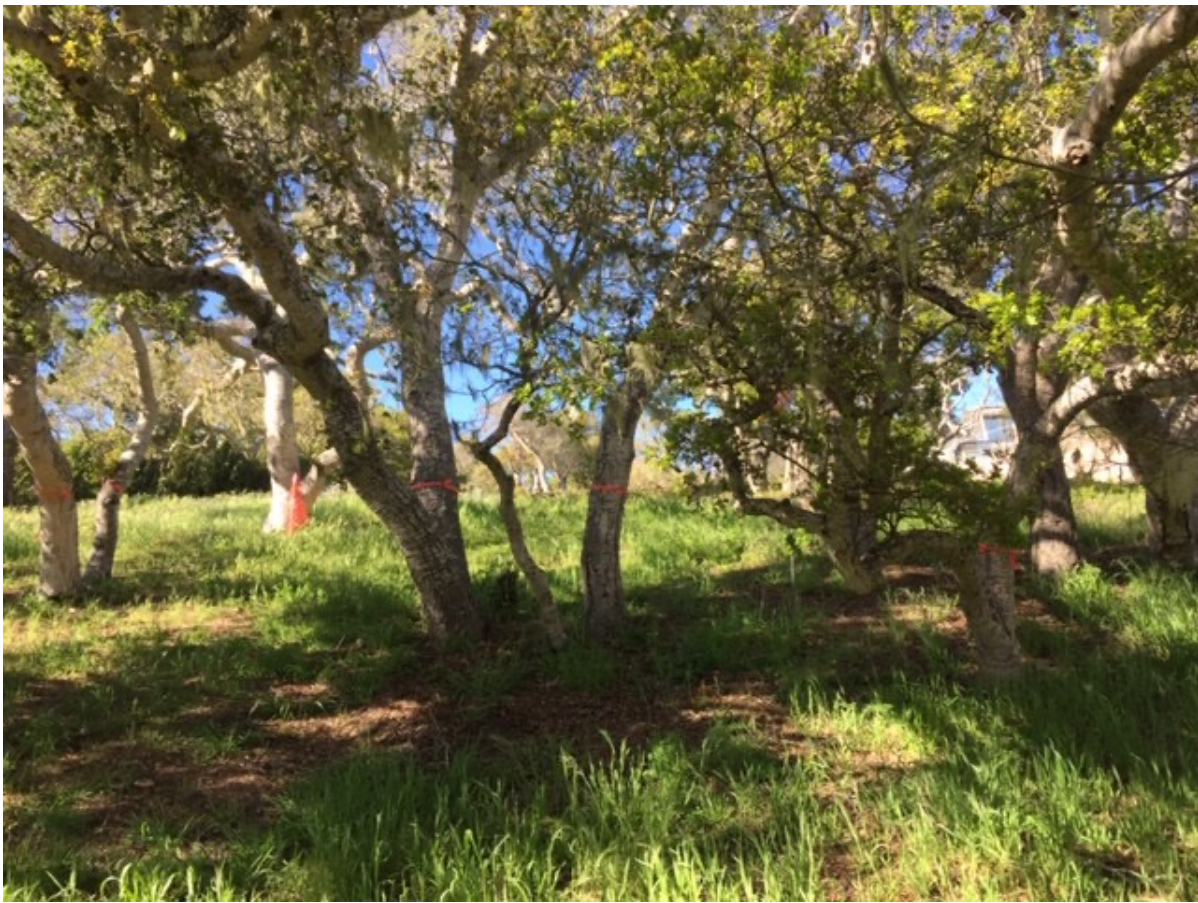
Figure 3. Several additional small to medium size oaks that will need to be removed due to location within proposed construction footprint.

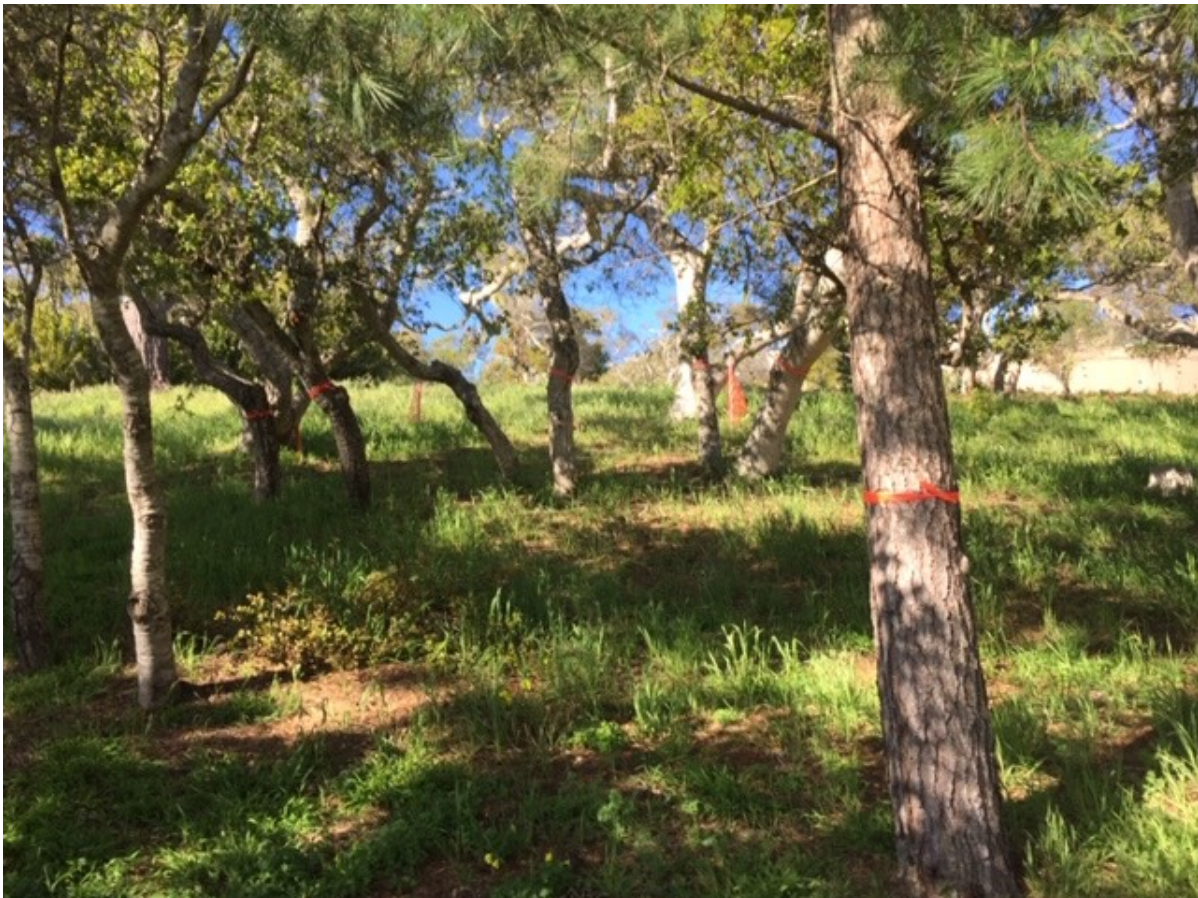
Figure 4. Small pine and several small to medium sized oaks proposed for removal due to construction impacts.
