Tree Resource Assessment
Management Plan
24726 Dolores Street

Hastings Construction

September 1, 2021

Dolores Pass LLC
11 Thomas Owens Way #201
Monterey CA 93940

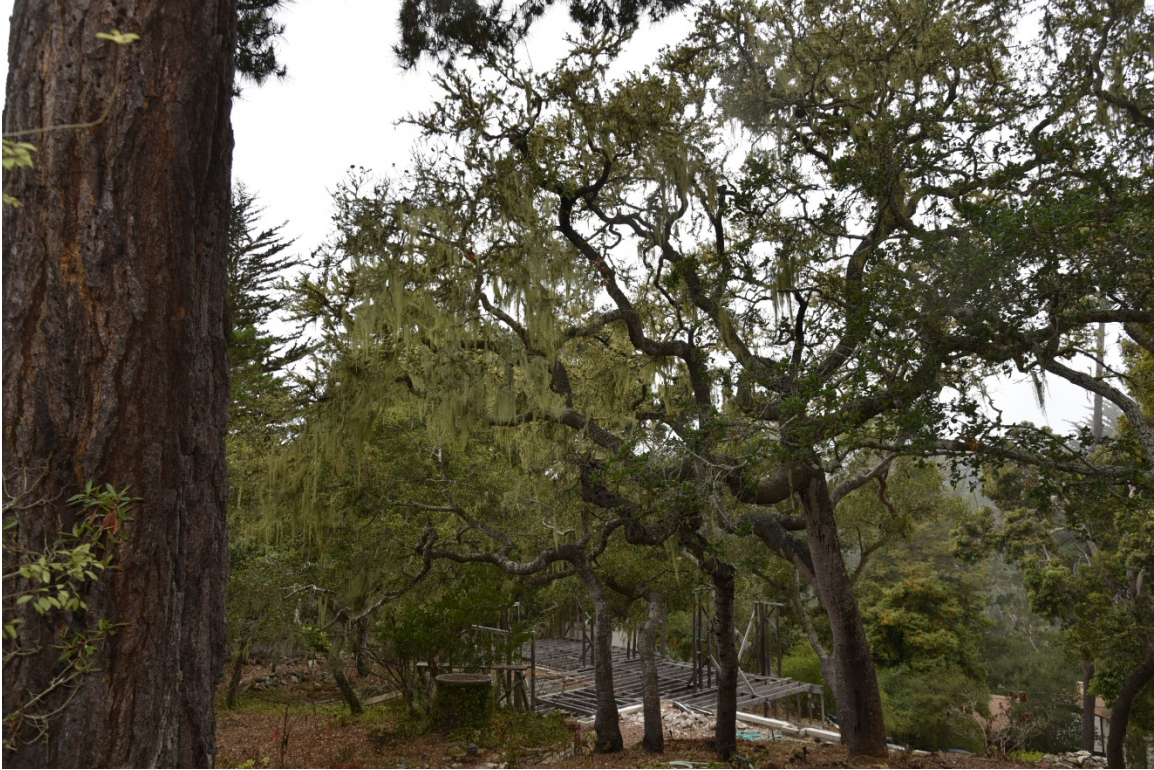
View of site looking west from gate (all trees are in fair to poor condition)

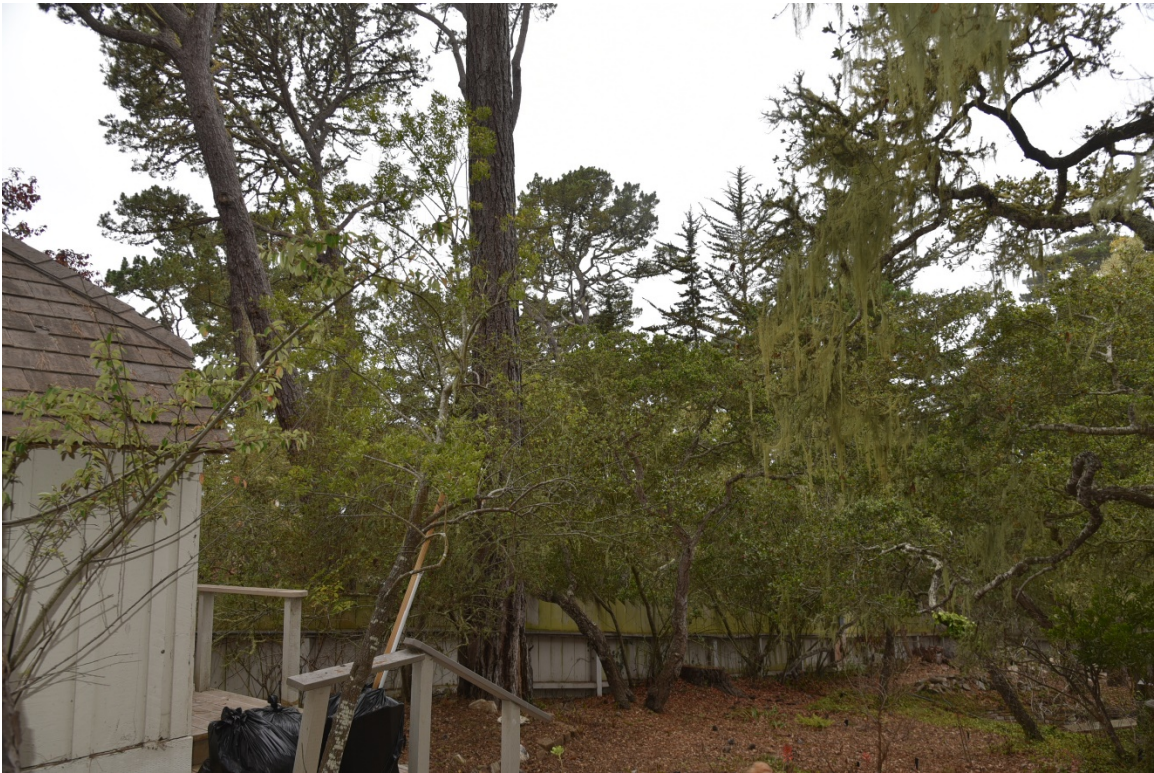
View of site looking south (note defoliation of lower story trees)

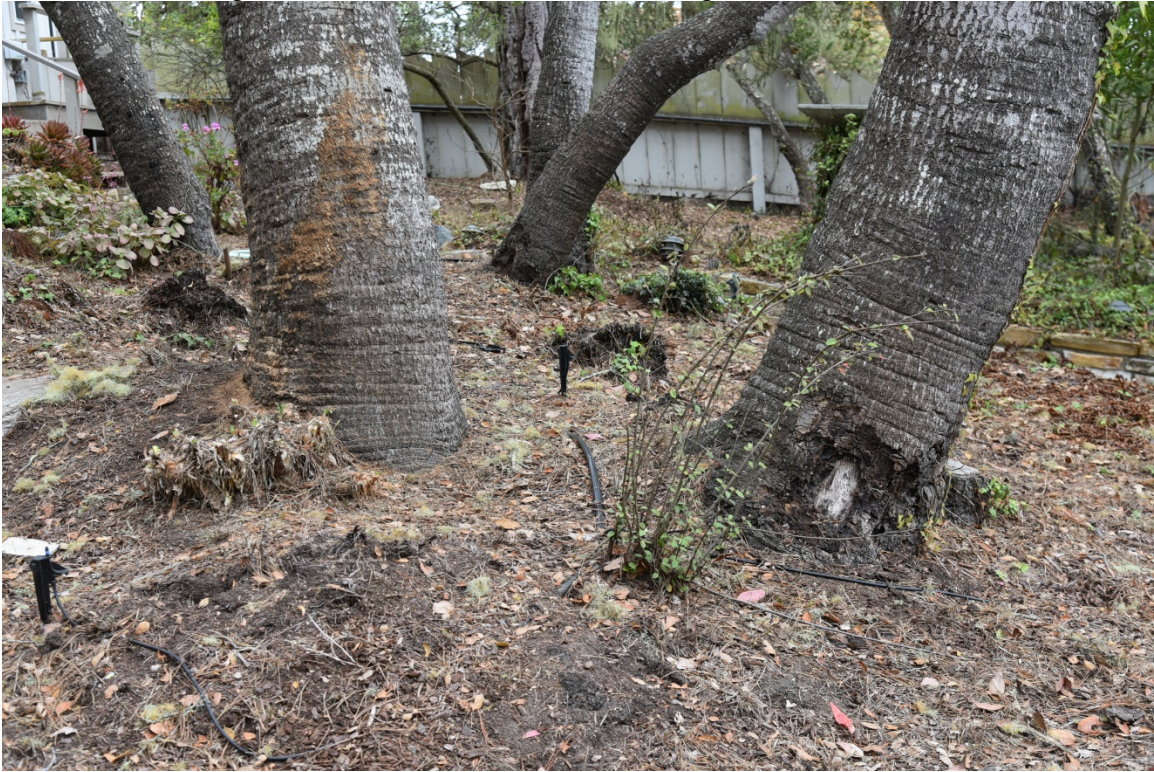
- 8) Forest Condition and Health: The forest condition and health are evaluated with the use of the residual trees and those of the surrounding Forest as a stand. This is a senescing pine forest, degrading and landscaped with ornamental planting. The trees appear distressed due to drought conditions. The overstory is composed of tall Monterey pines, Coast live oak, and planted Coast redwood. In the pines, the trunks exhibit raised columns of support wood with sunken columns of wood decay are observed, indicating these are aging trees. The pines are in decline and the latter stages of their life spiral, having lost most of their lower lateral limbs; resulting in very small live crowns and long extended leaning trunks. The redwoods appear to have been planted along the northeast corner of the property as a privacy hedge, these have since grown beyond containment. The oaks are in poor condition due to the high presence of western oak bark beetle and fungal activity. These trees exhibit bark loss at their root collars, circumcission of trunks with beetle frass, Hypoxylon fungus, and crown dieback.

Base of oak trees where bark is sloughed away from fungal activity and infested with bark beetles (orange/rust color is insect frass, indicating a severe infestation)

Once plans are finalized and after granted permission by local authorities, remove trees in poor condition before any grading or excavation. Currently it is not appropriate to designate replanting areas until a finalized plan is presented. A landscape plan should also be presented to dictate what areas are available for planting once the design is finalized. Replacement ratios should be less than a 1:1 ratio due to the limited space on the lot. Trees should be planted in the areas with the greatest opening in the stand to allow for a minimum of competition, maximum sunlight, and availability of water. Replacement trees should be five-gallon stock or larger, if available. Trees may be planted in clusters to simulate natural growth patterns. Occasional deep watering (more than two weeks apart) during the late spring, summer, and fall is recommended during the first two years after establishment.
