Tree Assessment/ Construction Impact Analysis 3 Wild Turkey Run

Prepared for:

Mr. David Fehrman

November 25, 2022

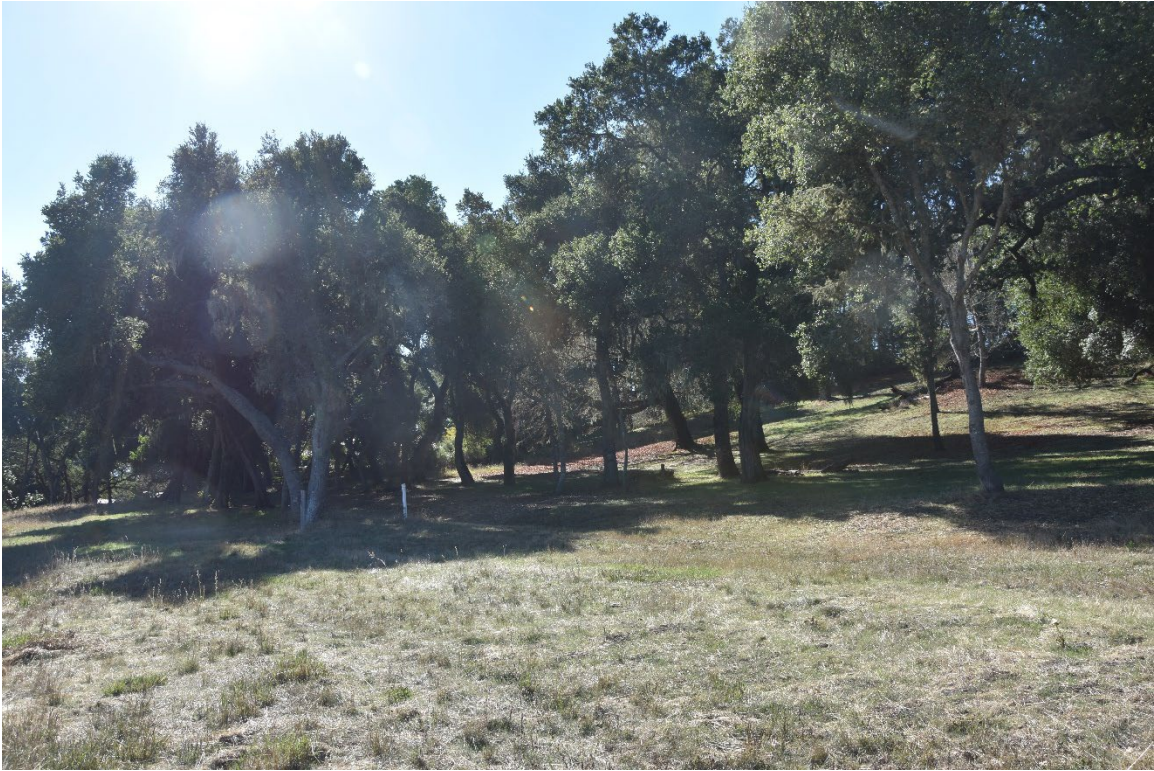
View south west towards the proposed building site.

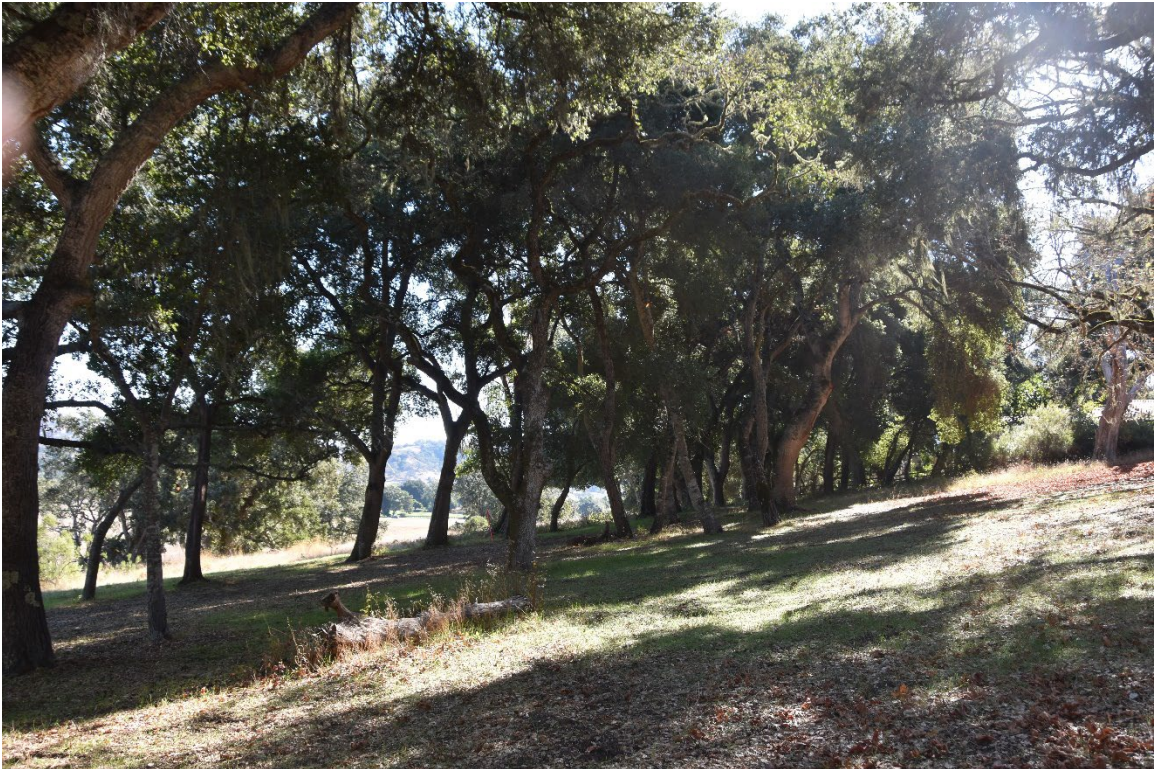
View southwest towards the proposed building site.

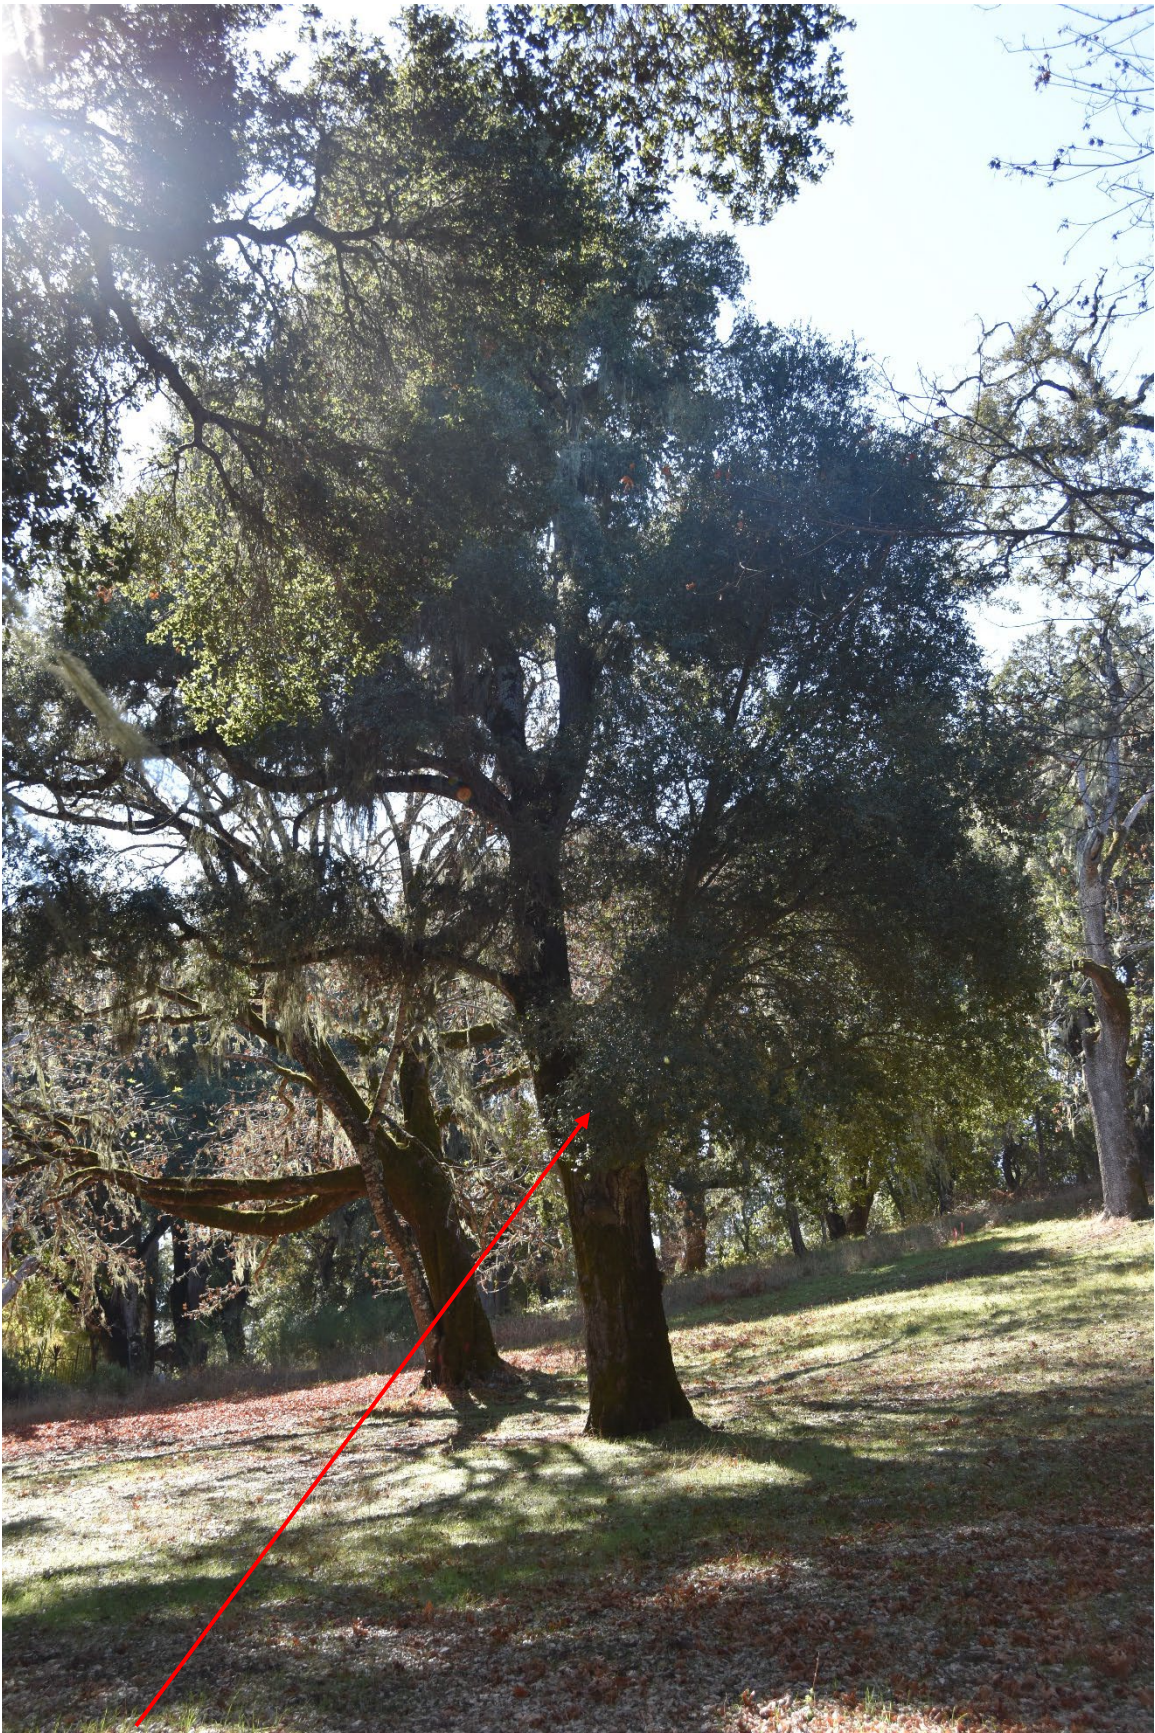
| Tree # | Species | DBH | Health | Structure | Remove | Impacted | Height | Crown | CRZ | Comments |
|---|---|---|---|---|---|---|---|---|---|---|
| 1040 | Coast live oak | 42 | Fair | Fair | x | | 75 | 40 | 20 | Grading |

Tree #1040 is proposed for removal.

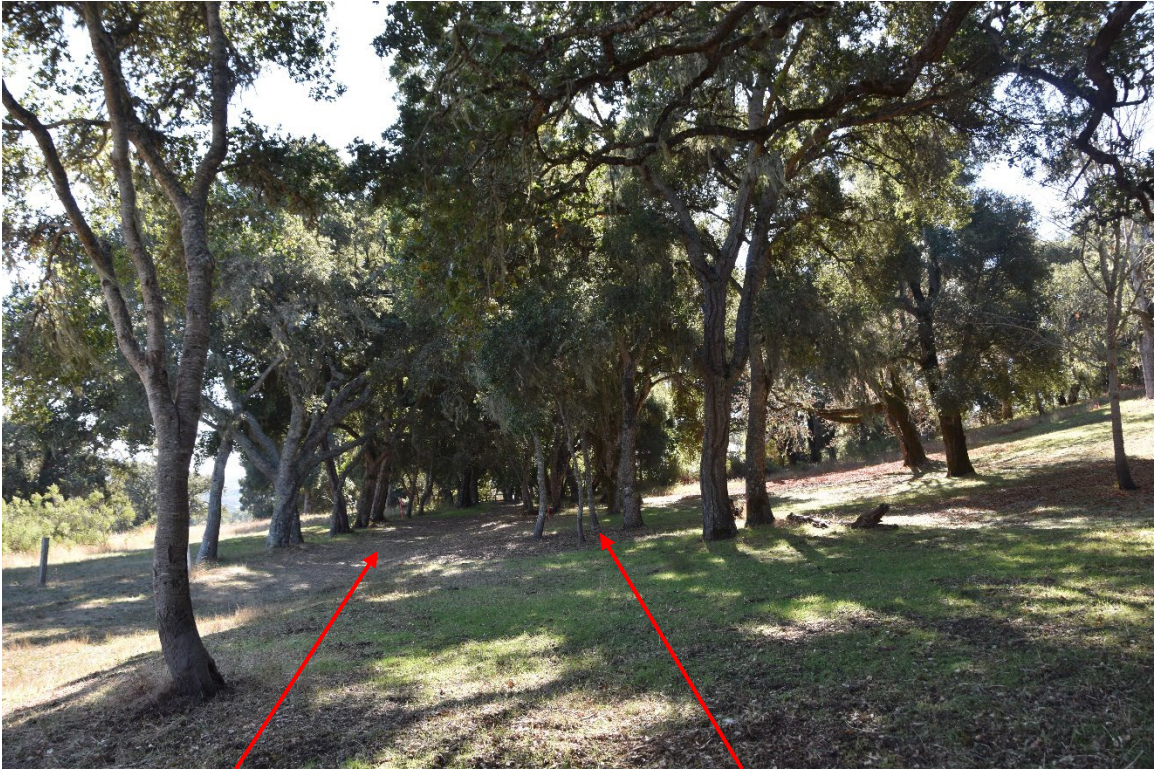
- Trees #1030, #1031, #1063, and #1064 are adjacent to the proposed motor court.
- There is a decommissioned road that extends to the southeast from Wild Turkey Run. There is a row of planted trees lining the road on the east side with one (1) small tree proposed for removal due to crowding and clearance for fuel mitigation (tree is factored into tree removal count). The remaining trees should experience minor impacts from excavation as the compaction should have lessened root growth in that area.

View of decommissioned road and building site where the majority of tree removal will occur.

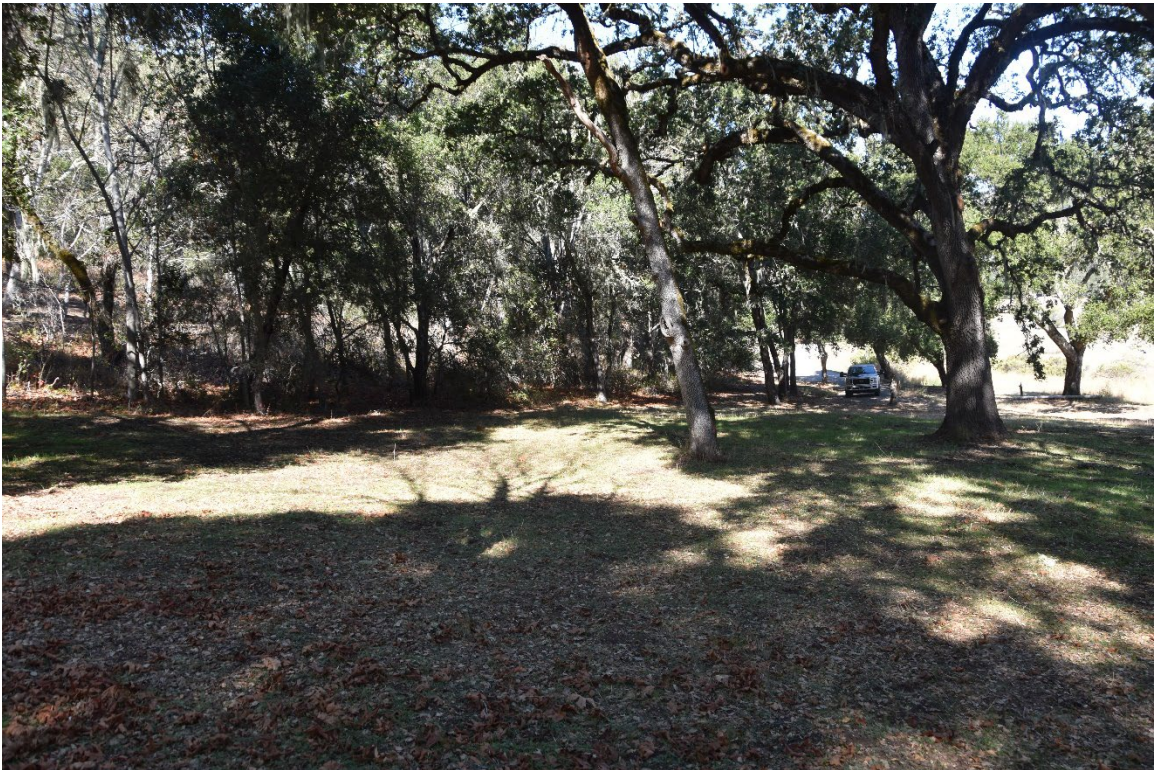
View of driveway and motor court area.

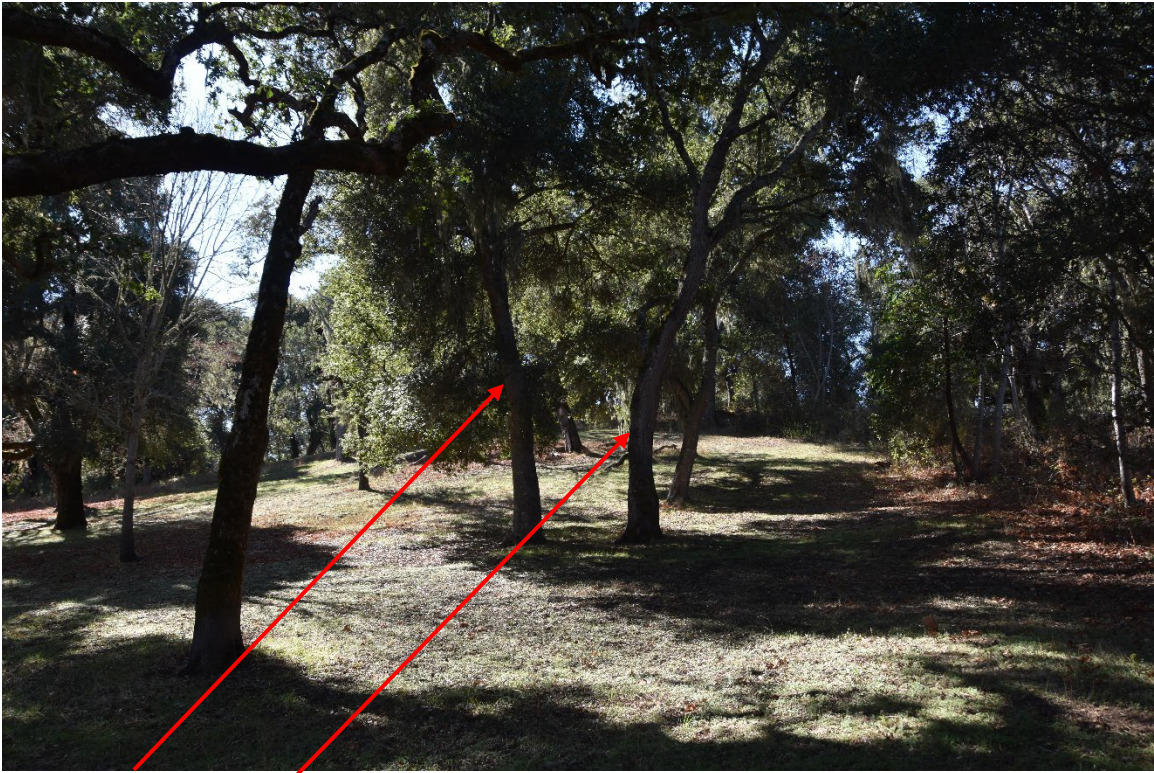
| Tree # | Species | DBH | Health | Structure | Remove | Impacted | Height | Crown | CRZ | Comments |
|---|---|---|---|---|---|---|---|---|---|---|
| 1030 | Coast live oak | 24 | Fair | Fair | | x | 50 | 40 | 20 | |
| 1031 | Coast live oak | 24 | Fair | Fair | | x | 50 | 40 | 20 | |

Trees #1031 and #1030 are located adjacent the motor court and will need to be protected.

- Trees located adjacent to the construction area shall be protected from damage by construction equipment by the use of temporary fencing set out to tree drip lines and through wrapping of trunks with protective materials. No stripping of topsoil or grubbing of understory shall occur in tree preservation zones.

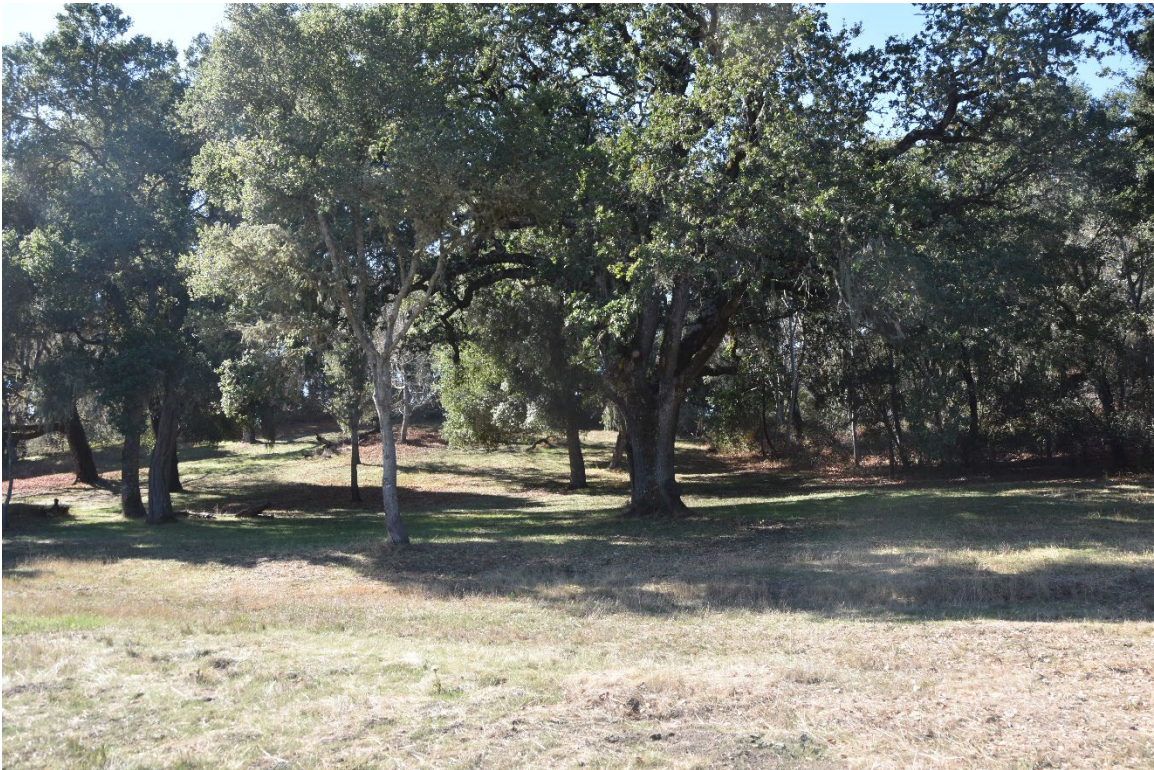
View of driveway, motor court, and garage area.
