Tree Assessment/
Forest Management Plan
Amatya Residence

October 19, 2018

Development is proposed for this site located at 24723 Handley Drive in Carmel CA. Because native trees forest this site, a tree assessment/arborist report has been prepared that identifies and addresses the affects that the project will have to the existing tree resources on site as well as a list of recommendations for the project.

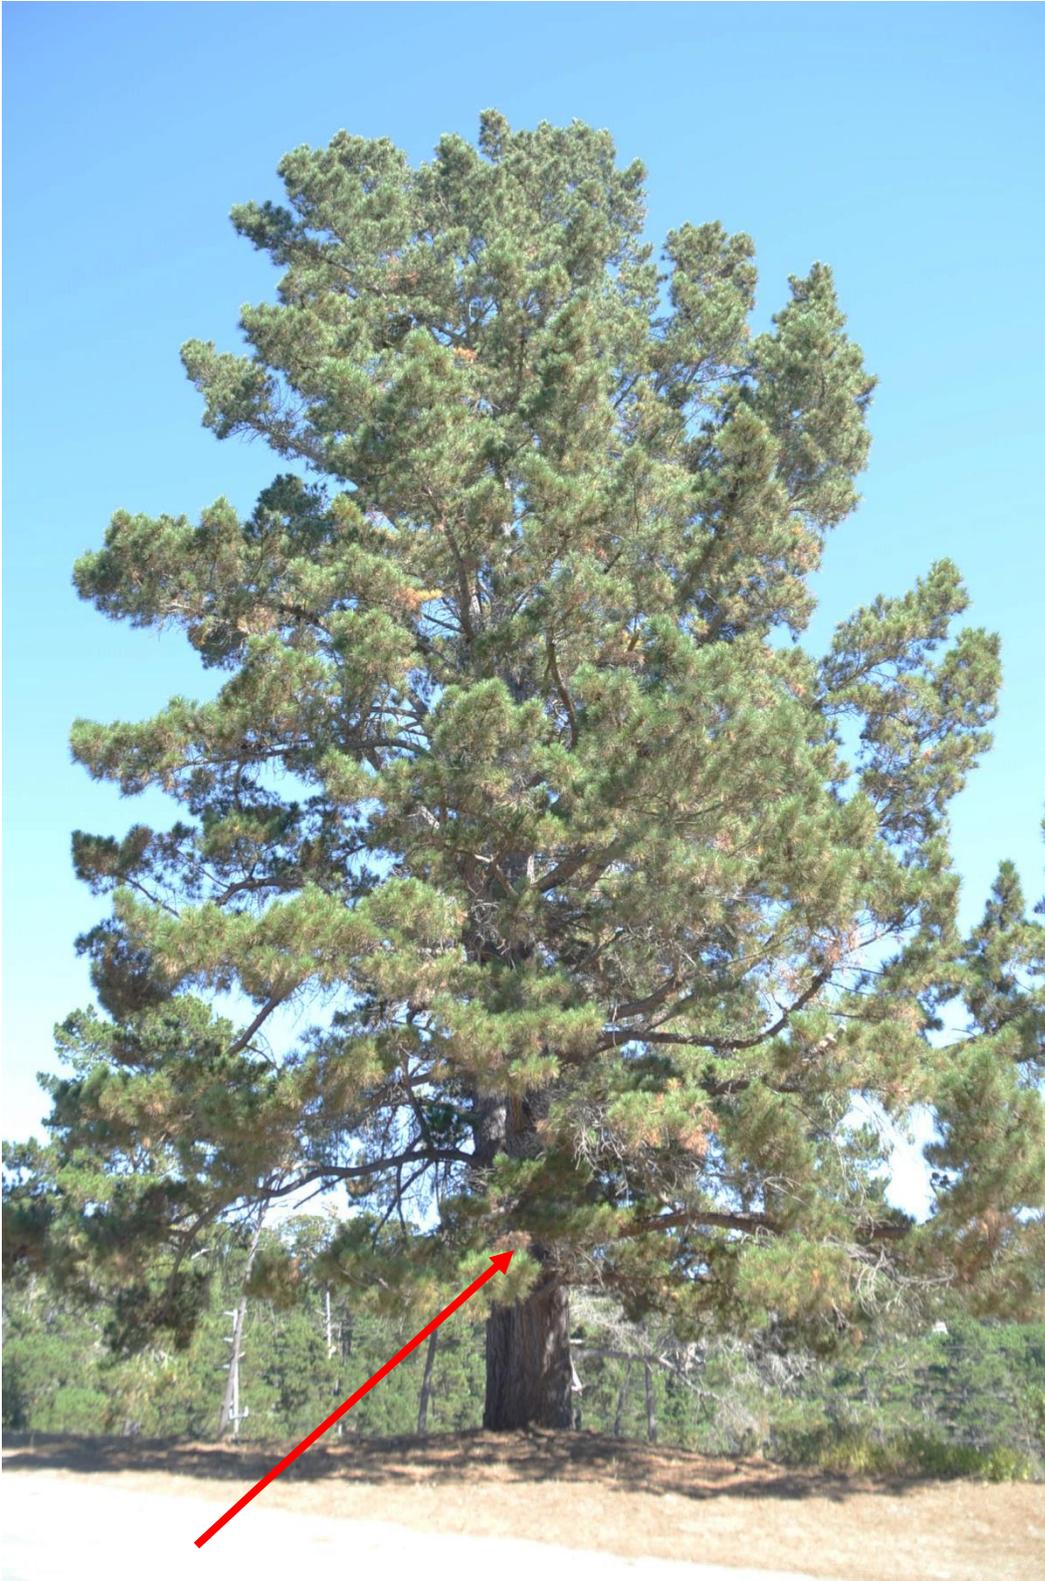
Tree #123.

ID#	Species	Diameter	Structure	Health	Remove	Comments
123	Pine	26+36	Poor	Fair	x	splitting down center, in driveway
124	Oak	7	Poor	Good		codominant stems
125	Oak	7	Poor	Good		codominant stems
126	Oak	6	Good	Good		
127	Pine	13	Poor	Fair		
128	Pine	22	Fair	Fair		
129	Pine	29	Fair	Poor		On neighboring property

One (1) tree is to be removed (#123) with the design as stated in the previous tree removal chart. Also, though it is not a detriment to the project construction at this point, efforts should be made to contact the adjacent property owner of tree #129 for its removal. A hazard tree assessment should be made for that property owner as part of their removal process.

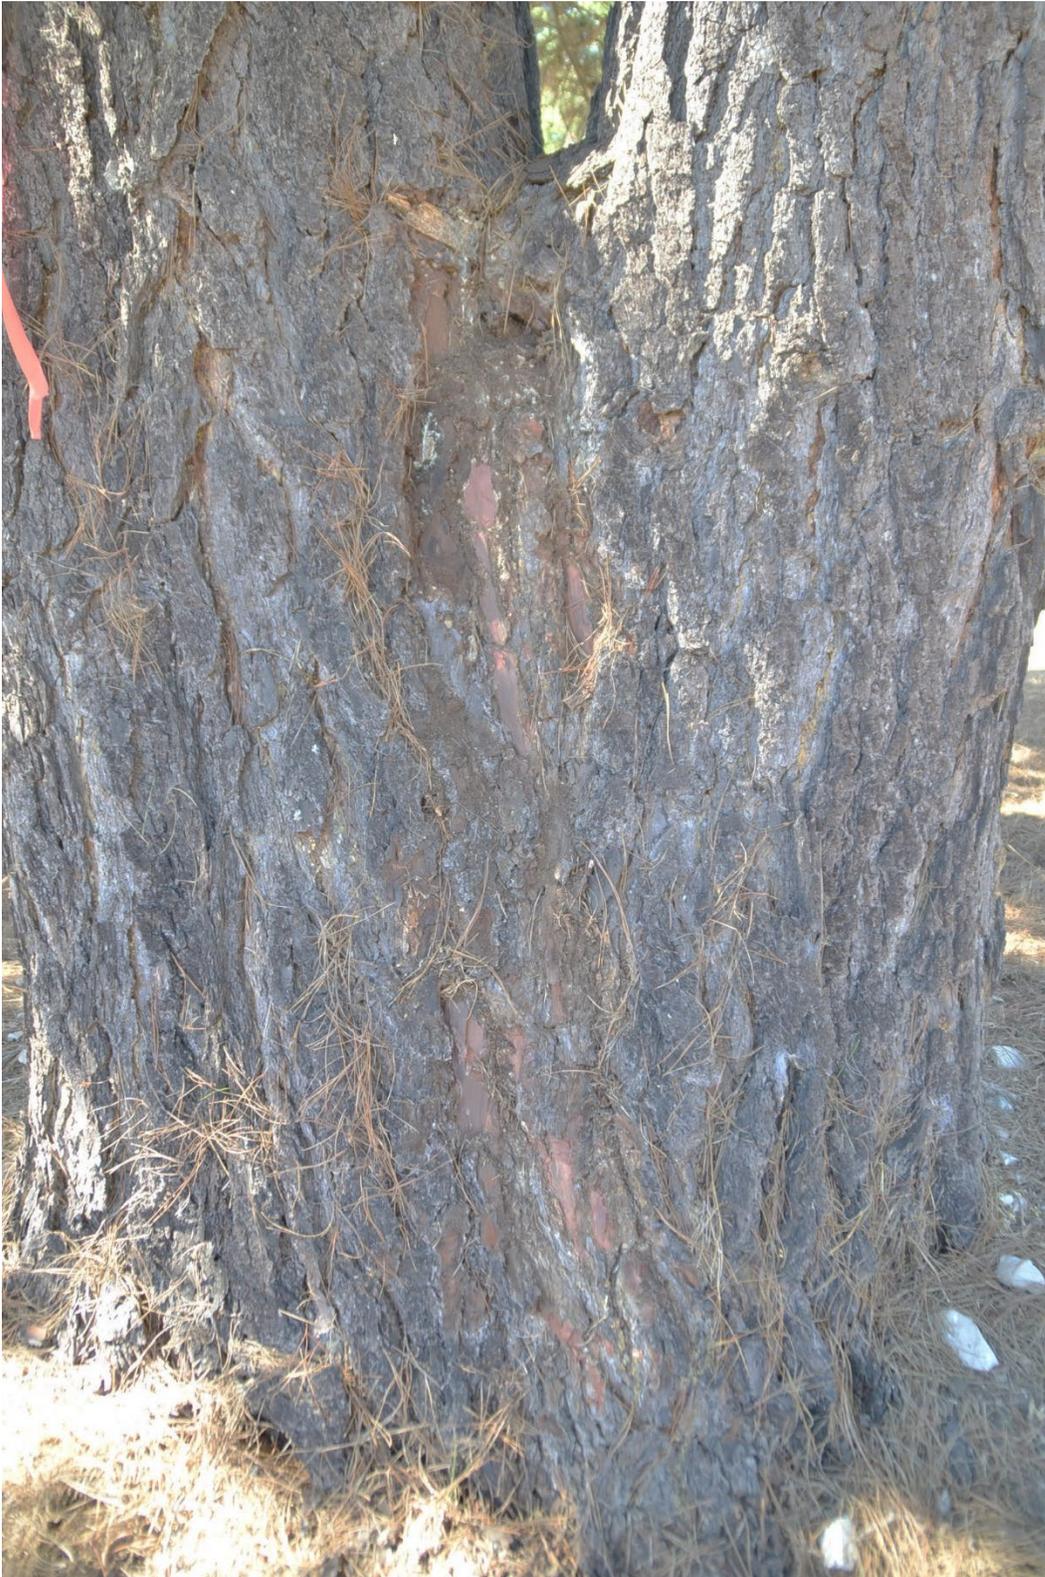
- The site is forested mainly with mature Monterey pine trees.
- One (1) trees is proposed for removal due to its location within the driveway which is necessary given the slope and access to the property. This tree has two stems that are weakly attached and appears to be splitting. The tree has a tree hazard evaluation form (THEF) score of 10. The THEF score sheet is attached with this report.

Tree #123 bulging and splitting seam down center. This is typical of tree with narrow tight crotches and a common failure point

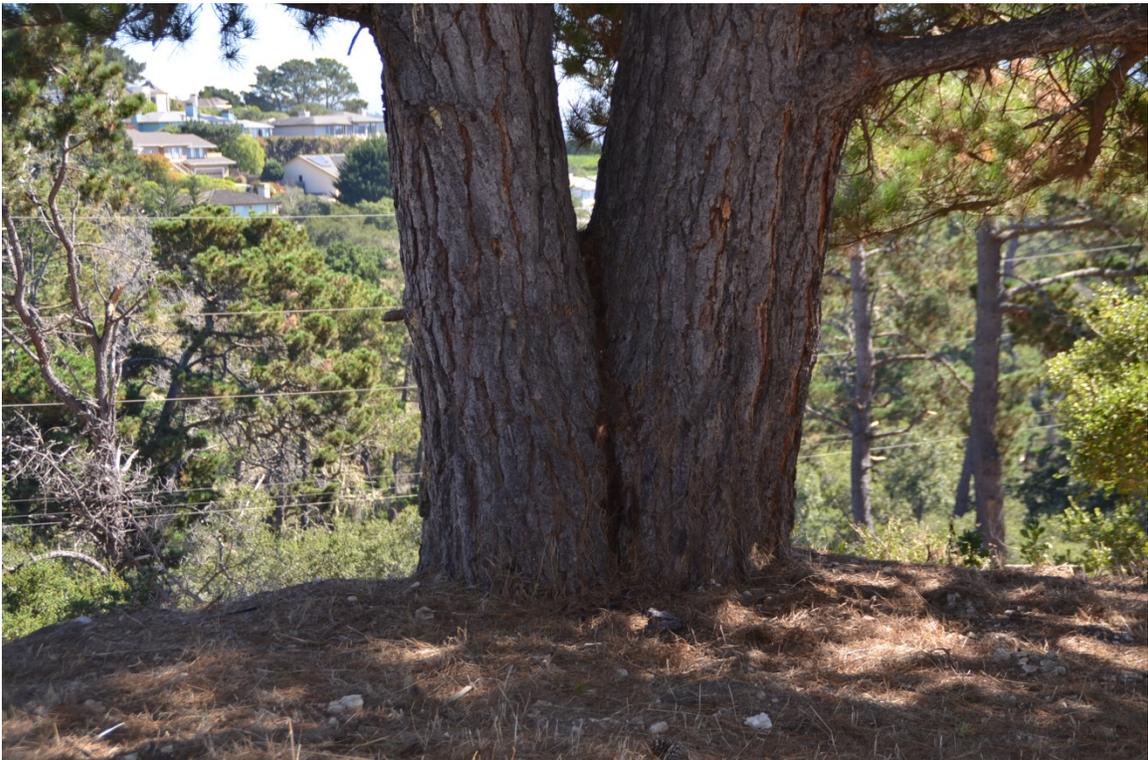
Seam between two stems of tree #123.

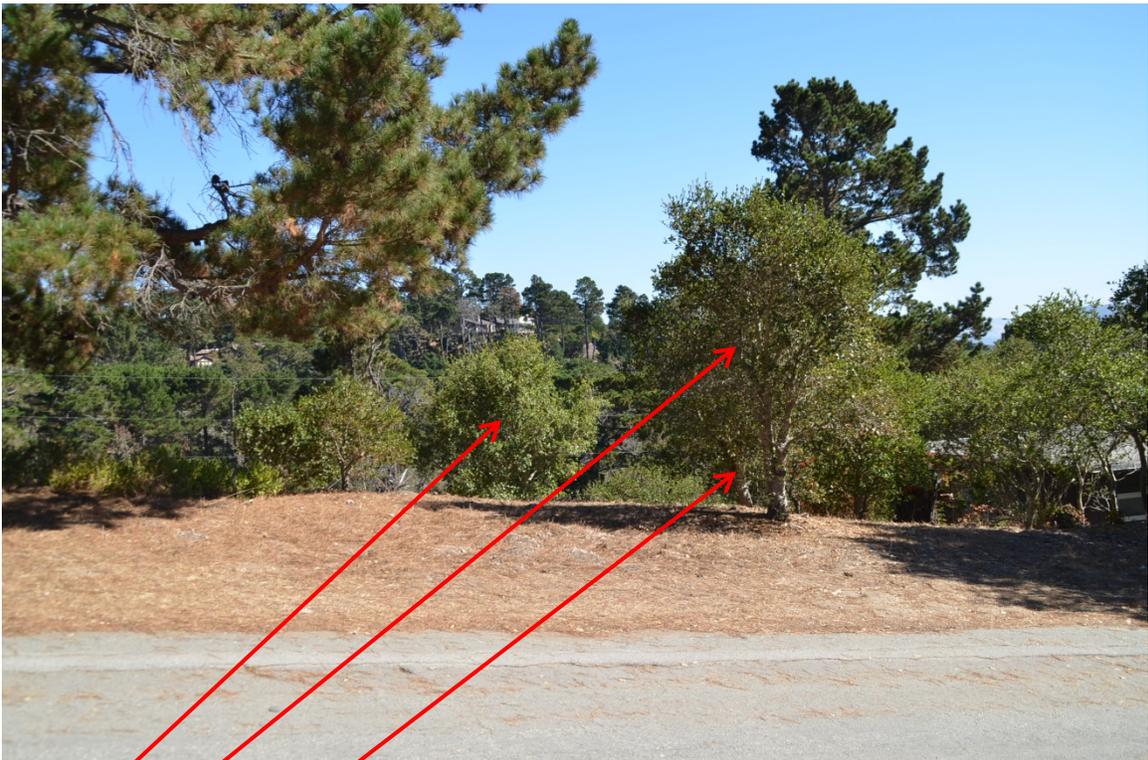
Trees #126, #124, and #125.

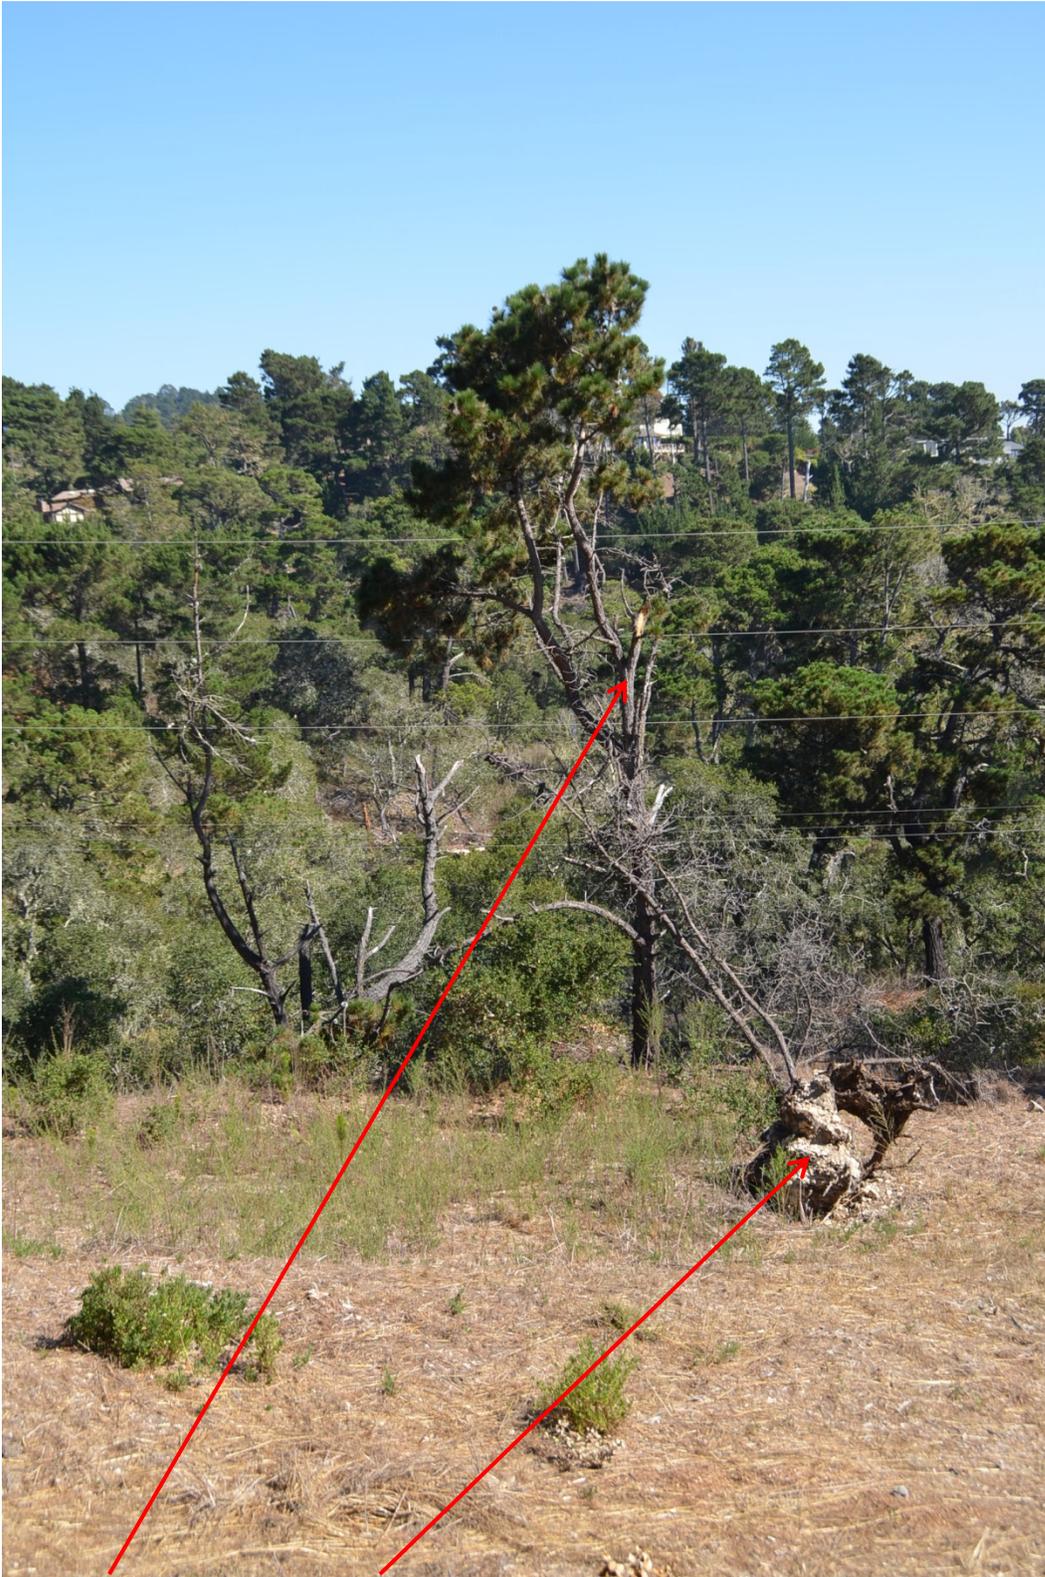
Tree #127 and previous tree failure.

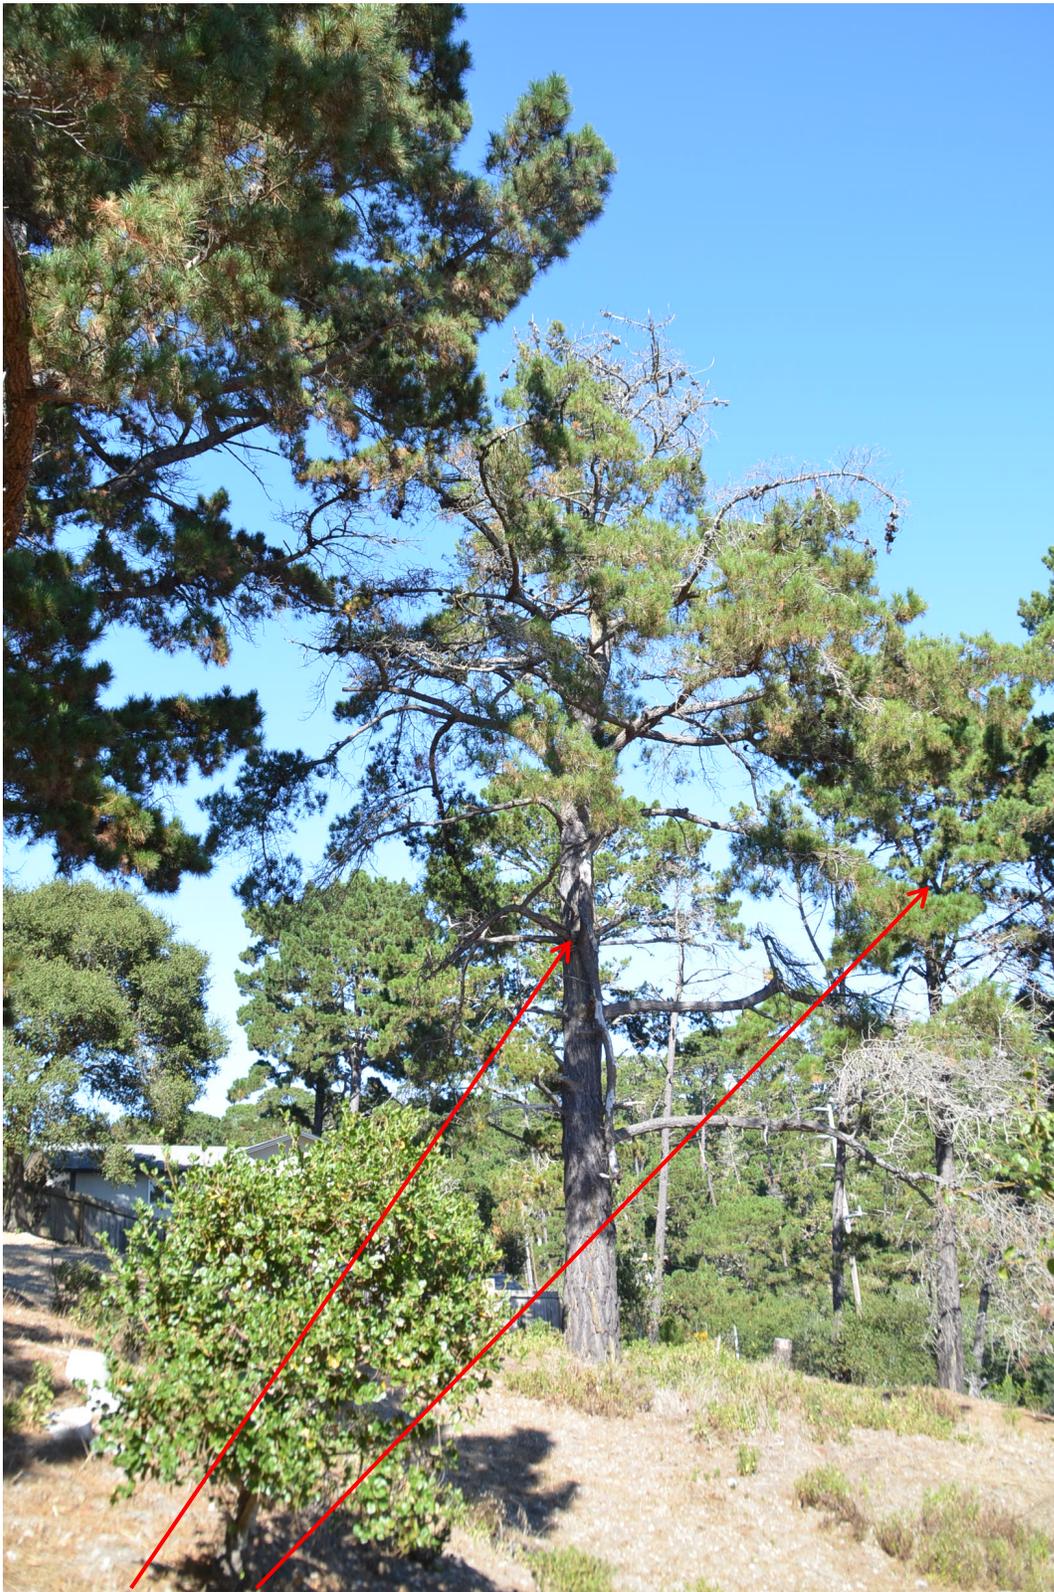
Trees #129 (on adjacent property) and tree #128.

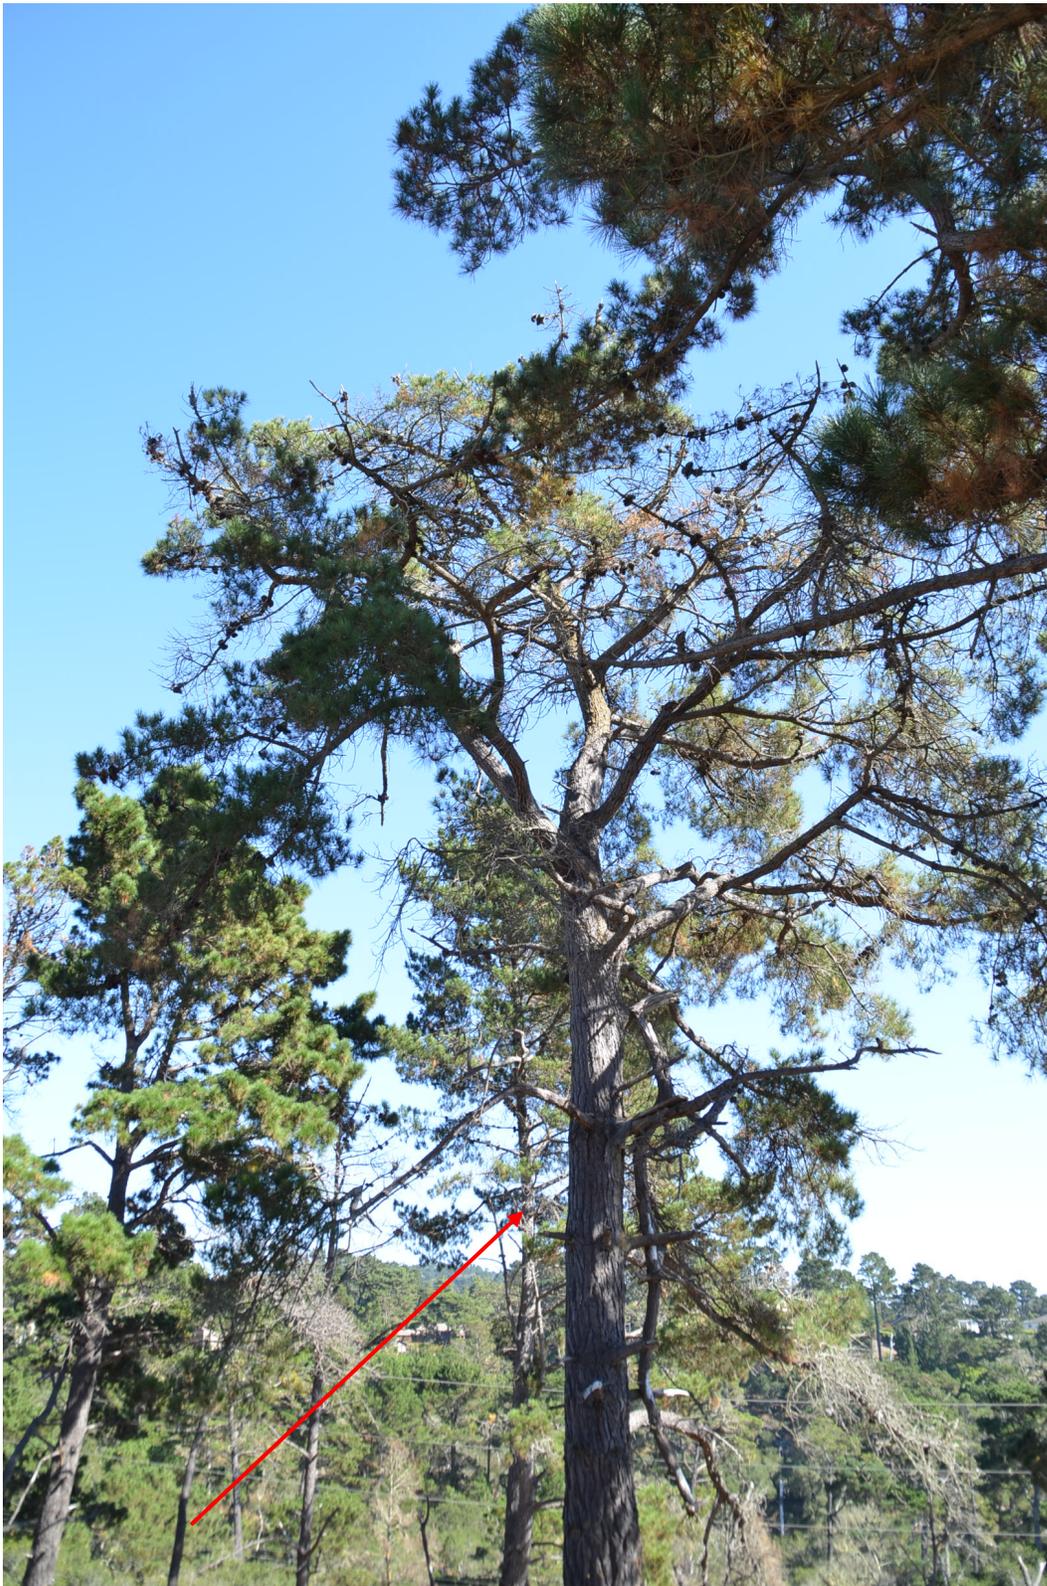
Tree #129 in declining shape. Property owner should be contacted to seek permission for its removal
