Natividad Medical Center Facility Assessment Report

*Prepared by Kitchell
For*

County of Monterey, California

December 9, 2015
Job No. 4983A3

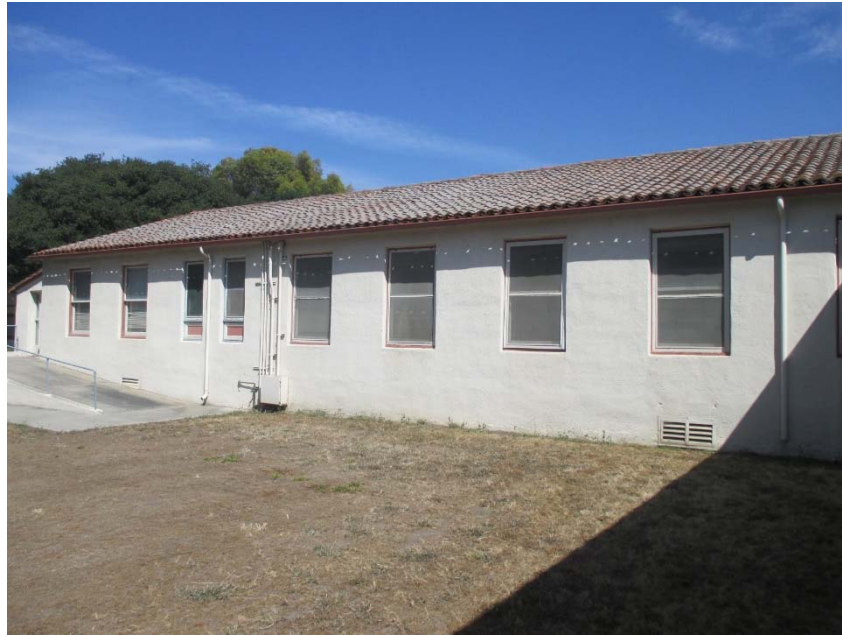
Exterior photo showing roof, wall finish and windows

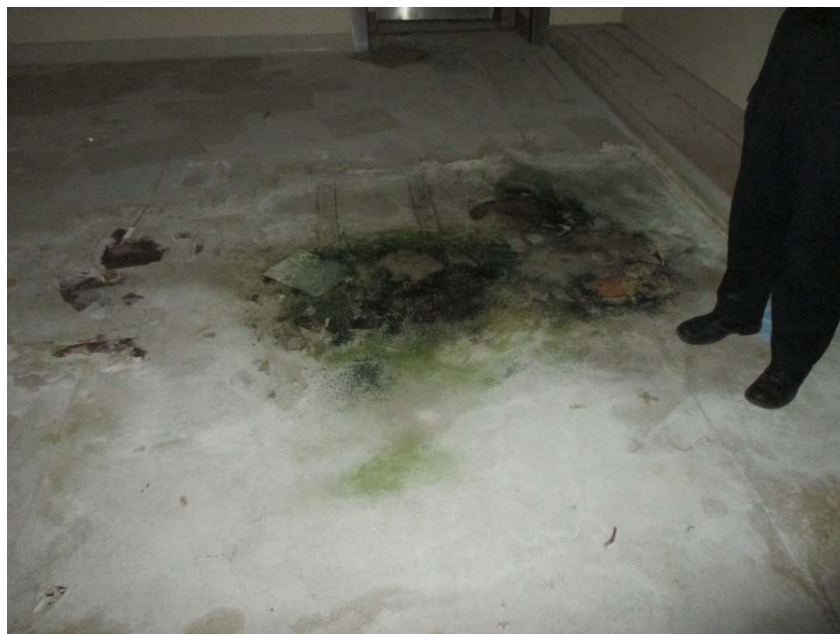
Exposed slab showing water damage / staining

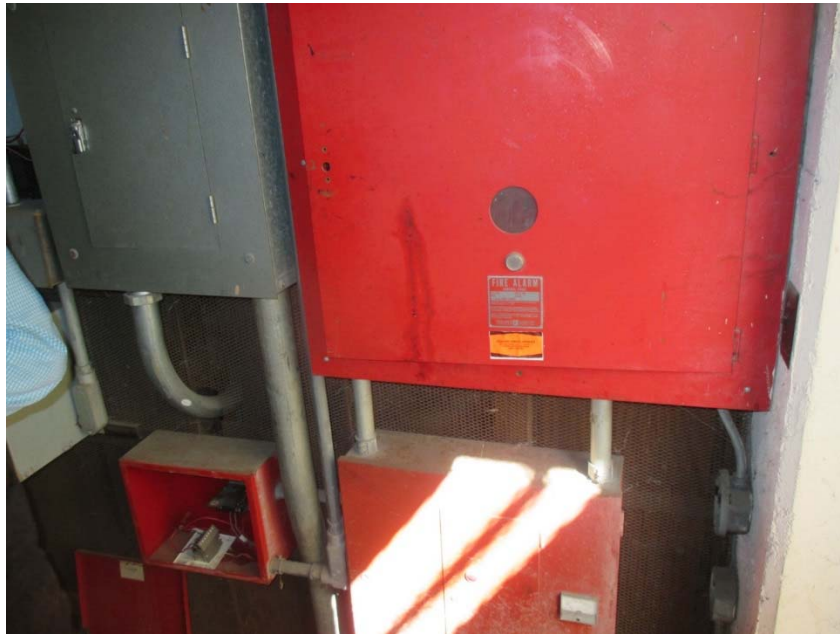
The fire alarm panel is past its expected useful life.

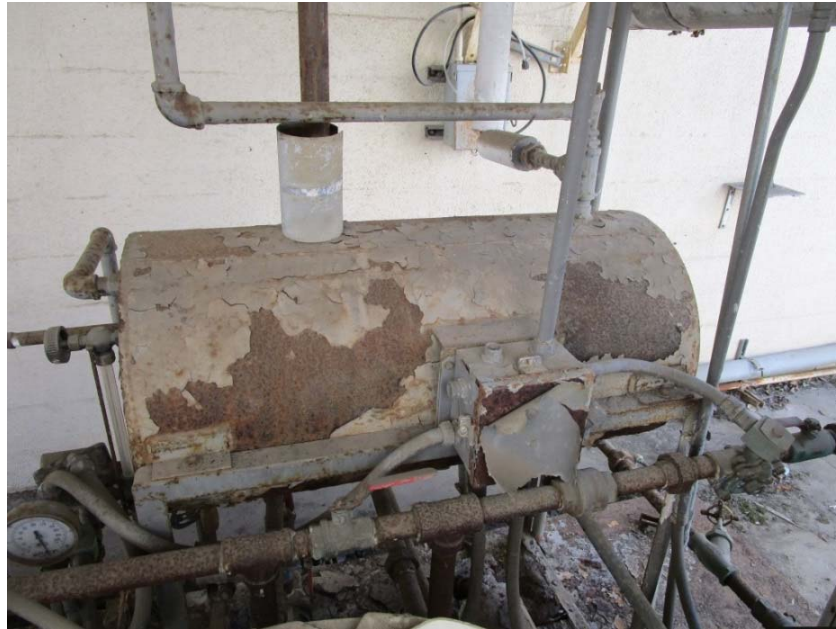
Two expansion tanks located in the Mechanical Room are original to the building (1928) and appear to be in poor condition and will need to be replaced.

Expansion tank is in poor condition and will need to be replaced.

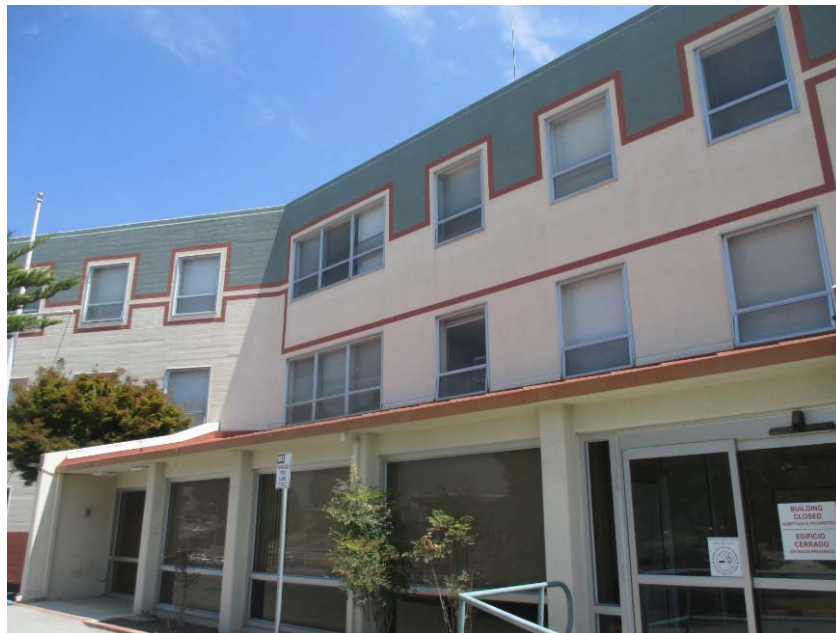
Building exterior, main entry.

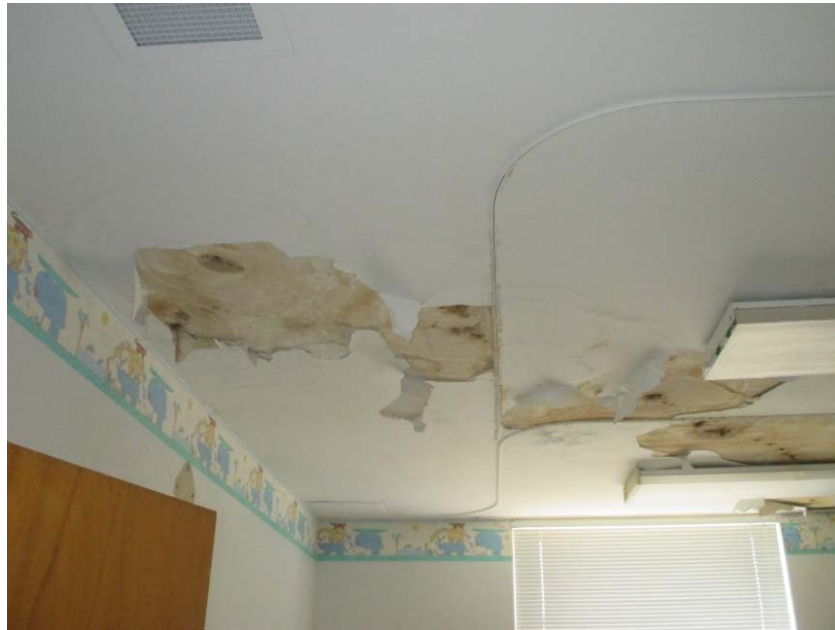
Typical ceiling damage at gypsum ceiling in patient rooms

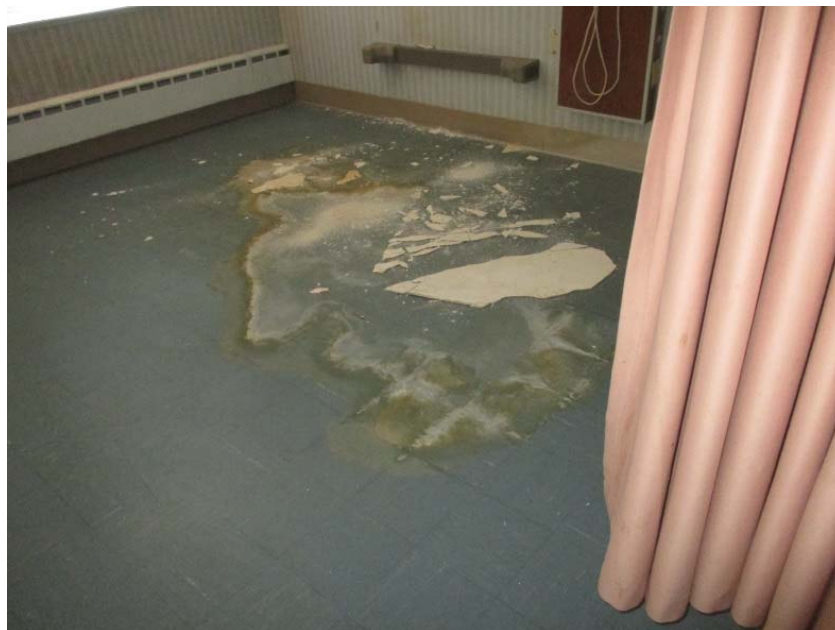
Typical floor damage at patient rooms

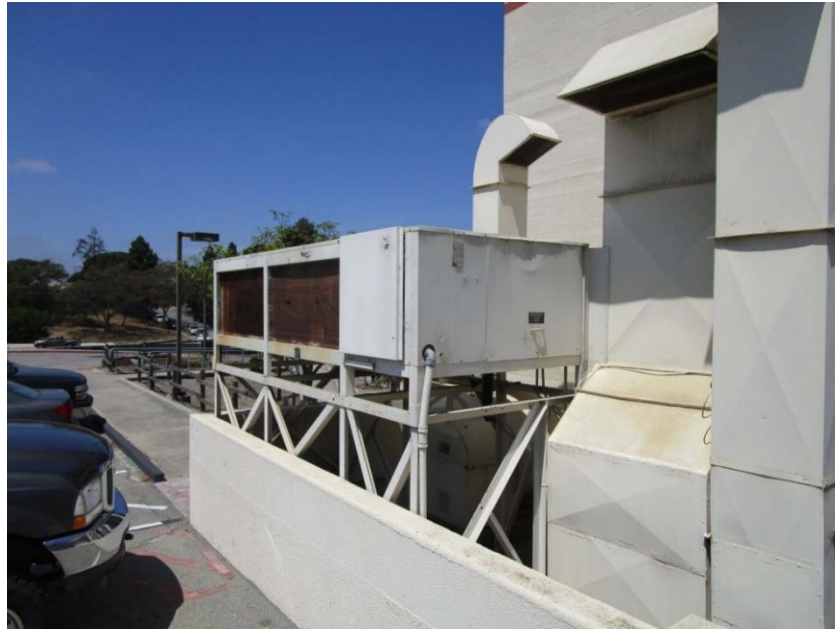
Packaged DX cooling with gas heating air conditioning unit is at the end of its expected useful life.

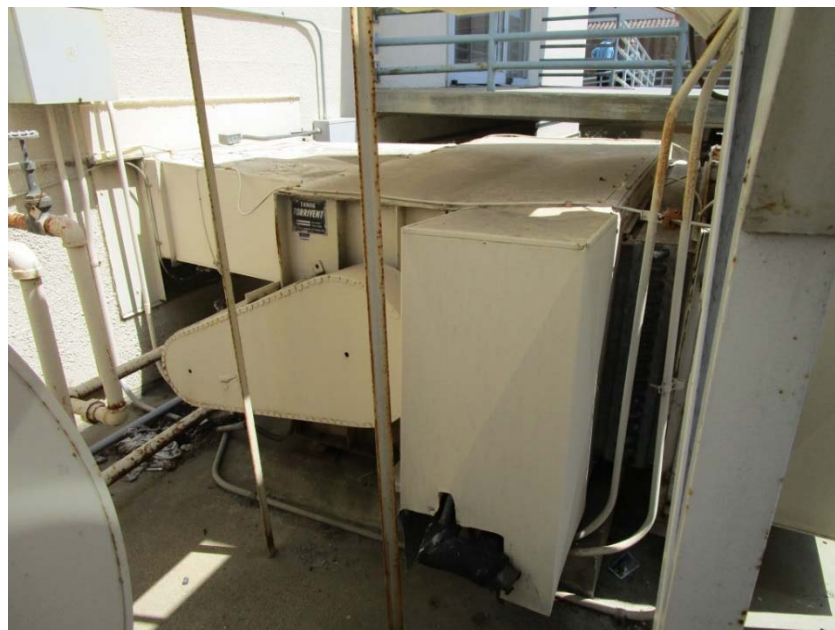
Heating and ventilation unit is at the end of its expected useful life.

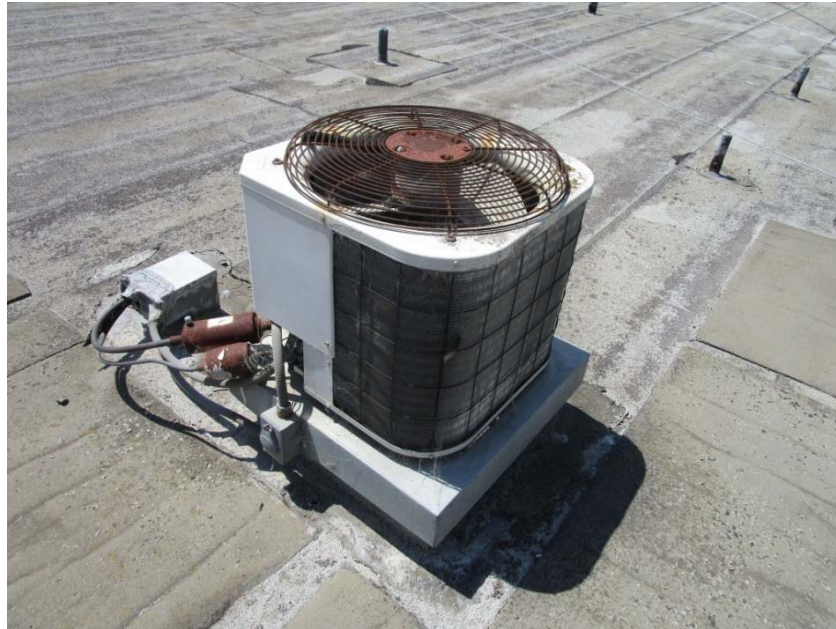
Split air conditioning systems with outdoor condensing units and indoor fan coil units are at the end of their expected useful lives.

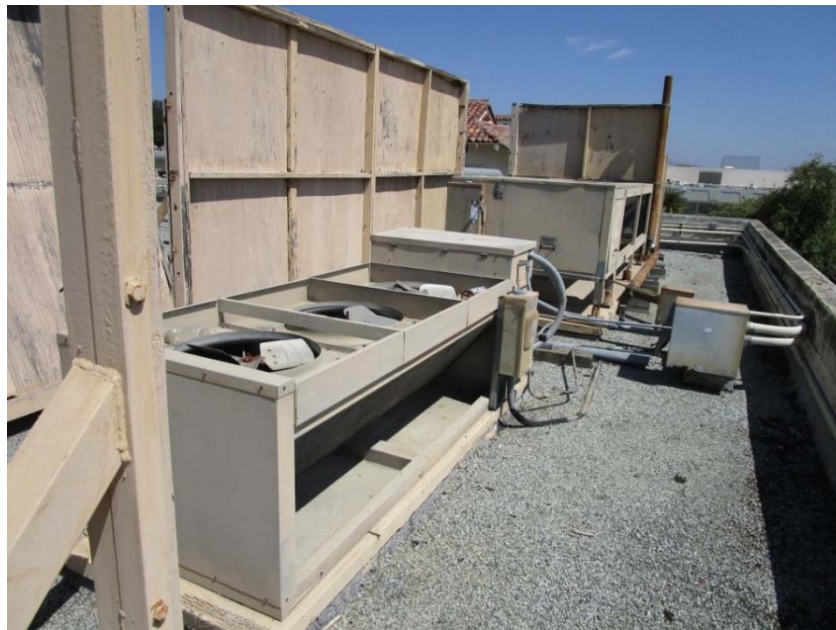
Rooftop air cooled chillers are at the end of their expected useful lives.

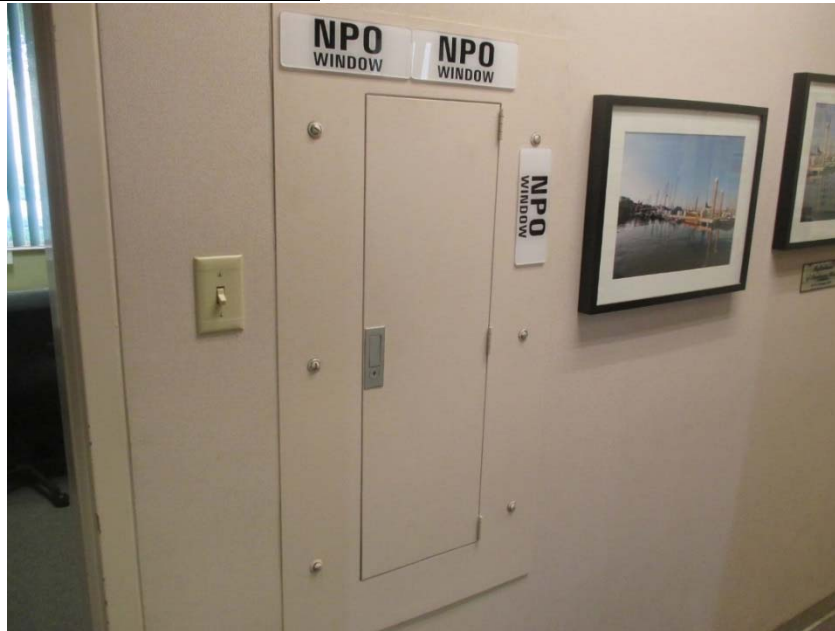
Panel is past its expected useful life.

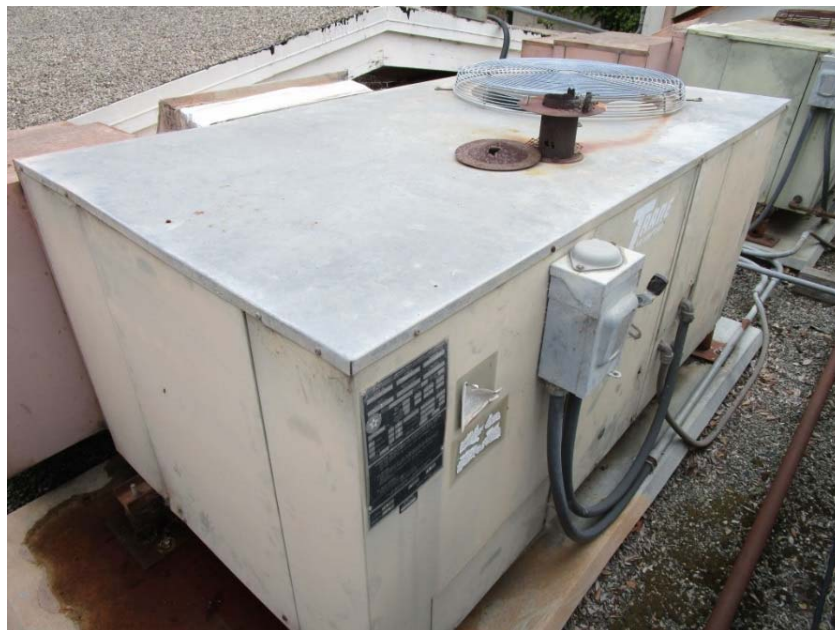
Packaged rooftop DX cooling with gas heating air conditioning unit is at the end of its expected useful life.

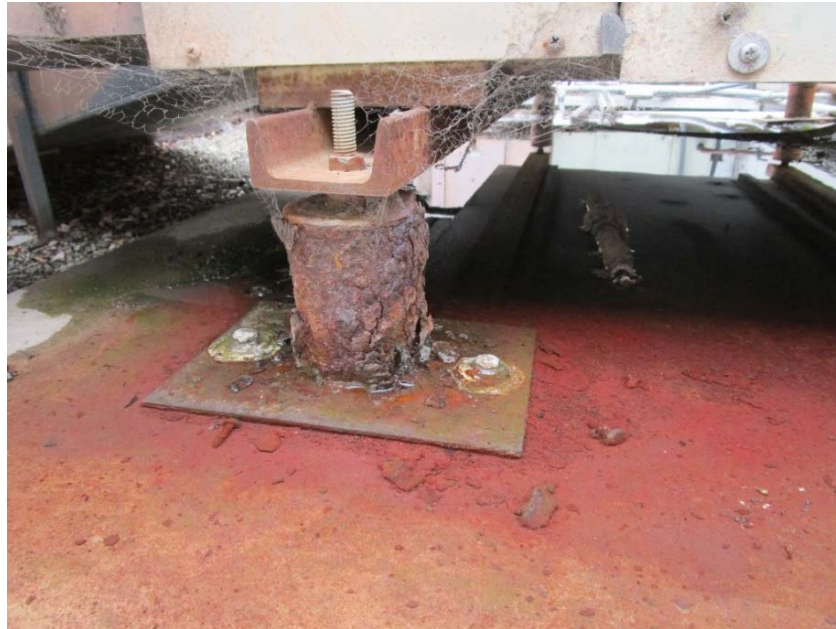
Standing water on the roof is causing the mounts to rot away. Suggest installing a 4" curb for both HVAC units to mitigate this.

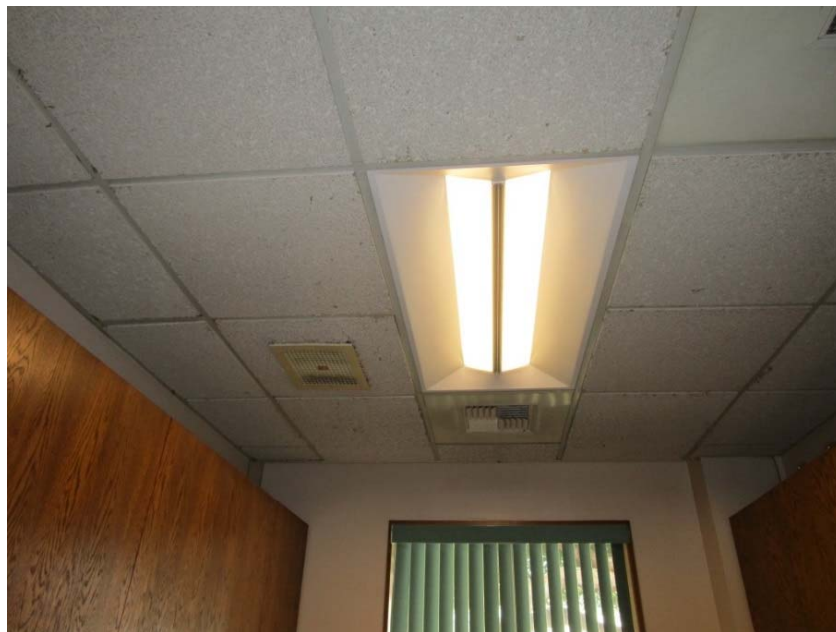
Ceiling exhaust fan is at the end of its expected useful life.

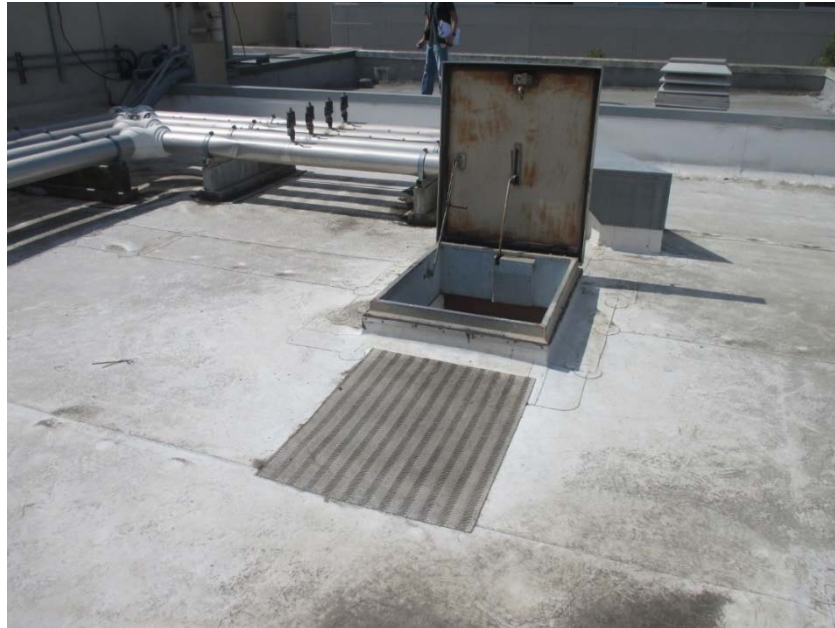
Roof hatch requiring fall protection

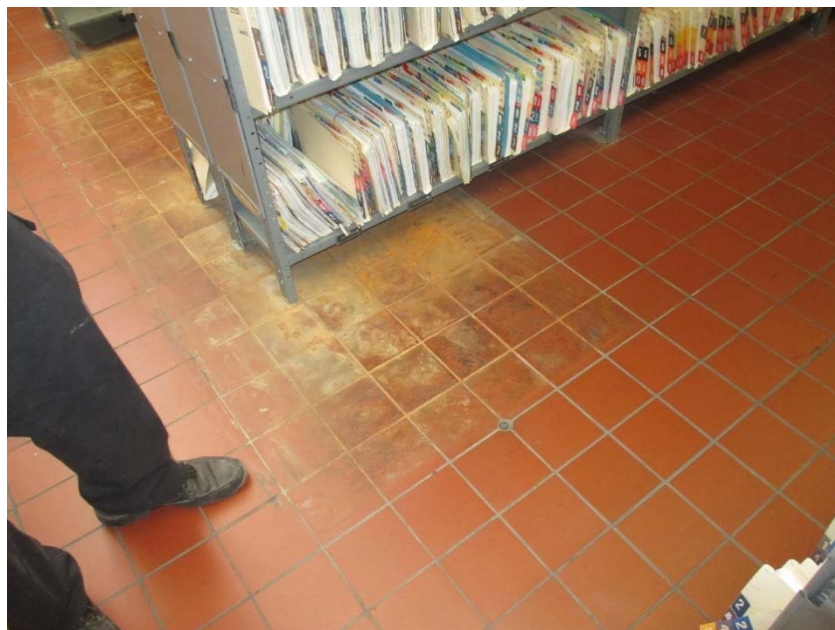
Damaged floor tile

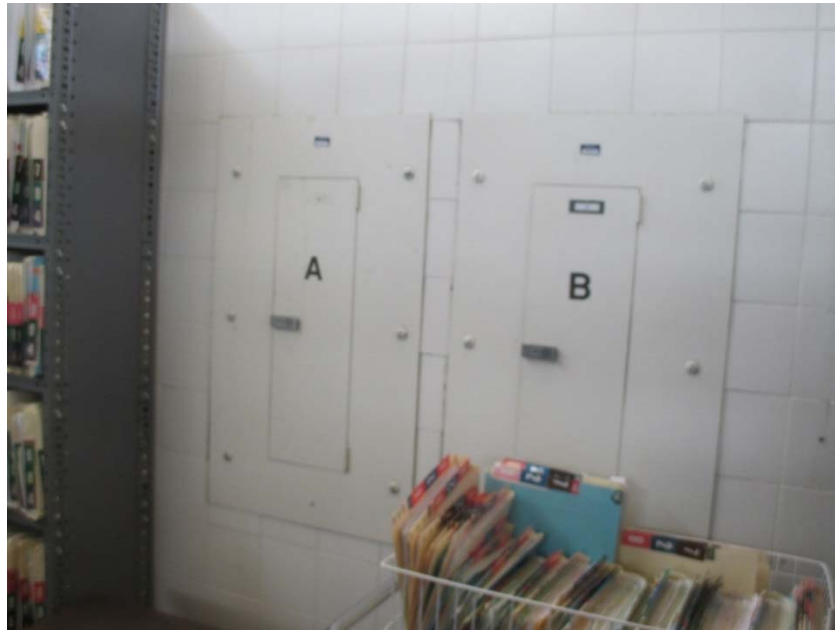
All wall recessed panels are approaching the end of their expected useful lives.

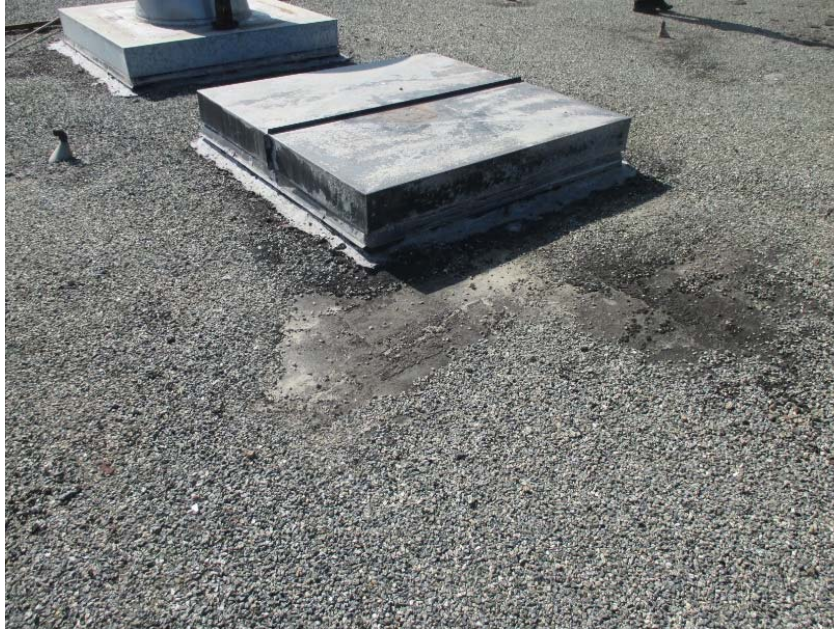
Worn gravel roof

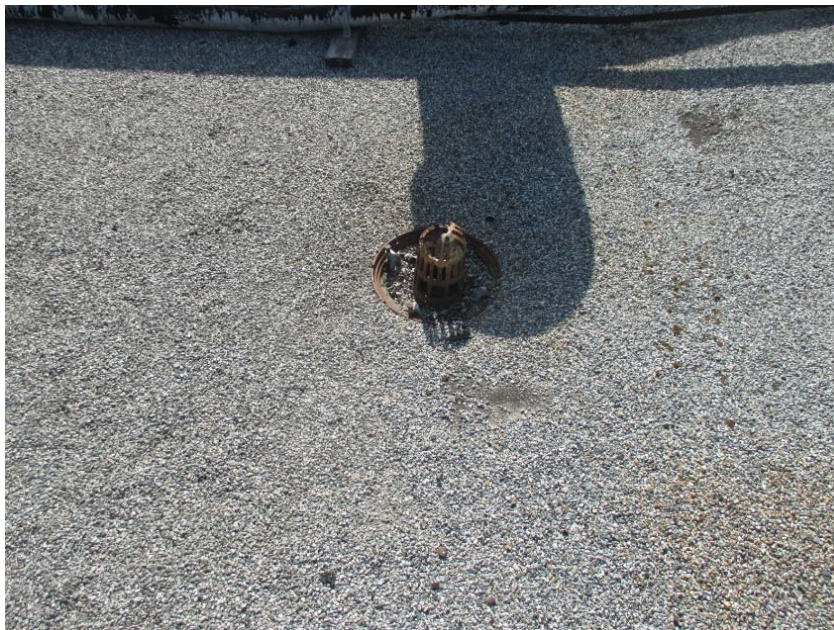
Damaged roof drain

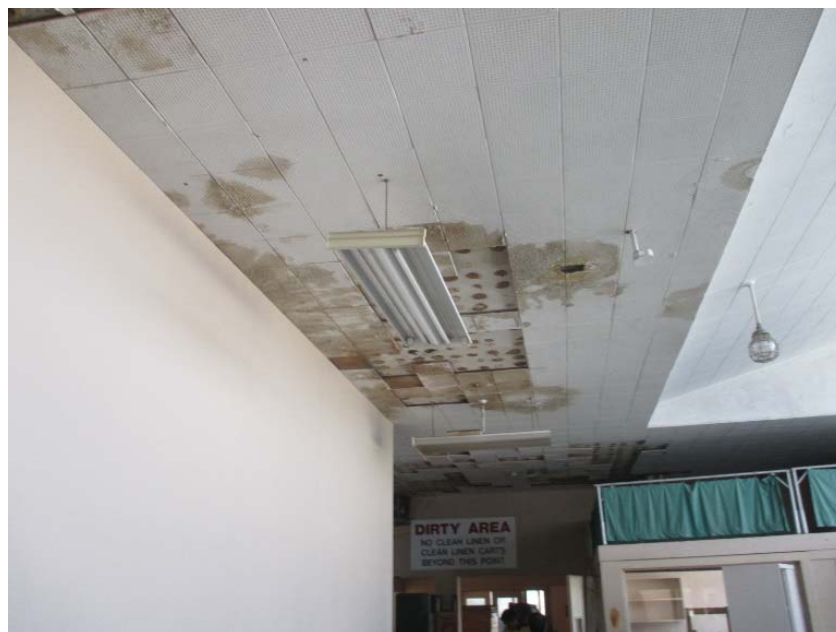
Damaged ceiling

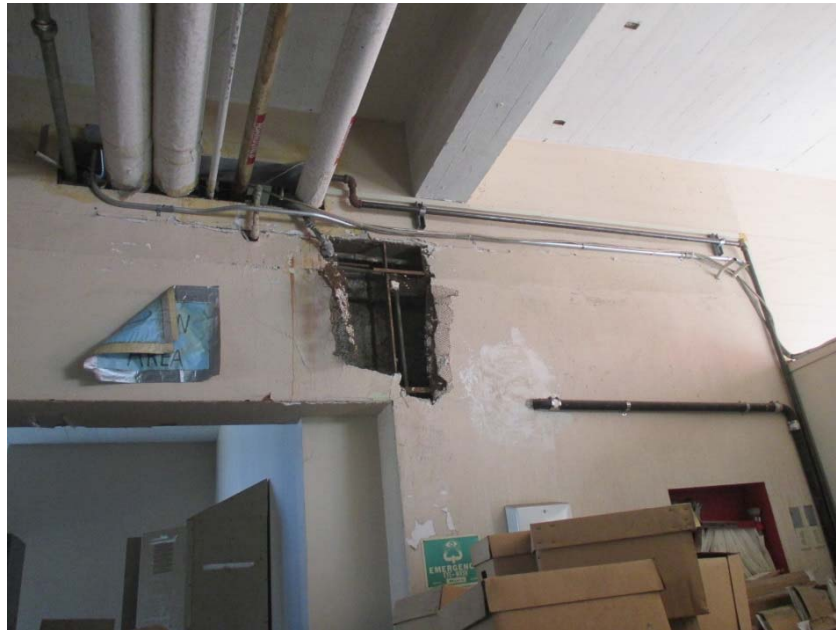
Damaged walls

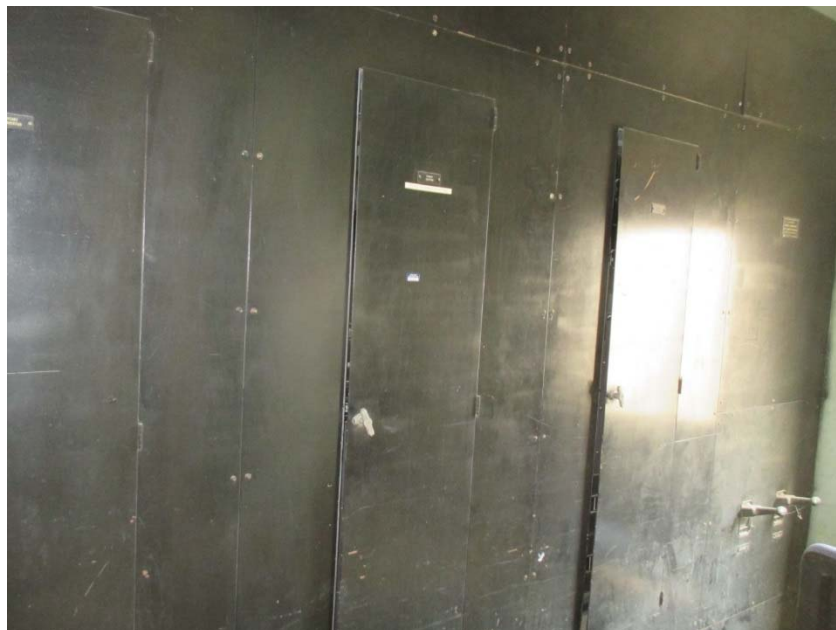
The panelboards are past their expected useful lives.

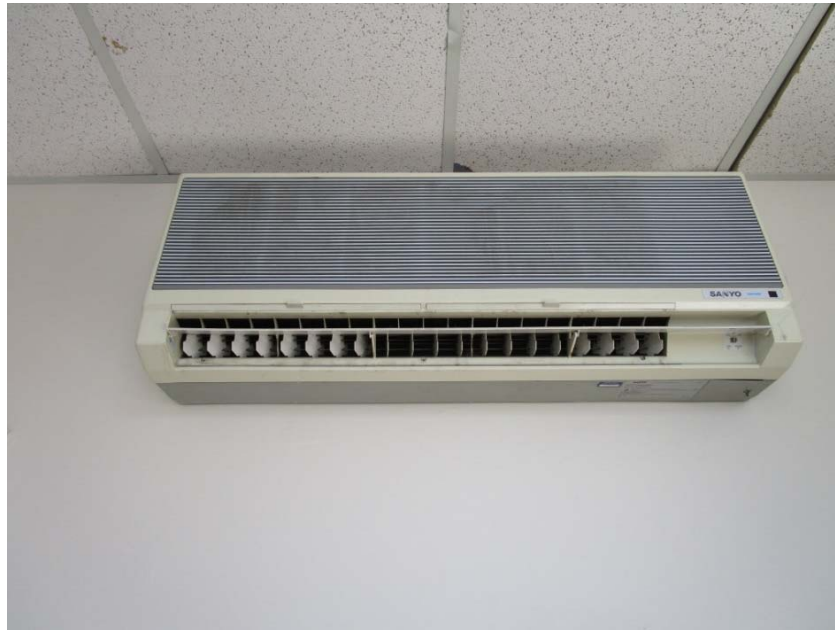
Split ductless air conditioning system is at the end of its expected useful life.

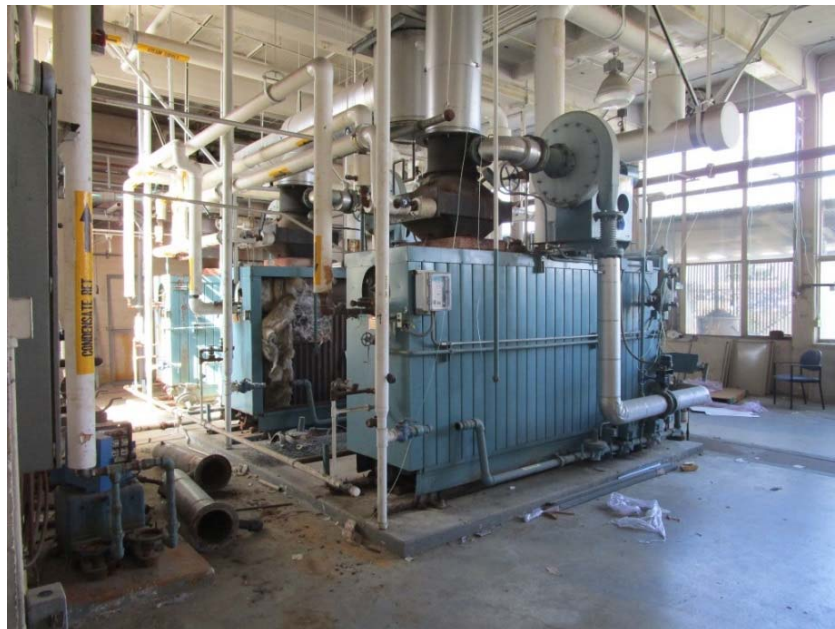
Heating hot water boilers are in poor condition and will need to be replaced.

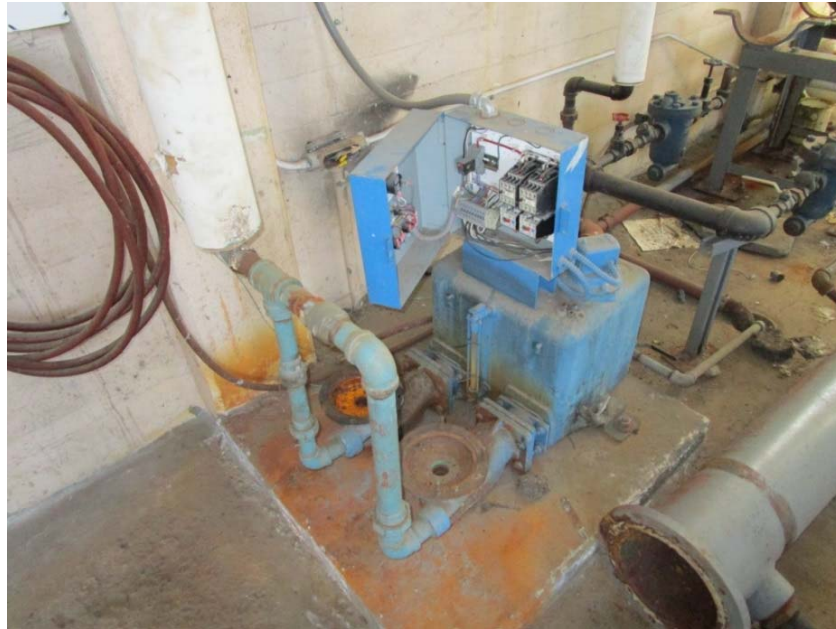
Steam condensate vacuum pump unit is in poor condition and will need to be replaced.

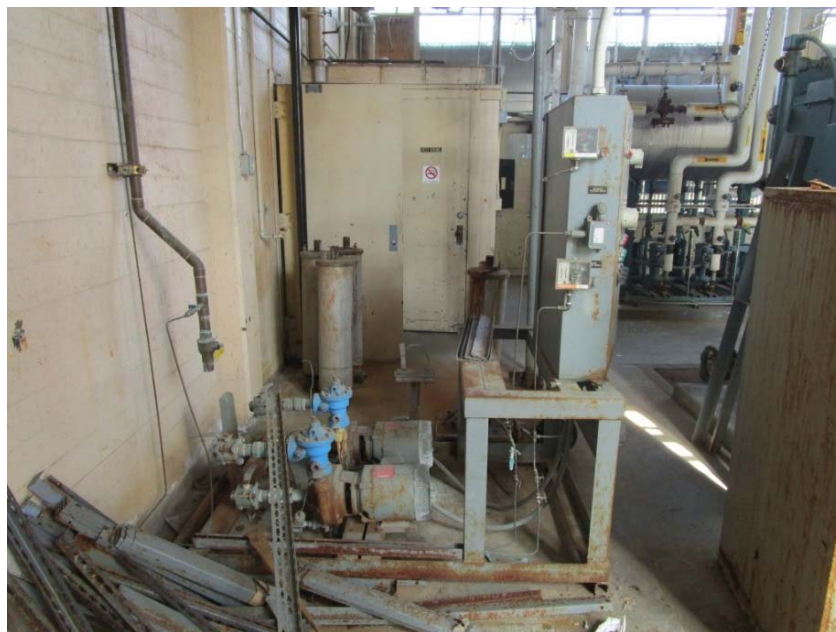
Recirculating pumps are in poor condition and will need to be replaced.

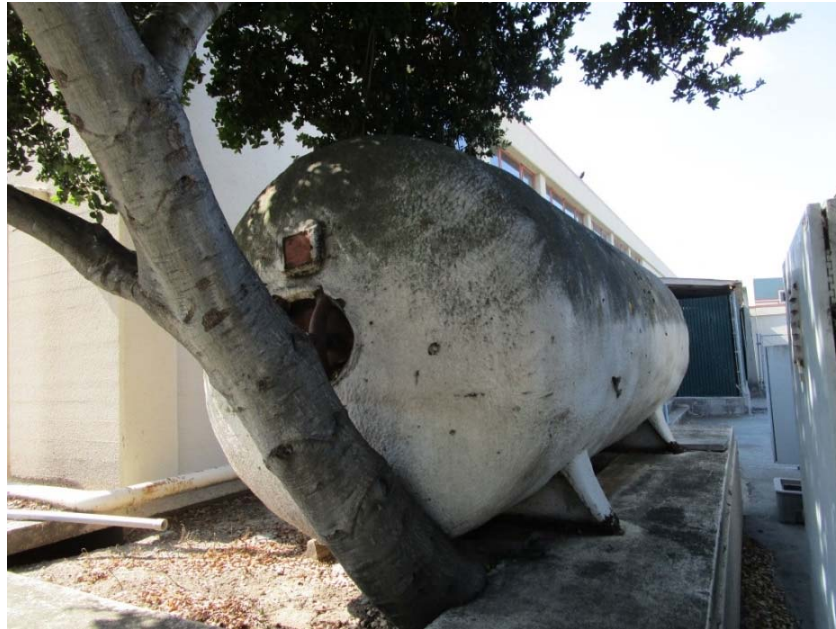
Hot water storage tank is at the end of its expected useful life.

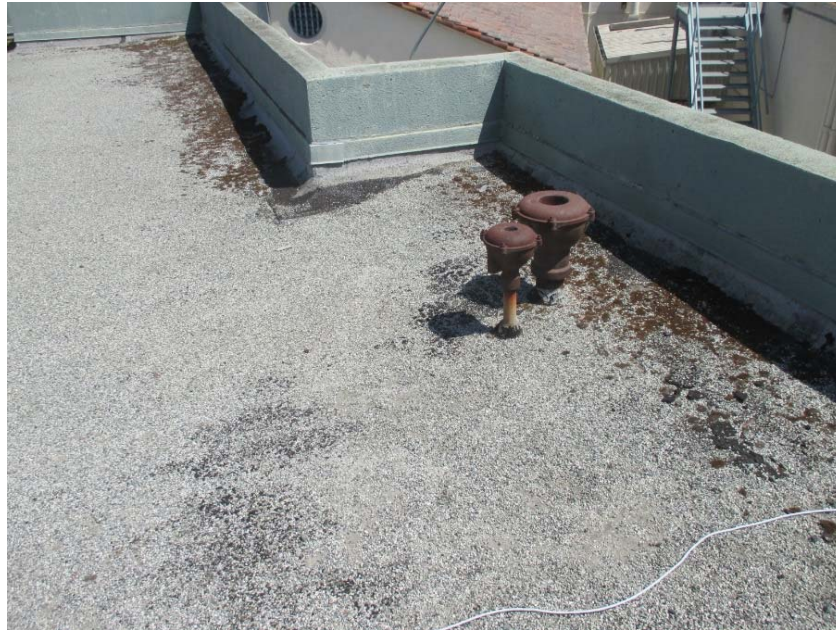
Worn roof with moss

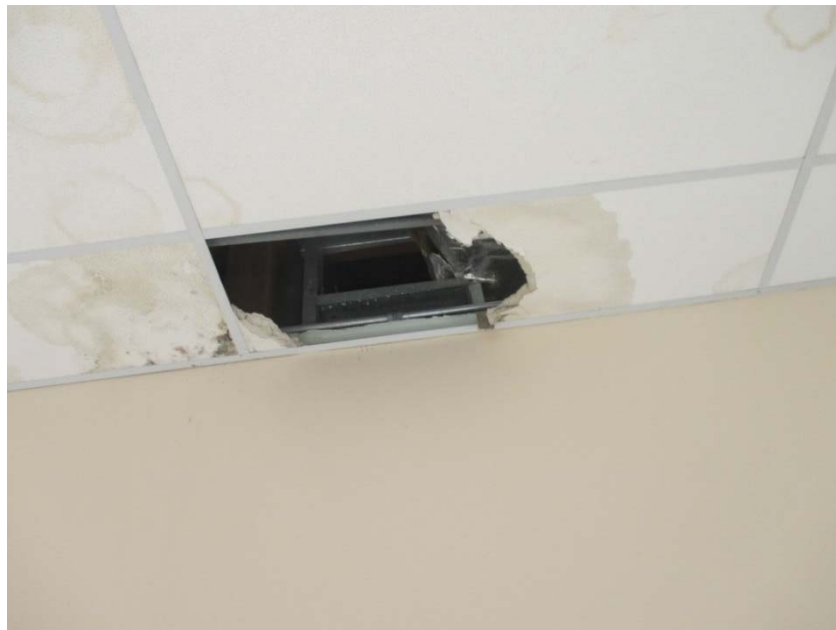
Damaged ceiling tiles

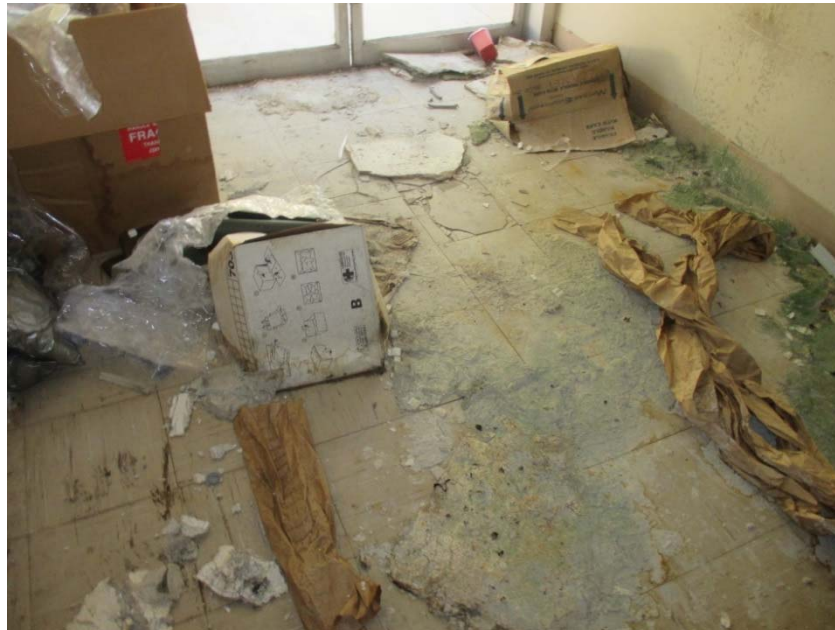
Floor tile is damaged, debris present.

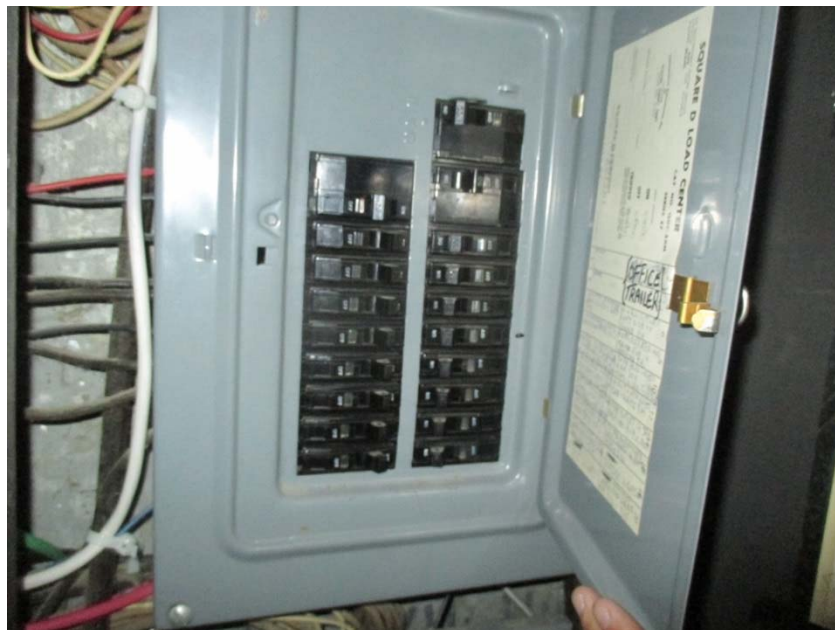
All panels are past their expected useful lives.

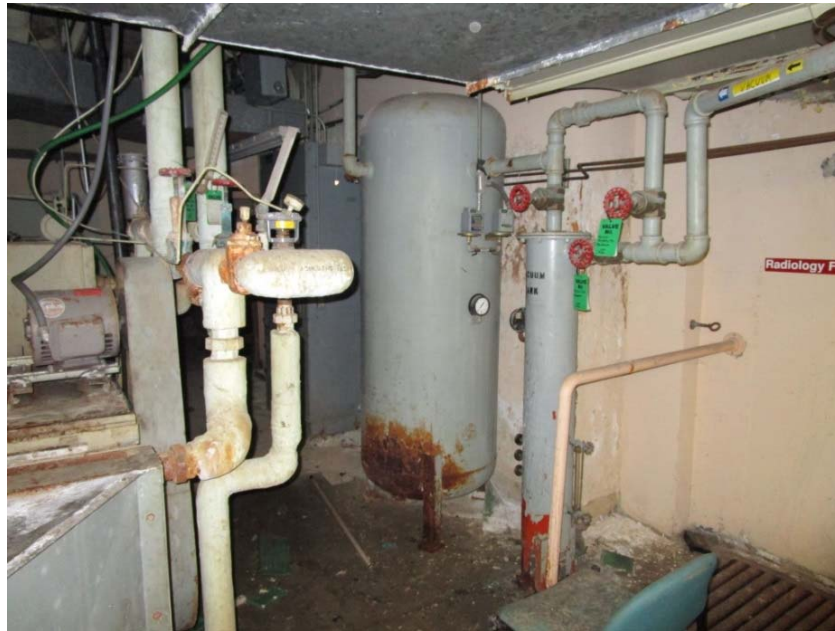
Expansion tank is in poor condition and needs to be replaced.

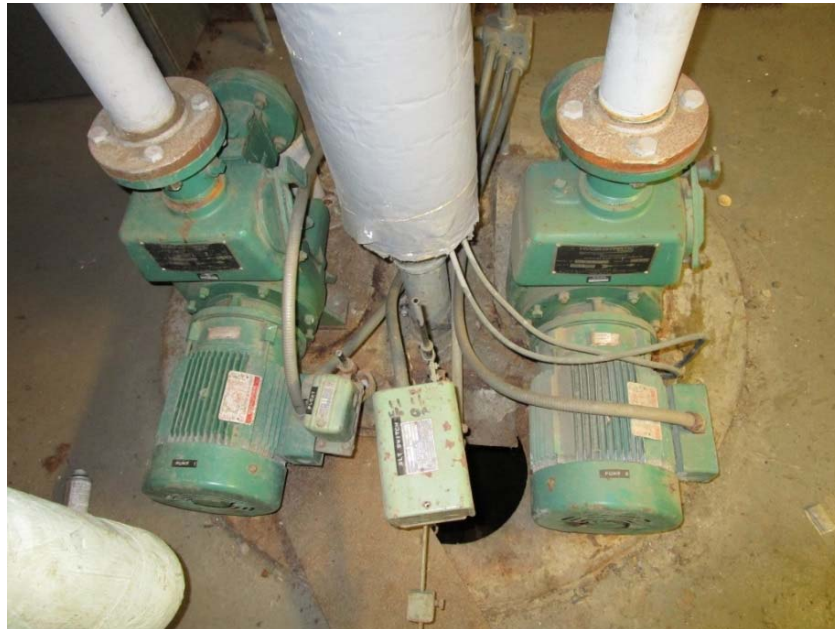
Recirculating pumps are at the end of their expected useful lives.

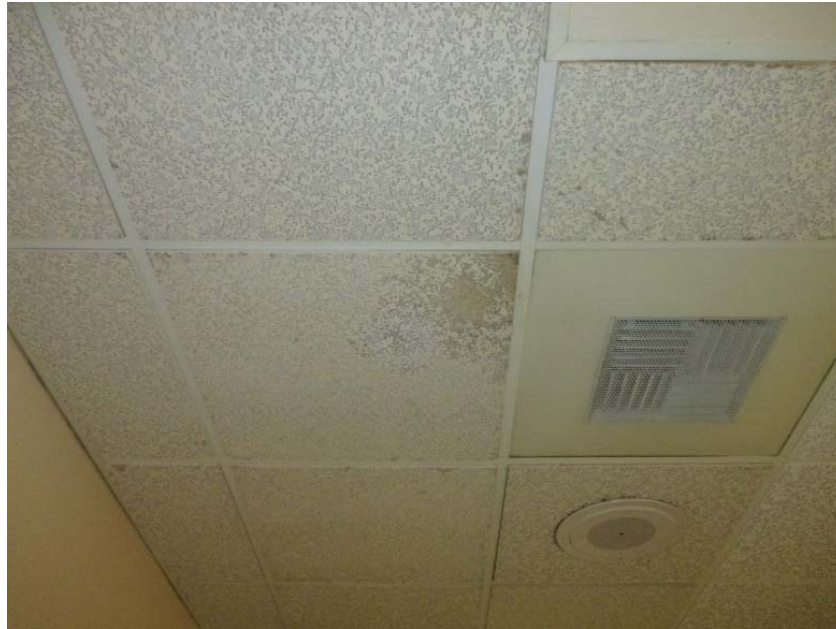
Worn ceiling tiles

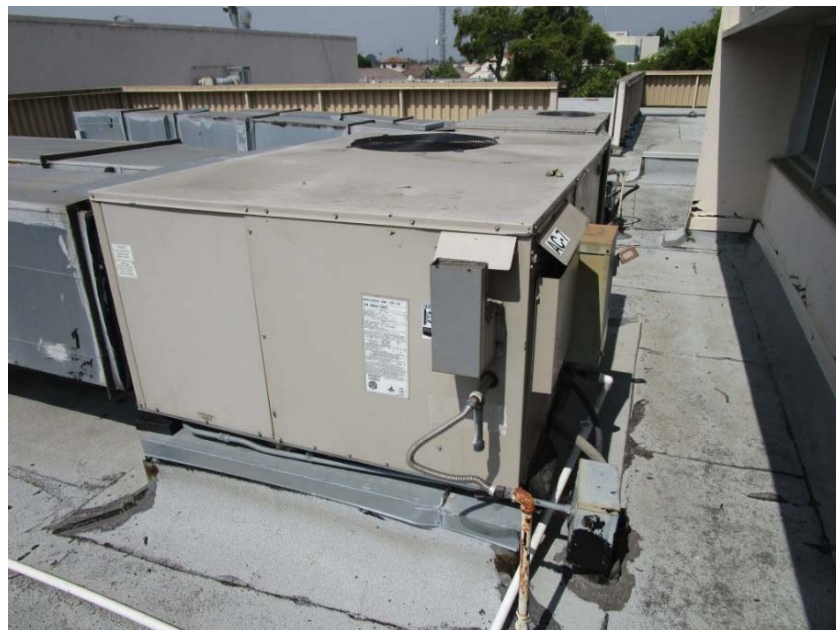
Packaged rooftop DX cooling with gas heating air conditioning unit is at the end of its expected useful life.

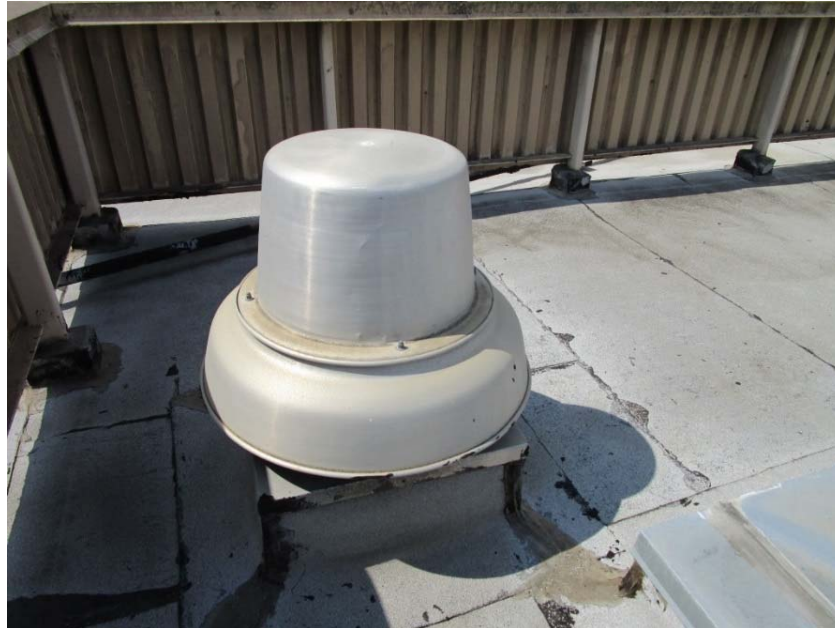
Rooftop exhaust fan is at the end of its expected useful life.

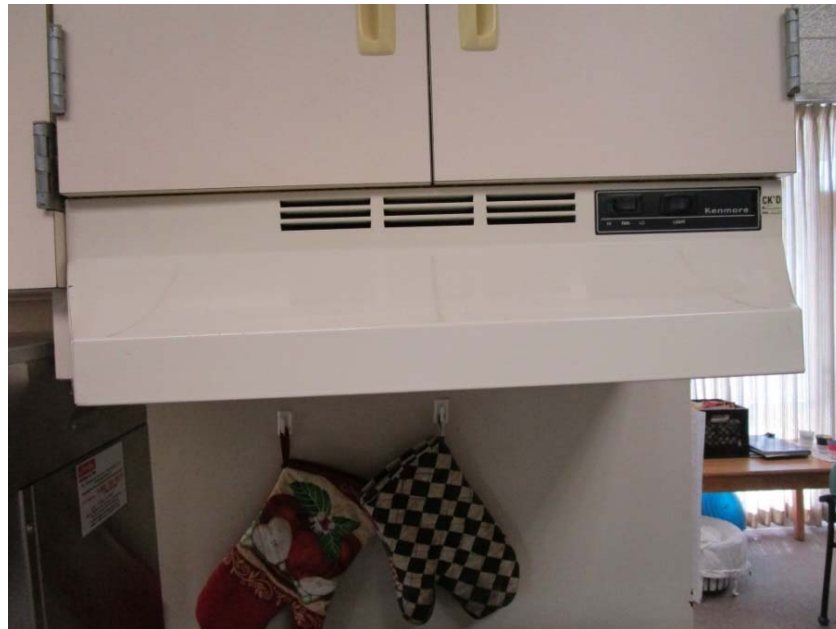
The range hood for the oven/range is at the end of its expected useful life.

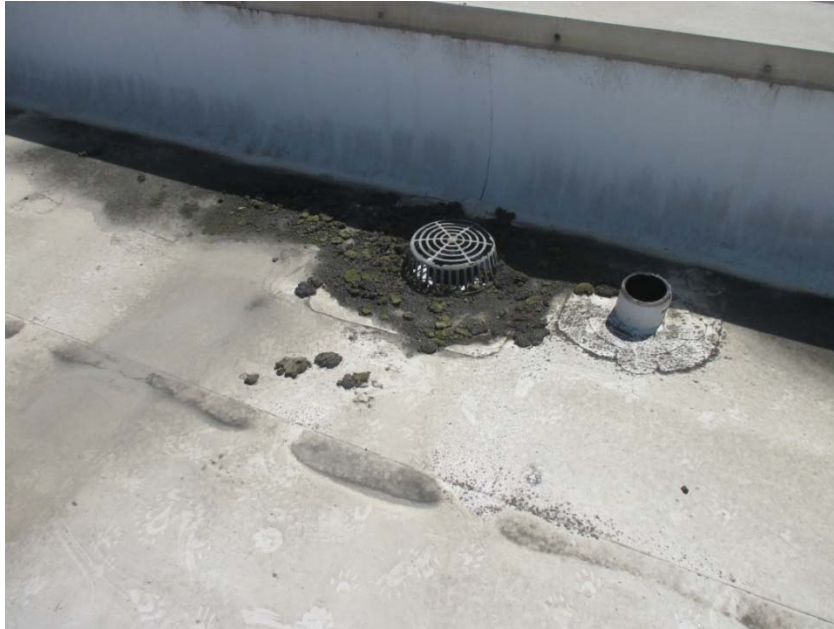
Roof drain with sediment and vegetation

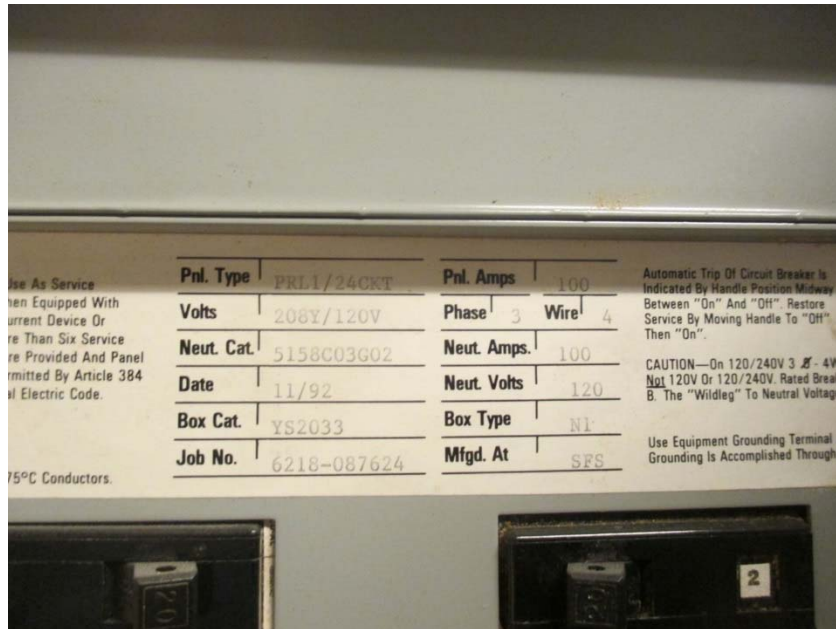
Panel "V" is past its expected useful life.

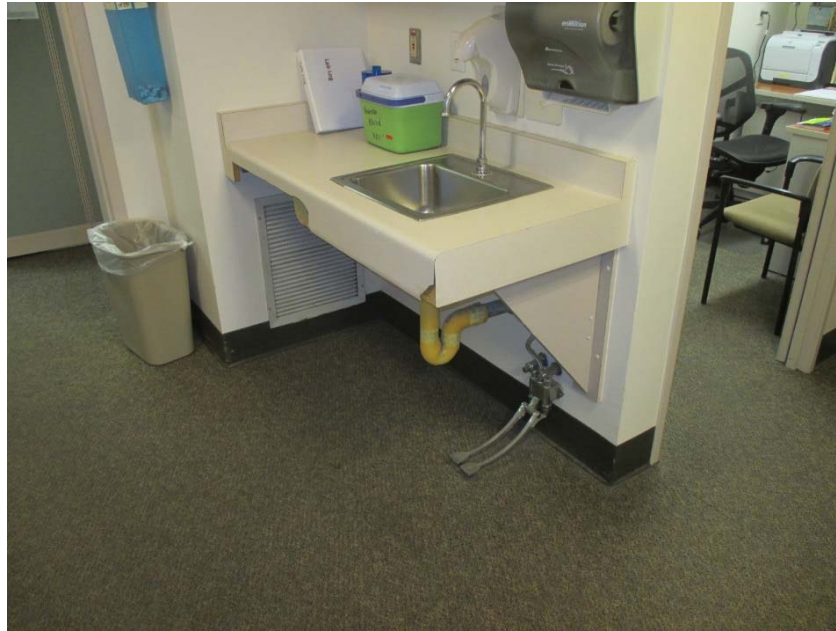
Damaged handwash station

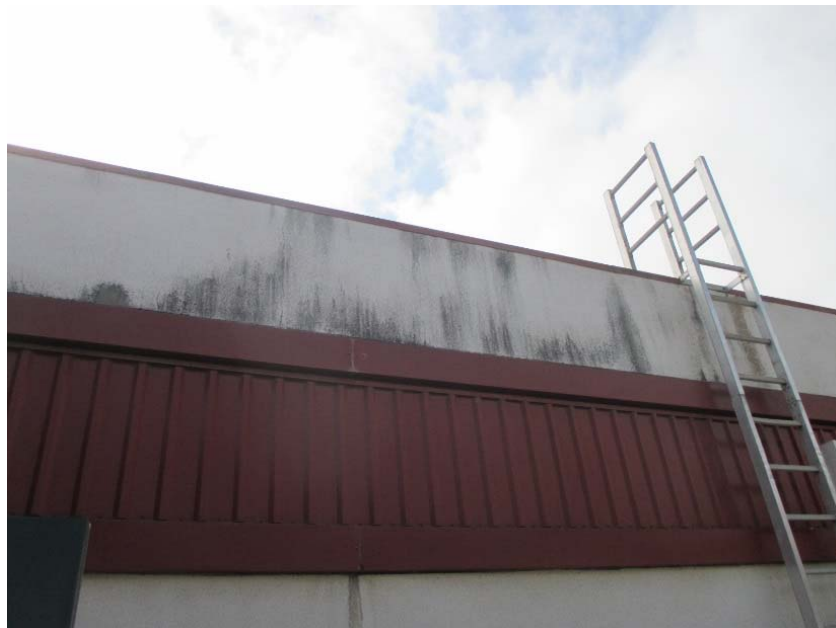
Exterior finish has staining

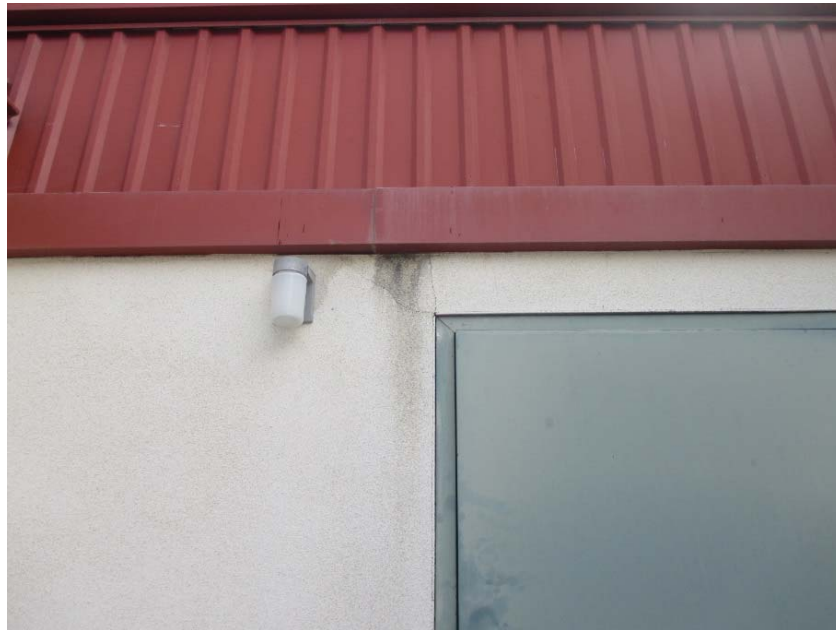
Cement plaster cracking
