Natividad Medical Center Facility Assessment Report

*Prepared by Kitchell
For*

County of Monterey, California

December 9, 2015
Job No. 4983A3

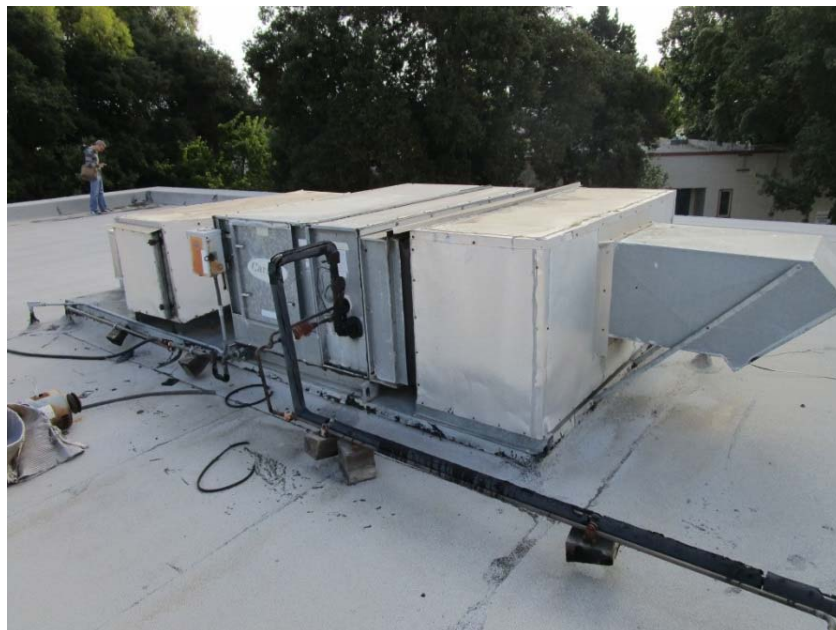
Rooftop packaged DX cooling with gas heating air conditioning unit is at the end of its expected useful life.

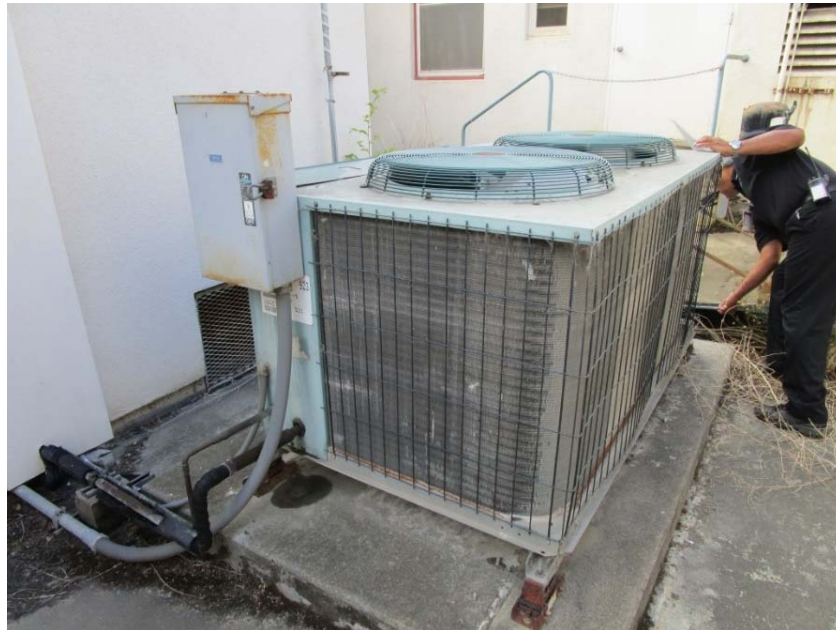
Ground mounted heat pump unit is at the end of its expected useful life.

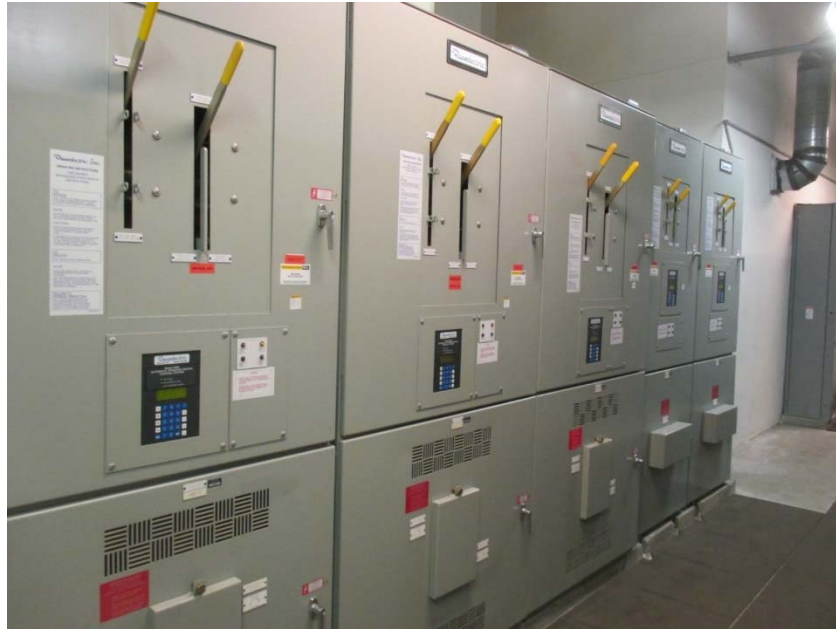
The automatic transfer switches have reached the end of their expected useful lives.

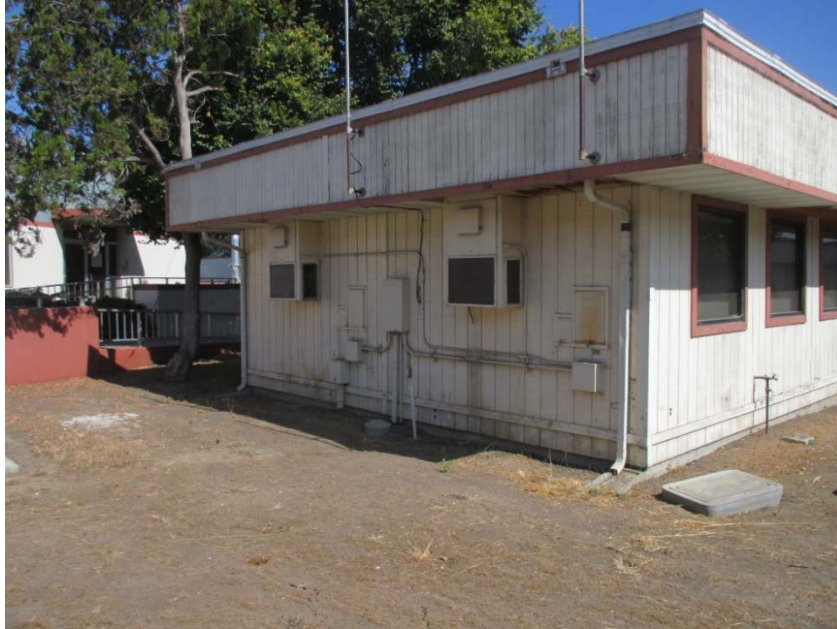
Typical deteriorated plywood siding.

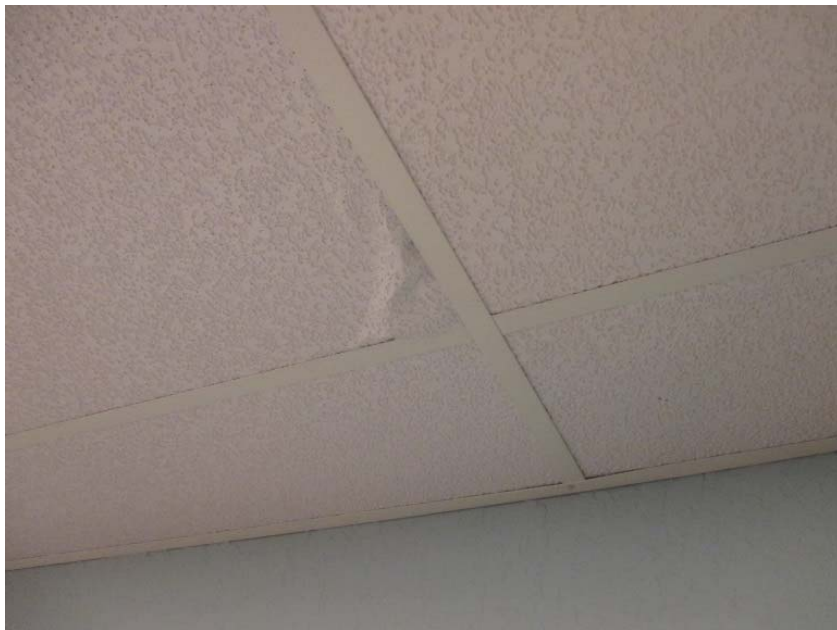
Typical ceiling tile needing replacement

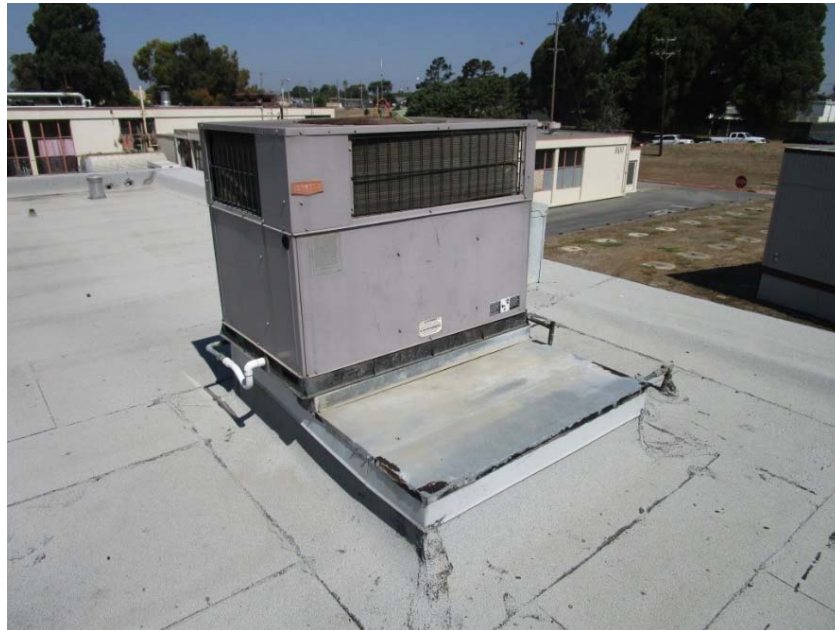
Building 840 packaged rooftop DX cooling with gas heating air conditioning units are at the end of their expected useful lives.

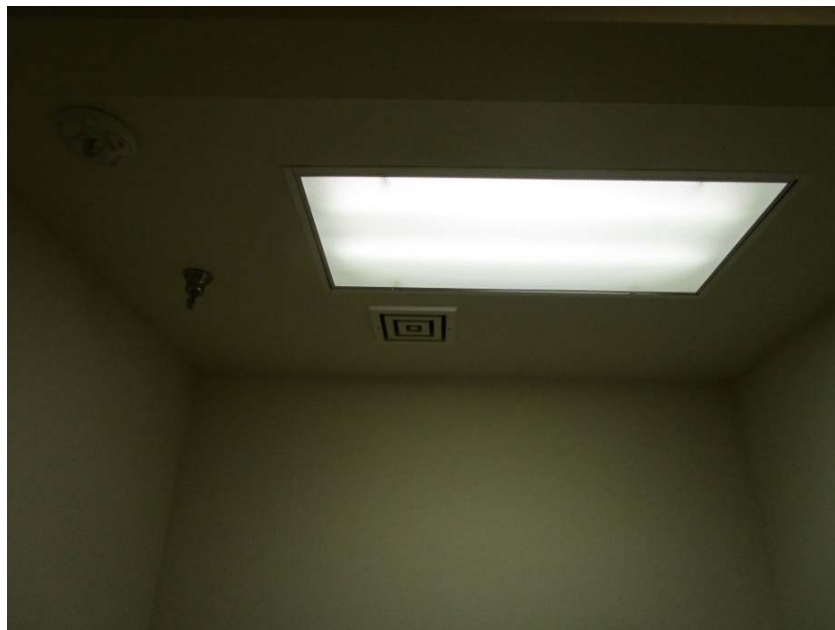
Buildings 840 and 870 ceiling exhaust fans are at the end of their expected useful lives.

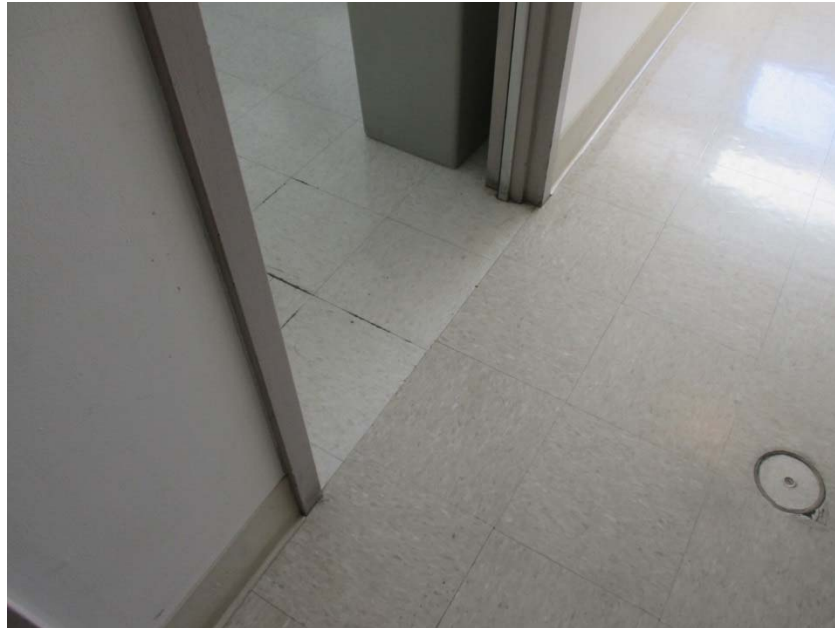
VCT flooring is failing

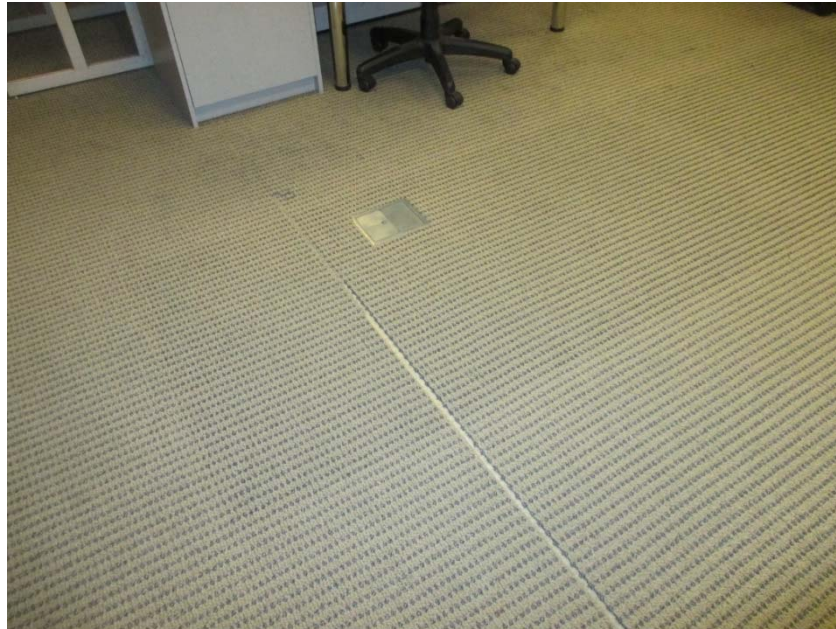
Carpet requiring replacement.

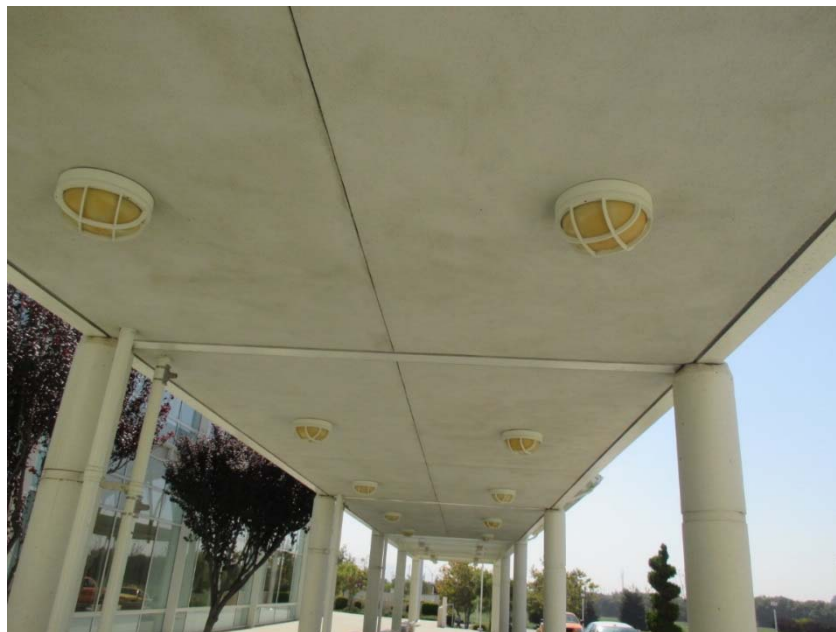
Exterior lighting fixtures are yellowing and should be replaced.

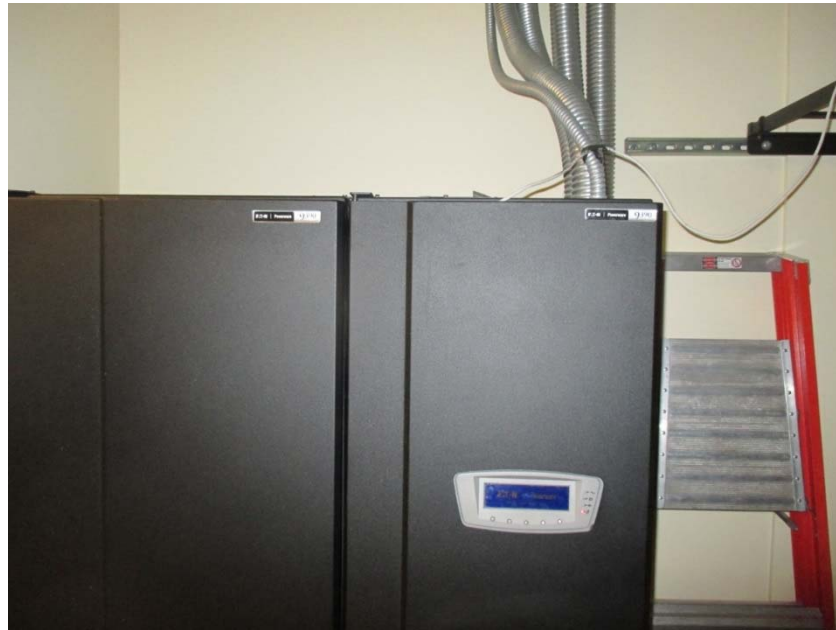
Uninterruptible Power Supply (UPS) is due for a battery replacement.

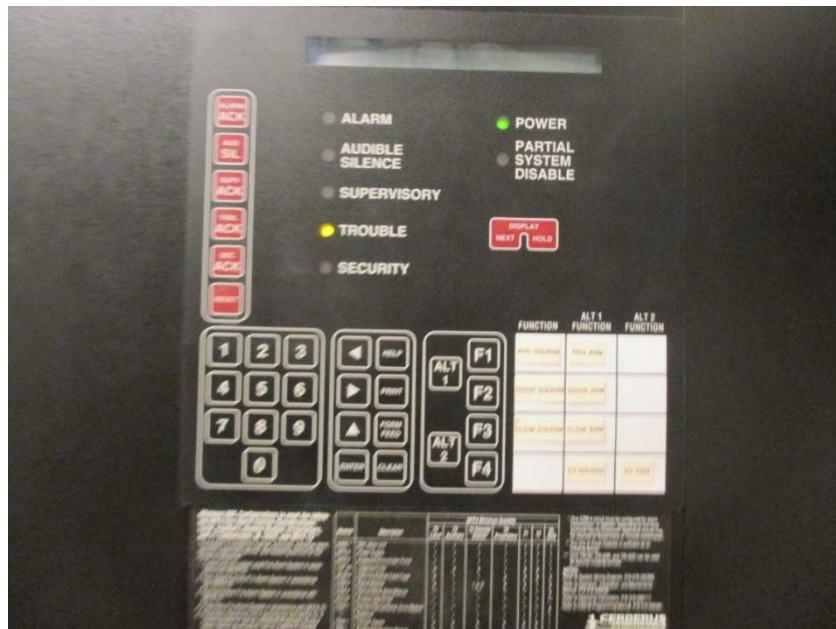
Fire alarm control panel is past its expected useful life.

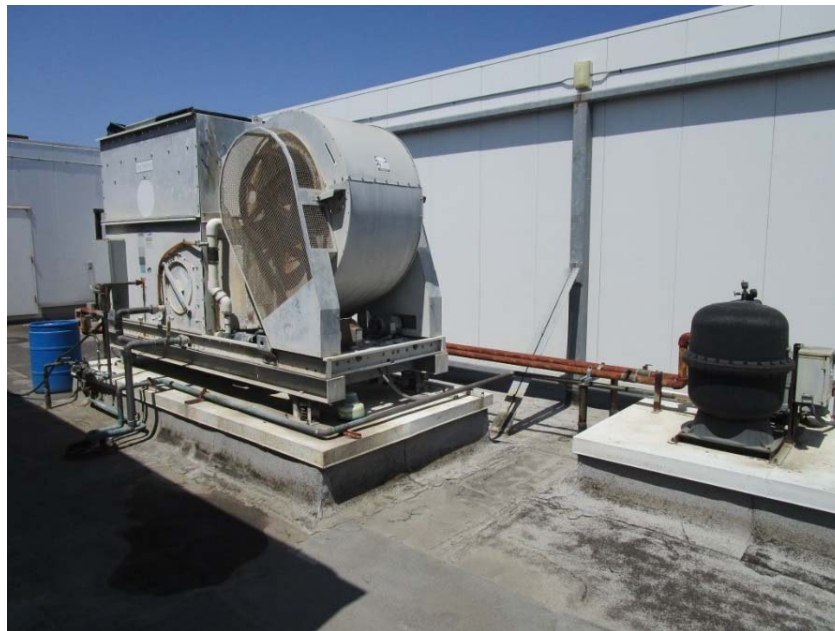
Cooling tower and sand filter are not working and will need to be replaced.

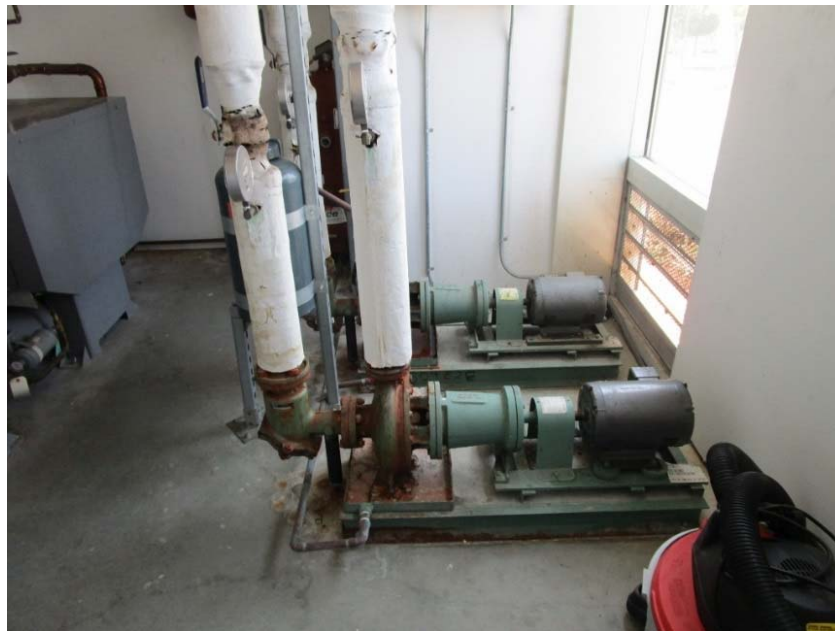
Recirculation pumps are at the end of their expected useful lives.

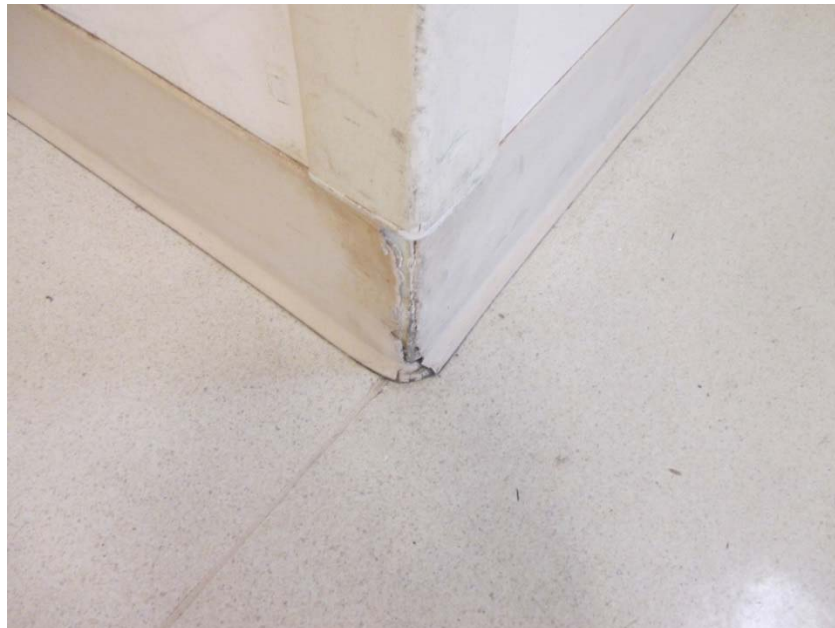
Damaged wall base.

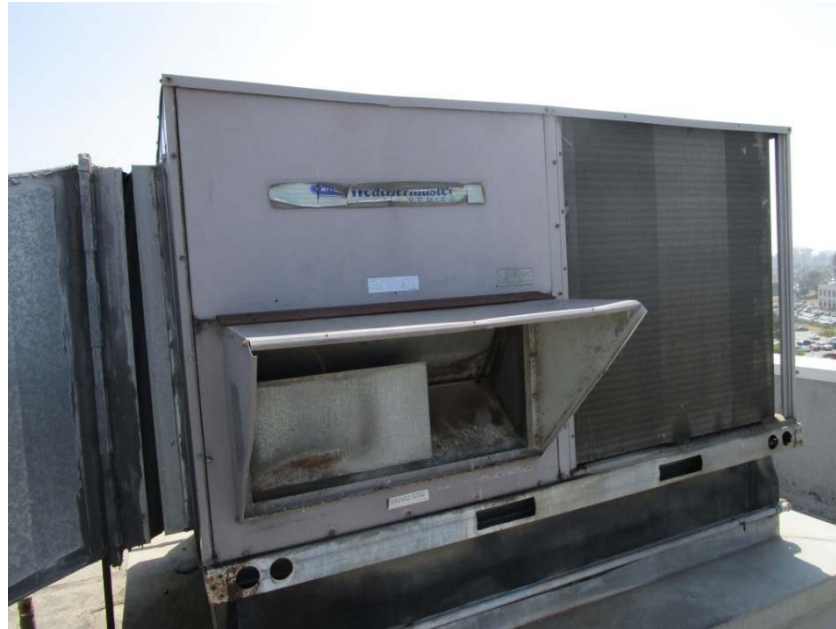
Packaged rooftop DX cooling with gas heating air conditioning unit is at the end of its expected useful life.

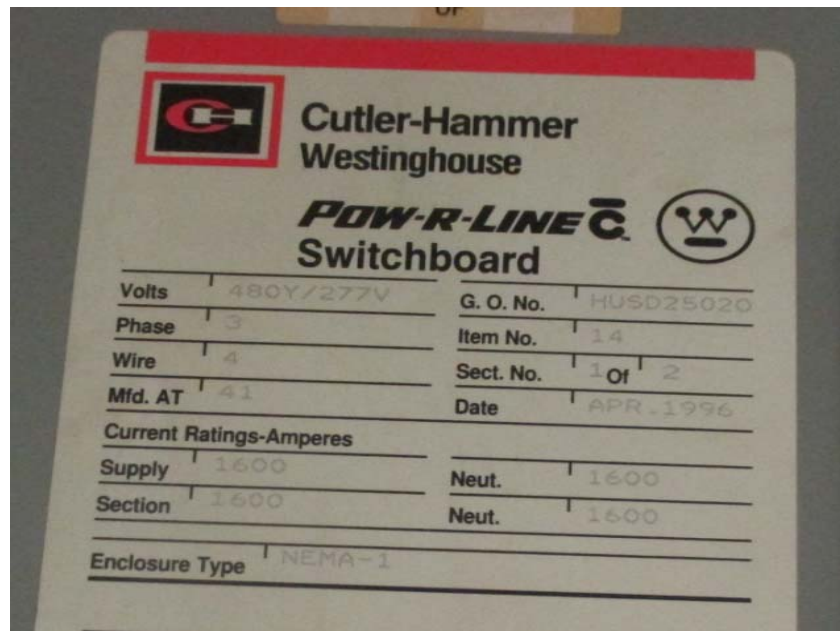
1600A Switchboard is approaching its expected useful life.

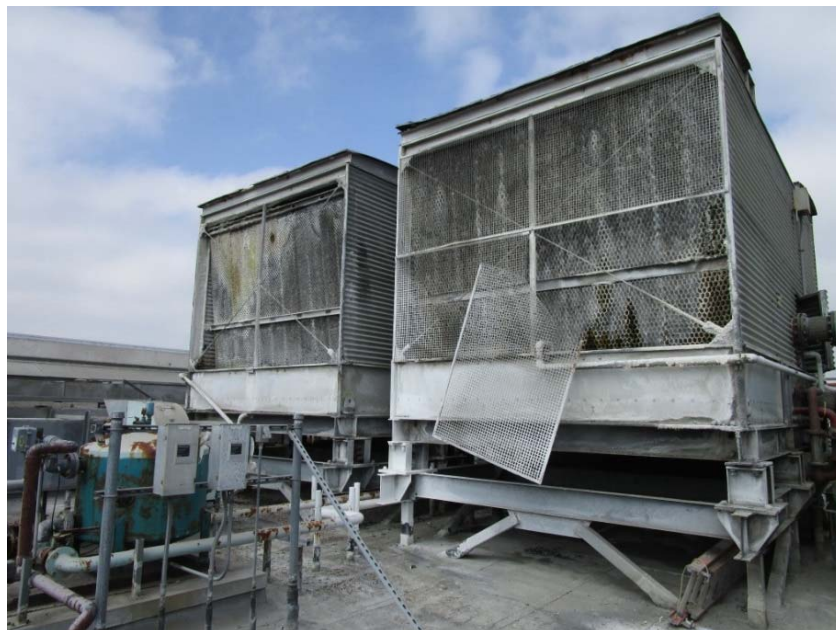
Cooling towers are in poor condition and will need to be replaced.

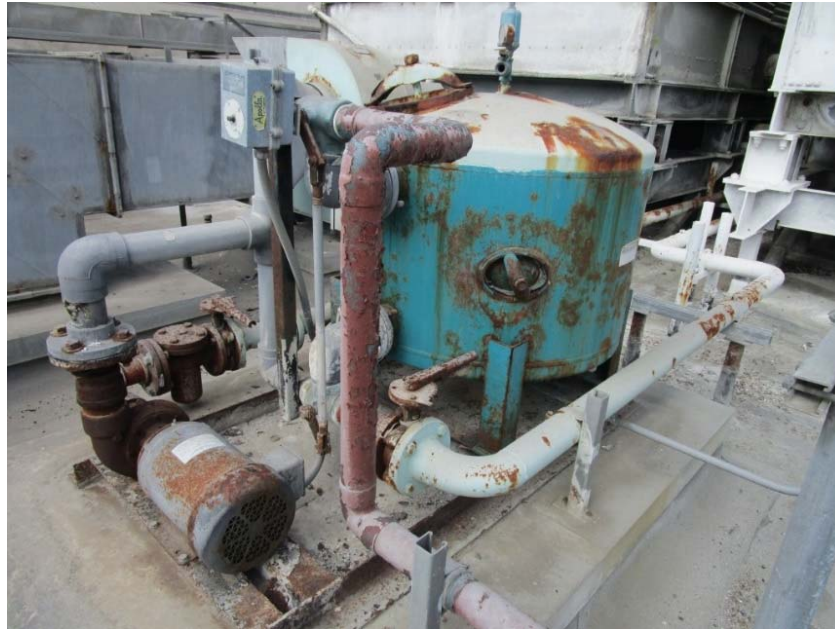
Rooftop sand filter is no longer working and will need to be replaced.

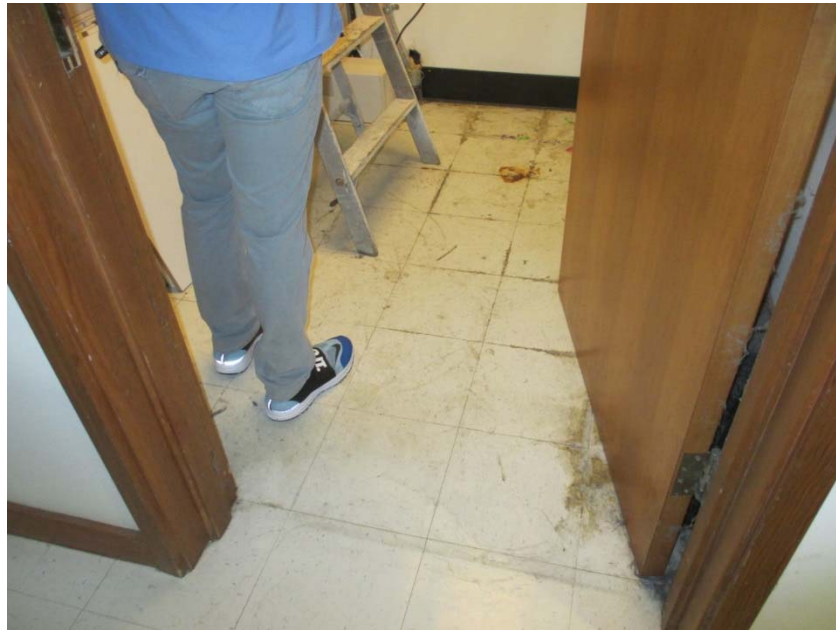
Failing VCT flooring

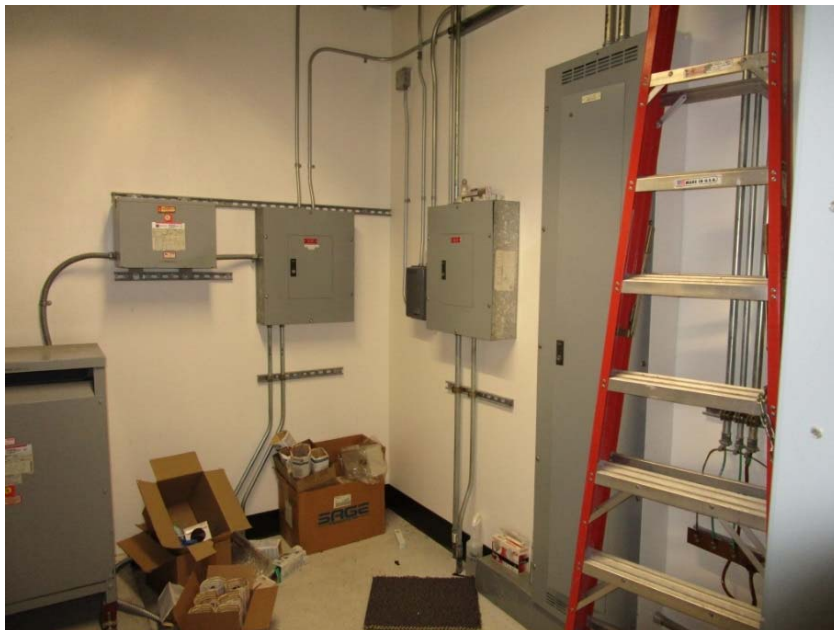
Recommend installing a new split ductless HVAC system in Electrical Room to maintain proper room temperature.

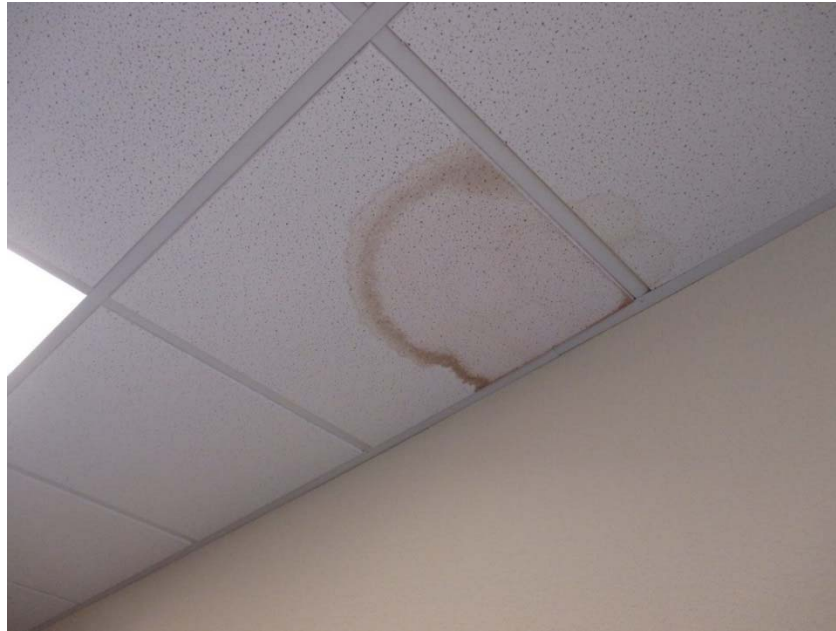
Stained ceiling tiles

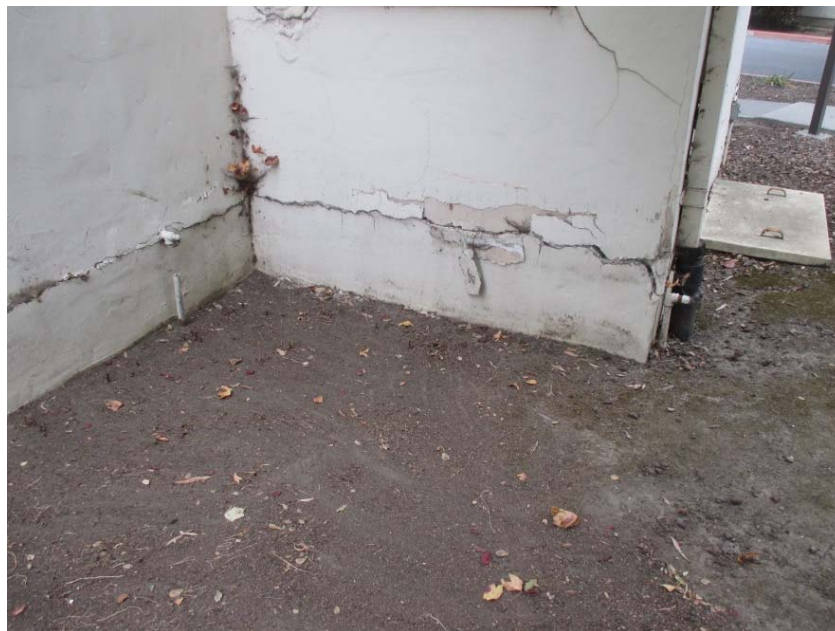
Failing cement plaster

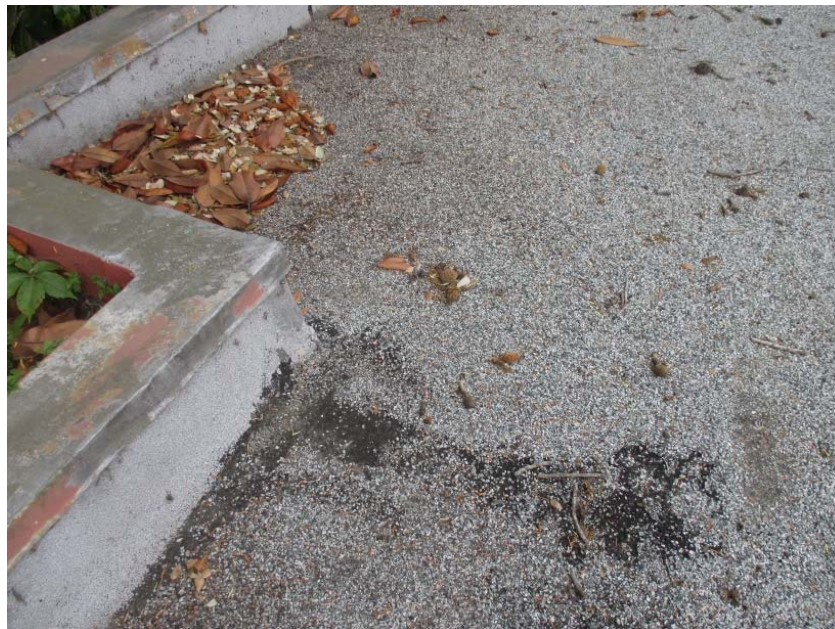
Gravel roof and parapet caps are beyond useful life

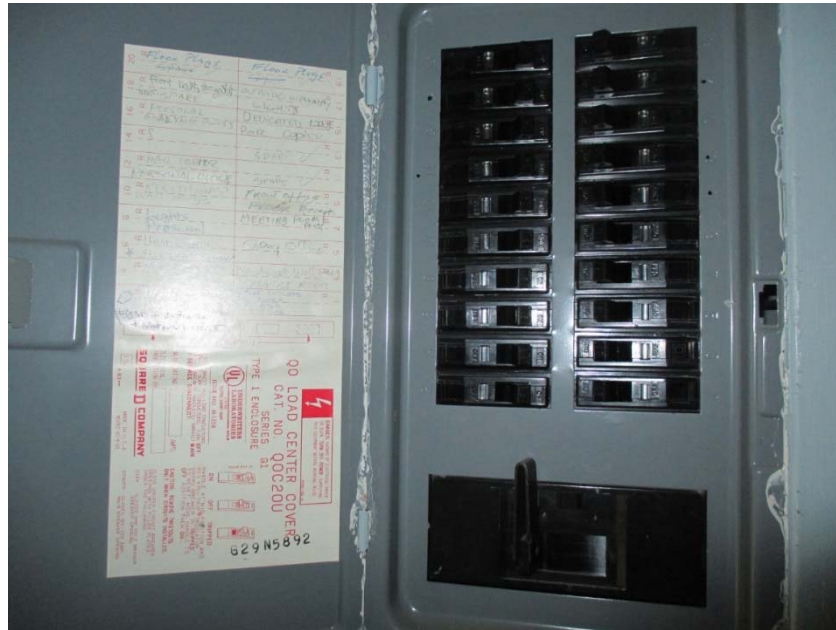
Two panels are past their rated usable lifetime and should be replaced.

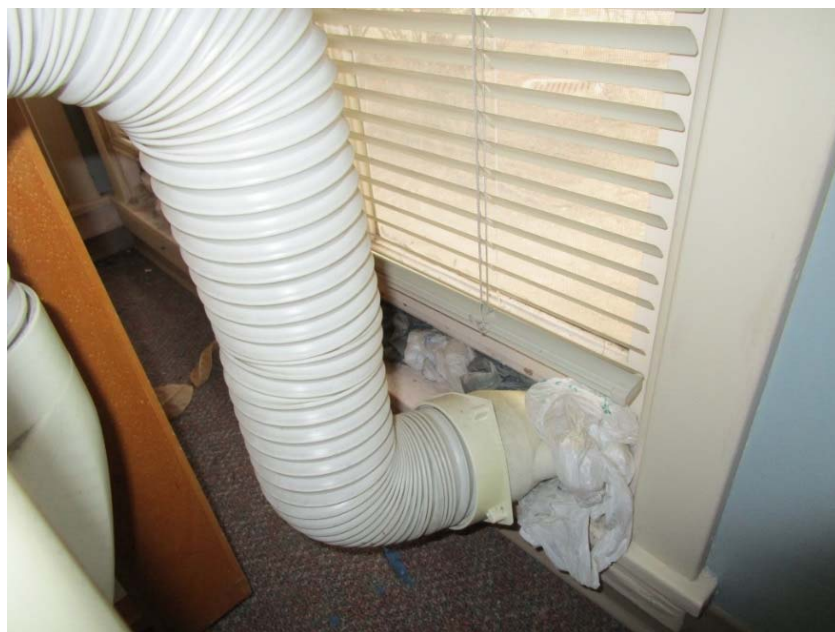
Exhaust duct for portable air conditioning unit is improperly installed.
