THOMPSON
WILDLAND MANAGEMENT

Zhang-Ding Residence
5486 Quail Meadows Drive
Carmel, CA 93923
APN: 157-171-017-000

Subject: Pre-construction tree impact assessment & removal report for 5486 Quail
Meadows Drive in Carmel

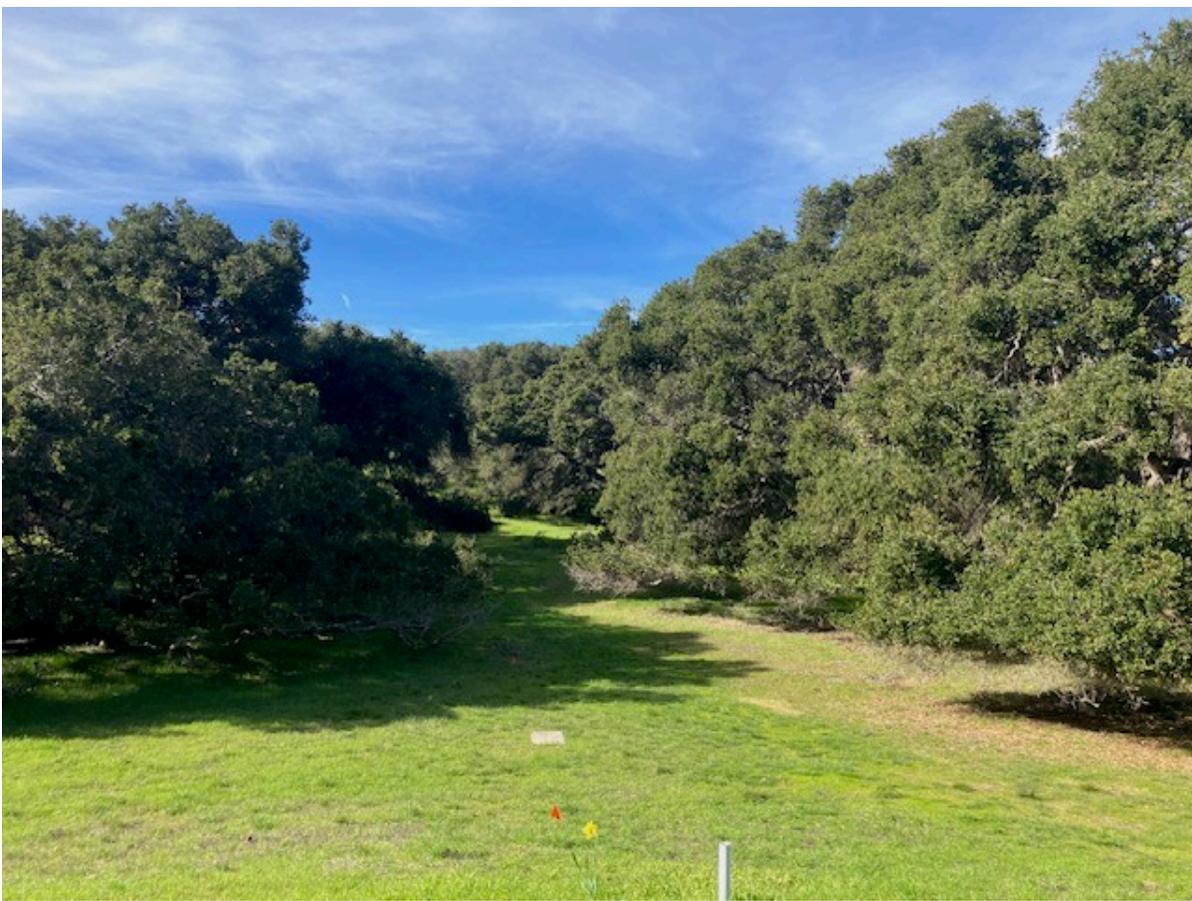
Figure 1. View of driveway entrance into oak woodland homesite area from Quail Meadows Drive. Driveway will primarily pass through clearing between canopy driplines and oaks will be protected with fencing to minimize impacts.

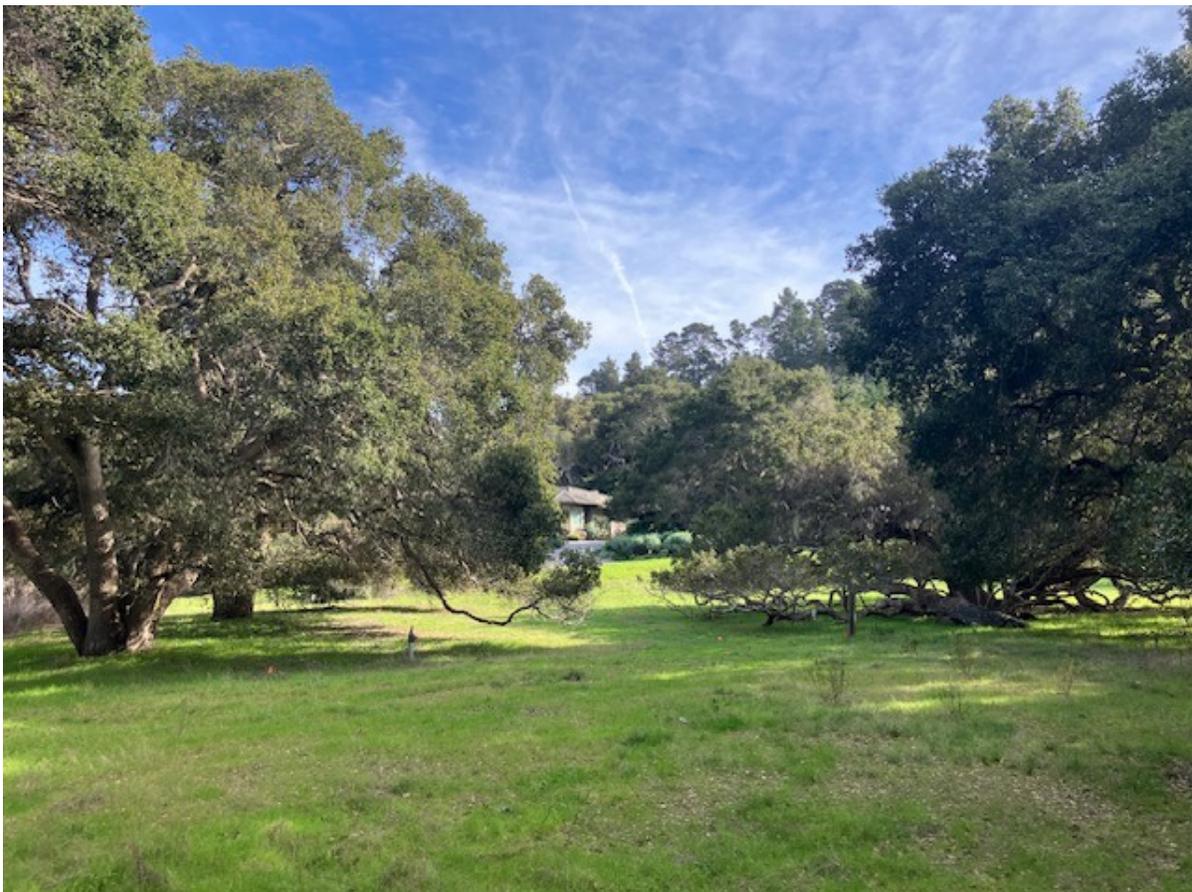
Figure 2. Another view of driveway entrance area taken from homesite looking back towards Quail Meadows Drive.

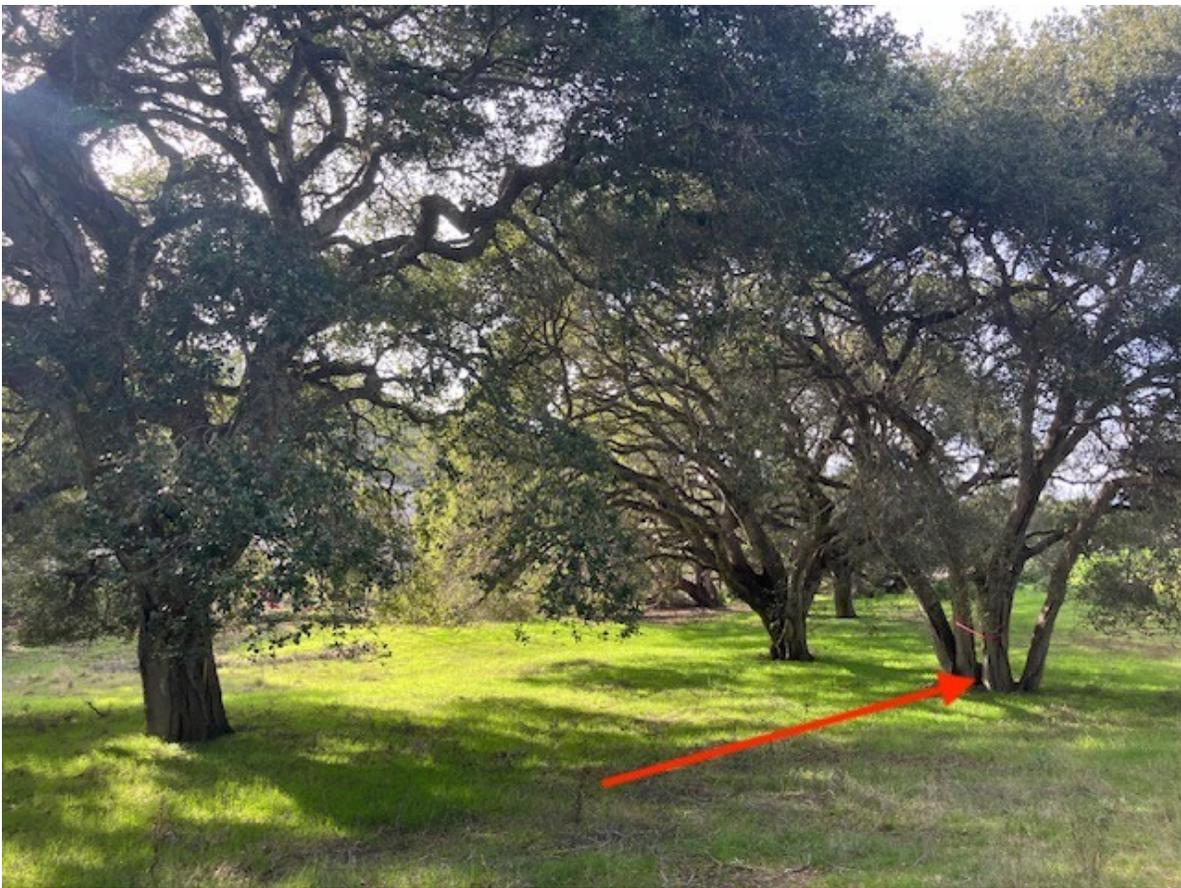
The large and aging multi-codominant trunk Coast Live Oak (*Quercus agrifolia*) identified as *Tree#1* on the project site plans (tag#437 is nailed to the trunk) has a DBH (diameter at breast height) of approximately 68 inches. This oak is recommended for removal due to its close proximity to the proposed main house that is located a short distance to the north and northwest of the subject tree, and the driveway looping around the tree is a short distance to the east, south and west of the tree (refer to *Figures 3, 5 & 6*). It should be noted that this tree has poor canopy balance and symmetry with a significant natural lean in the direction of the proposed main house. This oak is in fair physiological health and condition, but is generally in poor structural condition due to poor canopy balance and symmetry, multiple structurally problematic co-dominant trunk and stem attachments, and visible decay features that are compromising structural integrity. Per County requirements, two 5 to 15-gallon replacement oaks will need to be planted on the property to satisfy tree removal permit conditions.

Figure 3. Proposed driveway passes between oaks up through center of photo. Oak identified as Tree#1 (red arrow) is proposed for removal. Other nearby oaks will be retained and protected.

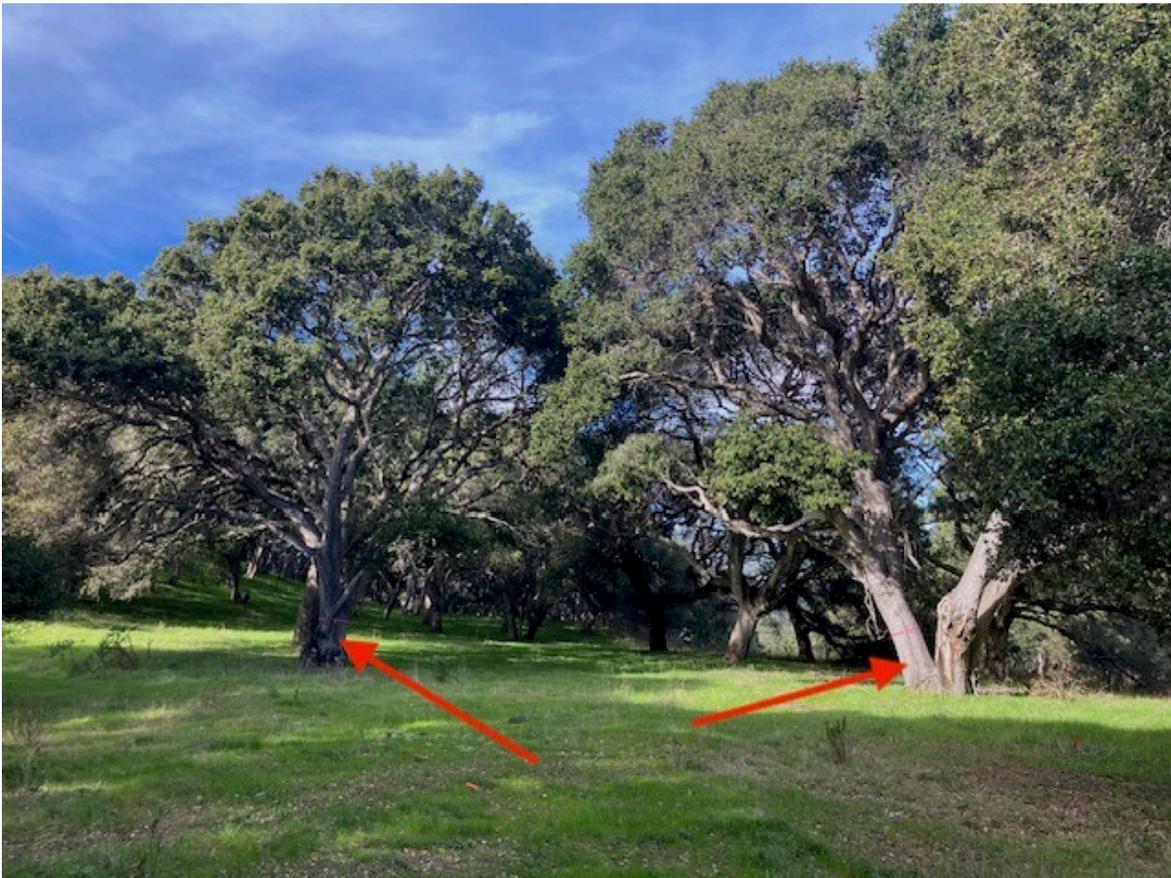
Figure 4. Oaks identified as Tree#2 (red arrow to the left) & Tree#3 (red arrow to the right) will need to be removed due to their location within the proposed construction footprint.

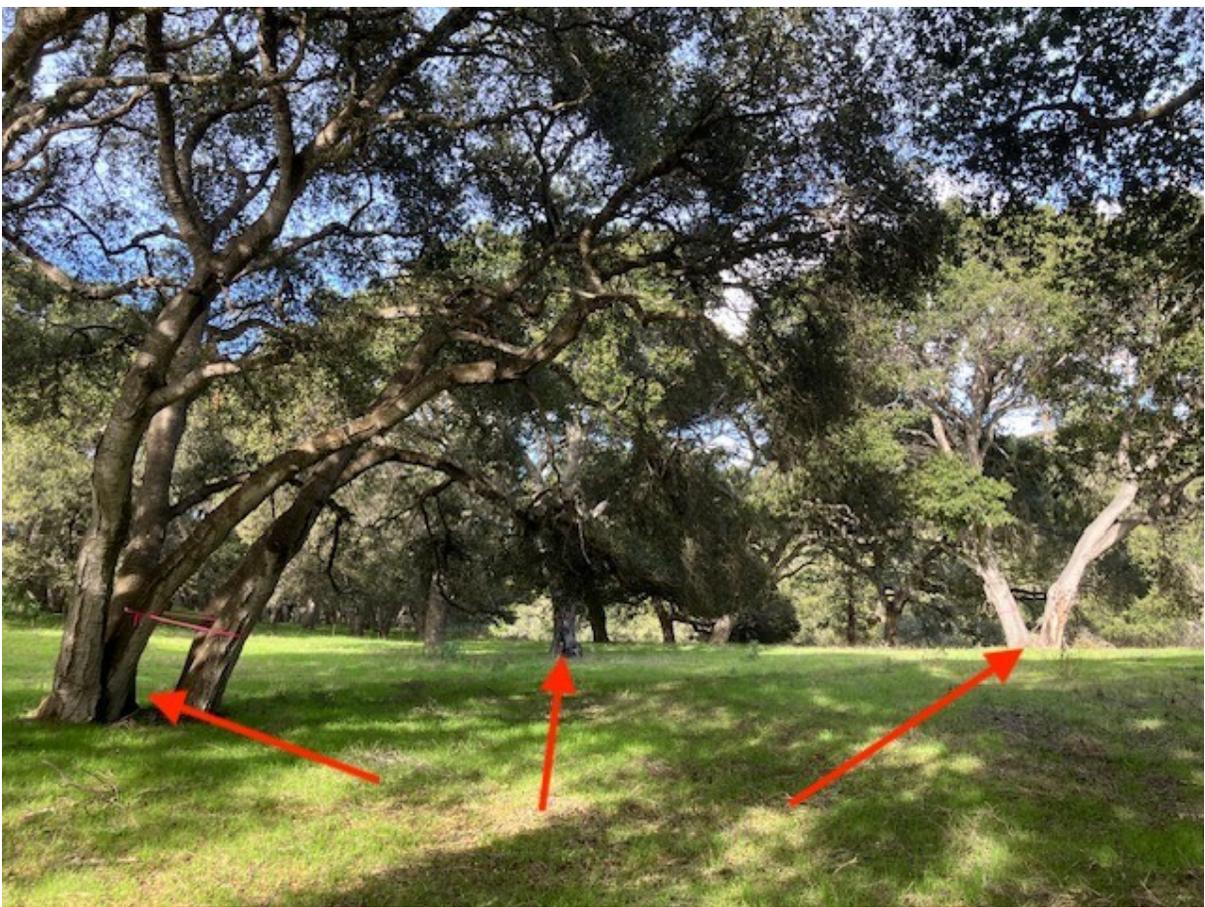
Figure 5. Tree#1 (left), Tree#2 (center background) and Tree#3 (right) are proposed for removal due to construction impacts.

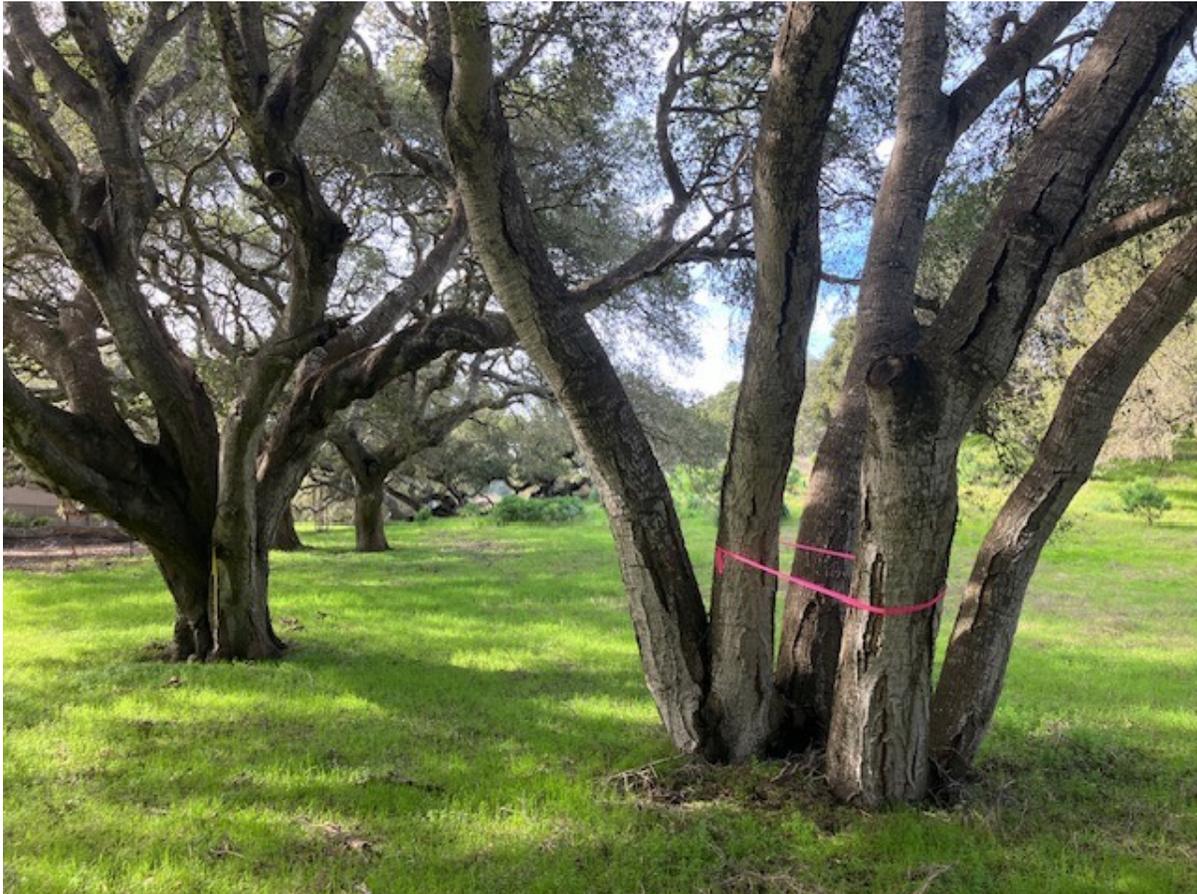
Figure 6. Closer view of multi-trunk Coast Live Oak (Tree#1) identified with pink flagging tape. Oak in left background will be retained and protected.

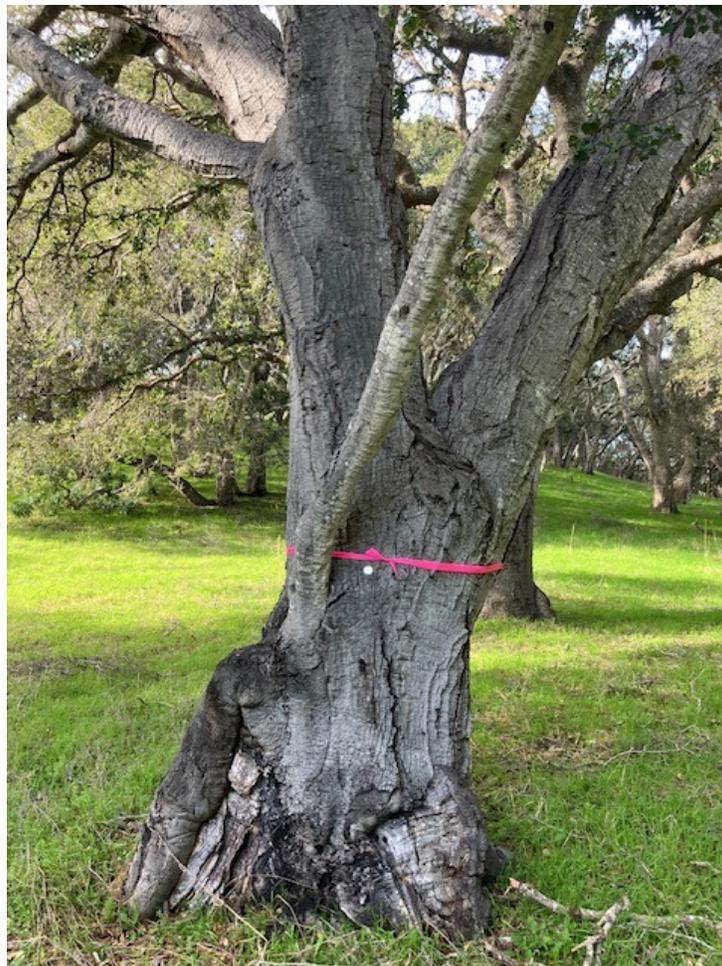
The large and senescing Coast Live Oak (*Quercus agrifolia*) identified as *Tree#2* on the project site plans (tag#438 is affixed to the trunk) has a DBH of 40 inches. Per the design plans, this declining oak will need to be removed due to its location within the proposed building footprint for the main house (refer to *Figures 4, 5, 7 & 8*). This oak is generally in fair physiological health and condition, but has a structurally problematic co-dominant stem attachment with visible decay features from a previous structural failure that is compromising the tree's structural integrity and increasing potential hazard concerns to the subject property. Per County requirements, two 5 to 15-gallon replacement oaks will need to be planted on the property to satisfy tree removal permit conditions.

Figure 7. Oak identified as Tree#2 has visible decay occurring in lower trunk and root crown due to previous structural failure.

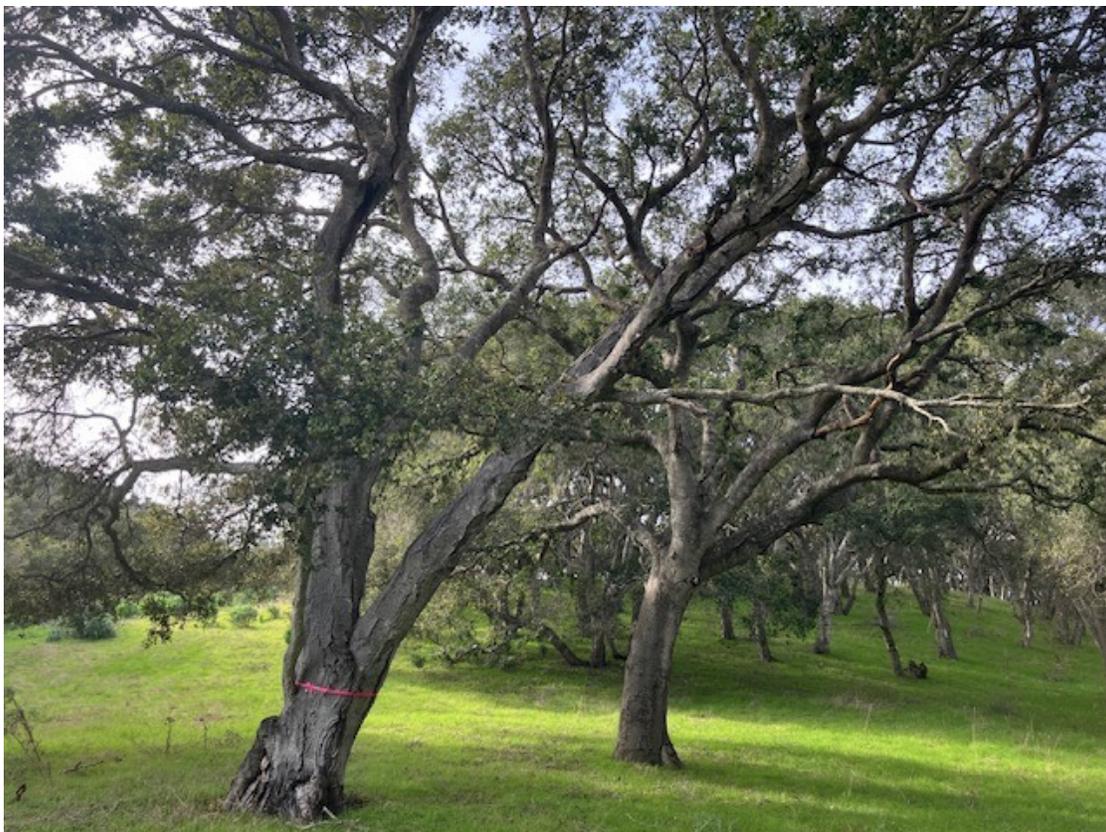
Figure 8. Another view of Tree#2 (left foreground) with decay and structurally defective co-dominant stem. Oak in center background will be retained and protected.

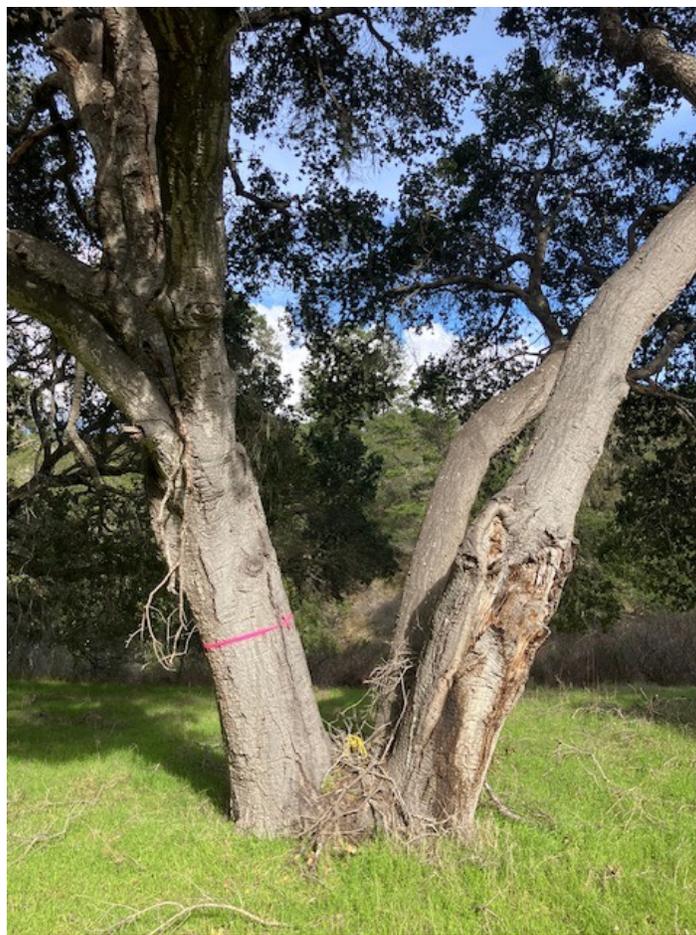
The large and aging Coast Live Oak (*Quercus agrifolia*) identified as *Tree#3* on the project site plans (metal tag#439 is affixed to the trunk) has a DBH of 58 inches. Per the project plans, this oak is recommended for removal due to its location within the proposed construction footprint (refer to *Figures 4, 5 & 9*). This oak is in fair, but declining physiological health and condition, and has a structurally problematic co-dominant trunk with cankers and decay features occurring at a previous structural failure point that is compromising the tree's structural integrity and increasing potential hazard concerns to the property. Per County requirements, two 5 to 15-gallon replacement oaks will need to be planted on the property to satisfy tree removal permit conditions.

Figure 9. Tree#3 also has co-dominant stem and visible decay and cankers due to previous structural failure.

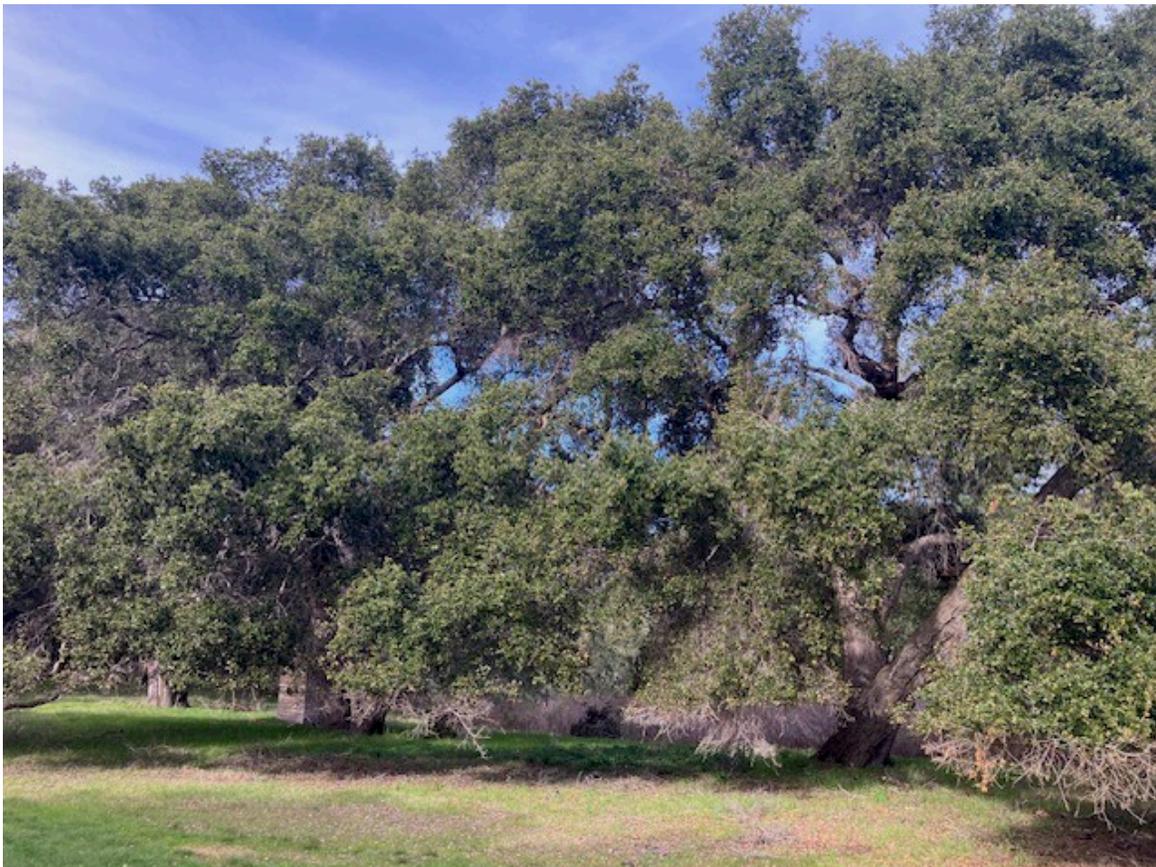
Figure 10. A few oaks near proposed permeable surfaced driveway, parking and turnaround area will be retained and protected to minimize impacts.

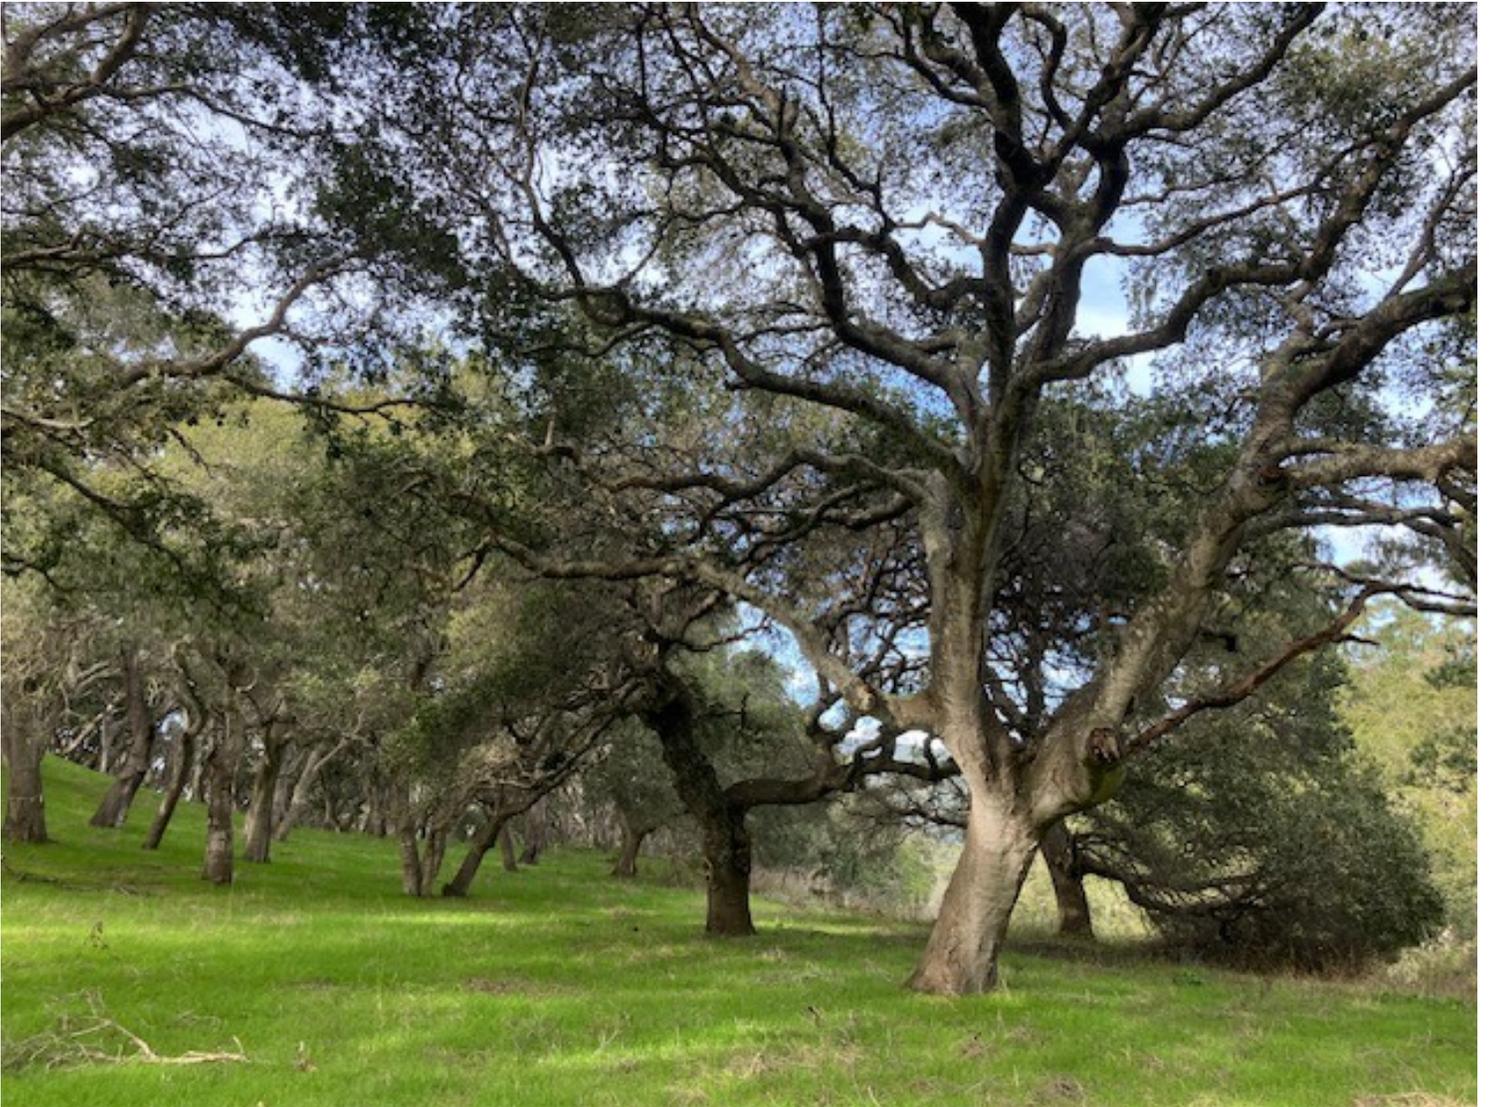
Figure 11. View of surrounding perviously mowed oak woodlands that will be protected and will have minimal impacts from property development activities.
