**Frank Ono**  
**International Society of Arboriculture**  
**Certified Arborist # 536**  
**Society of American Foresters Professional Member 48004**  
**1213 Miles Avenue**  
**Pacific Grove CA, 93950**  
Telephone (831) 373-7086  
Cellular (831) 594-2291

RE: 25475 Hatton Proposed ADU and Redwoods

The purpose of this report is to address concerns expressed by the neighboring property owner regarding construction related impacts to the 4 redwood trees. In response to these concerns and, per the project design plans, it is my professional opinion that construction related impacts to these 4 redwoods will be insignificant and not harmful to tree health due to the fact these redwoods are a safe distance away from the proposed ADU and, more importantly, the foundation of the ADU will be elevated (i.e., floated) resulting in minimal and inconsequential impacts to the critical root zones of the subject trees.

Ms. Nagafuji requested my services to assess the condition of twenty-two trees within or near the project limits, and the construction impacts that may affect them. Further, to provide a report with my findings and recommendations to meet MCMRA planning requirements.

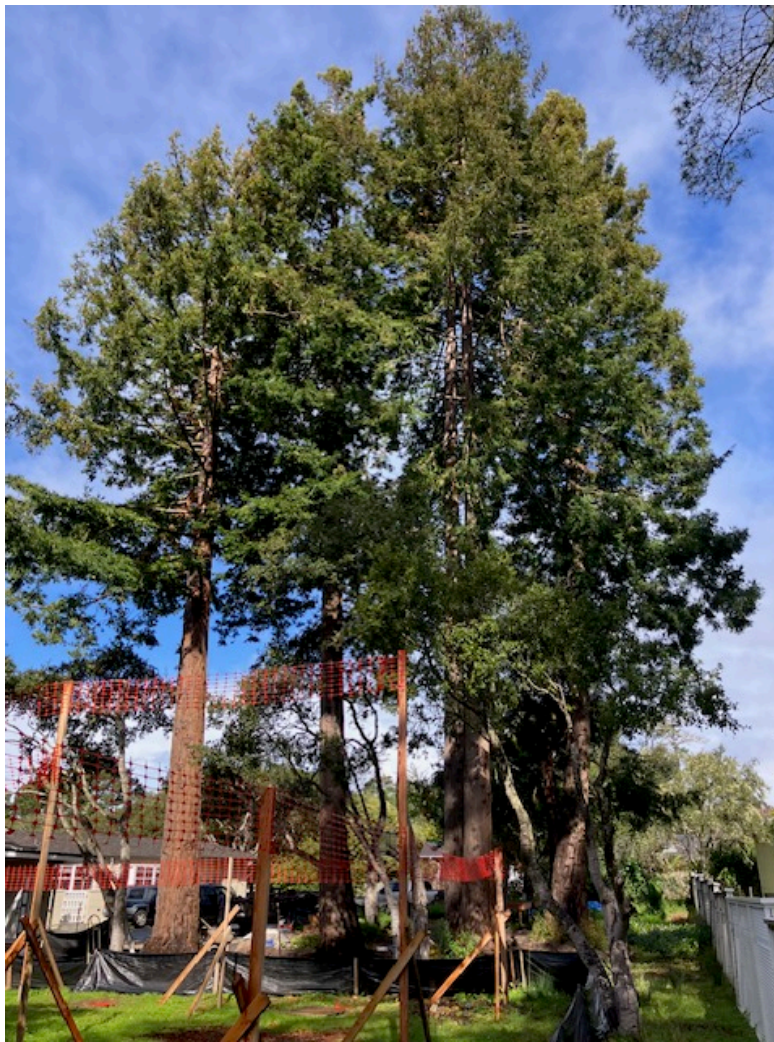
Figure 1. The proposed ADU and subject redwood trees are visible in this photo.

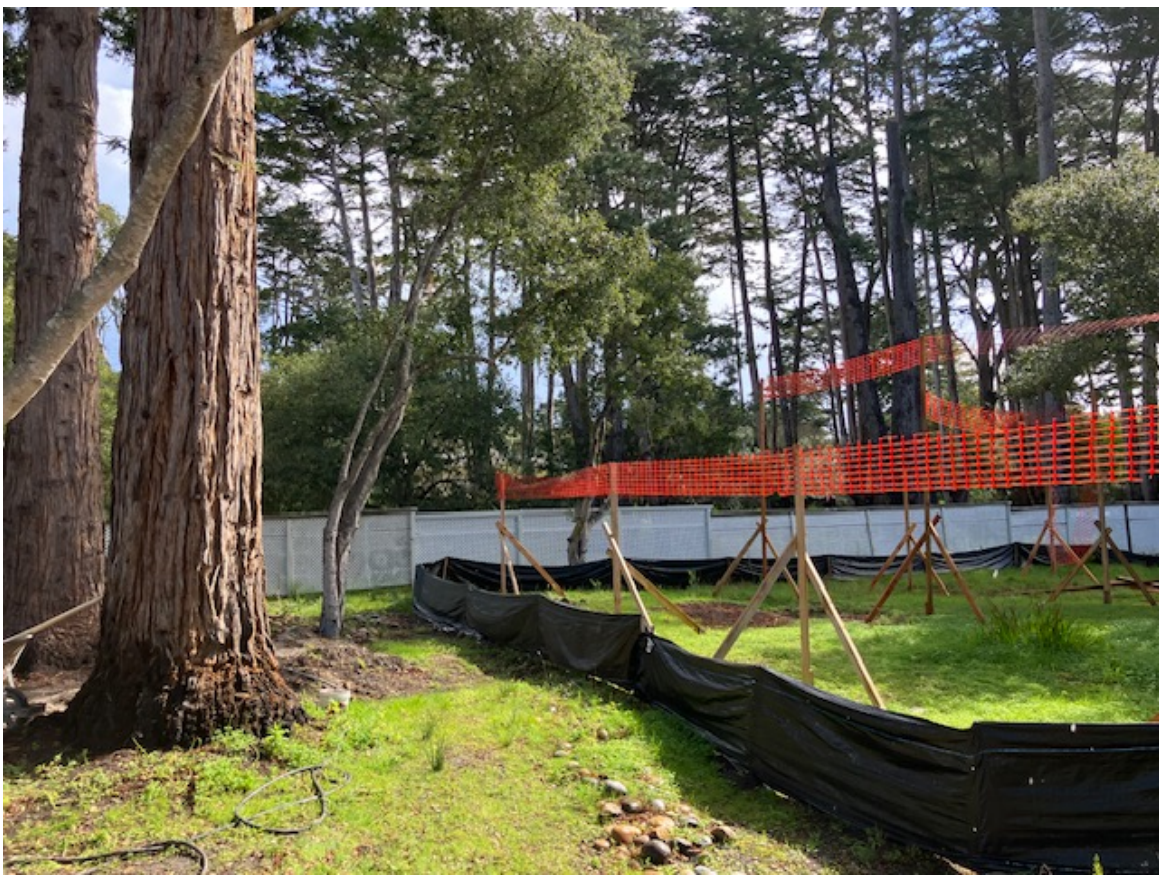
Figure 5. Another photo showing the location of the redwoods in relation to the proposed ADU. Significant tree impacts is not expected to occur due to the design (i.e., 3 small footings) of the floated foundation.

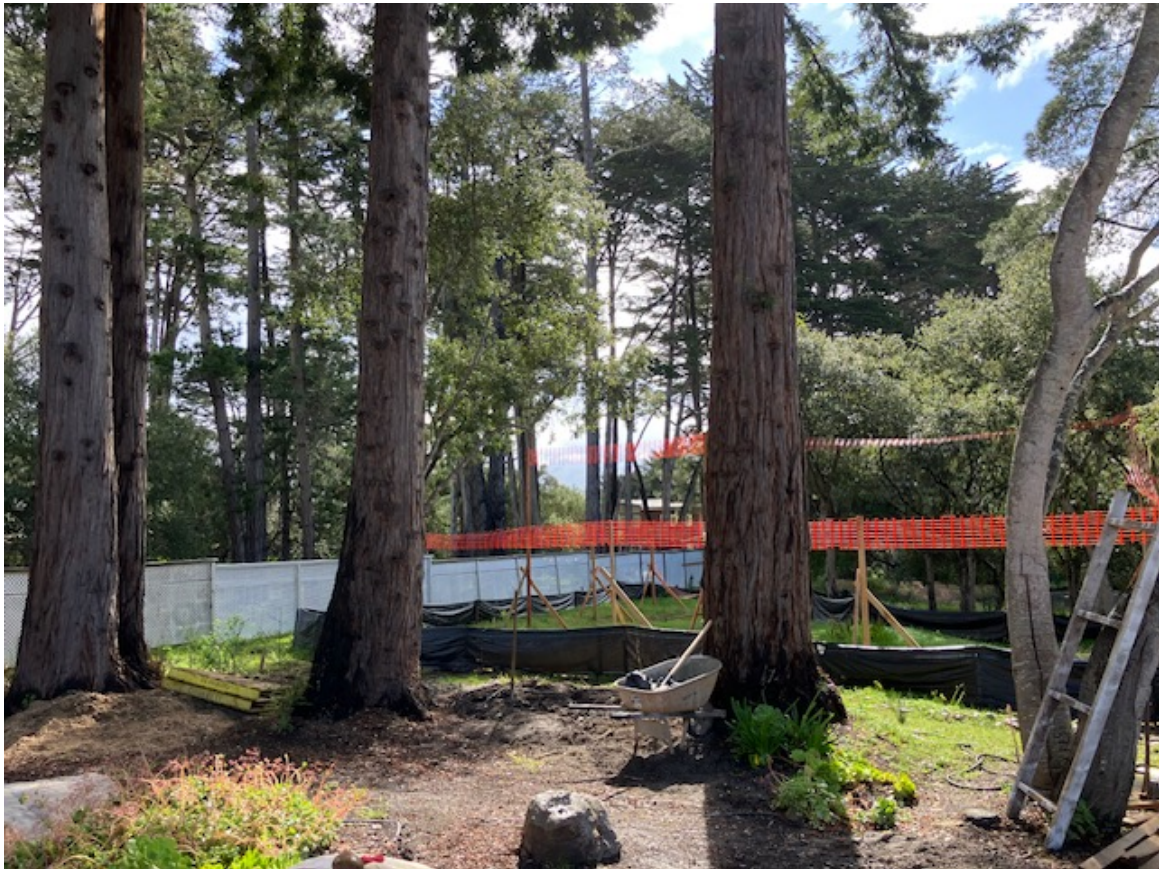
Figure 6. Per the design plans and given the proper installation, maintenance and monitoring of tree protection fencing, the health of the subject redwoods will not be adversely affected by the ADU due to a floated foundation and the trees are not expected to be a hazard concern to nearby structures.

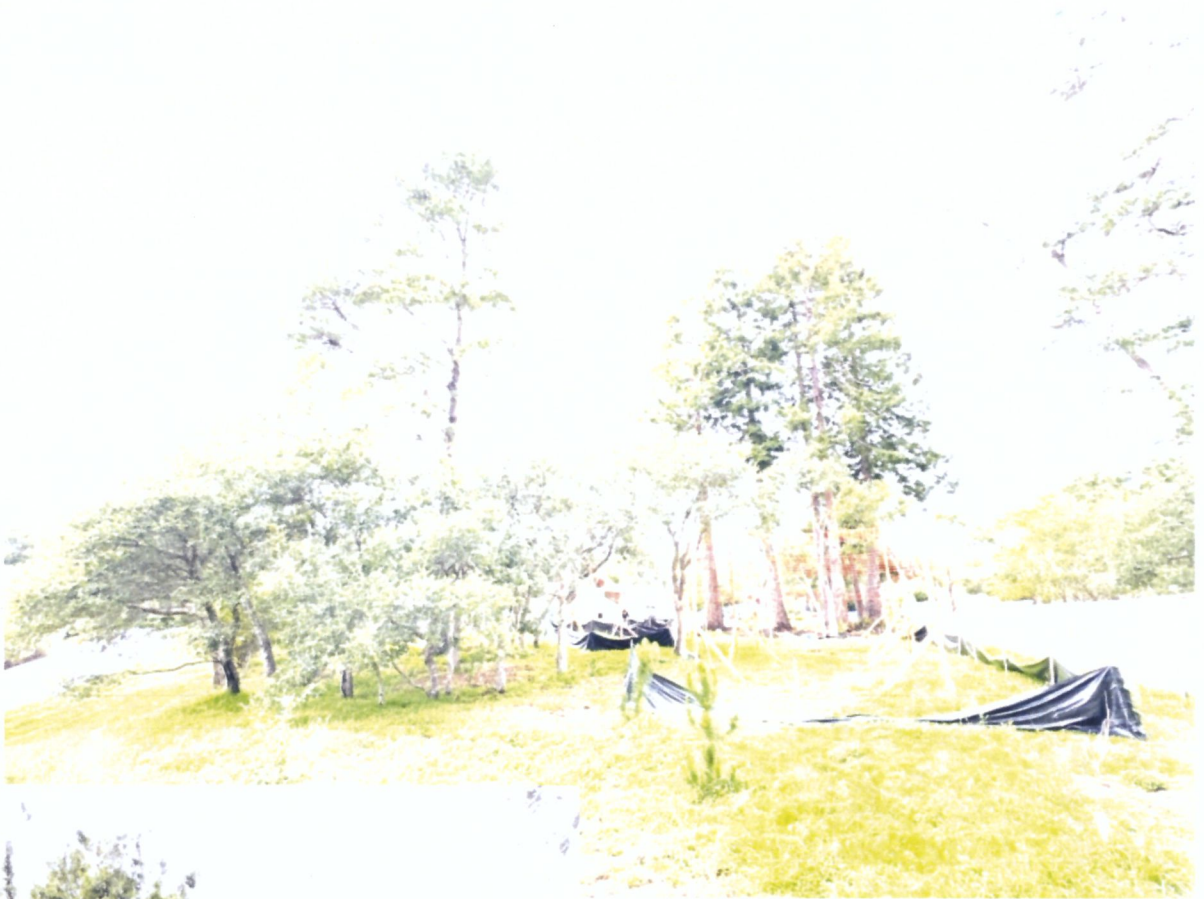
Upon inspection of the three test sites, the following was observed:

S. sempervirens with 3 test sites to determine if any roots are impacted by development.

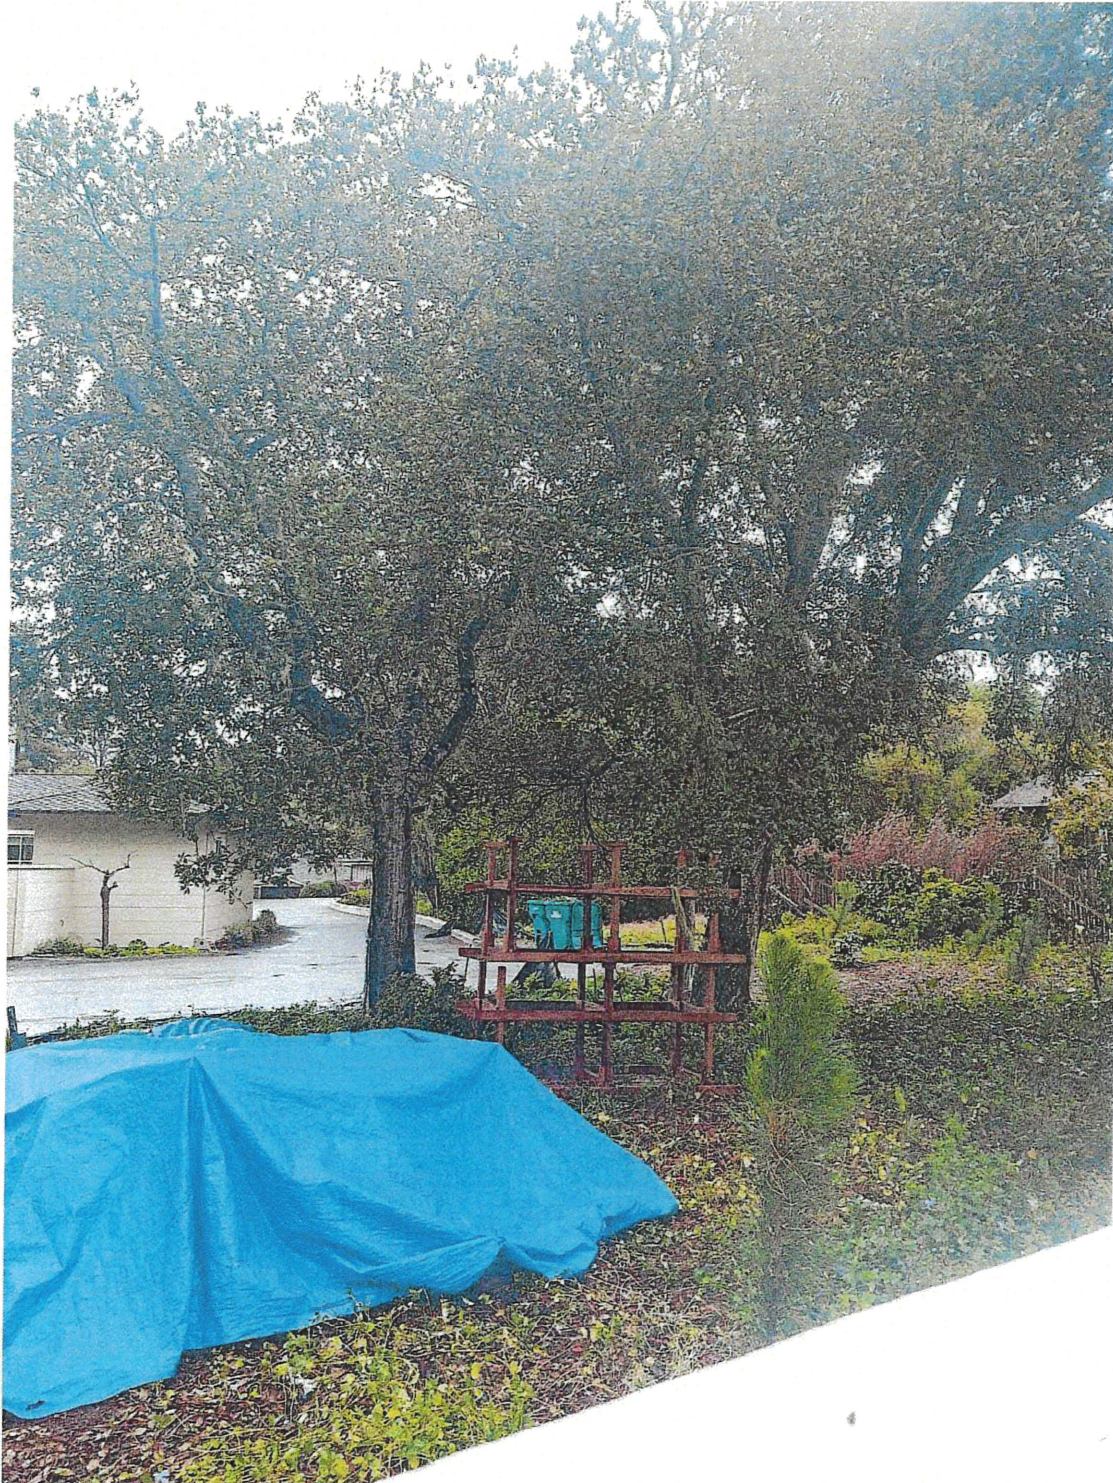
Figure No. 1: Site of northeast ADU reposition proposal, requiring removal of two maturing large oak saplings with large diameter bases and full crowns. Notice the numerous pine saplings.

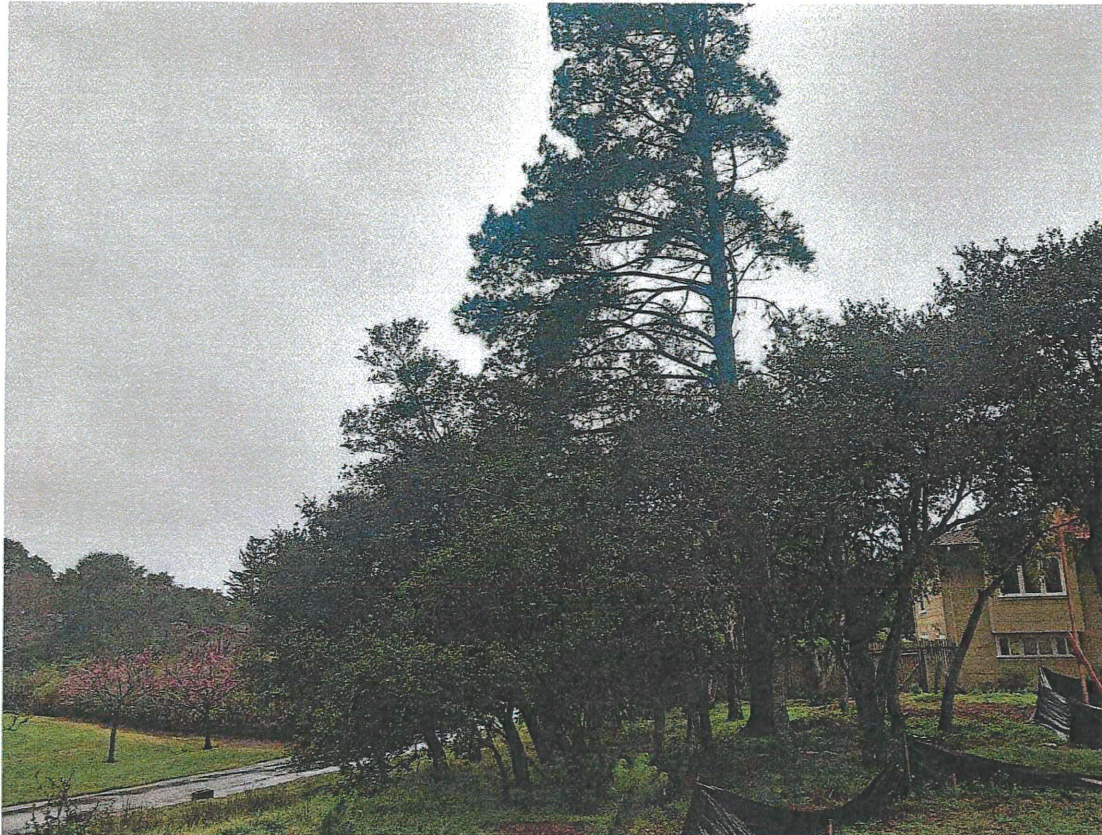
Figure No. 2: Site of southeast ADU reposition proposal, requiring removal of the senescent pine tree and small oak saplings. Notice the numerous pine saplings.

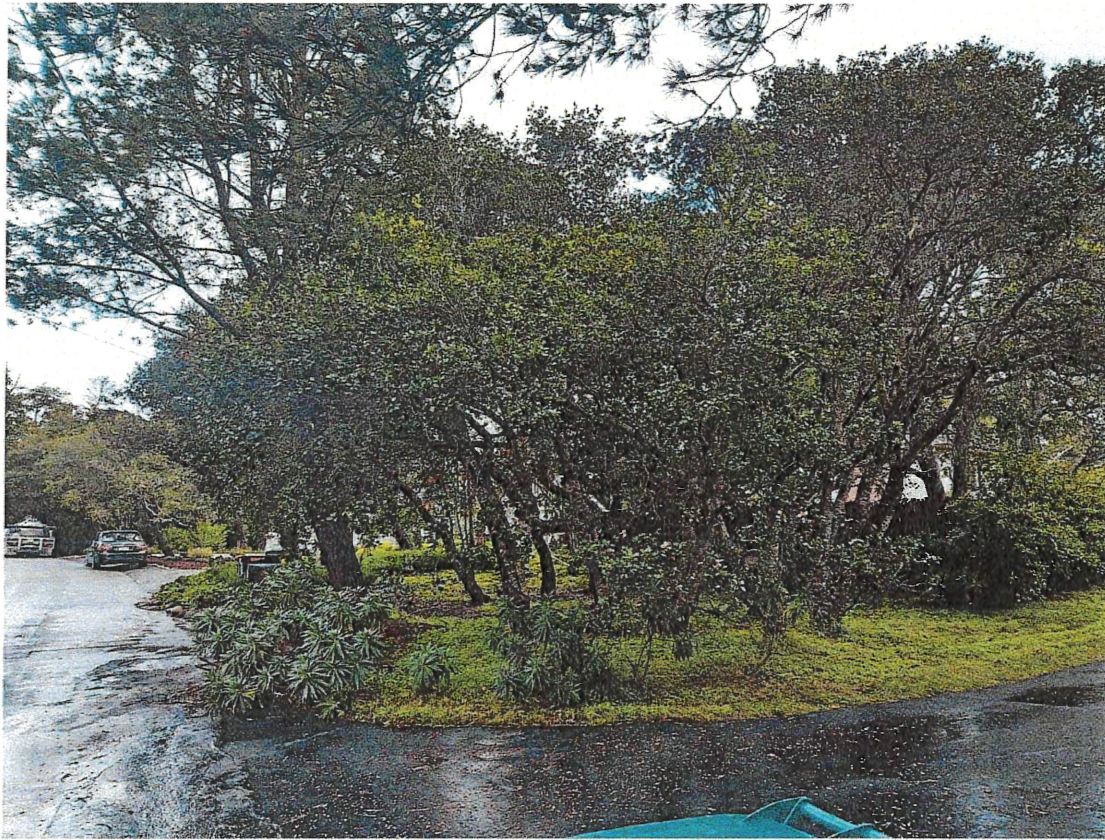
Figure No. 3: Site of southwest ADU reposition proposal, requiring removal of small and large oak saplings.
