Eric Miller Architects for  
Hetherington Residence  
8125 Carina Tehama Lot 80  
Carmel, Ca 93923  
APN: 259-092-020-000

Michael Tope  
ISA Certified #WE-12498A  
ISA Tree Risk Assessor

## Tree Assessment:

On August 22<sup>nd</sup> 2024, I visually inspected several subject trees as requested by Eric Miller Architects for the Hetherington residence. See below for my assessment of the subject trees.

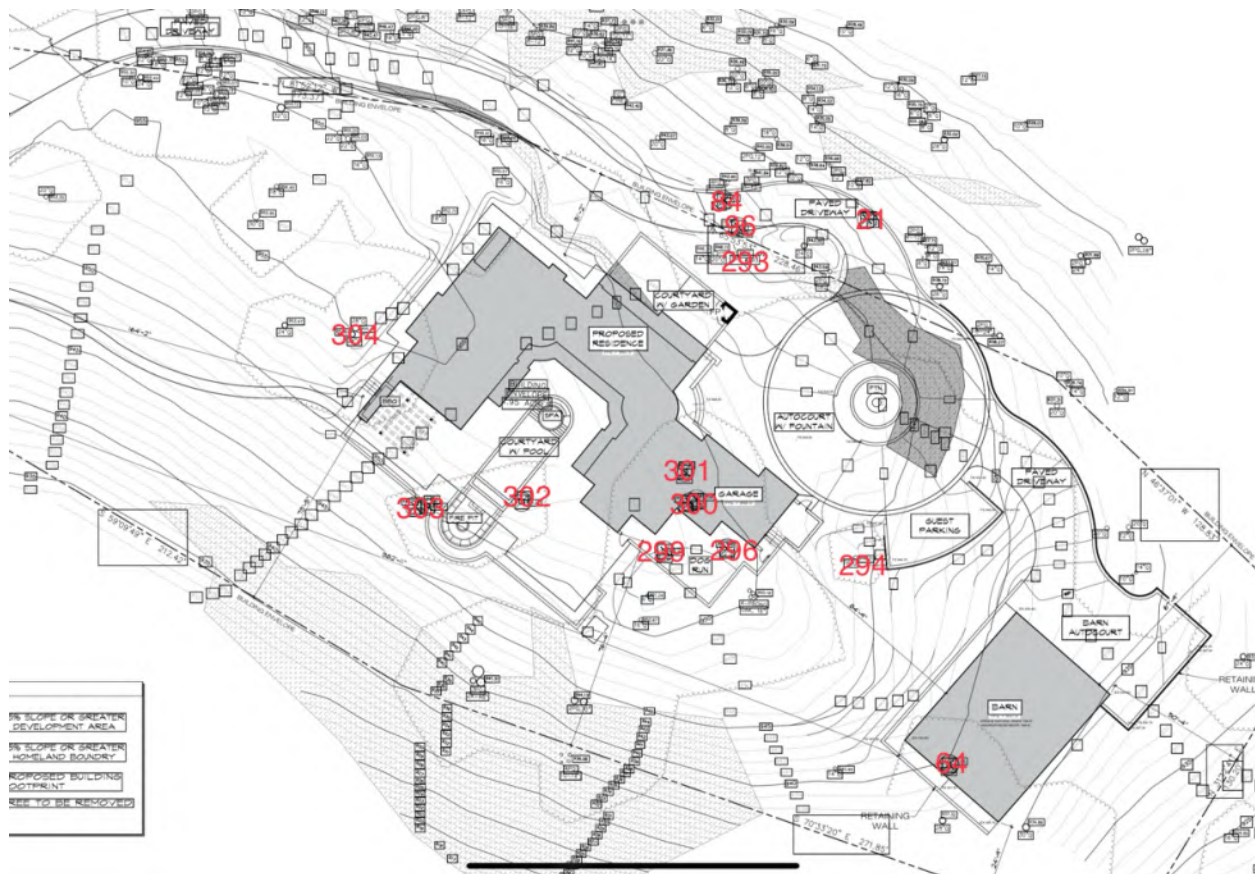
## Site Plan:

Pictured below shows the location of subject trees proposed for removal and pruning per construction site plan provided by Miller architects. Notice the numbers were added by the certified arborist in order to show where the trees are located on the site.

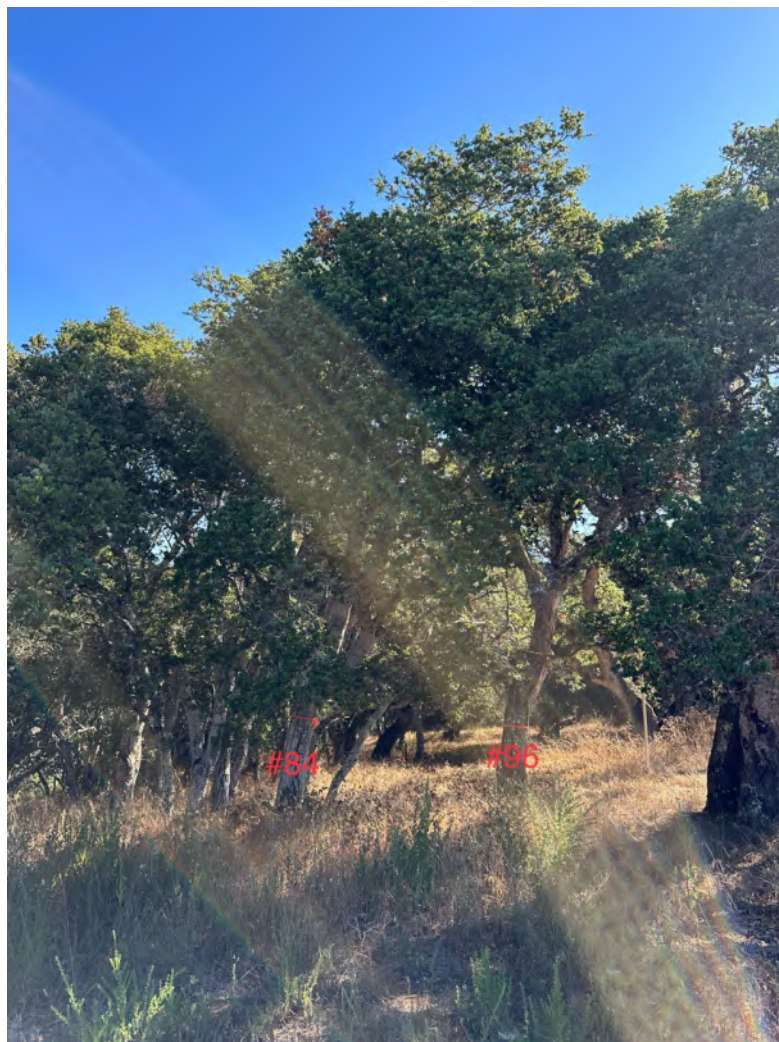
Subject Tree #84

Upon visual inspection the tree appears to be in fair condition. The tree does appear to be in a crowded growing location. The tree is growing into the proposed driveway location. If the tree is to be conserved preventative pruning is recommended. If the tree is to be removed, replanting at a 1:1 ratio with a Coast live oak tree is recommended.

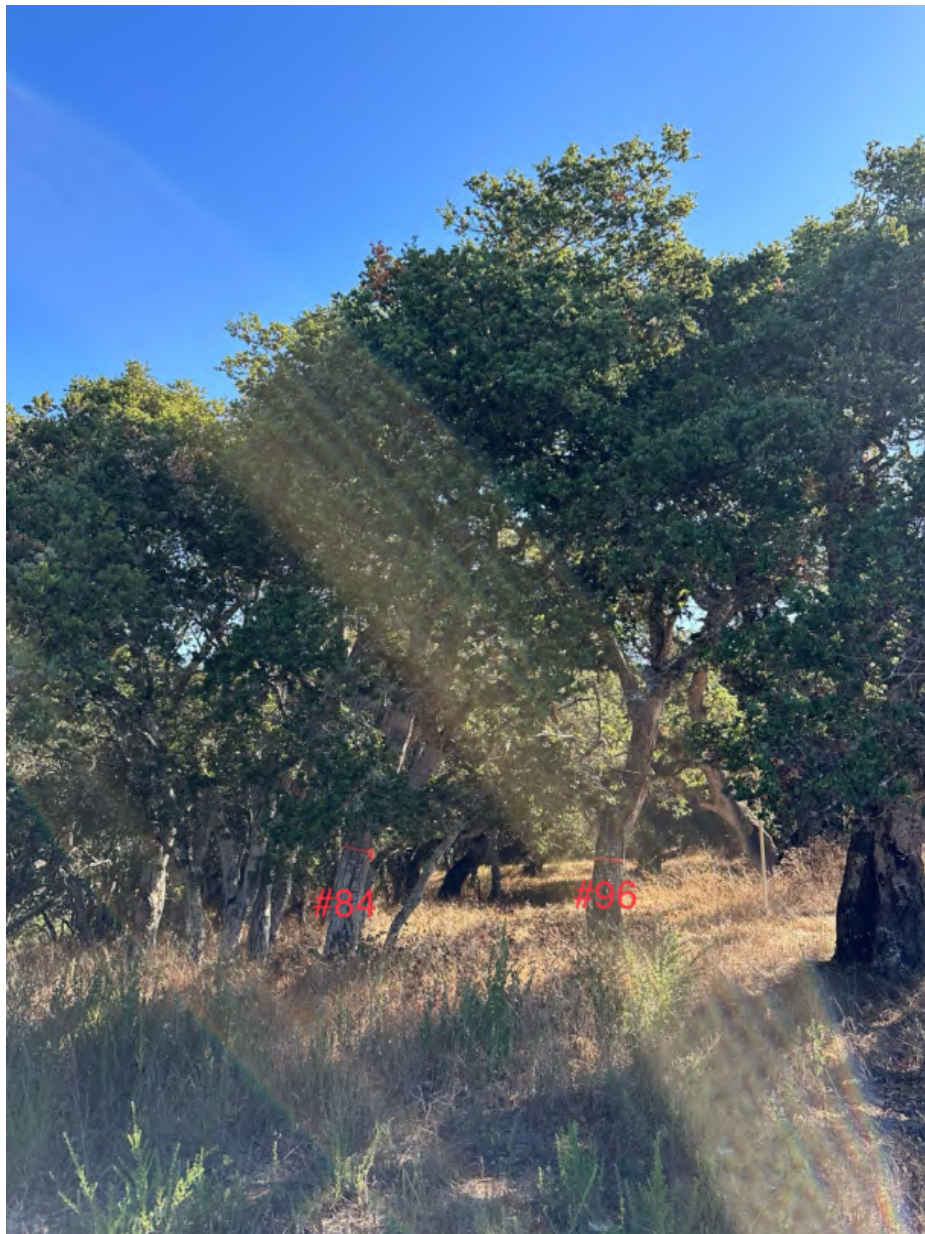
Subject Tree #96

Upon visual inspection the tree appears to be in fair condition. The tree does appear to be in a crowded growing location. Removal is recommended to reduce overcrowding. The tree is growing into the proposed driveway location. If the tree is to be conserved preventative pruning is recommended. If the tree is to be removed, replanting at a 1:1 ratio with a Coast live oak tree is recommended.

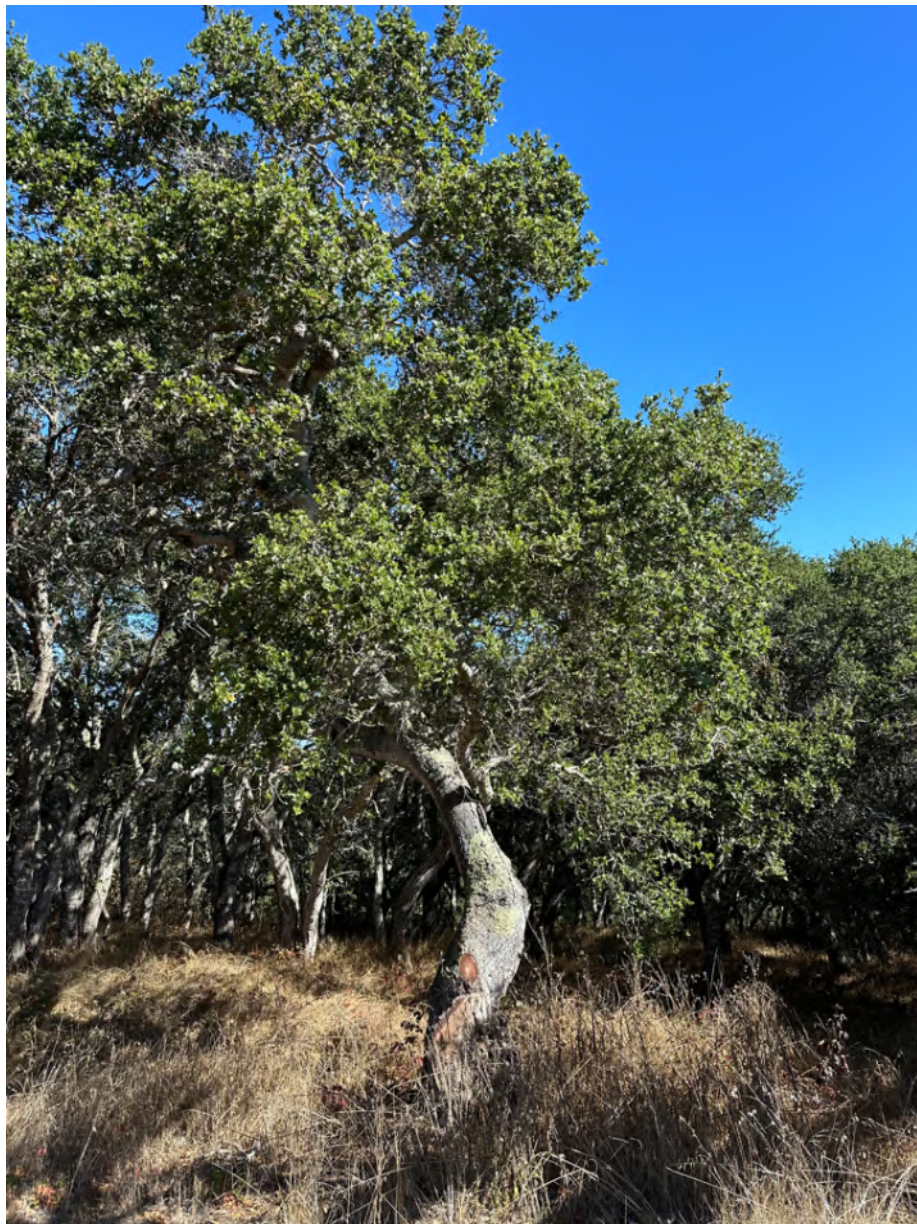
***Pictured below shows the tree which is within the footprints of the proposed driveway***

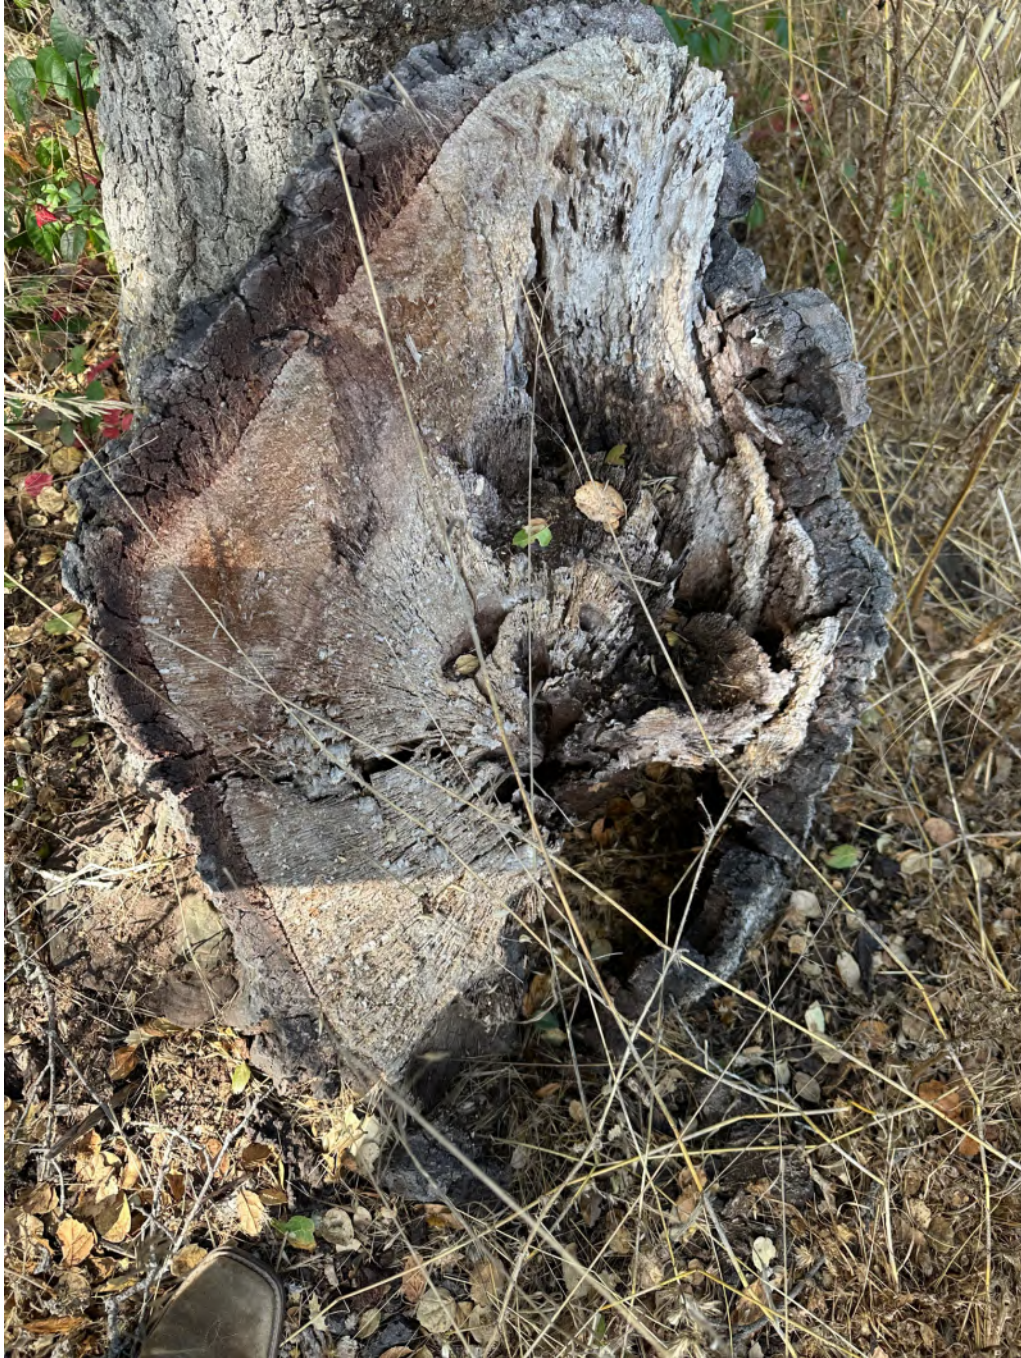
Subject Tree #21

Upon visual inspection the trees appears to be in poor condition. The tree has significant decay on the trunk. In order to reduce the risk of failure, tree removal is recommended. If the tree is removed a replant ratio of 1:1 with a Coast live oak is recommended.

***Pictured below shows significant decay on tree #21***

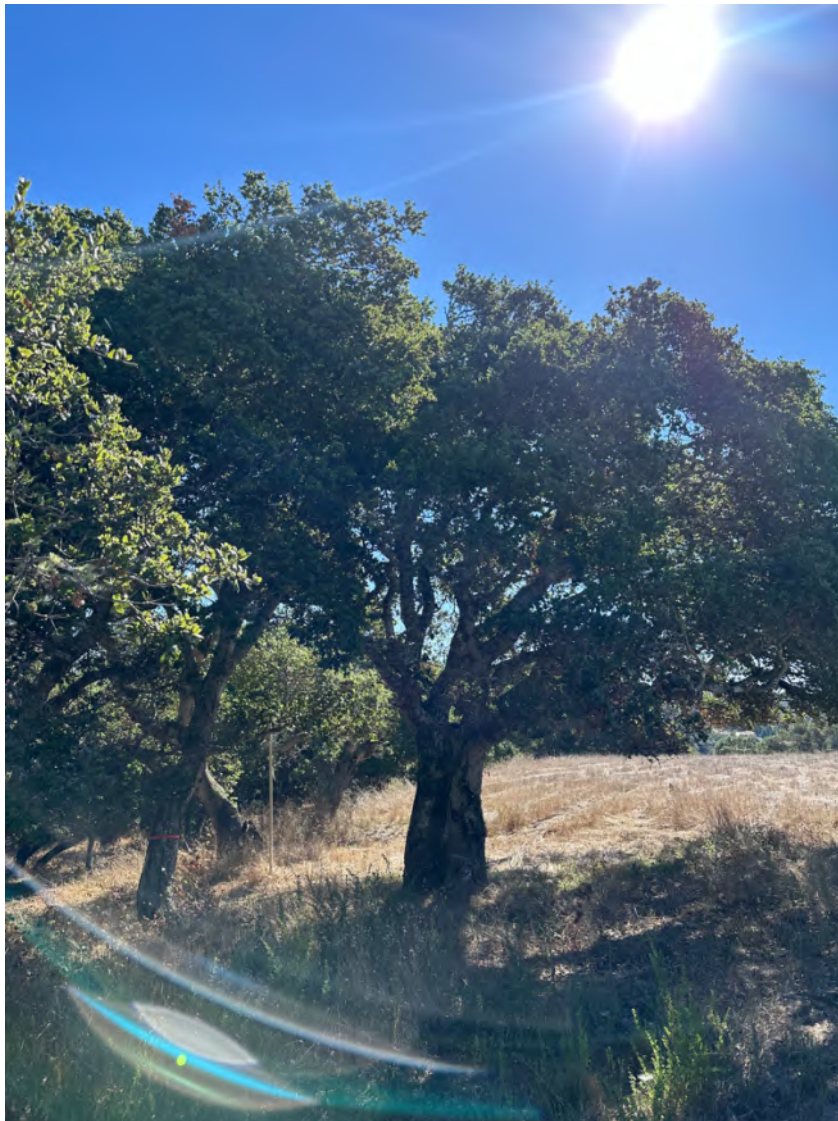
Subject tree #293

Upon visual inspection the tree appears to be in good condition. The tree is not on the proposed plans for removal, but preservation of health is important. In order to reduce the construction impact on the tree; preventative pruning is recommended, fertilizing, and applying mulch in the root zone of the subject tree to reduce compaction.

***Pictured below shows the health of the subject tree.***

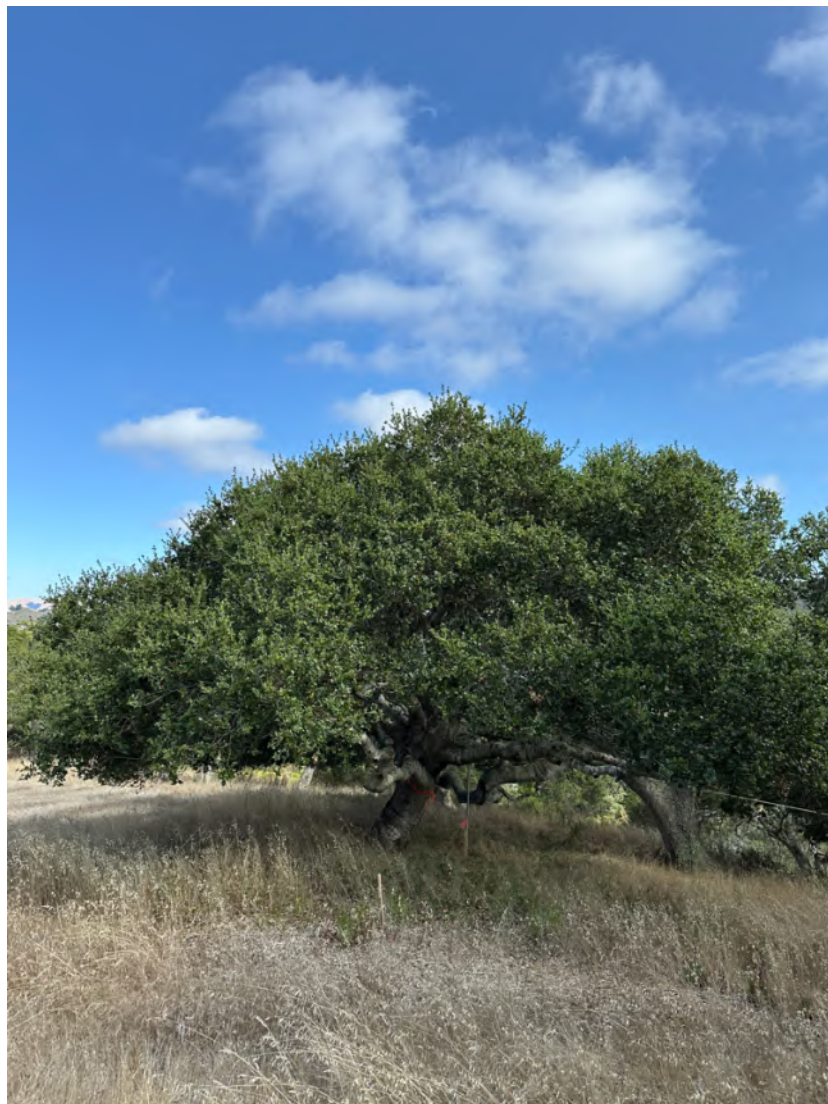
Subject tree # 64

Upon visual assessment the canopy of the subject tree appears to be in fair condition overall. The tree is in the proposed footprints of the barn. If the tree is to be conserved preventative pruning is recommended. If the tree is to be removed, replanting at a 1:1 ratio with a Coast live oak tree is recommended.

***Pictured below shows the Coast live oak tree notice the orange flag where the tree is growing within the proposed structure.***

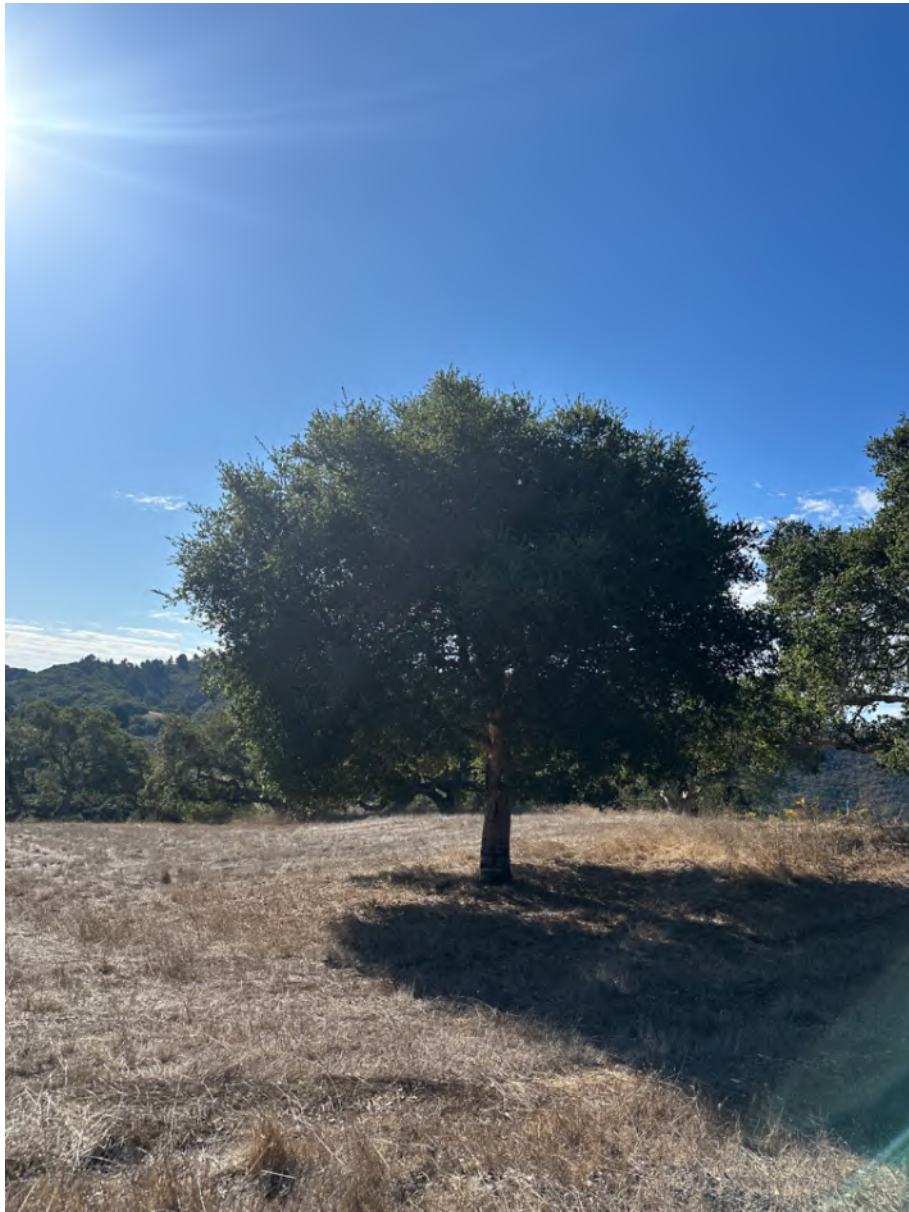
Subject tree #294: Coast live oak- *Quercus agrifolia*

This tree is outside of the building footprints and is not proposed for removal. Preventative pruning is recommended and annual inspections. Mulch is also recommended in order to reduce construction compaction. See picture below.

***Pictures below shows the good form but heavy canopy of the tree. Preventative pruning is recommended.***

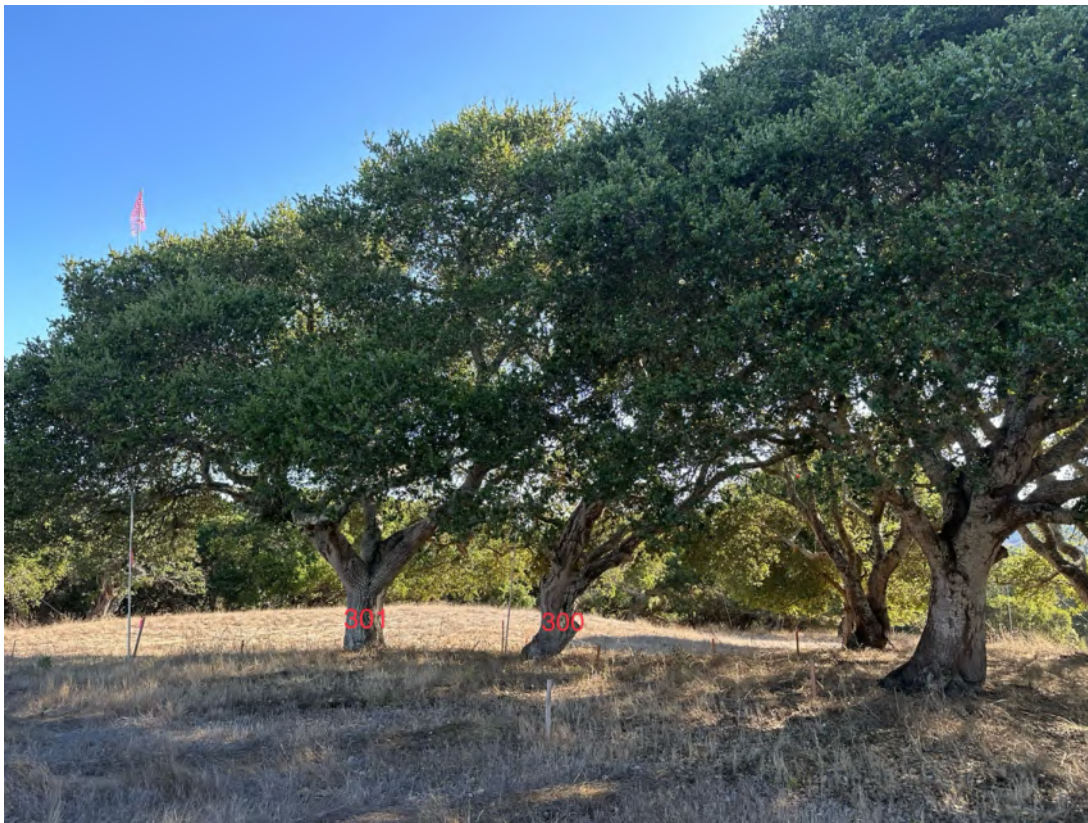
Subject tree #301: Coast live oak- *Quercus agrifolia*

Upon visual assessment the canopy of the subject tree appears to be in fair condition overall. The tree appears to have minor canopy dieback. The tree has a weak point where the trunk and two major limbs meet. This weak point may increase the likelihood of failure. The tree is also in the proposed footprints of the building. Due to the high likelihood of failure this tree poses tree removal is recommended. If the tree is to be removed, replanting at a 1:1 ratio with a Coast live oak tree is recommended. If the tree is to be conserved significant preventative pruning is recommended to reduce the likelihood of failure.

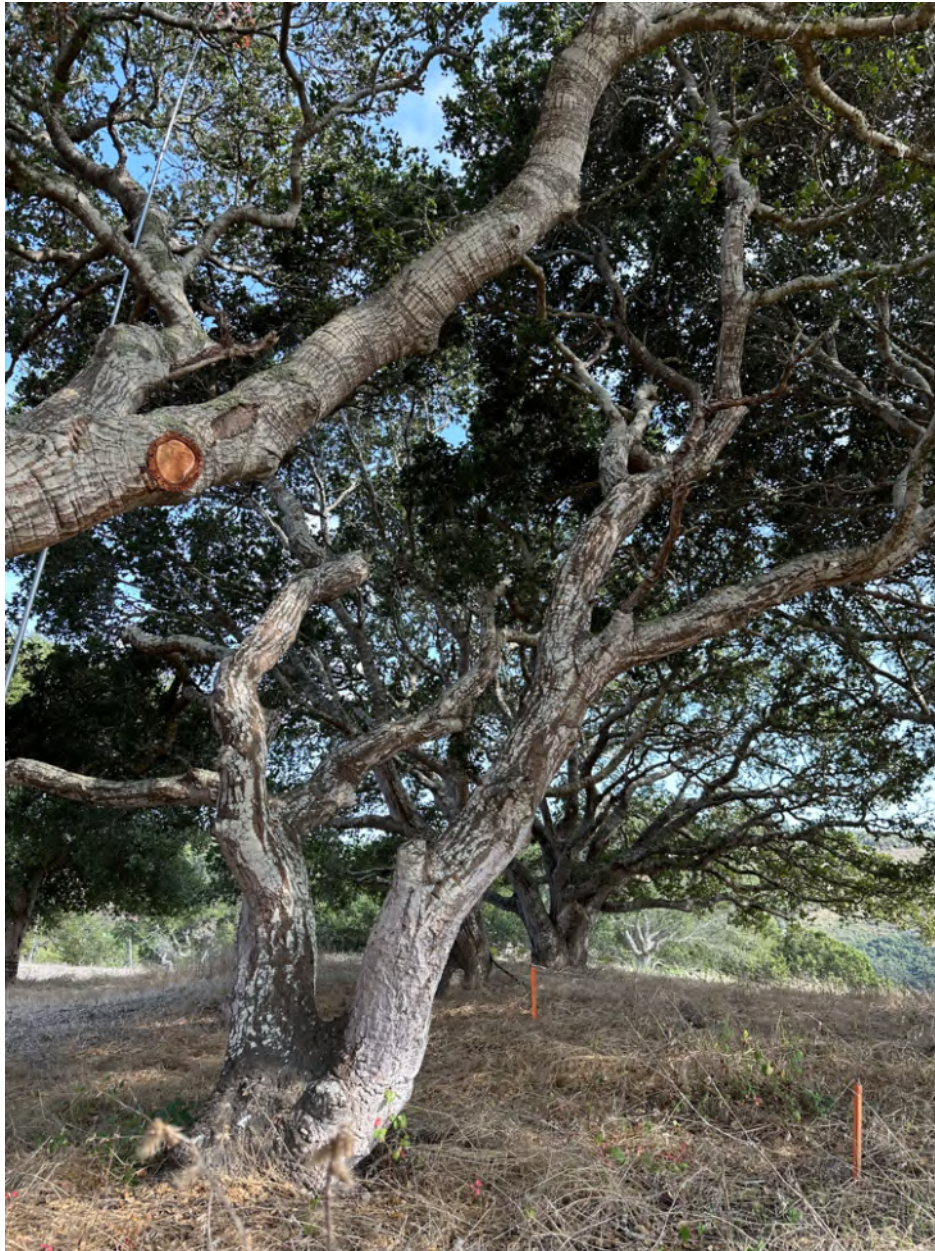
Subject tree #300: Coast live oak- *Quercus agrifolia*

Upon visual assessment the canopy of the subject tree appears to be in fair condition overall. The tree appears to have minor canopy dieback. There appears to be significant decay where the two trunks attach. This decay may increase the likelihood of failure. The tree is in the proposed footprints of the structure. Tree removal is recommended for this tree. If the tree is to be removed, replanting at a 1:1 ratio with a Coast live oak tree is recommended.

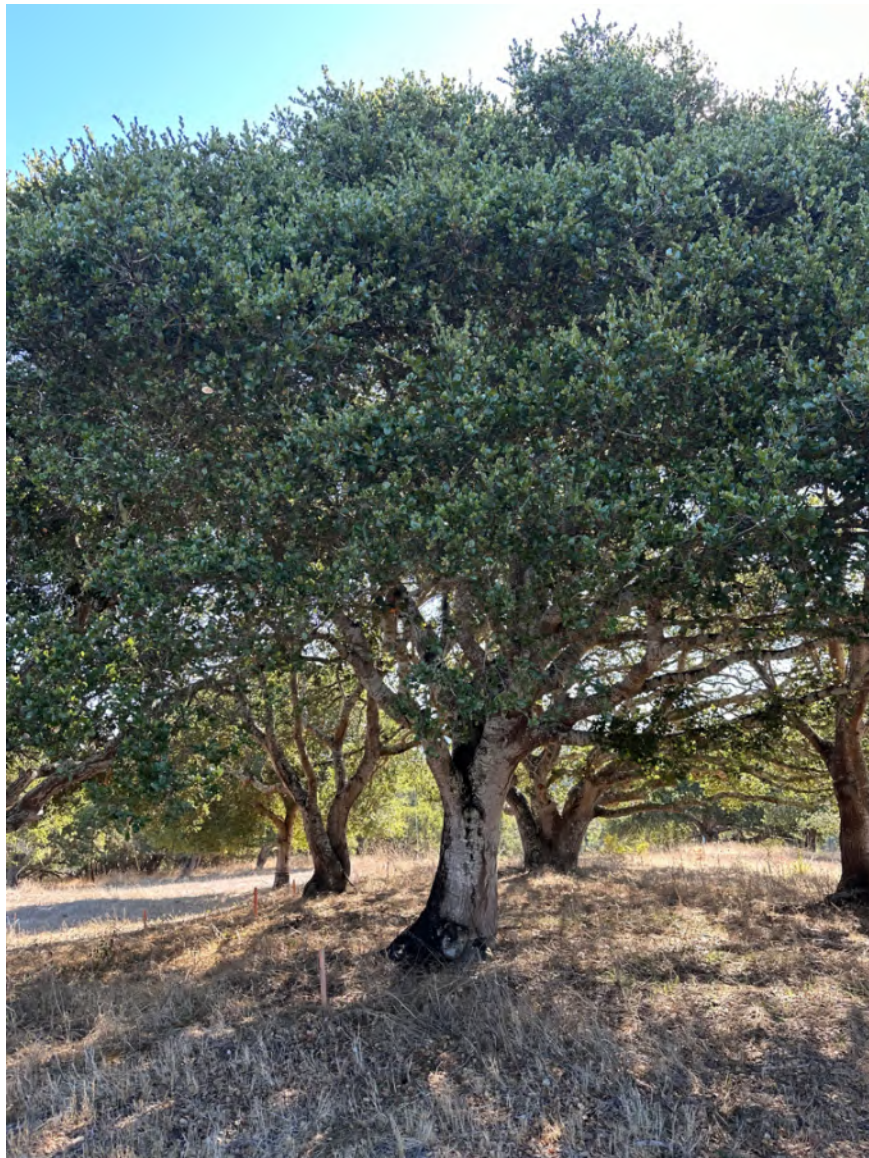
Subject Tree #299: Coast live oak- *Quercus agrifolia*

Upon visual assessment the canopy of the subject tree appears to be in fair condition overall. The tree appears to have minor canopy dieback. On the trunk there appears to be a fungal fruiting body which is an indication there may be internal decay. Tree removal is recommended due to the fungal fruiting body on the lower trunk. See picture below of fruiting body. If the tree is to be removed, replanting at a 1:1 ratio with a Coast live oak tree is recommended.

***Pictured below shows tree #299. The tree appears to have minor canopy dieback and possible previous canopy failure.***

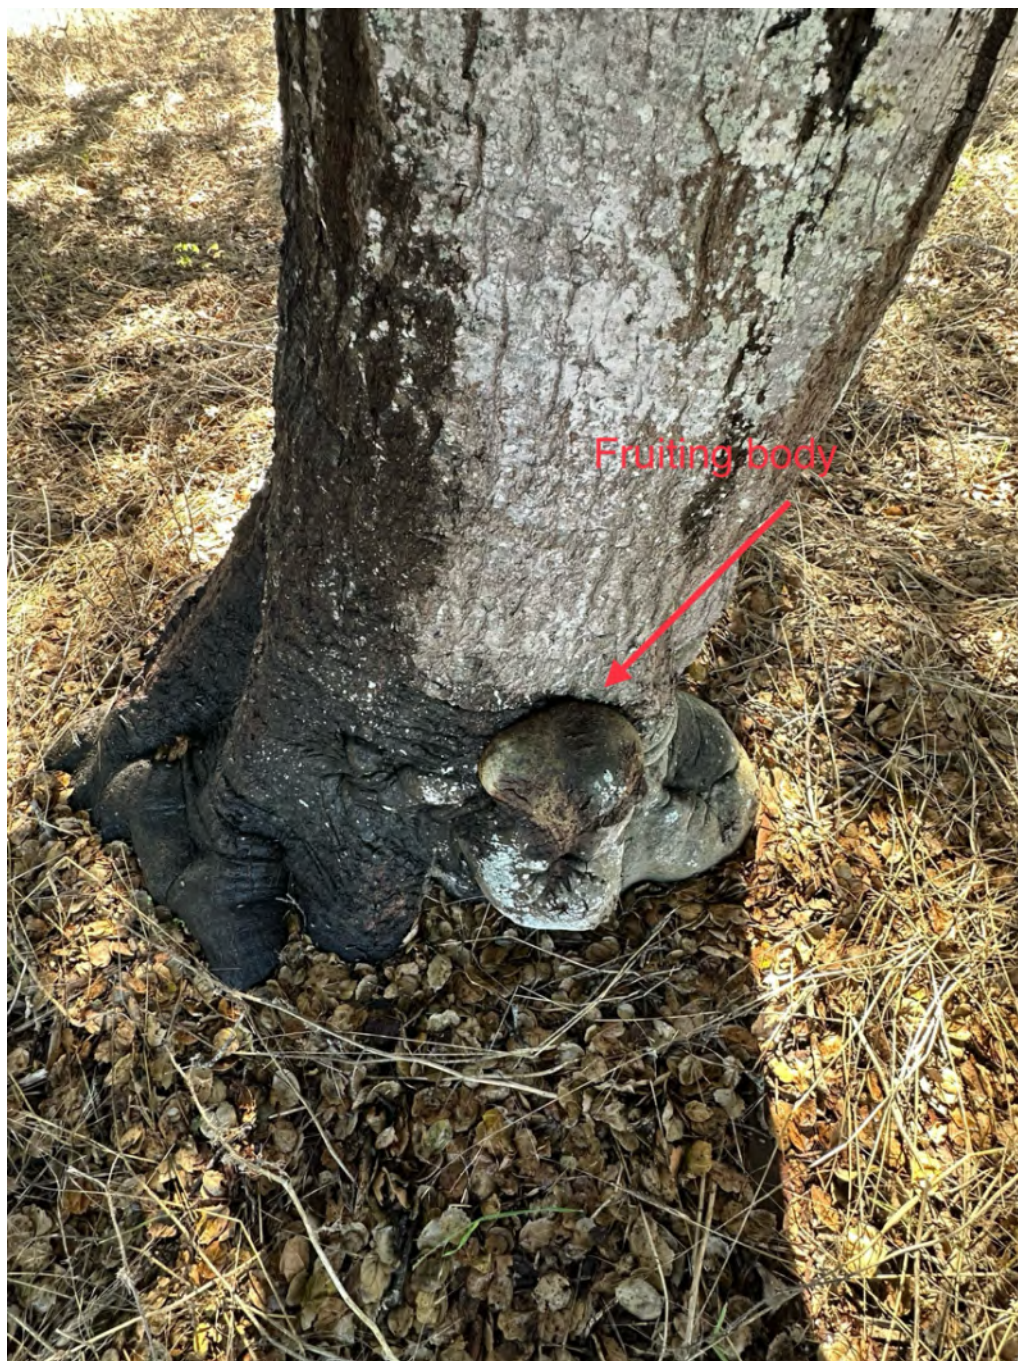
***Pictured below shows a large fruiting body on the trunk of tree #299. Fungal fruiting bodies are an indication there may be significant decay internally.***

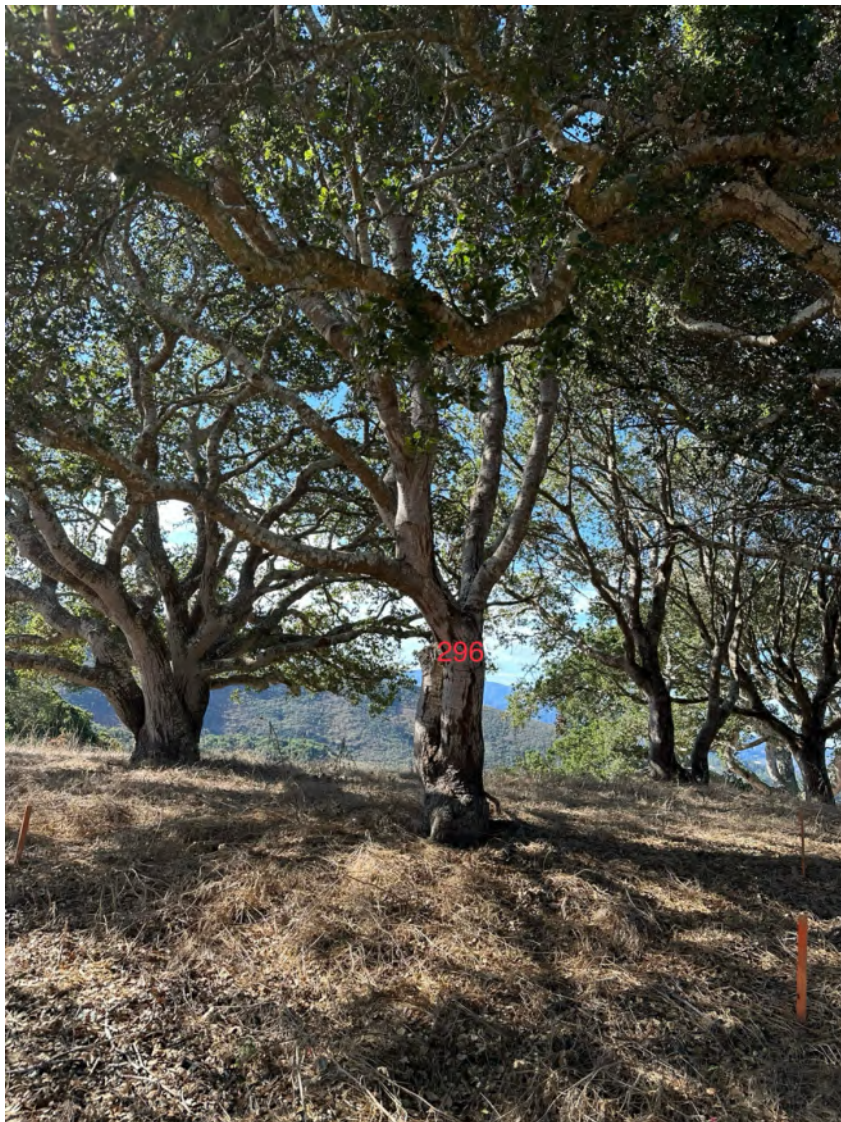
Subject tree #296: Coast live oak- *Quercus agrifolia*

Upon visual inspection the tree appears to be in fair condition. This Coast live oak tree has co-dominant trunks on it and included bark. Due to the included bark the tree has a higher likelihood of failure therefor tree removal is recommended. The tree is also in the proposed building footprints. Pictured below shows the location of the tree in relation to other trees. If the tree is to be removed, replanting at a 1:1 ratio with a Coast live oak tree is recommended.

***Pictured below shows tree #296 notice a significant mature Oak to the left to be conserved.***

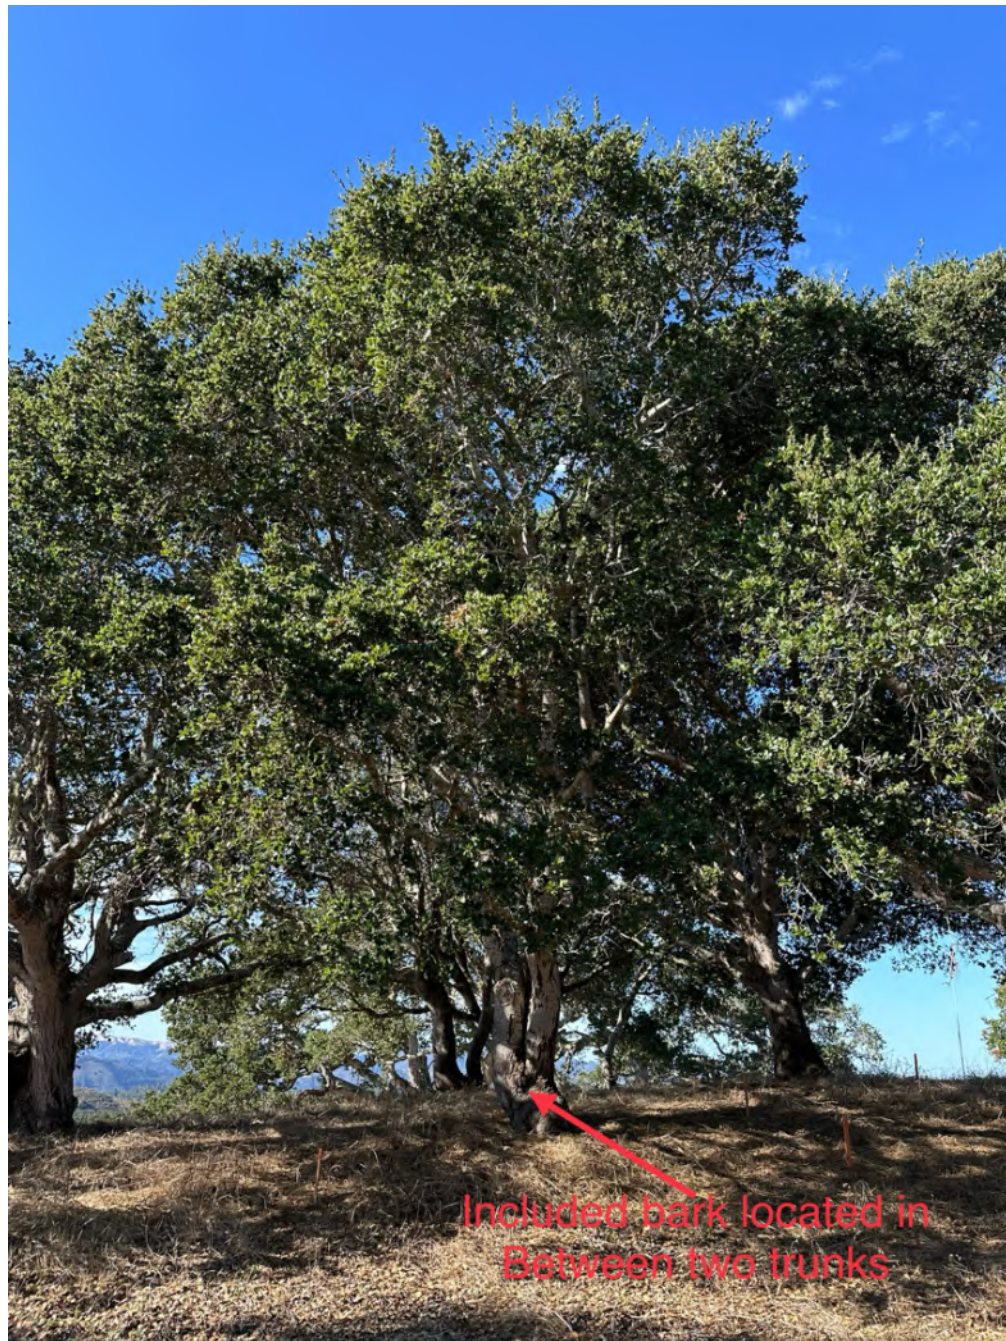
***Pictured below shows the included bark in between the co-dominant trunks.***

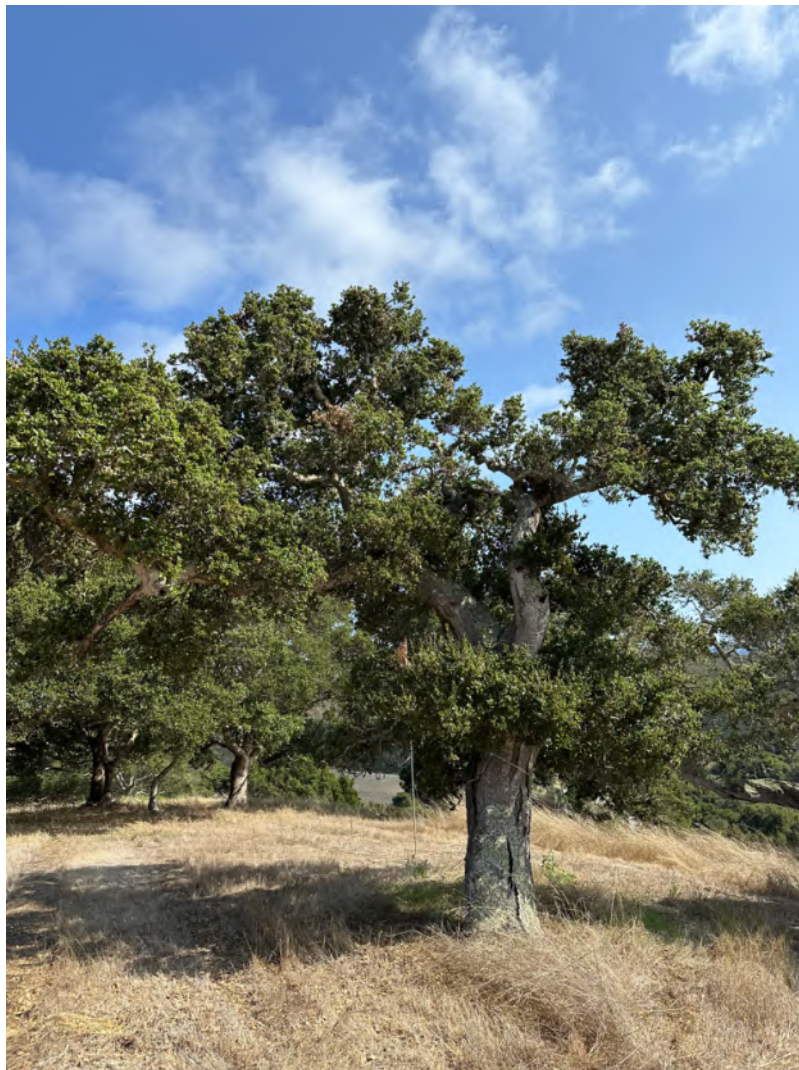
Subject tree #302: Coast live oak- *Quercus agrifolia*

Upon visual assessment the canopy of the subject tree appears to be in poor condition overall. The tree appears to have minor canopy dieback. Tree removal is recommended due to what appears to be a previous significant canopy failure. If the tree is to be removed, replanting at a 1:1 ratio with a Coast live oak tree is recommended.

***Pictured below shows tree #302. The tree appears to have minor canopy dieback and possible previous canopy failure.***

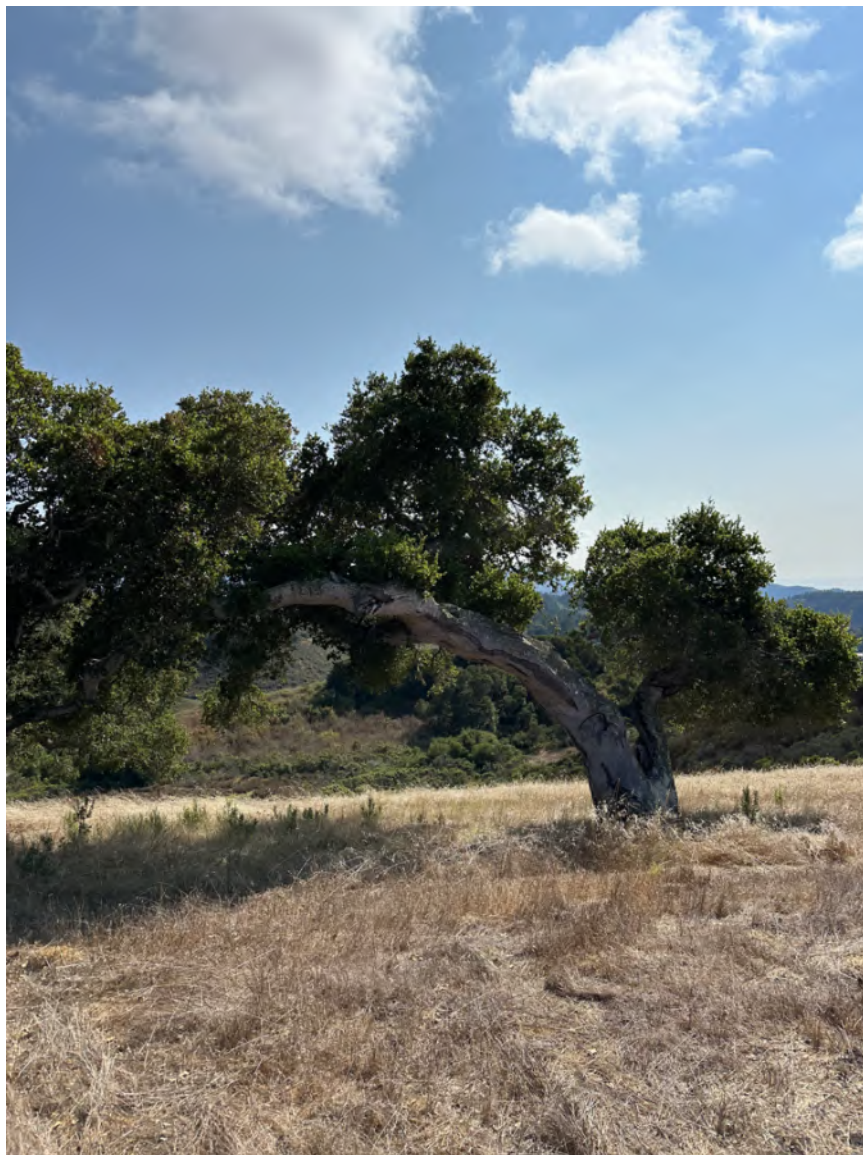
Subject tree #303: Coast live oak- *Quercus agrifolia*

Upon visual assessment the canopy of the subject tree appears to be in fair condition overall. The tree appears to have minor canopy dieback. This tree however has significant trunk decay that may make the tree structurally unsound especially in the event of inclement weather. Tree removal is recommended due to the decay and lean. If the tree is to be removed, replanting at a 1:1 ratio with a Coast live oak tree is recommended.

***Pictured below shows the significant lean of the tree.***

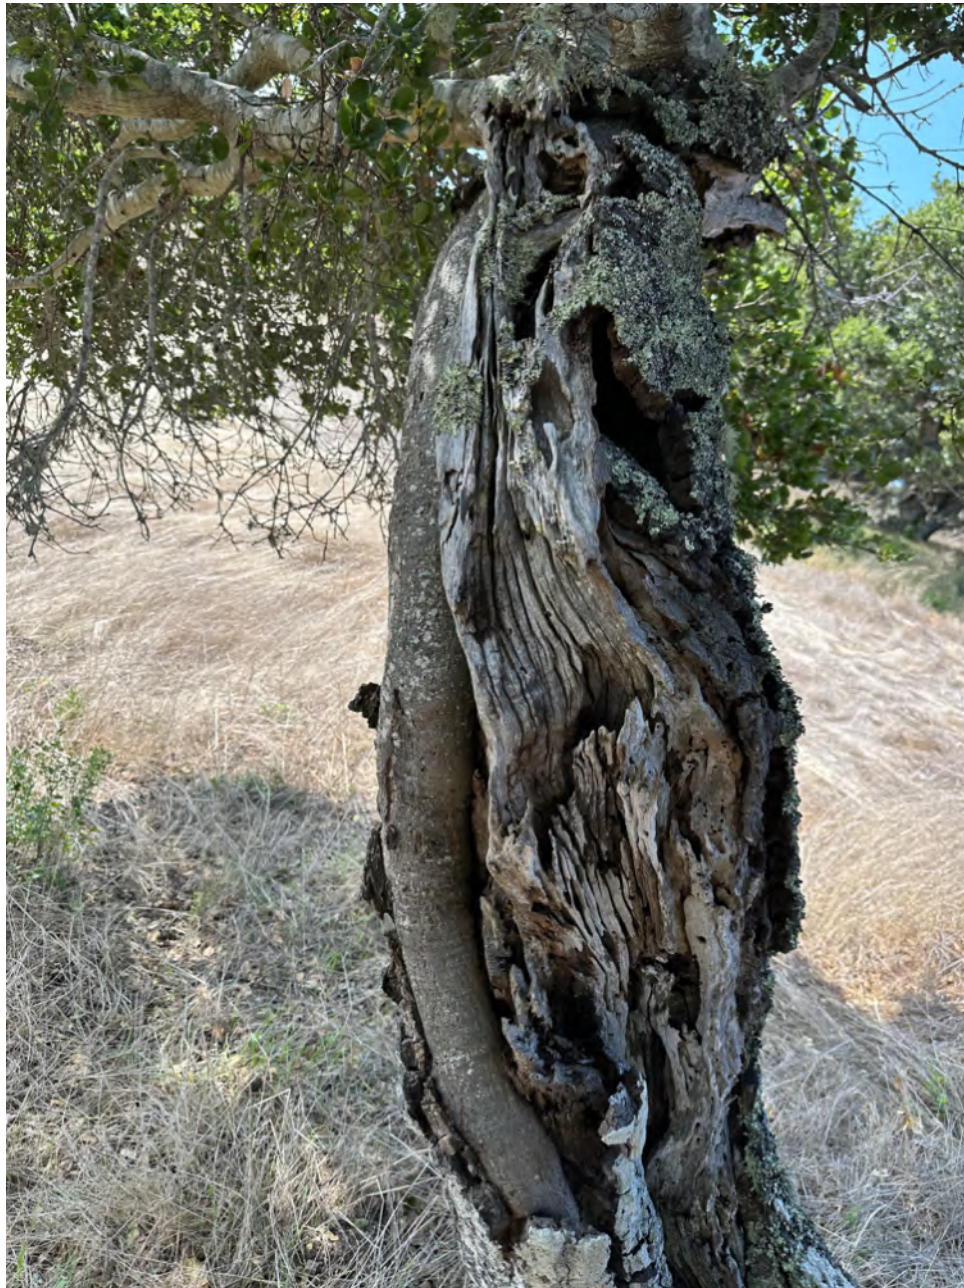
***Pictured below notice the significant decay on the trunk of the tree.***

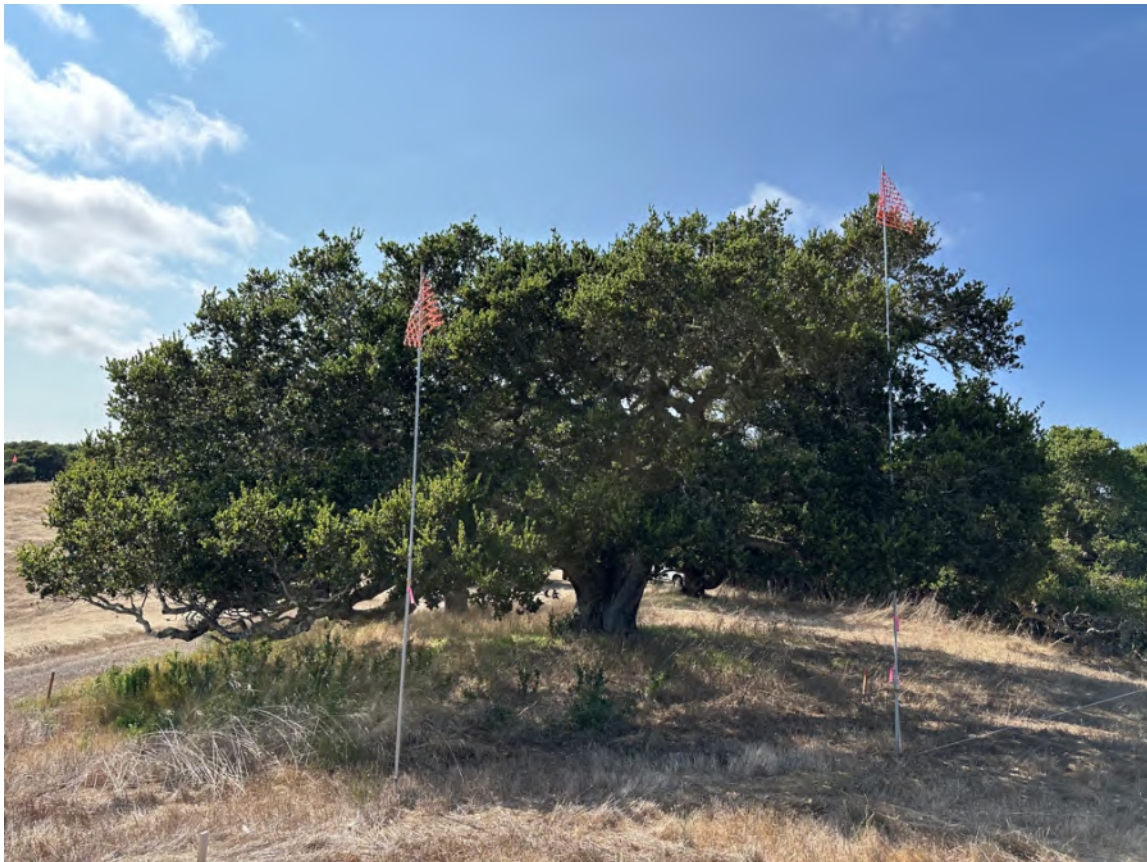
Subject tree #304: Coast live oak- *Quercus agrifolia*

Upon visual inspection the subject tree appears to in good health at the time of inspection. Due to the significance and health of the tree, pruning is recommended in order to reduce canopy weight on the tree and reduce the likelihood of failure. Annual inspections intervals are recommended for the trees on site.

***Pictures below shows the close proximity of the tree in relation to proposed construction. Significant limbs may need to be pruned in order to preserve the tree and construct a building.***

Tree protection is also recommended and roots no larger than 2inches in diameter should be cut.
