Tree Resource Assessment
Management Plan
24726 Dolores Street

Hastings Construction

Ono Consulting
Members Society of American Foresters
ISA Certified Arborist #WE-0536A
ISA Board Certified Master Arborist WE-9388B
1213 Miles Avenue
Pacific Grove, CA 93950

September 1, 2021

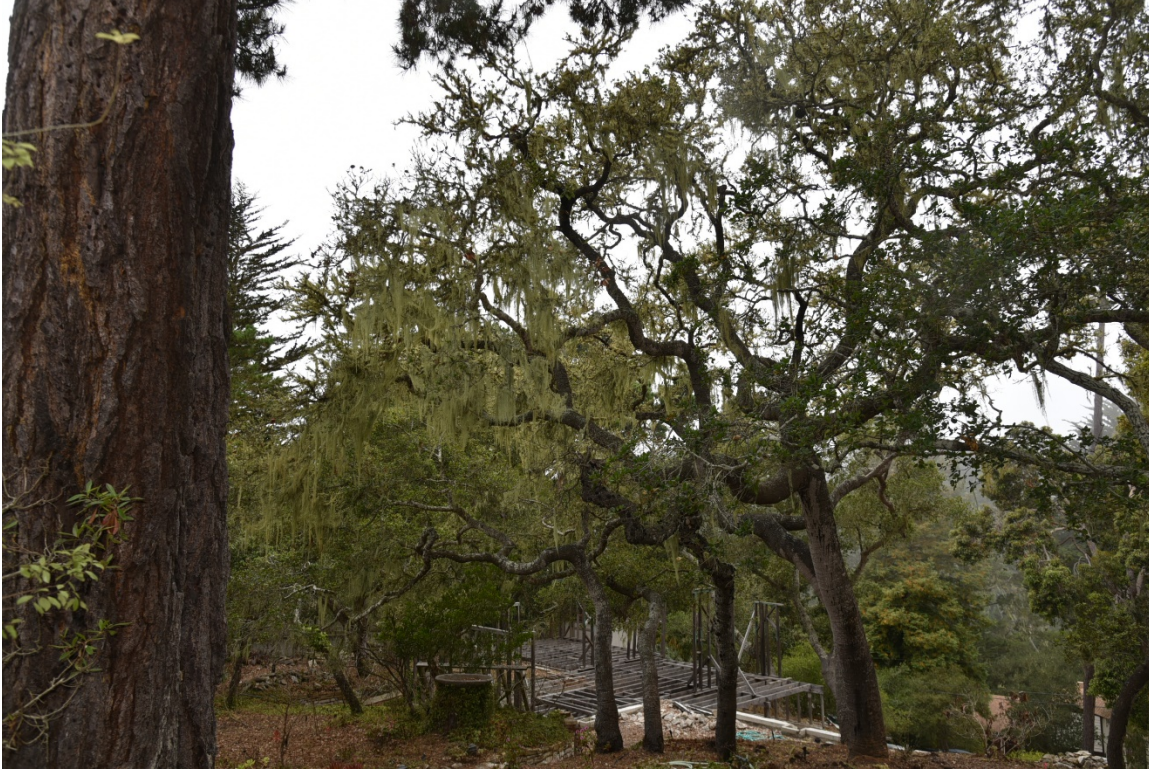
View of site looking west from gate (all trees are in fair to poor condition)

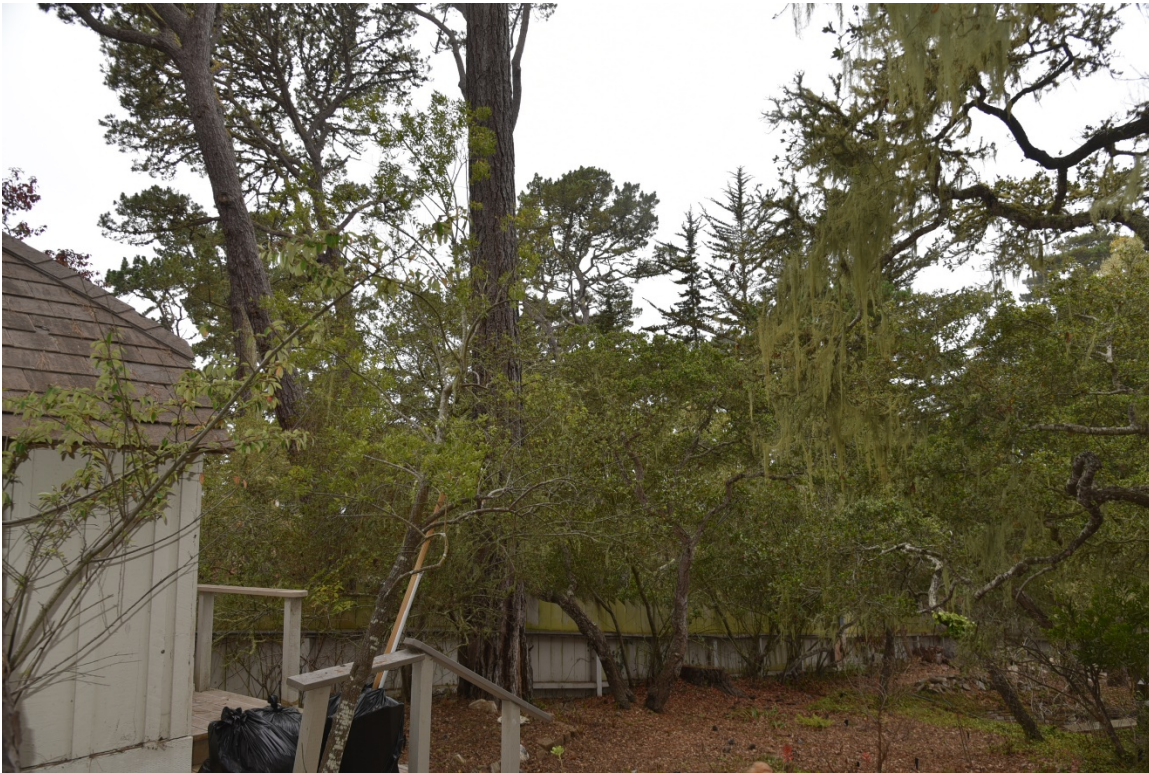
View of site looking south (note defoliation of lower story trees)

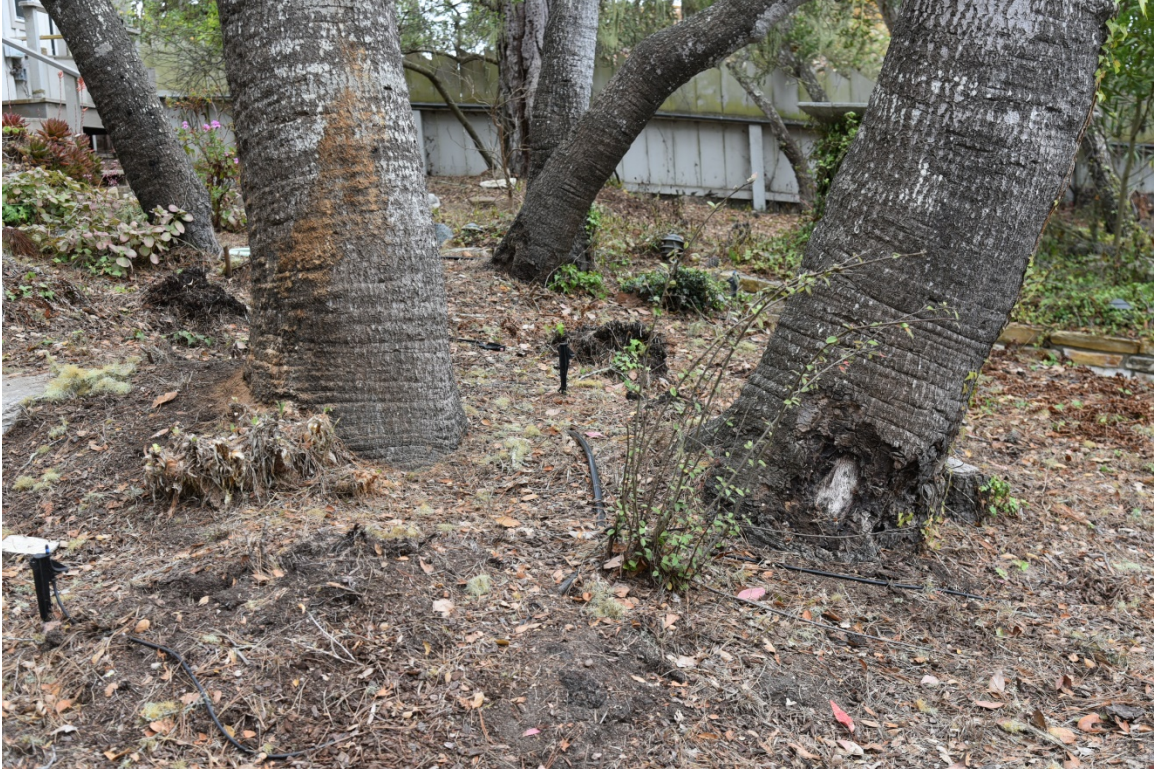
Base of oak trees where bark is sloughed away from fungal activity and infested with bark beetles (orange/rust color is insect frass, indicating a severe infestation)

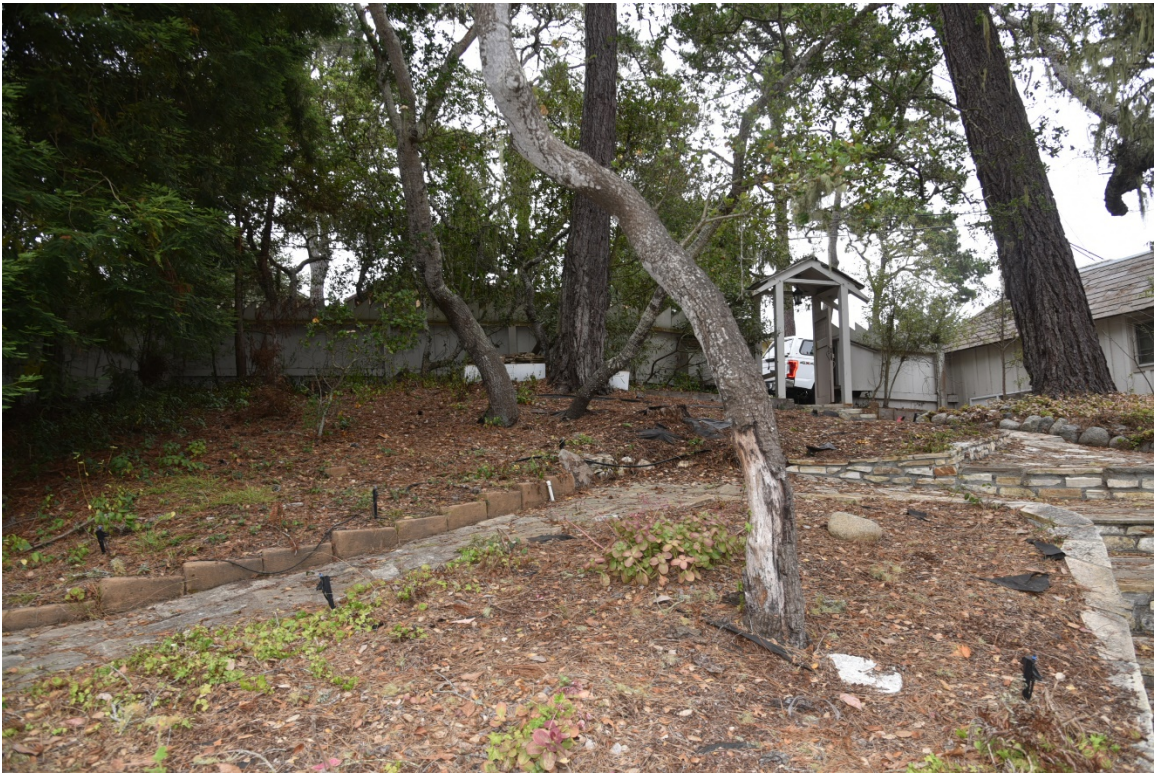
View of site looking north
