PORTER-VALLEJO MANSION/ PAJARO BRANCH LIBRARY REPAIRS

HRRB DRAWING SUBMITTAL
MONTEREY COUNTY

DECEMBER 07, 2023

29 BISHOP STREET PAJARO, CA 95076

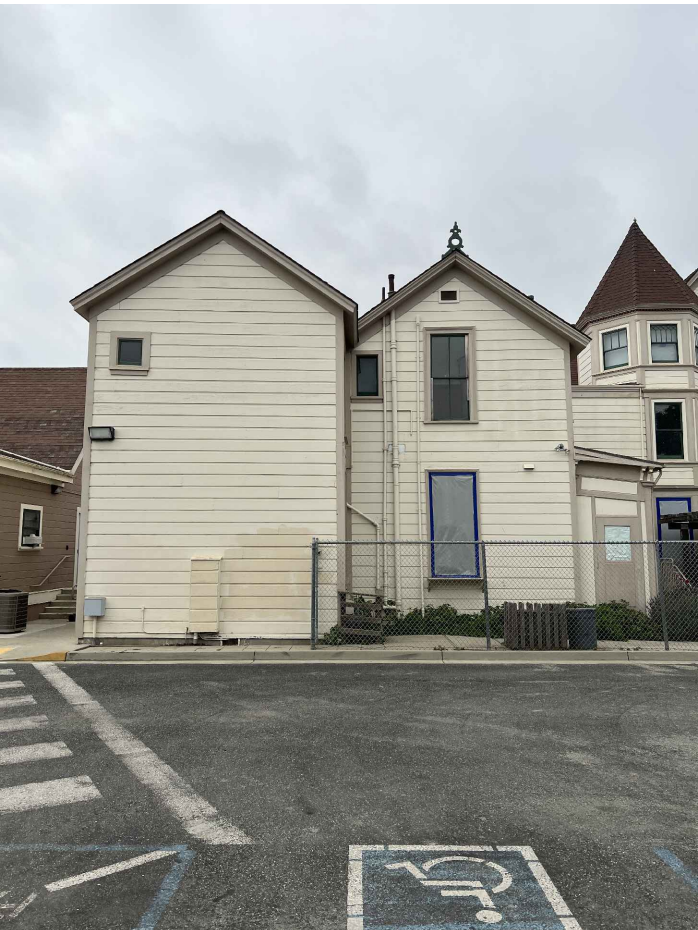
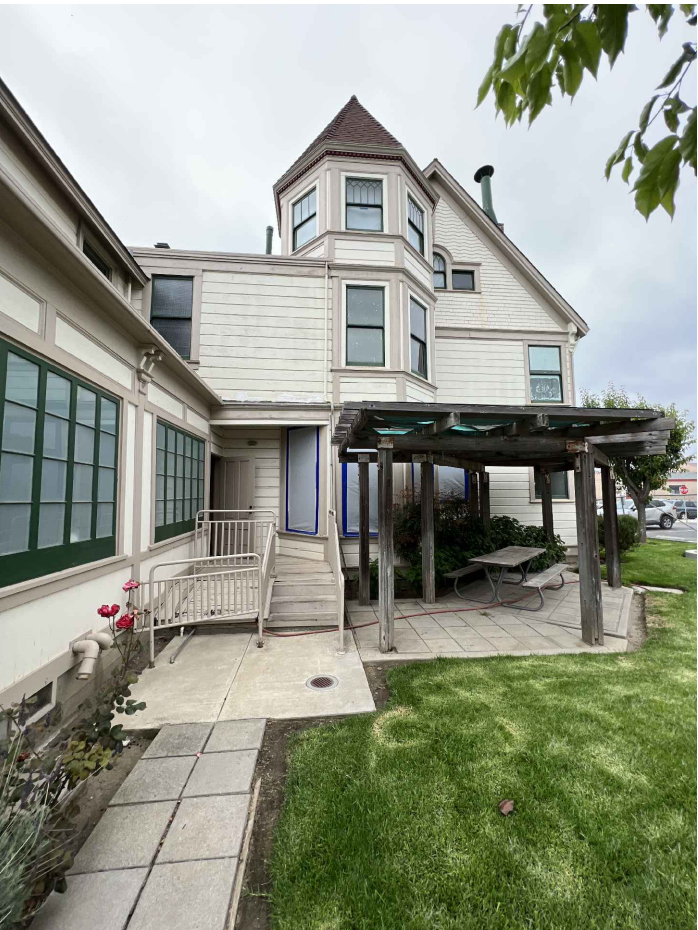
(D)

SOUTH VIEWS

PROPOSE TO REPLACE 100% OF 1924 ERA ADDITION SIDING WITH AMERICANA WOOD PRODUCTS. SEE DETAIL 3 PAGE-14 - NOTE: THIS IS THE ONLY FACADE PROPOSING REPLACEMENT - REFER TO PHASE II REPORT.
WHERE EXTERIOR PIPING OCCURS - G.C. TO STABILIZE VERTICAL PIPES WHEN REMOVING SIDING AND RE-INSERT BOARD BACK UNDER PIPES WITH CARE

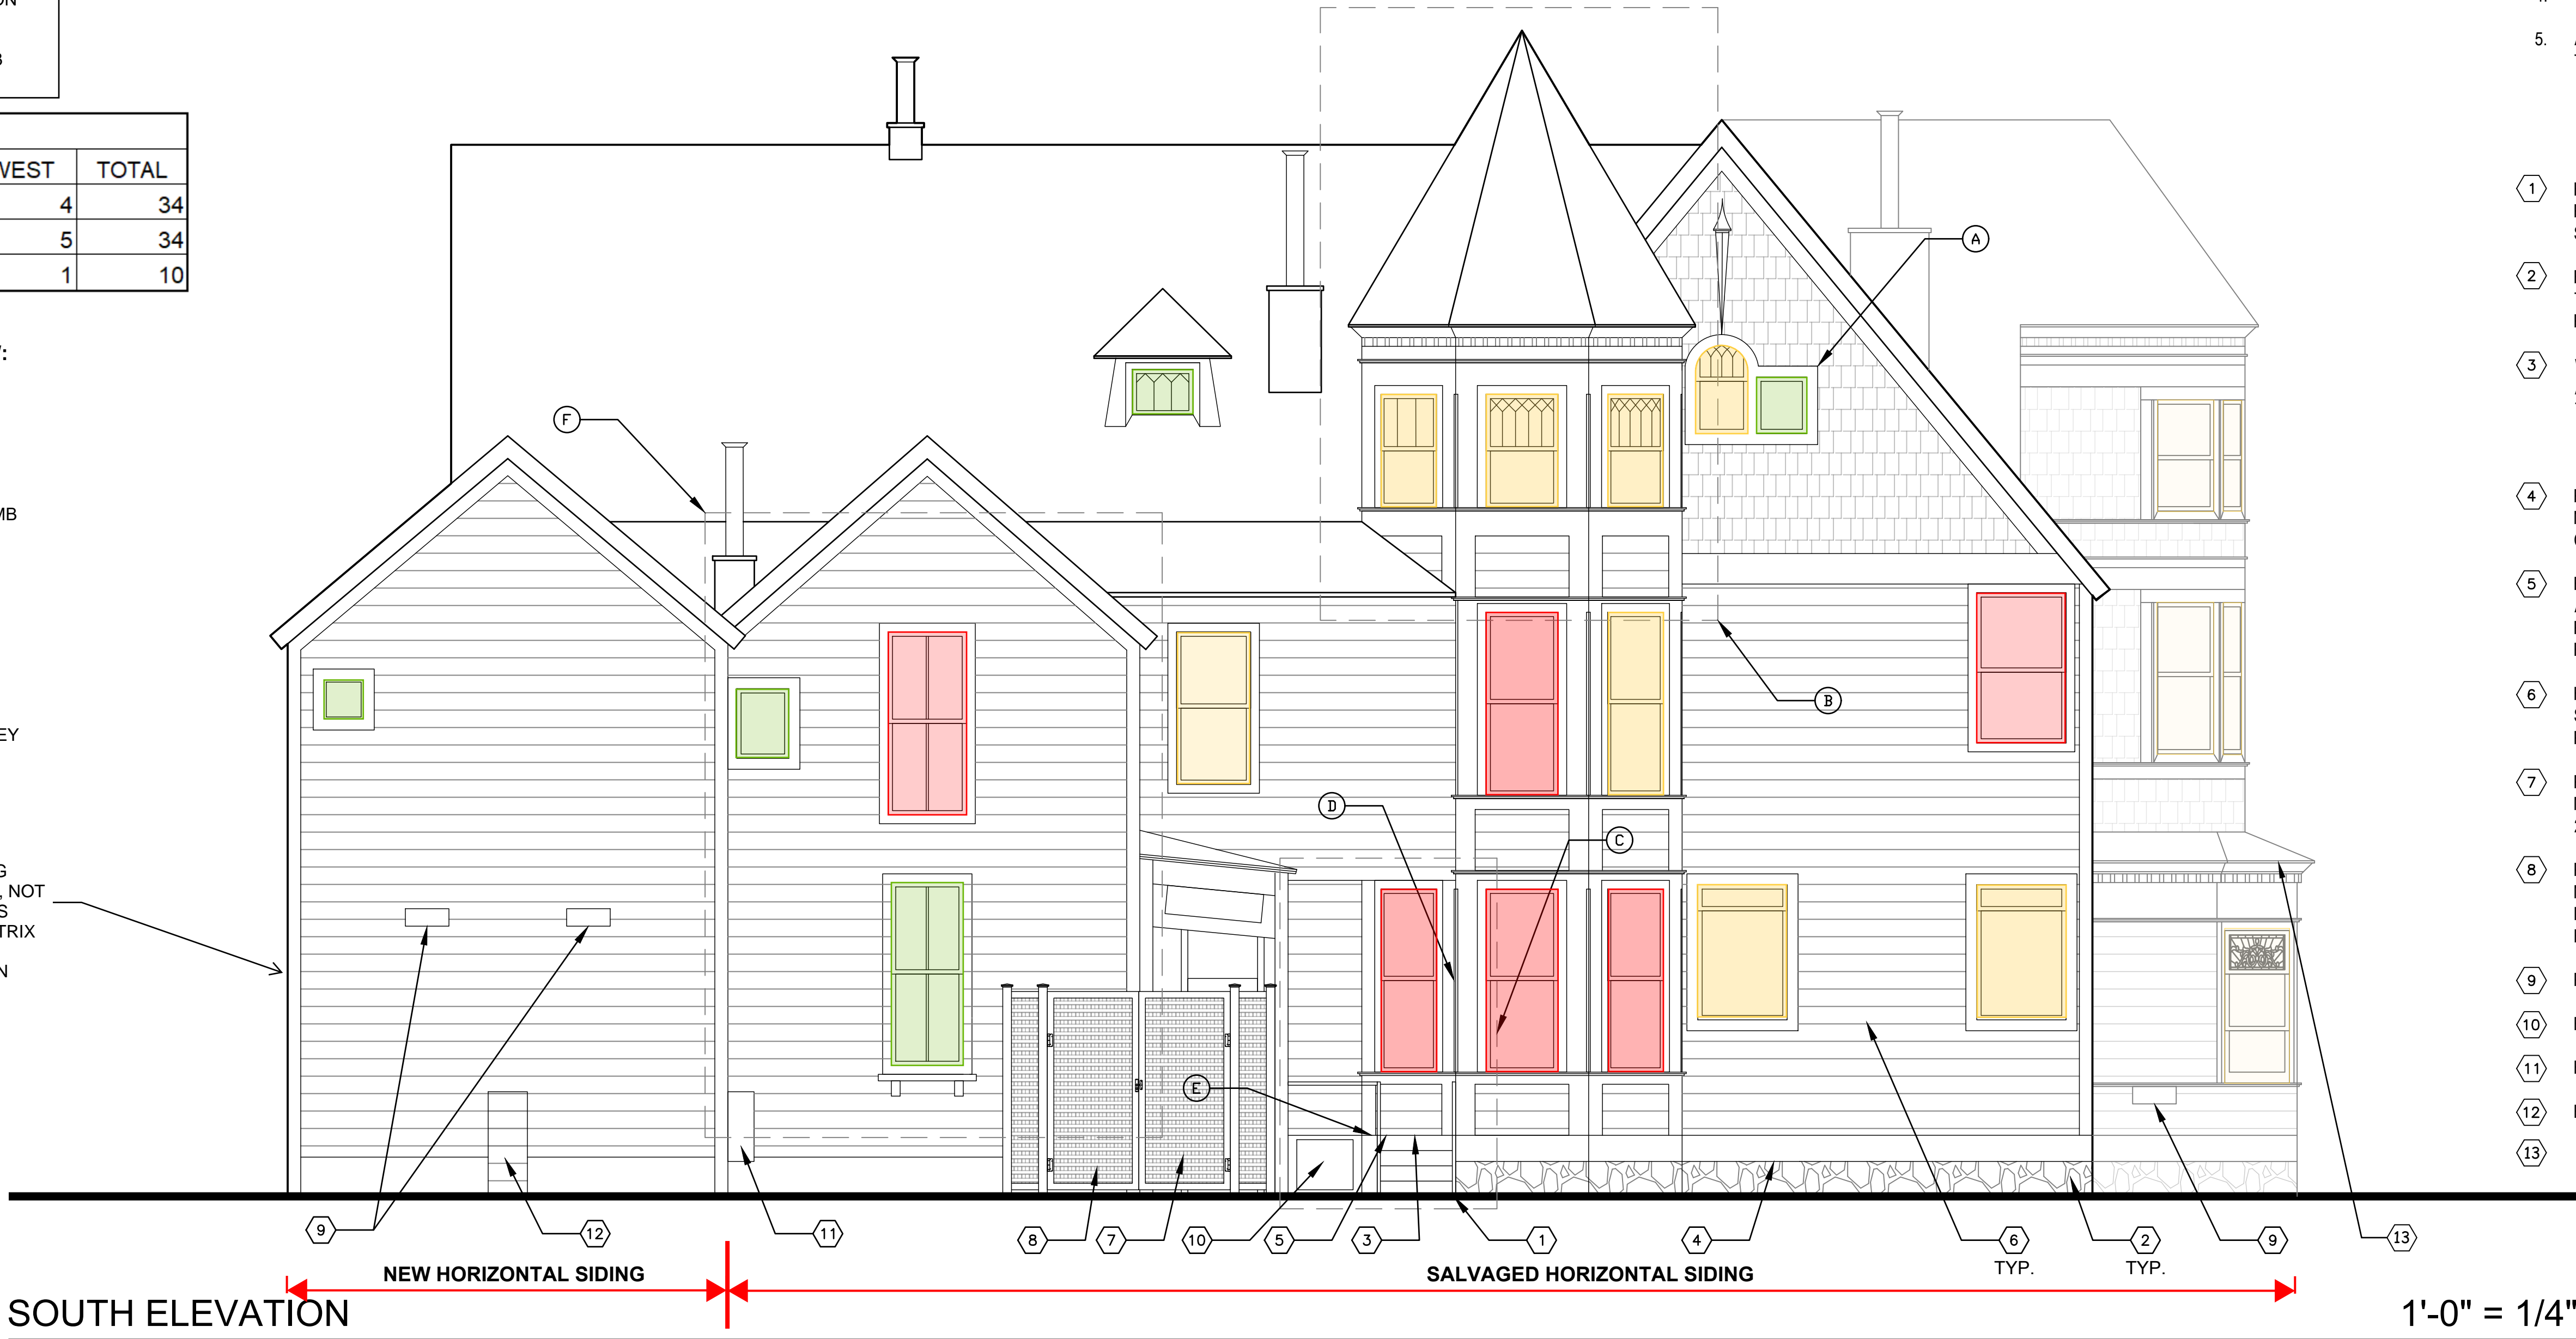
NEW SIDING

THE SOUTH FACADE (EXCEPT FOR 1924 ADDITION) SIDING TO BE PLACED WITH 100% SALVAGED HORIZONTAL SHIPLAP SIDING. 1924 ADDITION SIDING TO BE REMOVED, SALVAGED, AND REPLACED WITH AMERICANA THERMALLY MODIFIED WOOD SIDING TO MATCH EXISTING PROFILE. ALL PRESERVATION SHALL BE IN ALIGNMENT & COMPLIANCE WITH THE HRRB PHASE II REPORT*

NEW WEATHERPROOFING VAPOR BARRIER TO BE APPLIED TO EXISTING STRUCTURE WITH FLASHING AT ALL WINDOWS AND HORIZONTAL TRIM, PRIOR TO INSTALLATION OF SALVAGED SIDING.

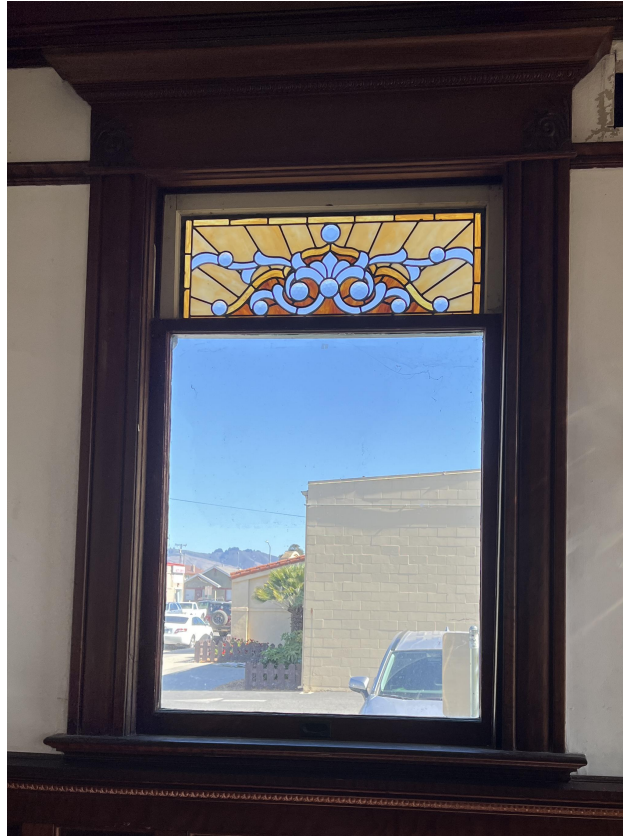
GOOD

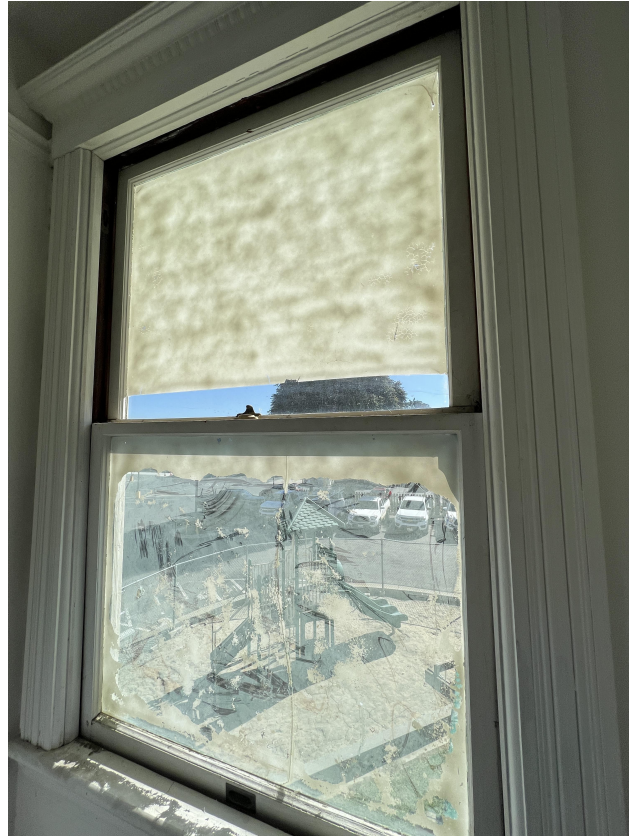
POOR

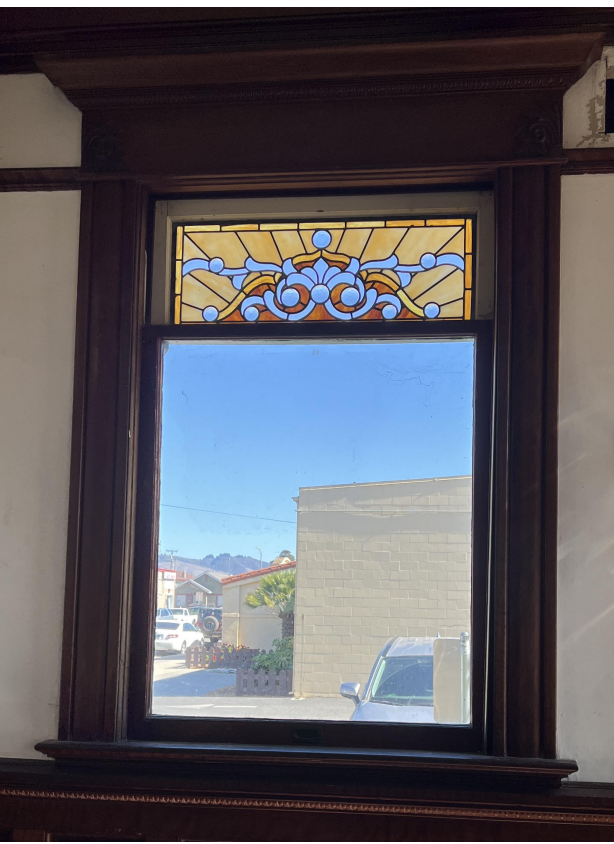
GOOD

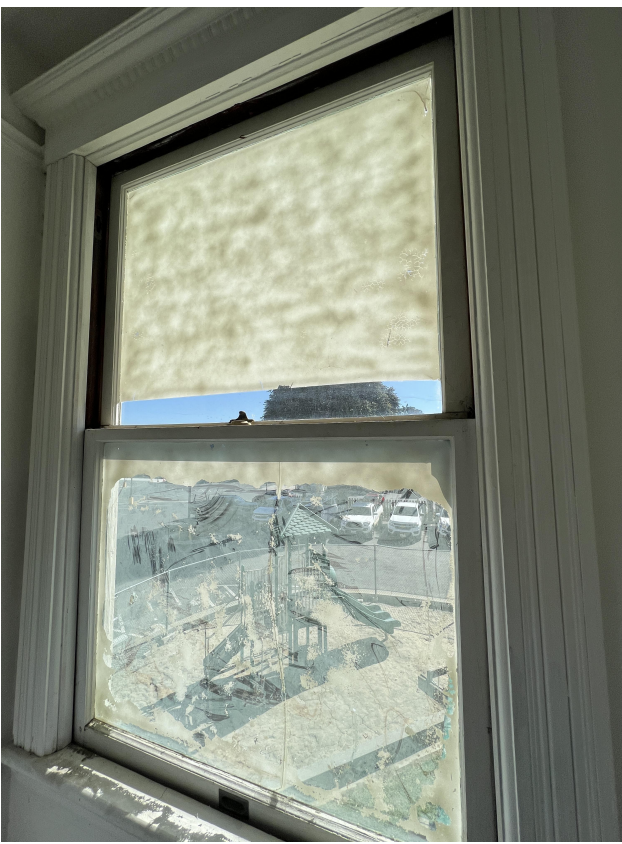
POOR

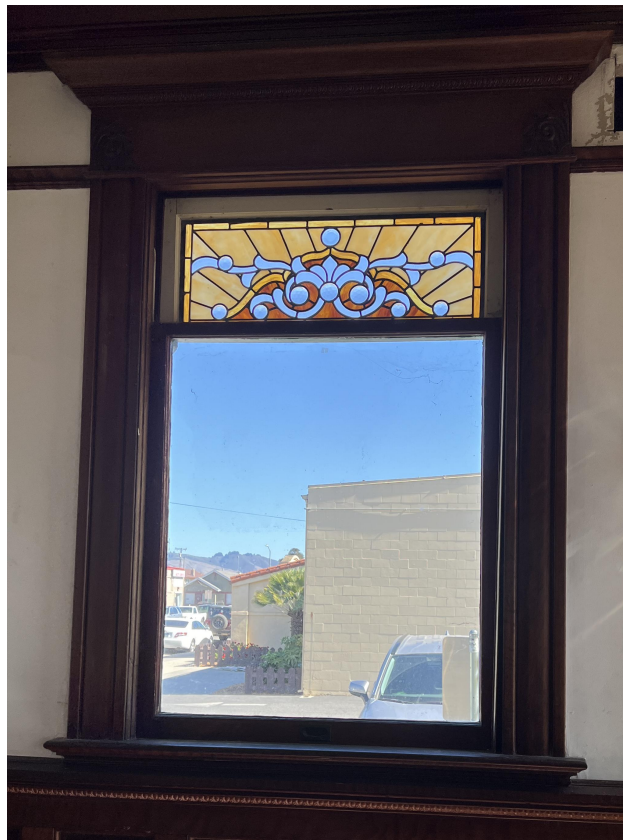
GOOD

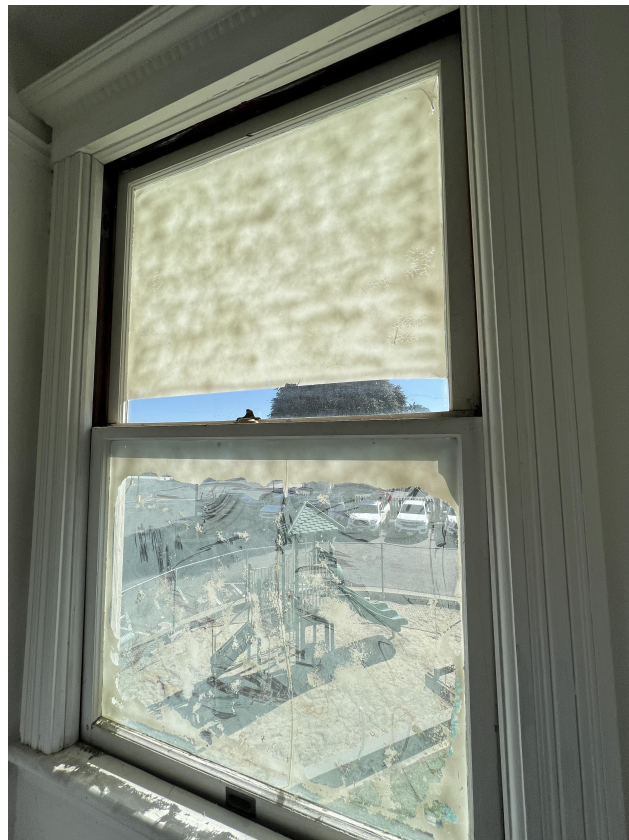
POOR
