# Exhibit B

Phil Garrett 4011 Los Altos Pebble Beach, Ca 93953 APN: 008-112-033-000

Michael Tope ISA Certified #WE-12498A ISA Tree Risk Assessor

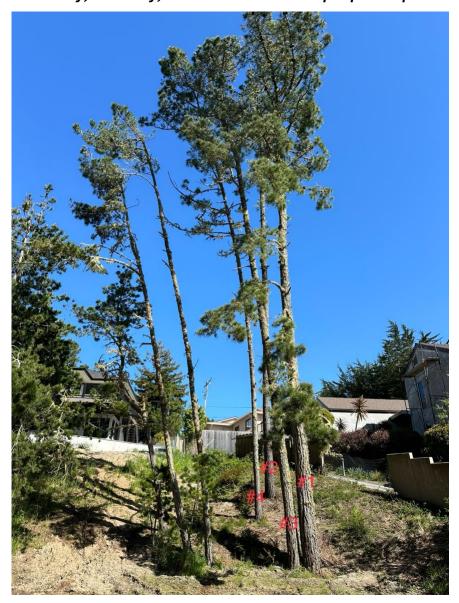
Subject tree #1: Monterey pine- Pinus radiata

Upon visual assessment the canopy of the subject tree appears to be in fair condition overall. The tree is top heavy and is over exposed to wind patterns. There is also minor cracking in the soil which may be a sign of uplift from overexposure. The tree has exit holes with frass coming out of it which is a sign of possible red turpentine beetle activity. See picture below to see the current site conditions.

Pictured below shows all four subject trees. The trees are within striking distance to the roadway, driveway, and structures where people frequent.

The four trees are within striking distance to people, vehicles, and structures. Due to possible compromised roots, top heavy canopies, and exposure to the coastal wind patterns the four trees could be removed. Tree removal will eliminate the likely of failure these trees pose.

Due to the high likely hood of failure tree removal is recommended for the four pine trees. The county of Monterey recommends replanting with a 2:1 ratio with Monterey pine trees. However, the current site is overcrowded, and replanting with a 2:1 ratio is not feasible. 1 Monterey pine tree at 5 gallon size is recommended. If you have any questions or concerns, feel free to contact me with the phone number or email below.

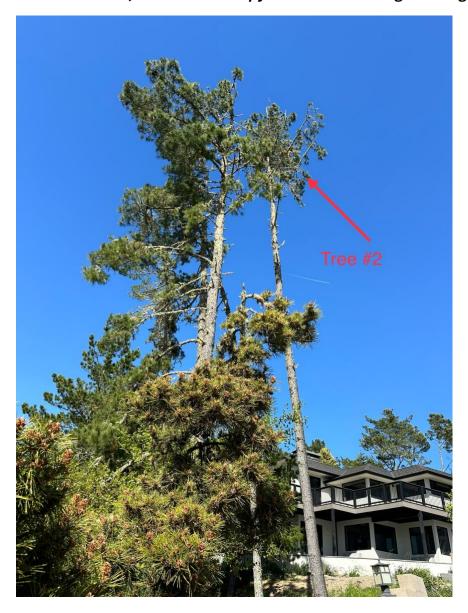
Subject tree #2: Monterey pine- Pinus radiata

Upon visual assessment the subject tree appears to in poor health. The tree has bad form overall and canopy dieback from bark beetle. The tree is top heavy and is over exposed to wind patterns. The tree has exit holes with frass coming out of it which is a sign of possible red turpentine beetle activity. See picture below to see the current site conditions.

Pictured below shows tree #2, notice the canopy dieback and foliage turning brown.

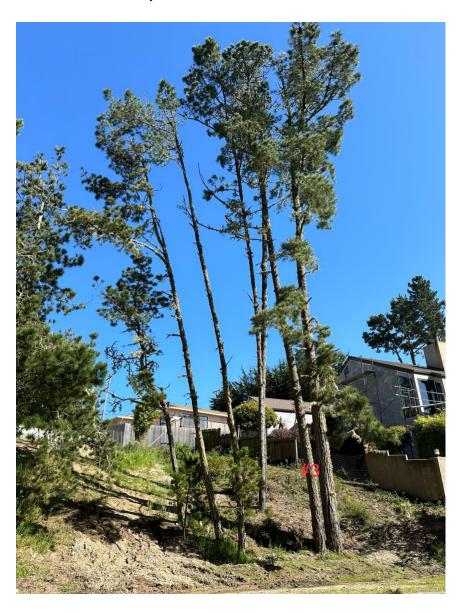
Subject tree #3: Monterey pine- Pinus radiata

Upon visual assessment the subject tree appears to be in fair condition overall. The tree has fair form overall with minor dieback in the canopy.

Pictured below shows tree #3, notice the tree has a bow and lean to it from uplift.

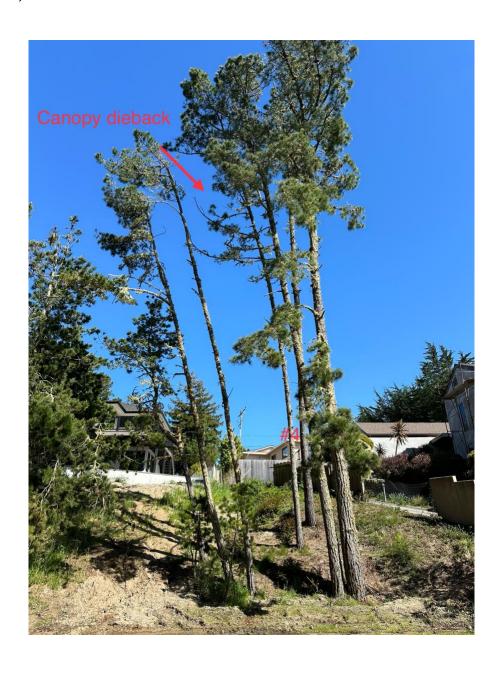
Subject tree #4: Monterey pine- Pinus radiata

Upon visual assessment the subject tree appears to be in poor condition overall. The tree has poor form with severe canopy dieback. The tree is within striking distance of people, structures, and vehicles.
