**ENVIRONMENTAL
CONSULTING LLC**

Re: Pre-Renovation Hazardous Material Inspection & Microbial Sampling for the Monterey County Courthouse East/West Wing Building Located at 240 Church Street in Salinas, California
M³ Project No. 15480.0 Task 1

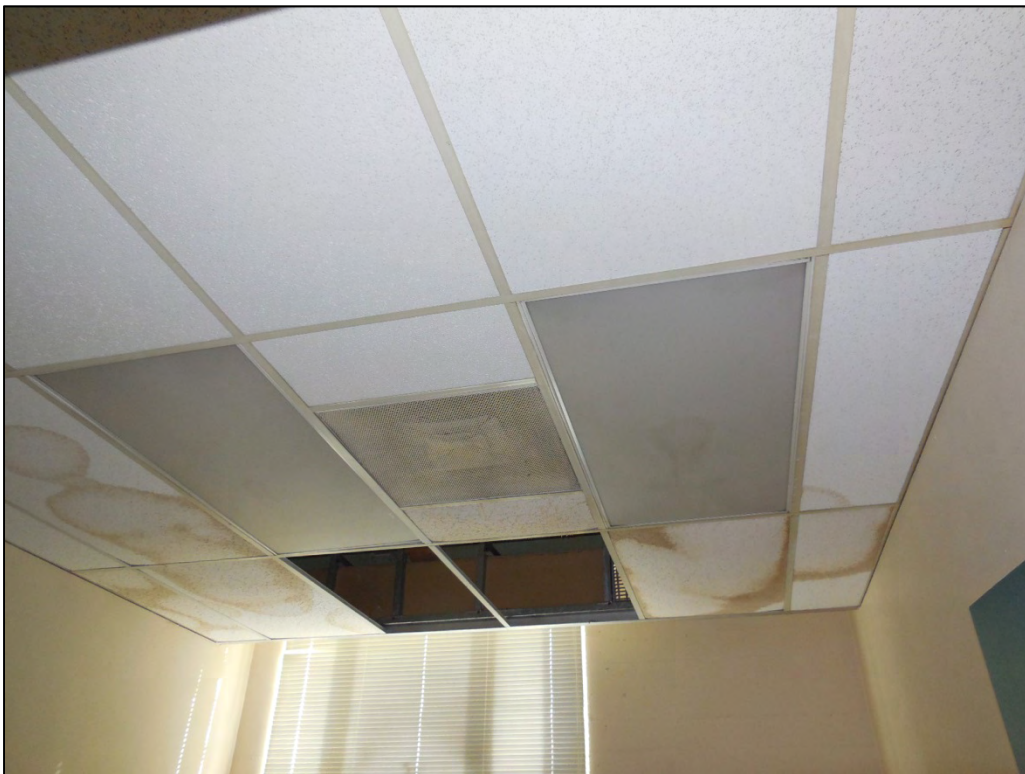
Visible water damage on lay-in ACP in West Wing

- All water and/or mold impacted surfaces should be properly removed.
- All windows should either be removed and replaced, or professionally inspected for leaks and repaired as necessary.
- The plumbing and HVAC system throughout the building should be professionally inspected for leaks and repaired as necessary.
- The roof should either be removed and replaced, or professionally inspected for leaks and repaired as necessary.
- All work should be performed by an experienced mold remediation contractor using appropriate engineering controls such polyethylene containments and high efficiency particulate air (HEPA) – filtered equipment.

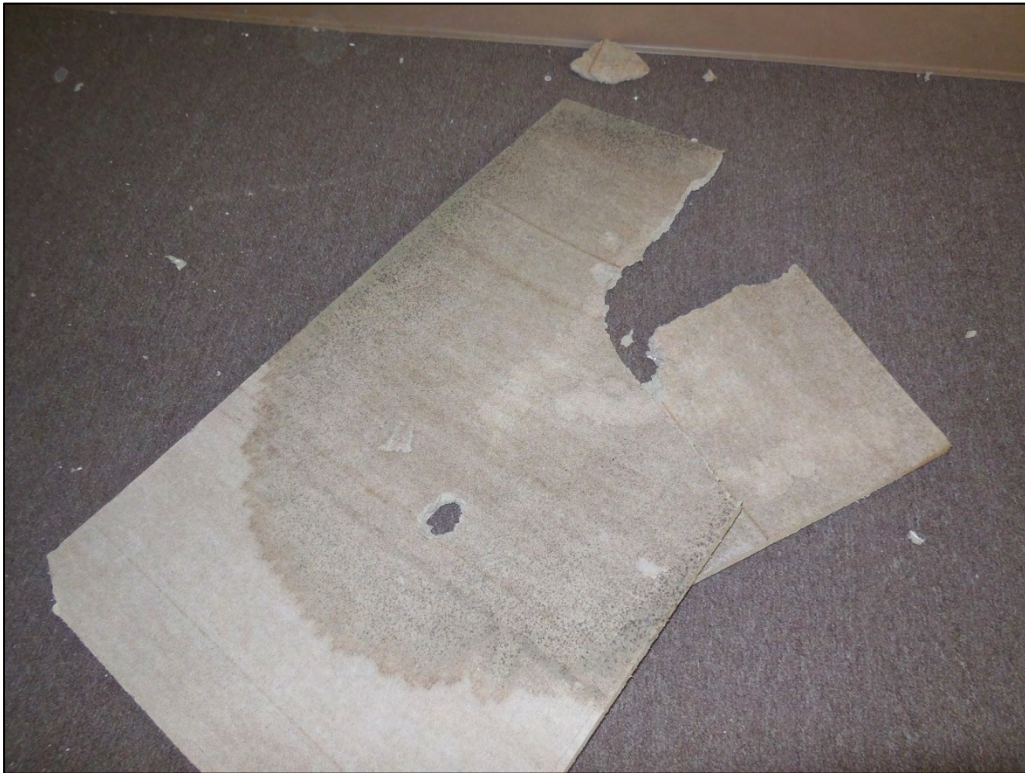
- Heavy water stains were noted on the lay-in ACP in rooms 1-36 → 1-39. Suspect mold growth was noted on the topside of the ACP. Water stains were noted on the hard concrete ceiling above, as well as down the walls.

Visible suspect mold growth on lay-in ACP in West Wing

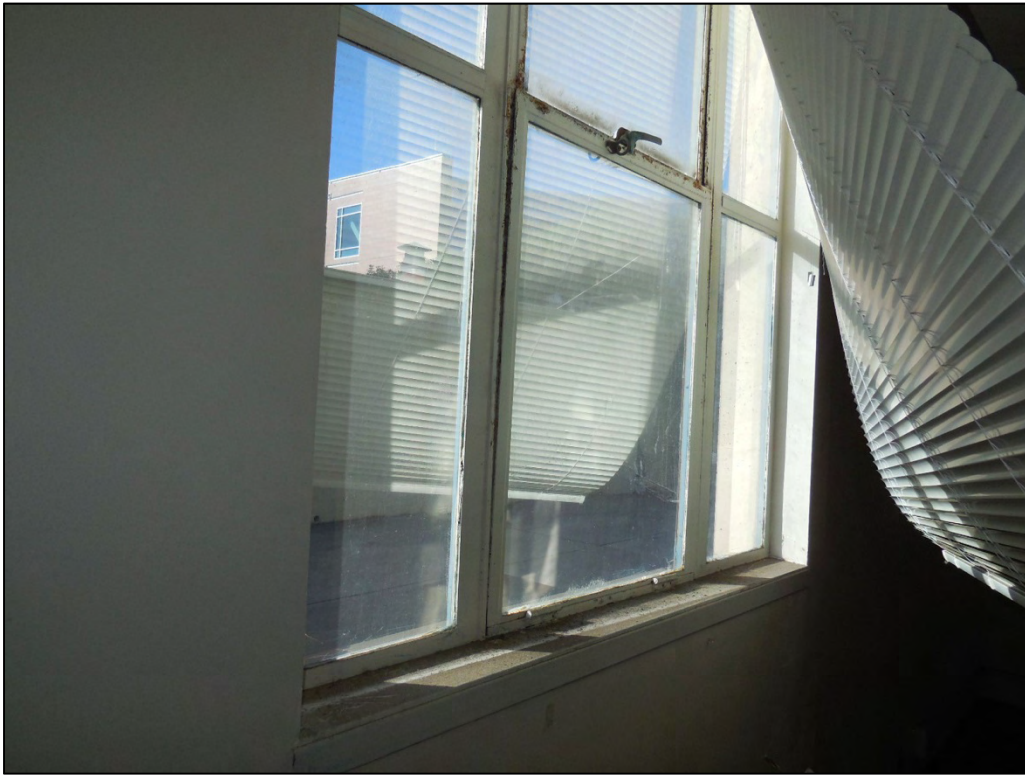
- Plant debris was scattered on the floor in the first floor entry corridor.
- The windows, window sills, and wall recesses (concrete, plaster, WB/JC) throughout the building appeared to be in moderate to poor condition (staining, cracked paint, rust, etc.).

West Wing window visibly in moderate-poor condition

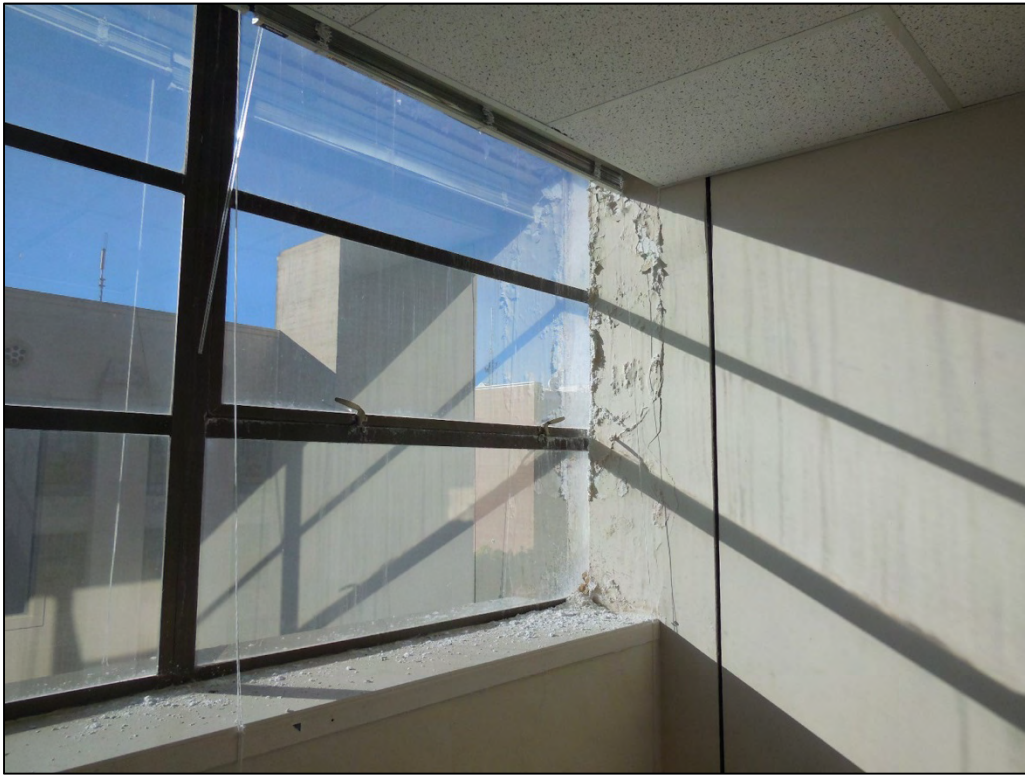
- Water stains were noted on the lay-in ACP in room 2-25. Peeling paint was noted on the wall/ceiling plaster throughout the adjacent rooms.
- Heavy efflorescence was noted on the plaster window recesses in rooms 3-35 and 3-38. Water stains were also noted on the lay-in ACP in these areas.

Heavy efflorescence visible on exterior wall in West Wing

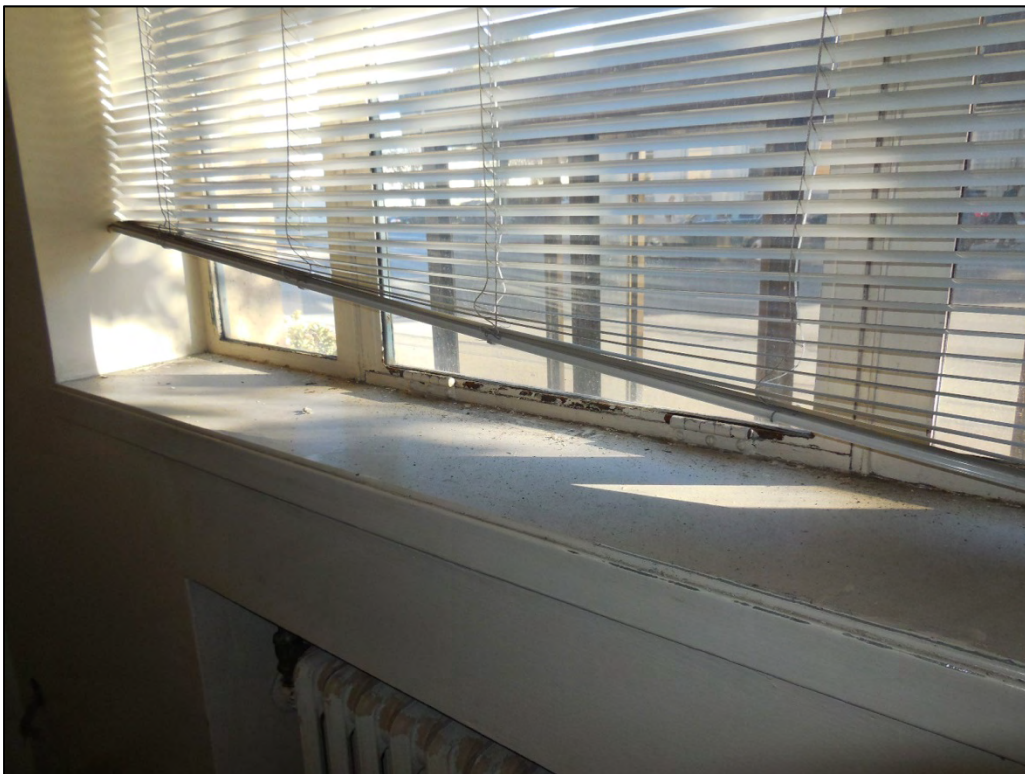
- Plant debris was scattered on the floor in the first floor entry corridor.
- The windows, window sills, and wall recesses (concrete, plaster, WB/JC) throughout the building appeared to be in moderate to poor condition (staining, cracked paint, rust, etc.).

East Wing window visibly in moderate-poor condition

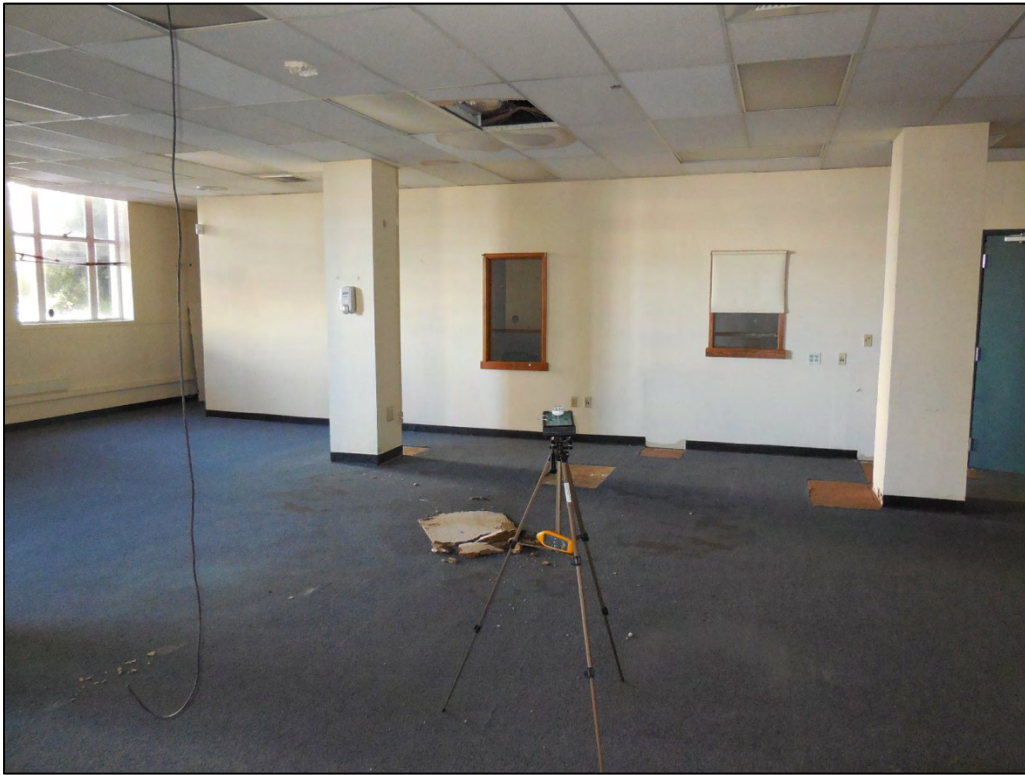
- Cracks were noted in the concrete/plaster ceiling in corridor 1-1.
- Light water stains were noted on the lay-in ACP in room 1-9.
- A heavy musty odor was noted in room 1-22. A water leak was noted in the room. The lay-in ACP were wet and falling to the floor. The carpet underneath was soaking wet. Water stains were noted in the ceiling cavity above. Suspect mold growth was noted on the lay-in ACP.

Air sampling in the East Wing cubicle area 1-22; Site of active leak visible in background

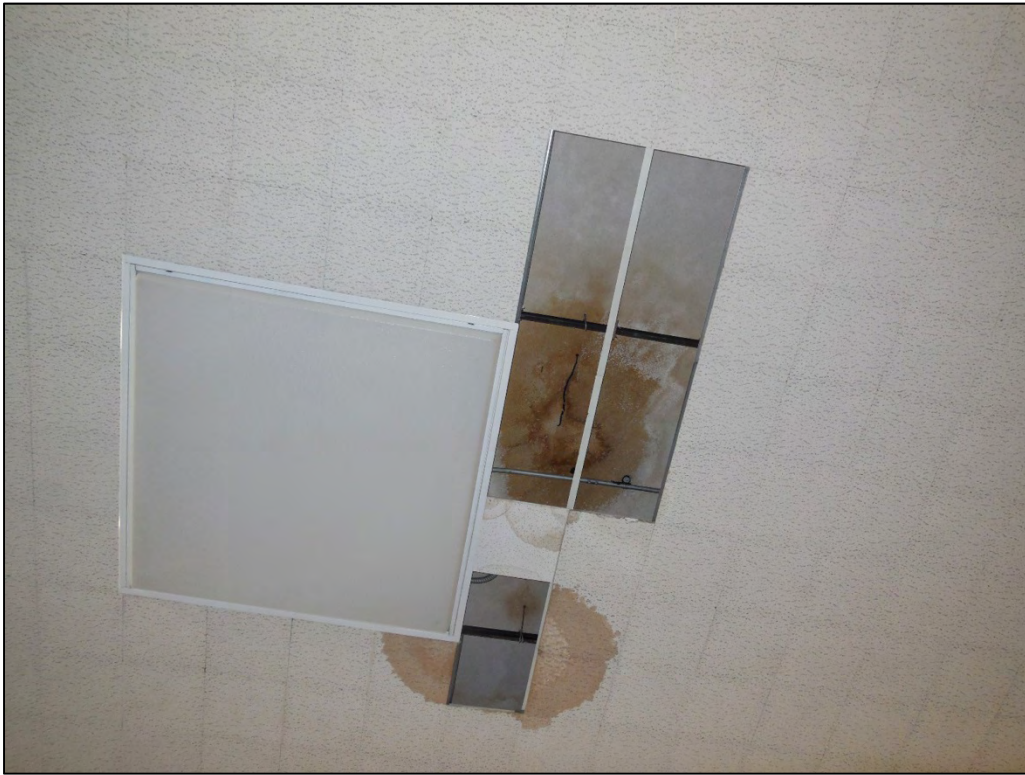
- Multiple visible signs of water leaks were noted on the courtroom 2-21 ceiling. The lay-in ACT were wet and falling to the ground. Water stains were noted on the hard plaster ceiling above. Suspect mold growth was noted on the lay-in ACT.

Water damage visible on ceiling in East Wing courtroom 2-21

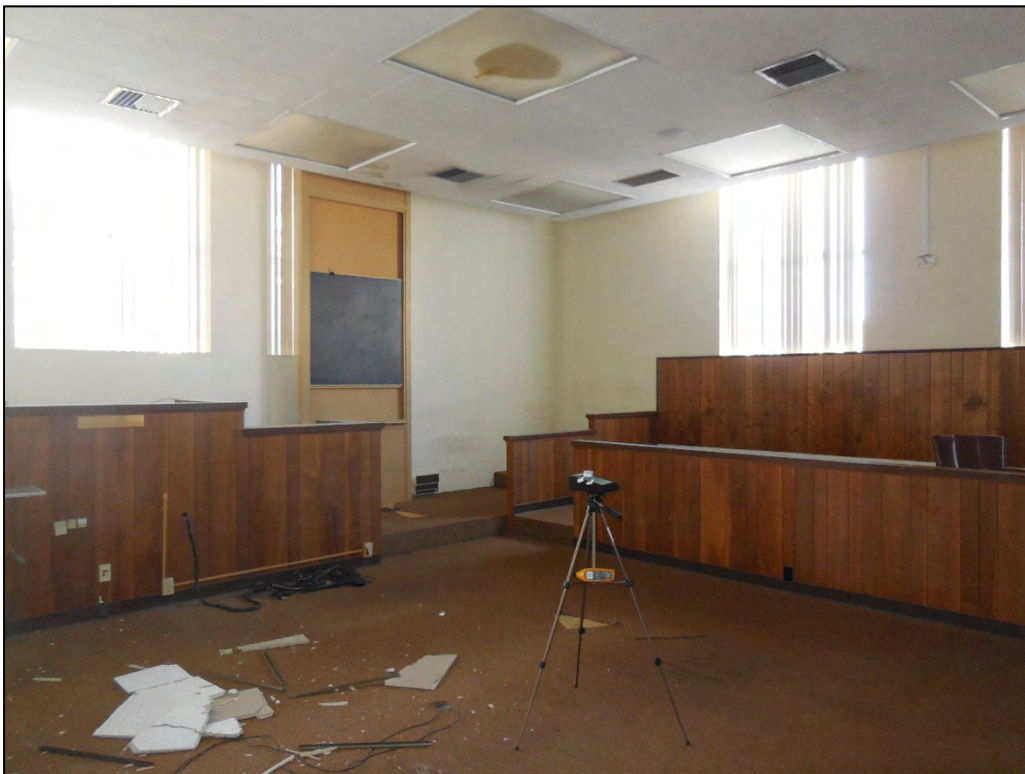
- Water stains and rust were noted on the ACT and metal lights fixtures in courtroom 2-4.
- Light water stains were noted on the lay-in ACP in room 2-12.

Air sampling in the East Wing courtroom 2-4; Water damage visible on ceiling in background

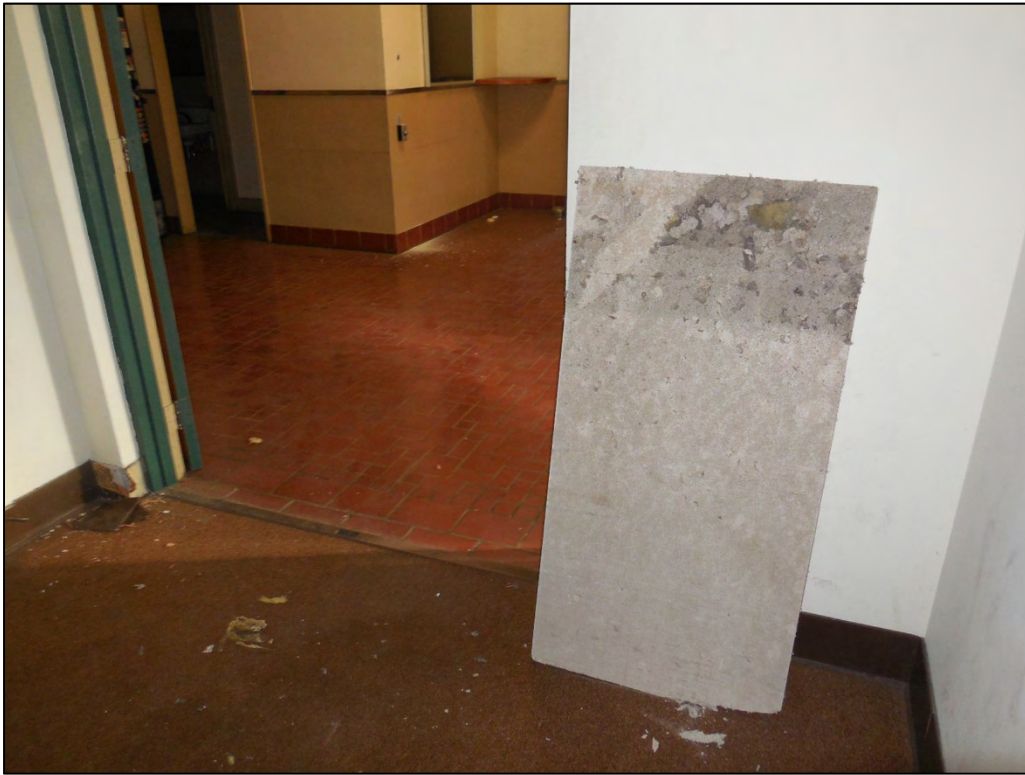
Suspect mold growth visible on lay-in ACP in East Wing
