FACILITY ASSESSMENT REPORT

San Ardo Branch Library

County of Monterey 62350 College Street San Ardo, California 93450

> June 14, 2013 FINAL

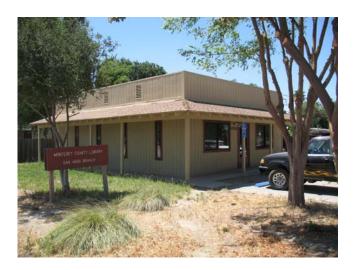
3.1.1 <u>Sidewalks:</u> The sidewalk leading to the front entry and to the rear exit is in fair condition but appeared dirty and not well maintained. It could be cleaned using a high power hose. The brush around the side and rear of the building is unsightly and should be cut back to maintain a fire safe area around the building.

Overall Condition: Fair.

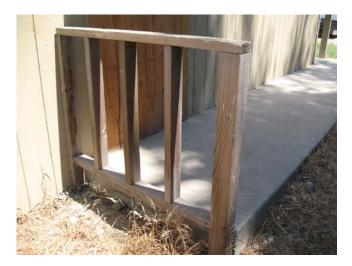
3.1.2 <u>Ramps, Steps & Railings</u>: No ramp and steps exist in this branch. The rear exit has old wooden barrier rail that is in need to re-finishing or painting. Overall Condition: **Fair**.

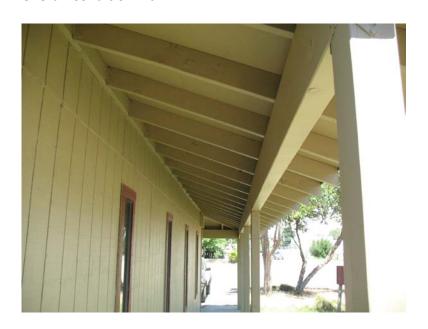
3.1.3 <u>Exterior Walls:</u> The exterior wood siding appears to be in fair condition. It could use some touch-up paint.

Overall Condition: Fair.

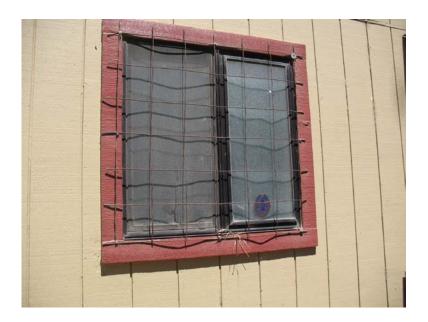
3.1.5 <u>Exterior Windows</u>: The exterior wood windows appeared to be in fair condition. One rear window has temporary security grille fabricated with rebar. This should be replaced with a more permanent security grille more securely attached to the window frame. *Overall Condition*: **Fair**.

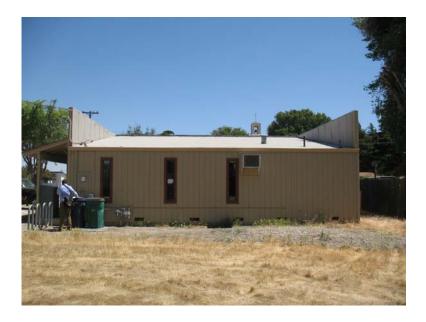
3.1.6 <u>Roof</u>: The sloping roof is in good shape. No roof leaking instances were reported by the branch manager.

Overall Condition: Good.

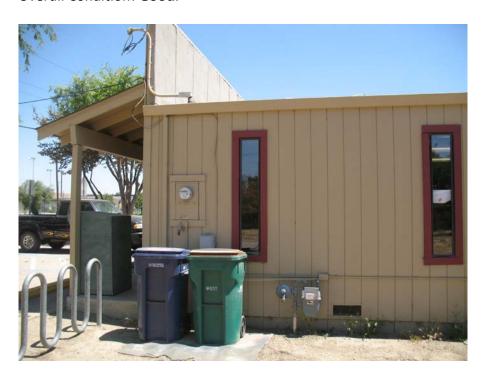
3.1.7 <u>Gutter & Downspouts</u>: Exterior gutter and downspouts are in good condition. Overall Condition: **Good**.

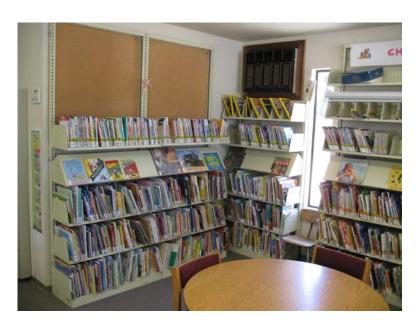
3.2.1 <u>Interior Walls & Partitions</u>: The interior walls and partitions are in good condition. Overall Condition: **Good**.

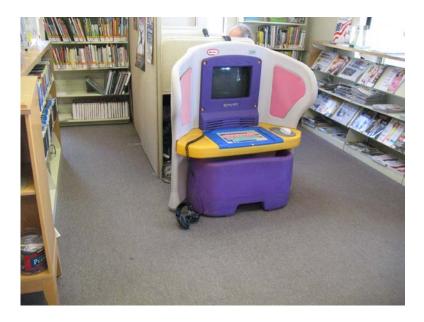
- 3.2.3 <u>Interior Windows</u>: No interior windows in this branch.
- 3.2.4 <u>Finishes</u>: The carpet is in fair condition. The plastic wainscoting and sheet vinyl floor in the Unisex restroom appeared to be in good condition. The walls and hard ceiling finishes are in good condition.

Overall Condition: Good.

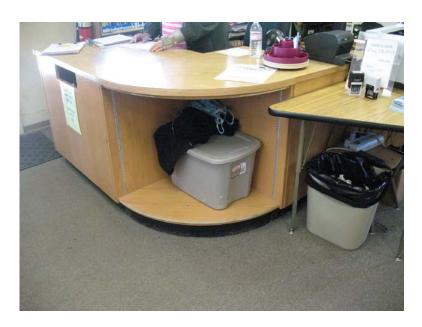
3.2.5 <u>Cabinets & Millwork</u>: The cabinets and millwork is in good condition Overall Condition: **Good**.

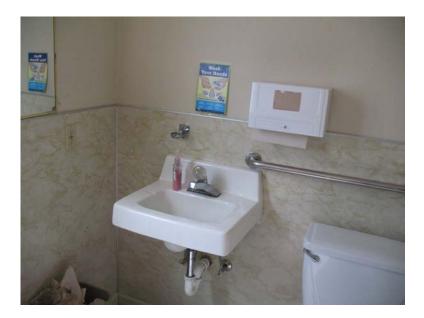
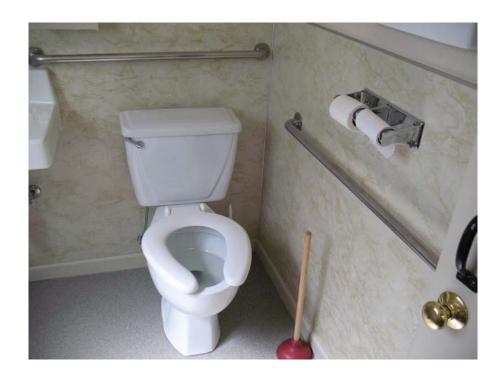
3.2.6 <u>Toilet Facilities</u>: The Unisex restroom is in good condition. The plumbing fixtures and toilet accessories are in good working condition. Please refer to section 1 (Accessibility Assessment) for accessibility compliance issues with the toilet facilities.

Overall Condition: Good.

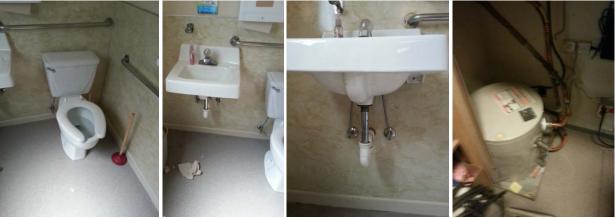
The building contained a total of one (1) gas fired wall heater unit, one (1) electric hot water storage unit, one (1) water closet and one (1) hand wash sinks.

(L to R) General Plumbing items, Water Closet, Hand Wash Sink, Hand Wash Sink connections, Hot Water Unit.

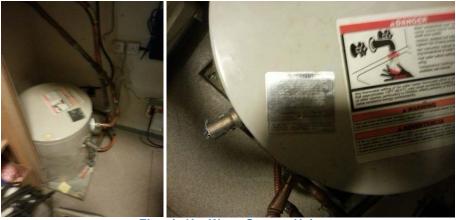
Electric Hot Water Storage Unit

4.2.3 <u>Hot Water</u>: Hot water to the building is supplied from a small electric heating and storage unit located in the closet next to the restroom. The tank capacity of the unit is stated as 15 Gallons. The unit appears to be in good working order and the installation was to a satisfactory level of workmanship.

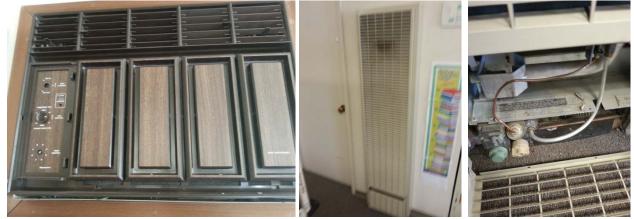
HVAC consisted of a wall mounted Room Air Conditioner, a ceiling fan and a wall mounted gas heating unit. All items were in fair condition.

(L to R) Room air conditioner, Wall Heater unit, Wall Heater Unit connection and control panel

- 4.3.1 <u>Heating</u>: A wall mounted gas fired space heater is provides the only heating to the space. The unit has a capacity of 25 MBtu/Hr and is manually controlled with eight (8) output steps. The unit is in fair condition however it was not apparent if the unit was serviced regularly.

- 4.3.2 <u>Cooling</u>: A wall mounted room air conditioner is installed to provide comfort during the summer months. The unit has a cooling capacity of approximately 3500 to 4000 Btu/hr and is in fair condition however many of the knobs are missing from the control panel. The cooling capacity is insufficient to maintain the space correctly however the unit's primary purpose is to provide some relief on hot days. The number of computers in the space have a heat rejection very nearly exceeds the air conditioners capacity. If additional electrical equipment is added and additional AC unit would be a wise choice to meet the extra heat load.

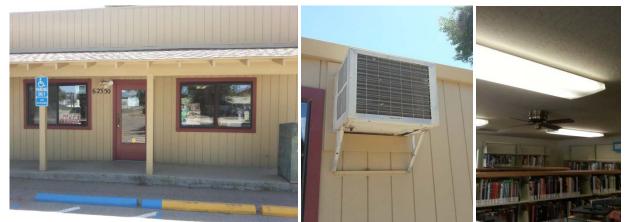
4.3.3 <u>Ventilation</u>: The building is naturally ventilated with no mechanical ventilation to the bathroom and some fresh air provided by the Room Air-Conditioner when it is running. A ceiling fan improves the air circulation in the space.

(L to R) Ventilation items: Operable windows, Room AC with fresh air intake, Ceiling fan

- 4.3.4 Access: There is no roof mounted equipment. Access is not necessary.
- 4.3.5 <u>Deficiencies</u>: Restroom exhaust should be installed in the bathroom.

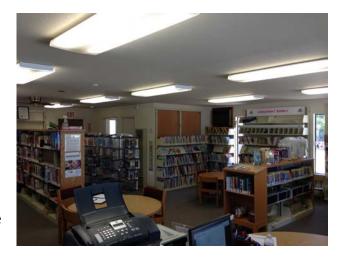
- 5.4.1 <u>Illumination Levels</u>: The Light levels appear to be adequate in all of the interior spaces.
- 5.4.2 <u>Fixture Types and Serviceability</u>: All of the interior lighting is surface mounted 4-lamp T-8 acrylic wrap lens fluorescent fixtures. The exterior of the building has only one flood type fixture in the front of the building.

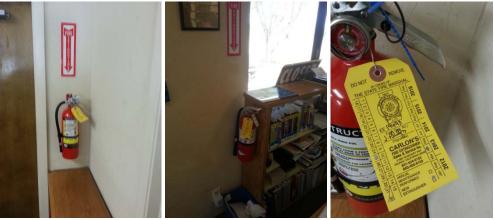
6.1.1 <u>Fire Extinguishers</u>: There are two (2) fire extinguishers installed in the building all of ABC classification. Two (2) 5 Lb units are located on wall hooks in the main entrance and near the restroom door.

(L to R) ABC type Fire Extinguisher's, Rear exit, near main entrance, service tag

Distance from all points of the library to an extinguisher is less than the mandated 75 ft and the coverage of the units is below the maximum stated by the International Fire Code and NFPA 10.

The extinguisher's visibility is good and they are easily noticed.

All extinguishers have been regularly serviced by a registered and licensed party.
