Lead Containing Ceramic Report

Site: 1441 Schilling Place, Salinas, California

Prepared for: County of Monterey Department of Public Works

S Tech Project: 15070

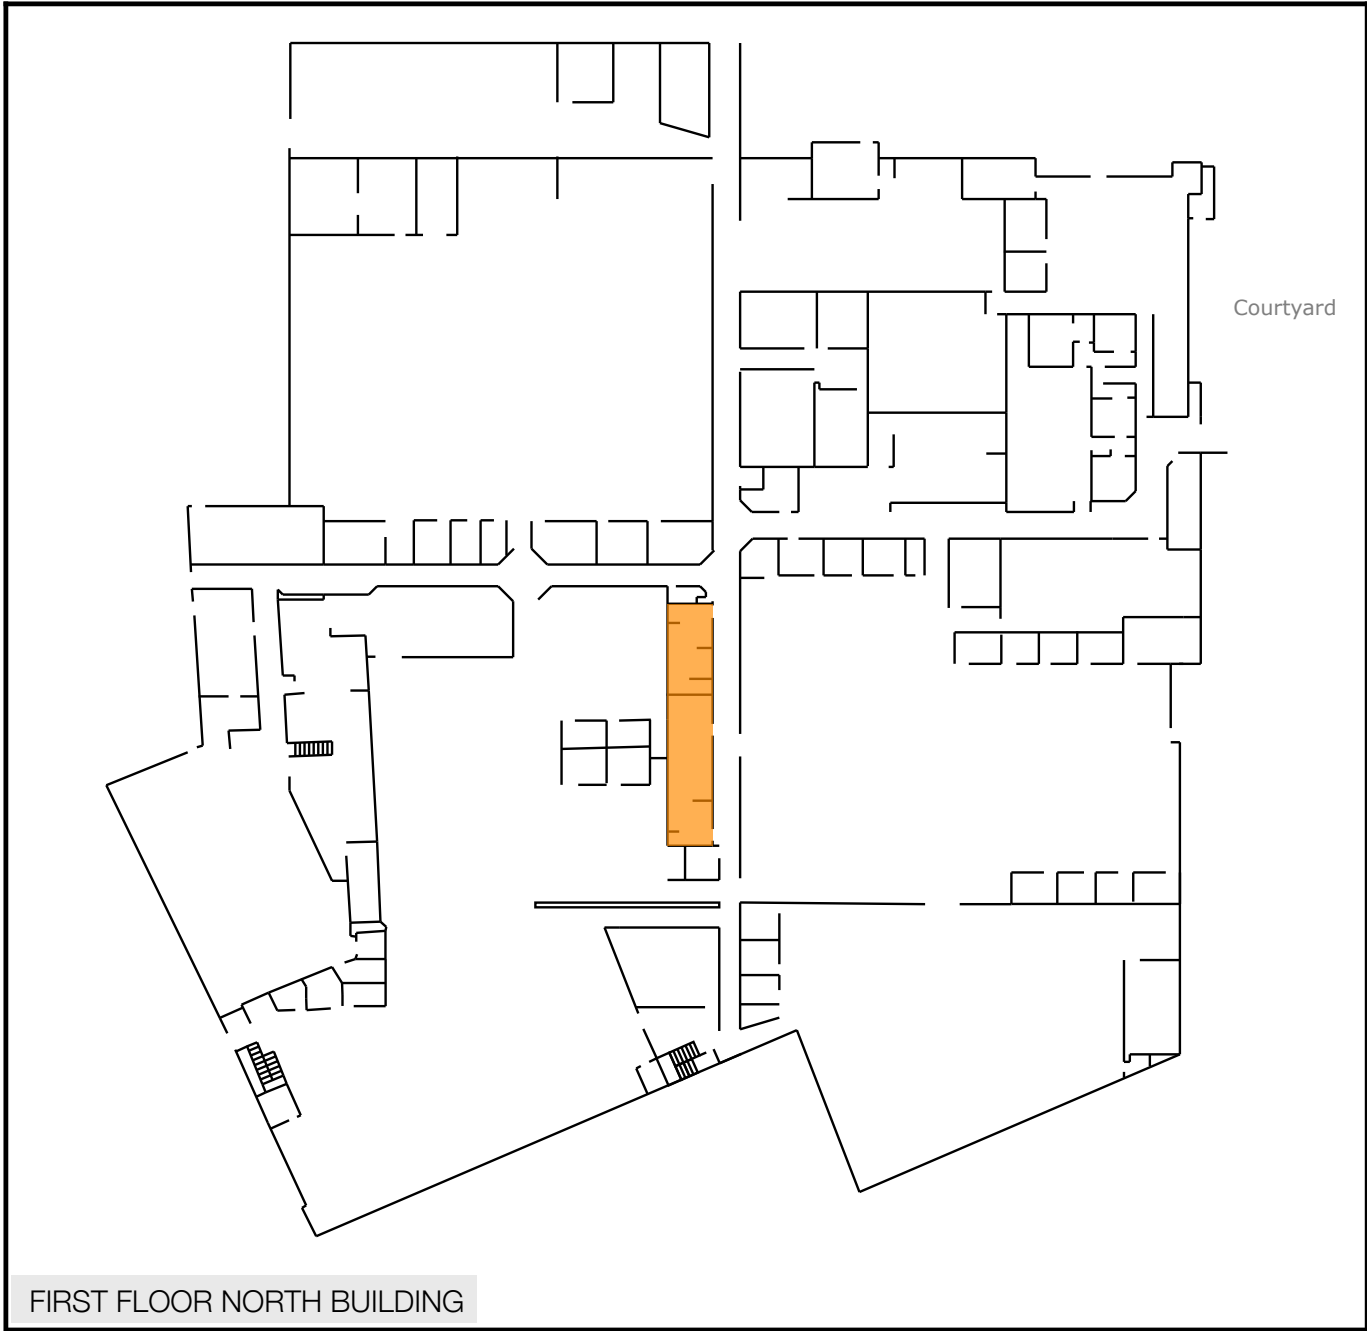
Site Plan & XRF Assay Locations

- * **The majority of the ceramic finishes contain only trace lead content, ranging from less than (<) 10 parts per million (ppm) to 291ppm. However, the rectangular ceramic tile in the gym restrooms (men’s & women’s) contains lead as high as 28,933ppm. The tile poses no exposure hazard unless it will be disturbed by construction activities which result in damage to the tile glazing.**

personnel. Environmental and safety concerns would result only if the tile will be demolished at some point in the future. In that case, the contractor conducting the removal must comply with Cal-OSHA Title 8 CCR 1532.1, the Lead in Construction Standard. Those not familiar with the requirements of the Standard can refer to a Cal-OSHA fact sheet on lead safety issues by following this link http://www.dir.ca.gov/dosh/dosh_publications/lead-fct-sheet-rev.pdf. Based on the methods of removal, engineering controls and personal protective equipment may be necessary during the demolition of ceramic finishes in this building.
