Live By The Sea LLC  
Tree Resource Assessment  
3387 Ocean Avenue  
Carmel, CA

Frank Ono  
Urban Forester  
Member Society of American Foresters #48004  
ISA Certified Arborist #536  
1213 Miles Avenue  
Pacific Grove, CA 93950

July 21, 2025

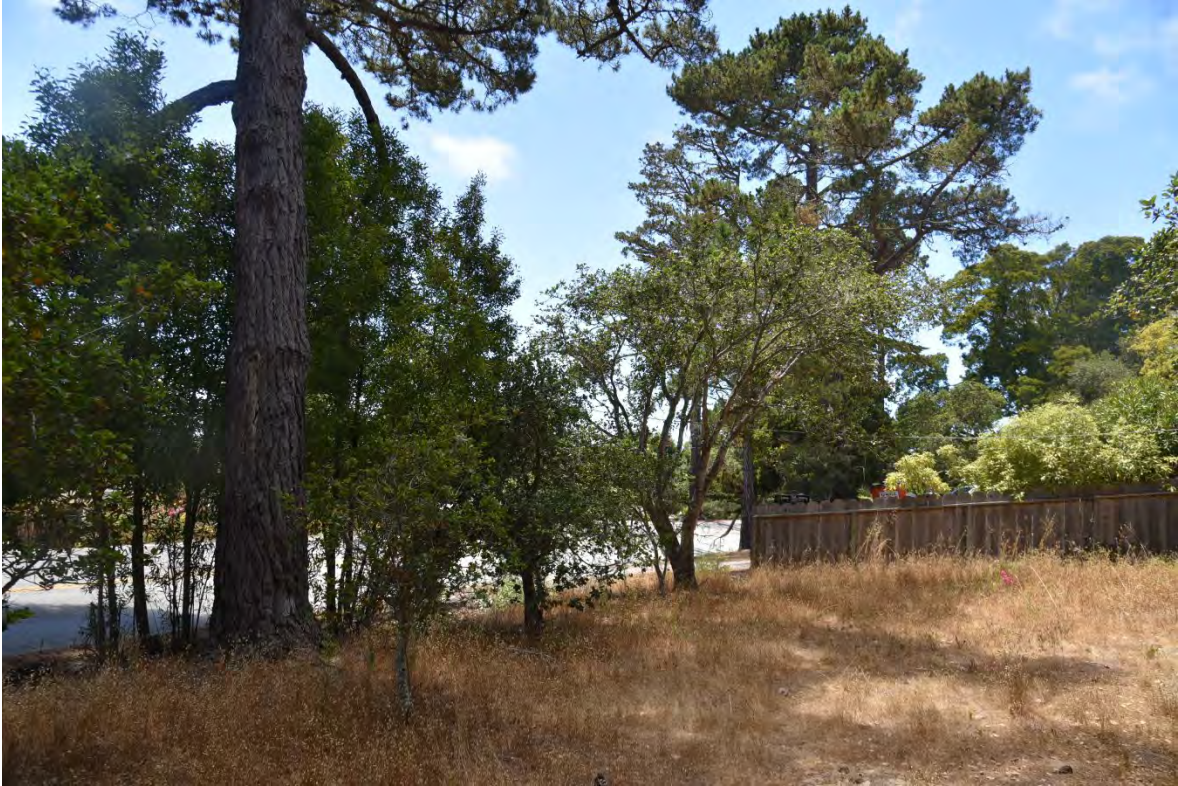
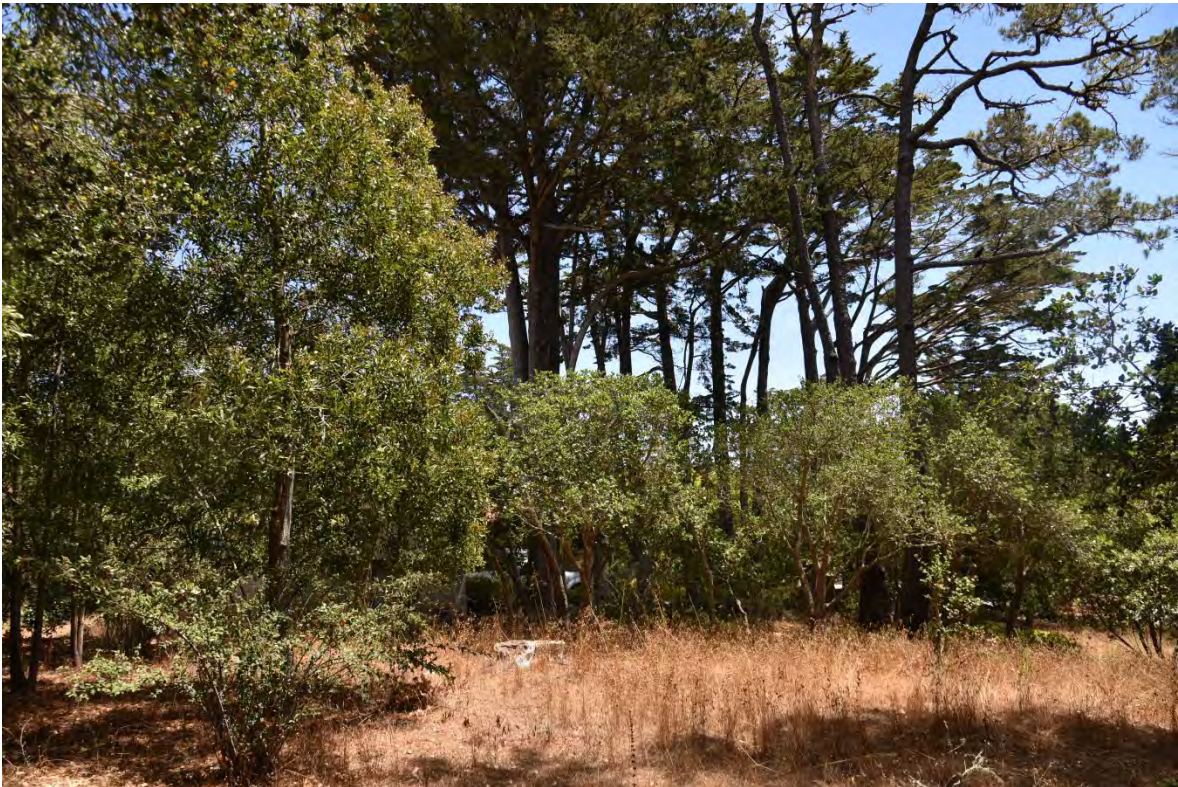
Entrance area where driveway will be located.

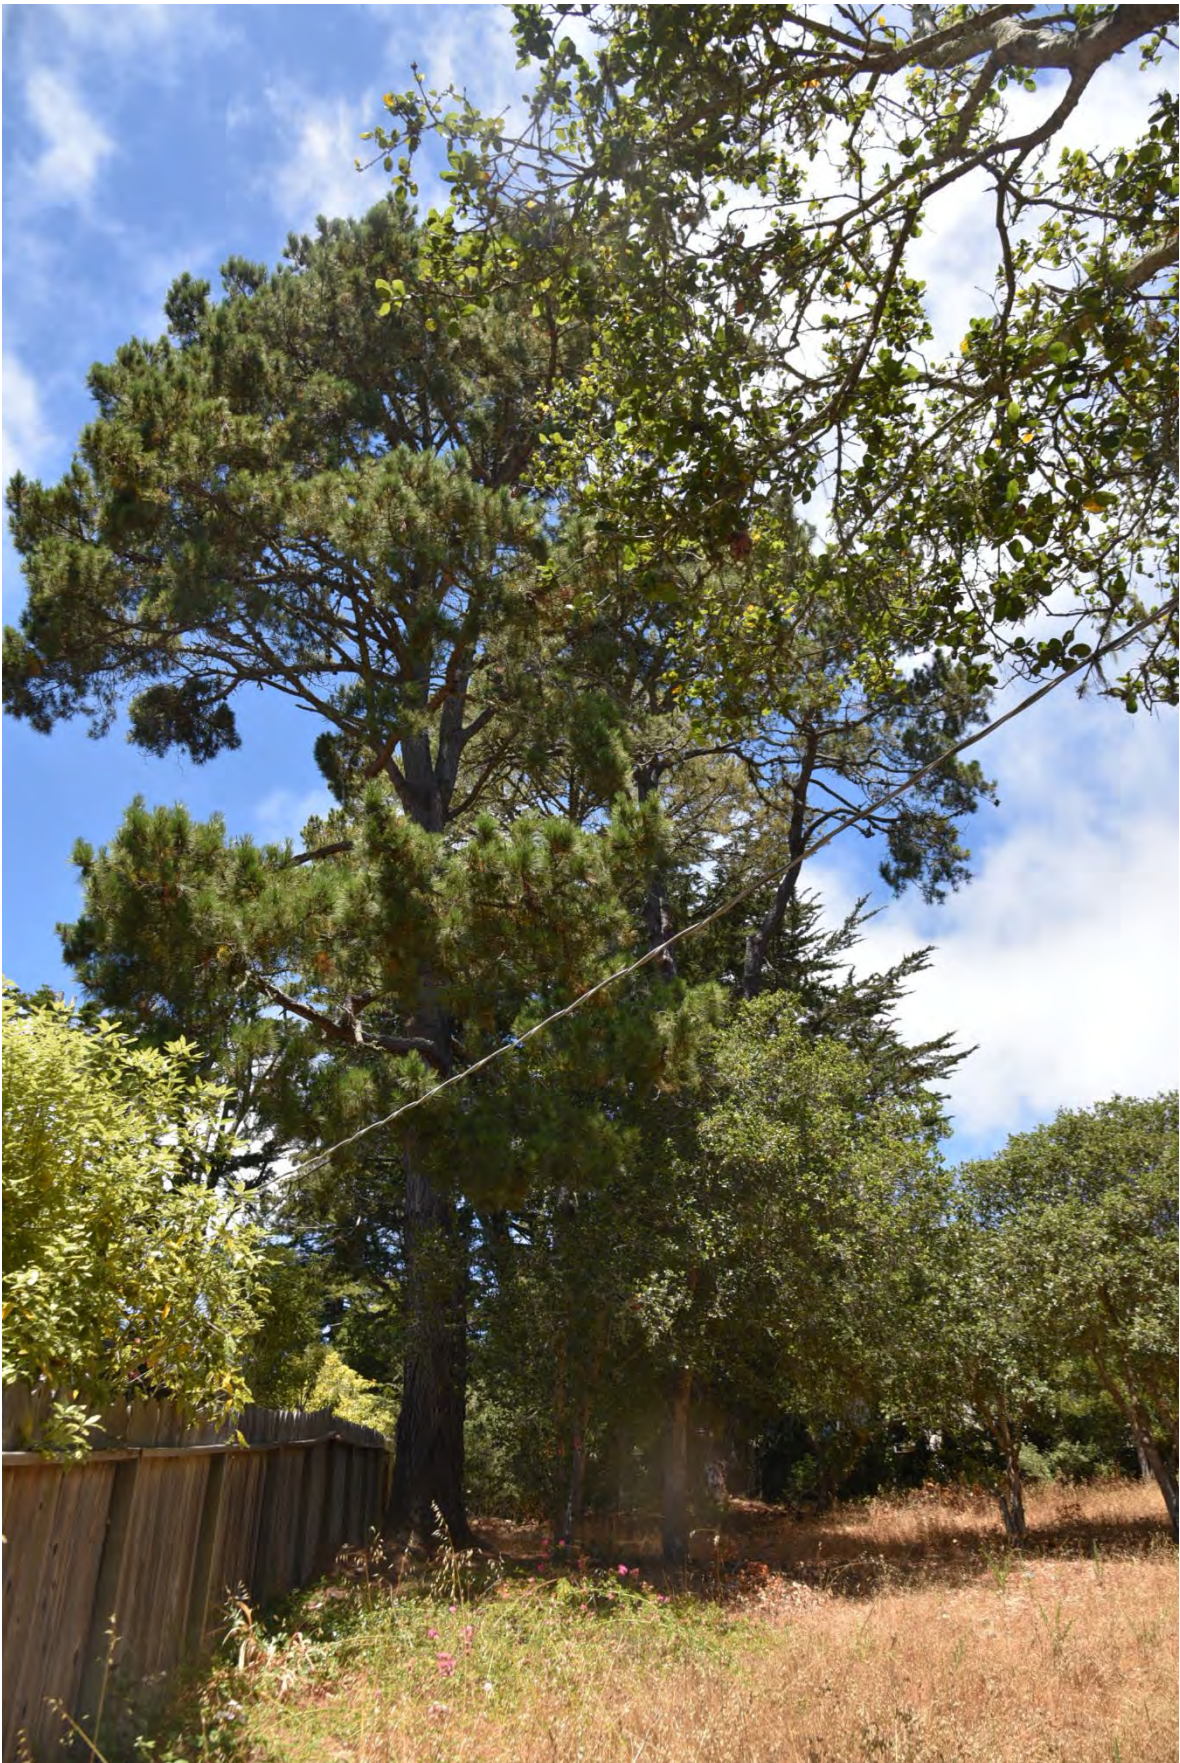
View looking to the east from the driveway area

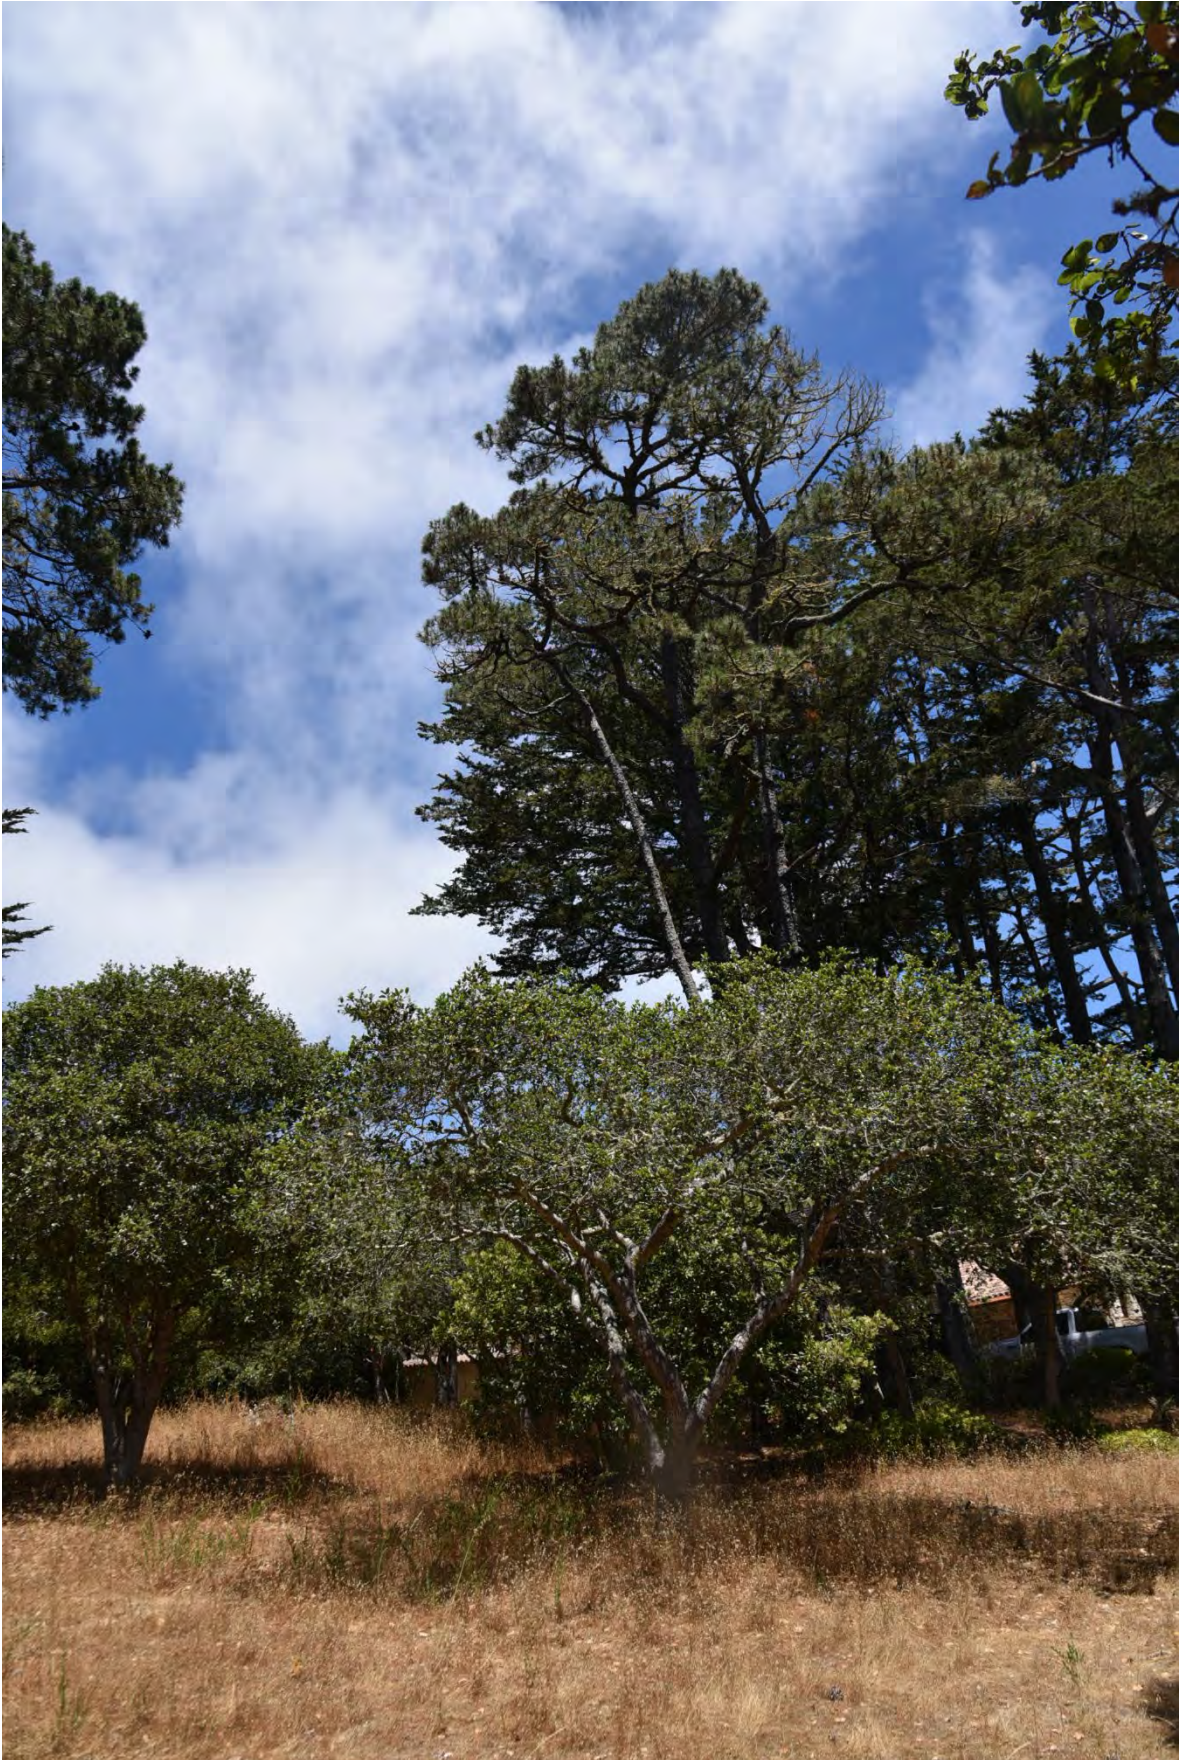
View looking to the north from the driveway area.
