Arborist Report

*Santa Lucia Preserve Lot #38
1 Rumsen Trace
Carmel, CA 93923
APN# 239-051-007*

*Inspection Date:
April 11, 2023
Revised: September 21, 2023*

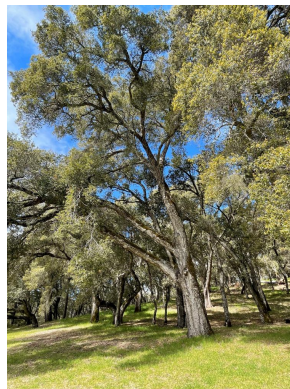
Tree #25

23	Coast live oak	28.7	70'/28'	f	fp	229.6	x	C	EWR, DWR, SP, RCE, leaning, dead limb
24	Coast live oak	9.6	25'/6'	f	fp	76.8	x	C	EWR, DWR, SP, RCE, heavy lean
25	Coast live oak	46.5	75'/40'	fg	f	372	x	B	EWR, DWR, SP, RCE
26	Coast live oak	28.0	60'/25'	fg	f	224	x	B	EWR, DWR, SP, RCE, slight lean in upper canopy
27	Coast live oak	72.0	60'/55'	f	fp	576	x	C	EWR, DWR, SP, RCE, CD at base, large tear in trunk from limb failure
28	Valley oak	28.0	55'/50'	f	f	224	x	B	EWR, DWR, SP, RCE
29	Coast live oak	32.0	45'/30'	f	f	256	x	C	EWR, DWR, SP, RCE, over shadowed by Valley oaks
30	Valley oak	48.0	70'/65'	f	fp	384	x	C	EWR, DWR, SP, RCE, CD @ 7', rotten limbs, heavy pruning needed, cable
31	Valley oak	48.0	75'/70'	f	fp	384	x	C	EWR, DWR, SP, RCE, CD @ 12', heavy pruning needed, cable
32	Valley oak	48.0	55'/45'	fg	fp	384	x	C	EWR, DWR, SP, RCE, CD @ 10', heavy pruning needed, cable
33	Coast live oak	22.0	30'/30'	fg	fp	176	x	B	EWR, DWR, SP, RCE, CD @ base
