Tree Resource Assessment
3257 17 Mile Drive
Pebble Beach CA

Frank Ono
Urban Forester
Member Society of American Foresters #48004
ISA Certified Arborist #536
1213 Miles Avenue
Pacific Grove, CA 93950

July 17, 2017

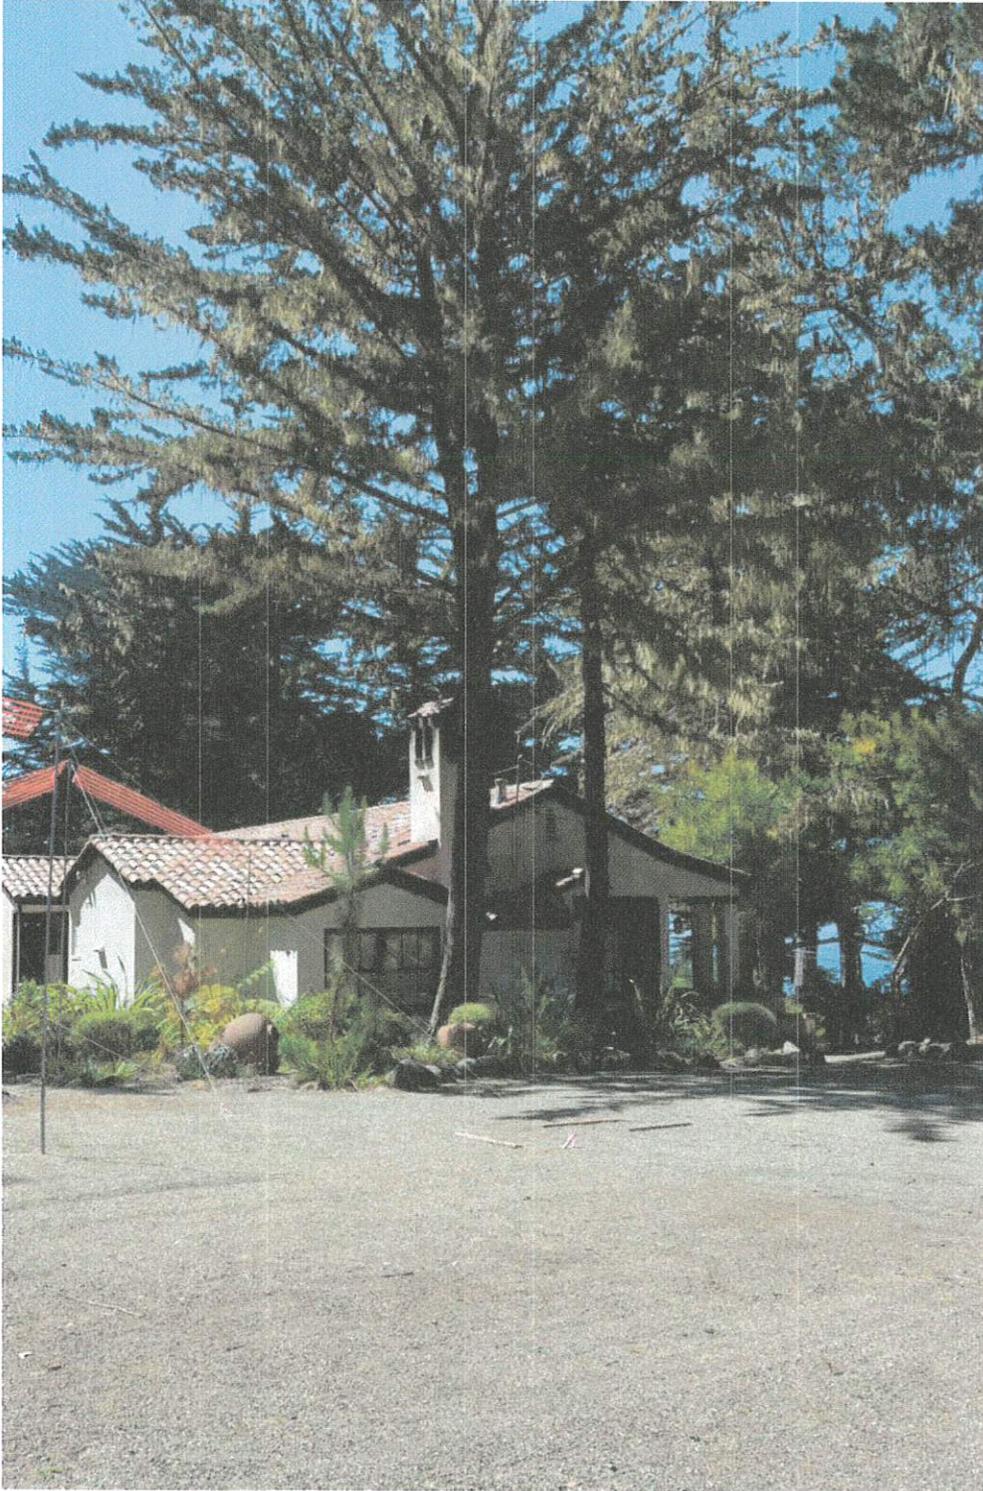
View of existing house and previous disturbance (shown in front of house are trees #224 and #223)

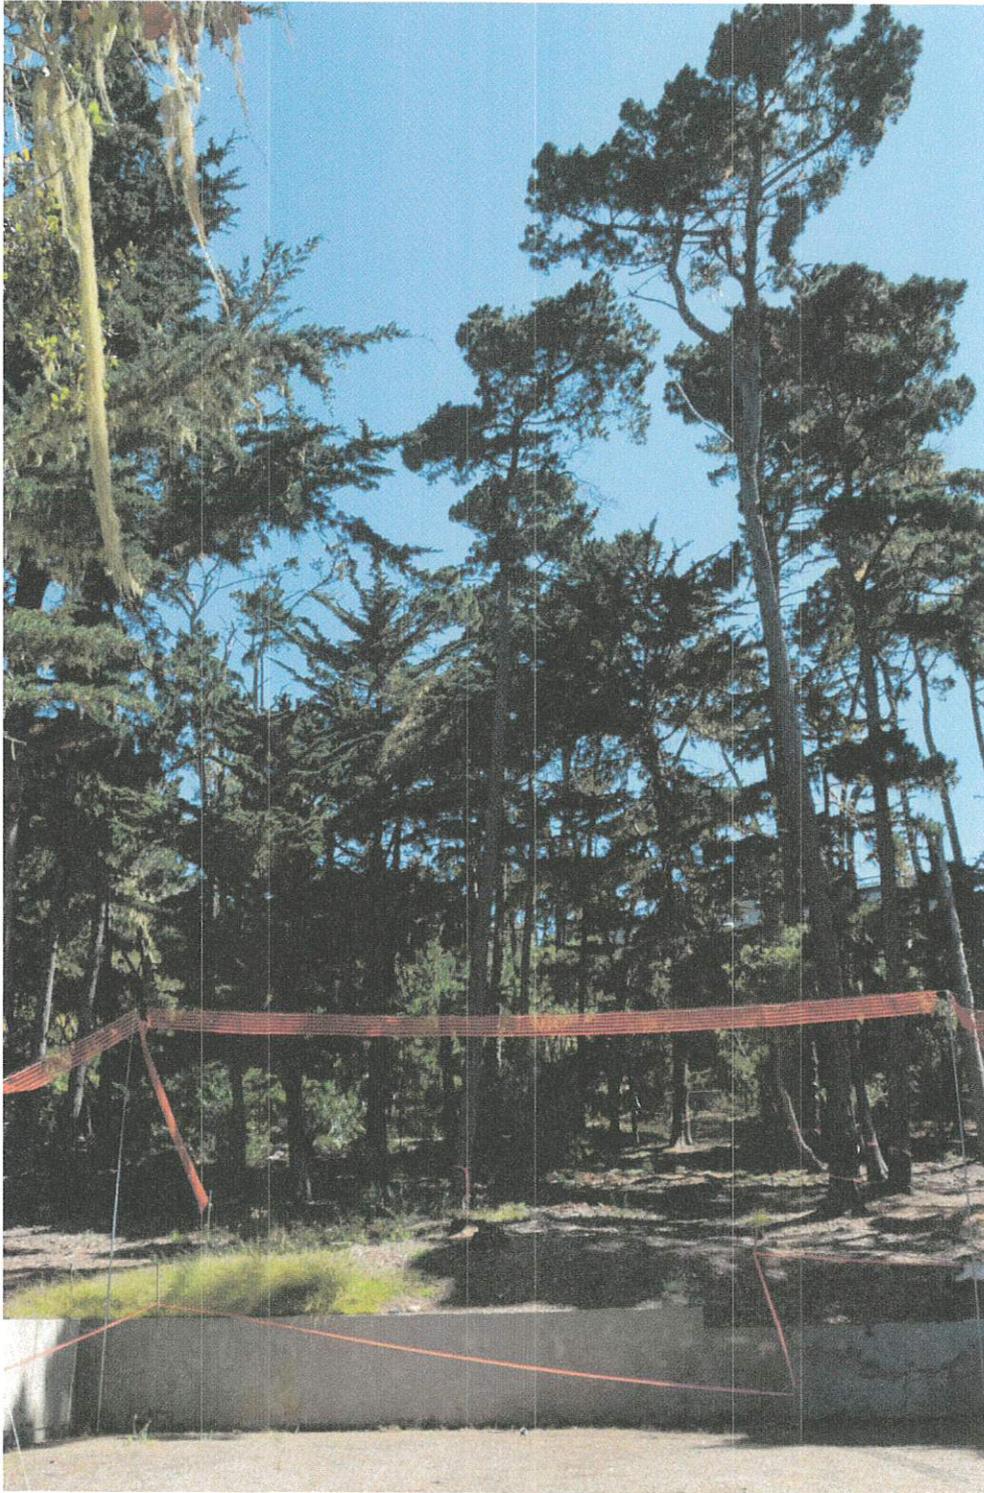
Red line shows new footprint of house. The building footprint is site to take advantage of previous disturbance and not significantly impact existing trees.

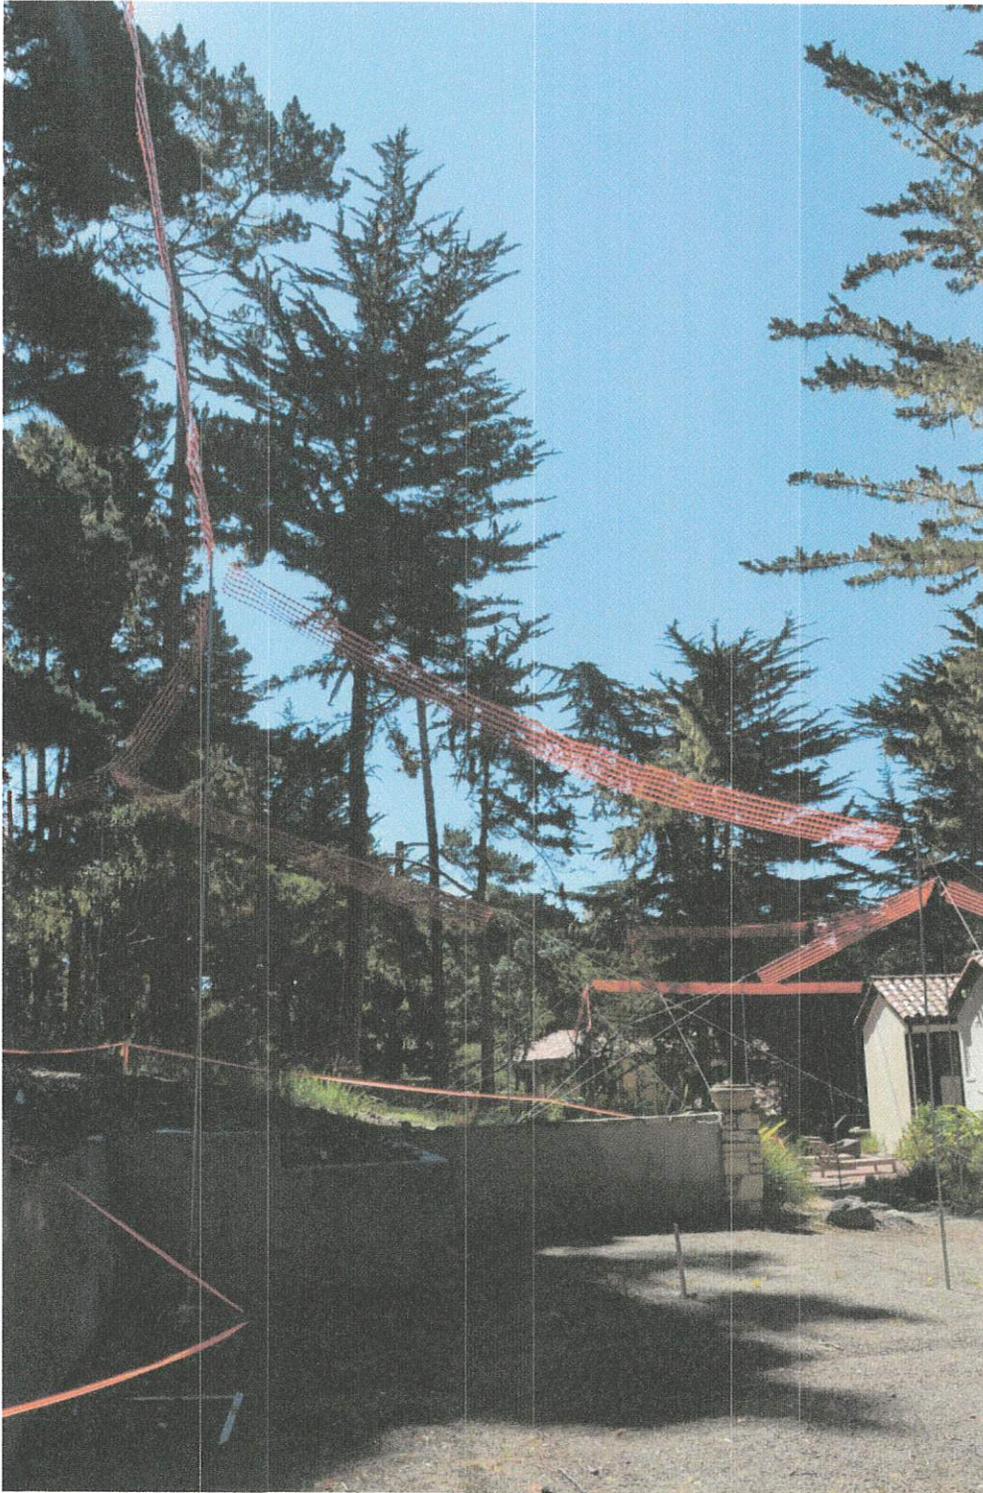
View looking to the south where new footprint conforms to previous disturbances.

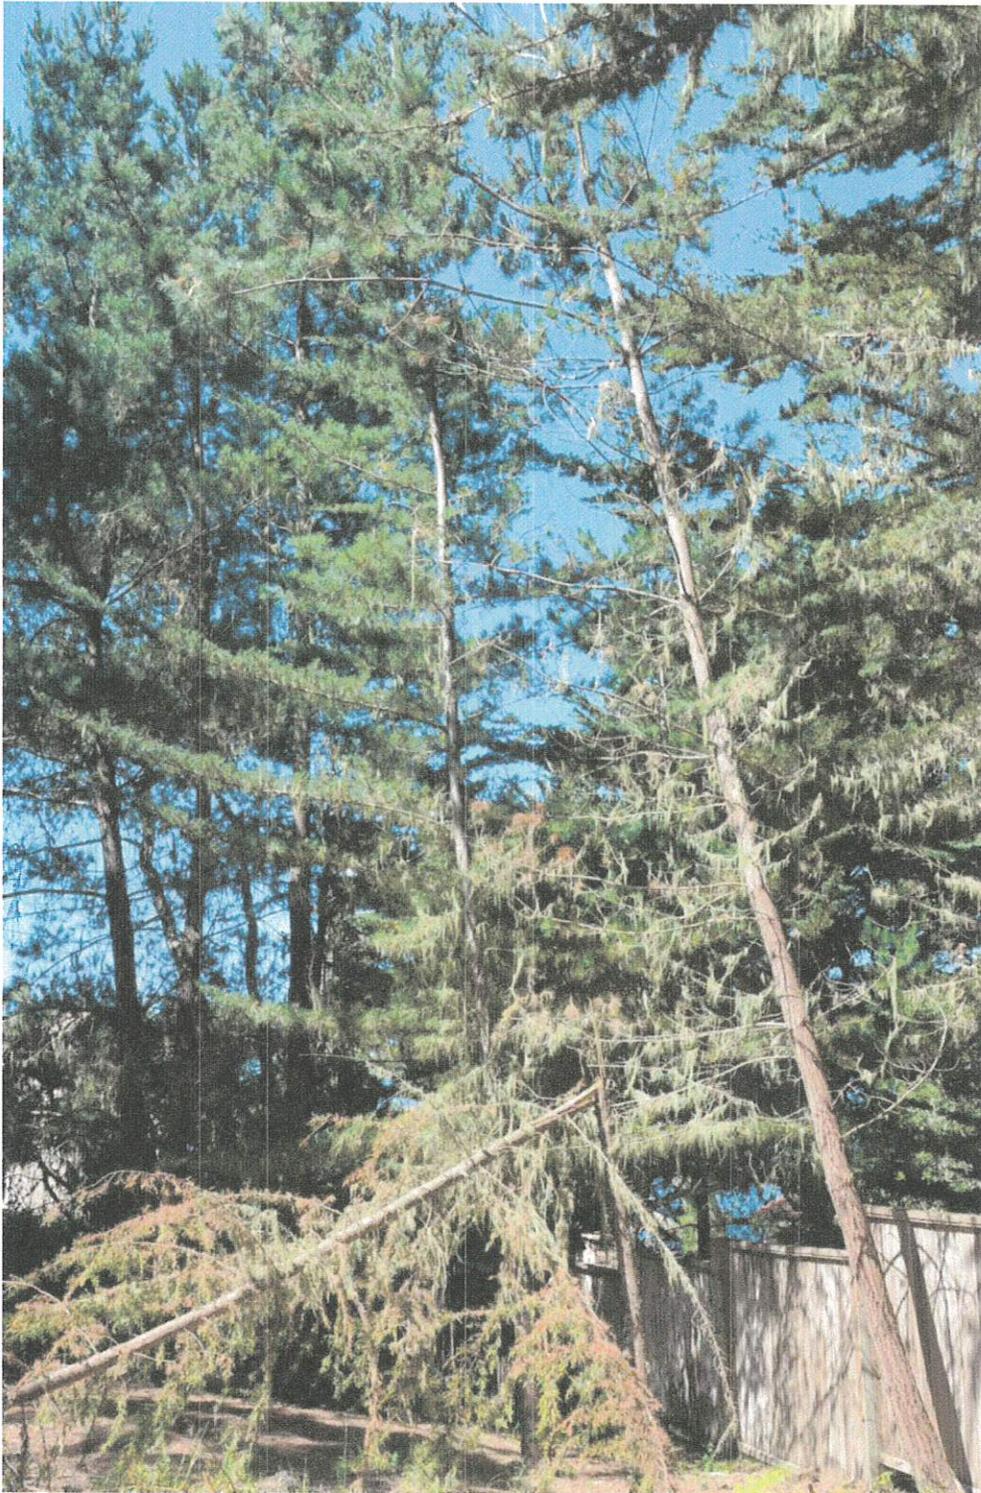
- Monterey cypresses are interspersed with the existing pines all appearing to be in fair or better condition with a number of trees near the existing house removed because they failed during recent storm activity. Whole tree failure and limb breakage is evident in several of the mature trees. There are a number of large limbs which have broken off which have been removed. One small cypress has been found where significant limbs have snapped the tree (see photographs).

Small cypress was found snapped by previous wind storms

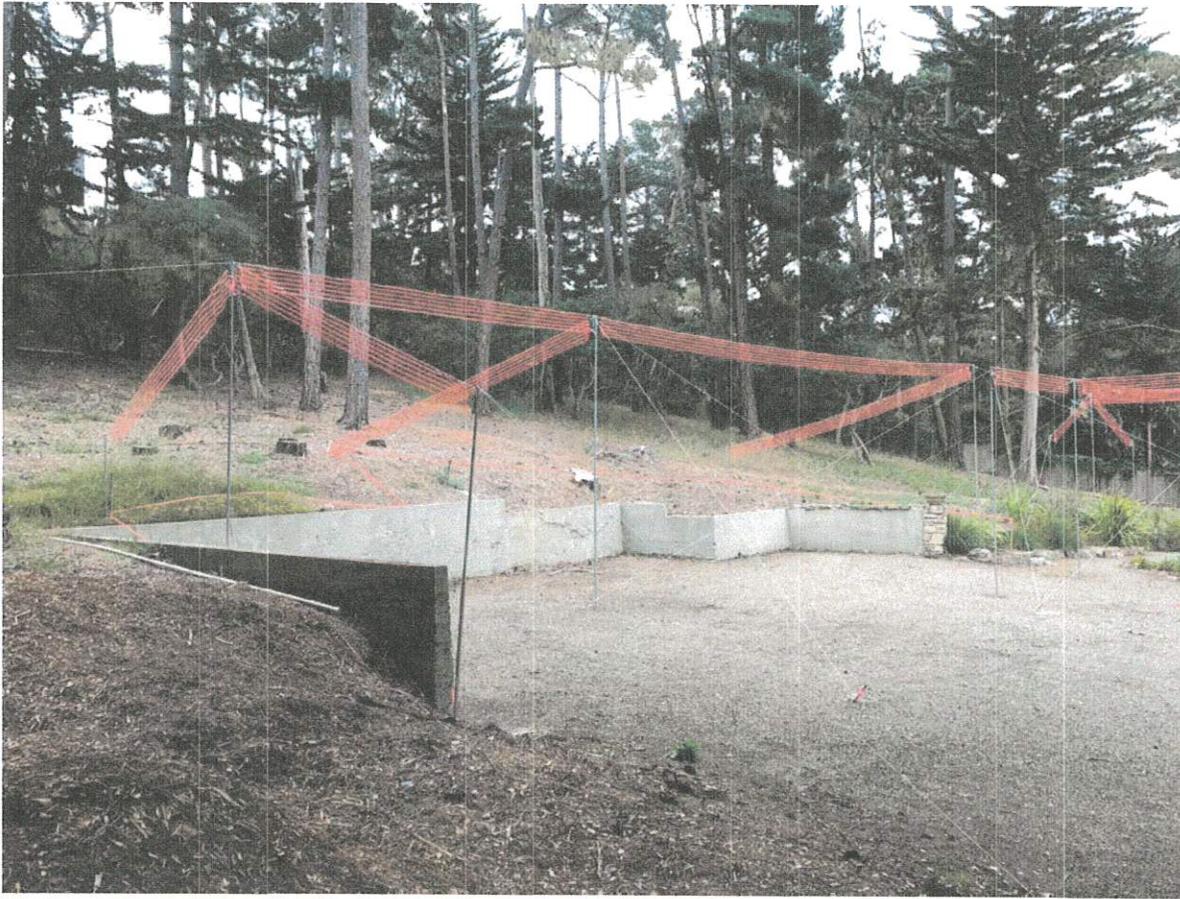
Staking shows footprint of new addition is outside and away from cypresses
