December 19, 2023

Covin Residence
3307 #4 17 Mile Drive
Pebble Beach, CA. 93953
APN: 008-521-004-000

Subject: 3307 #4 17 Mile Drive tree removal report

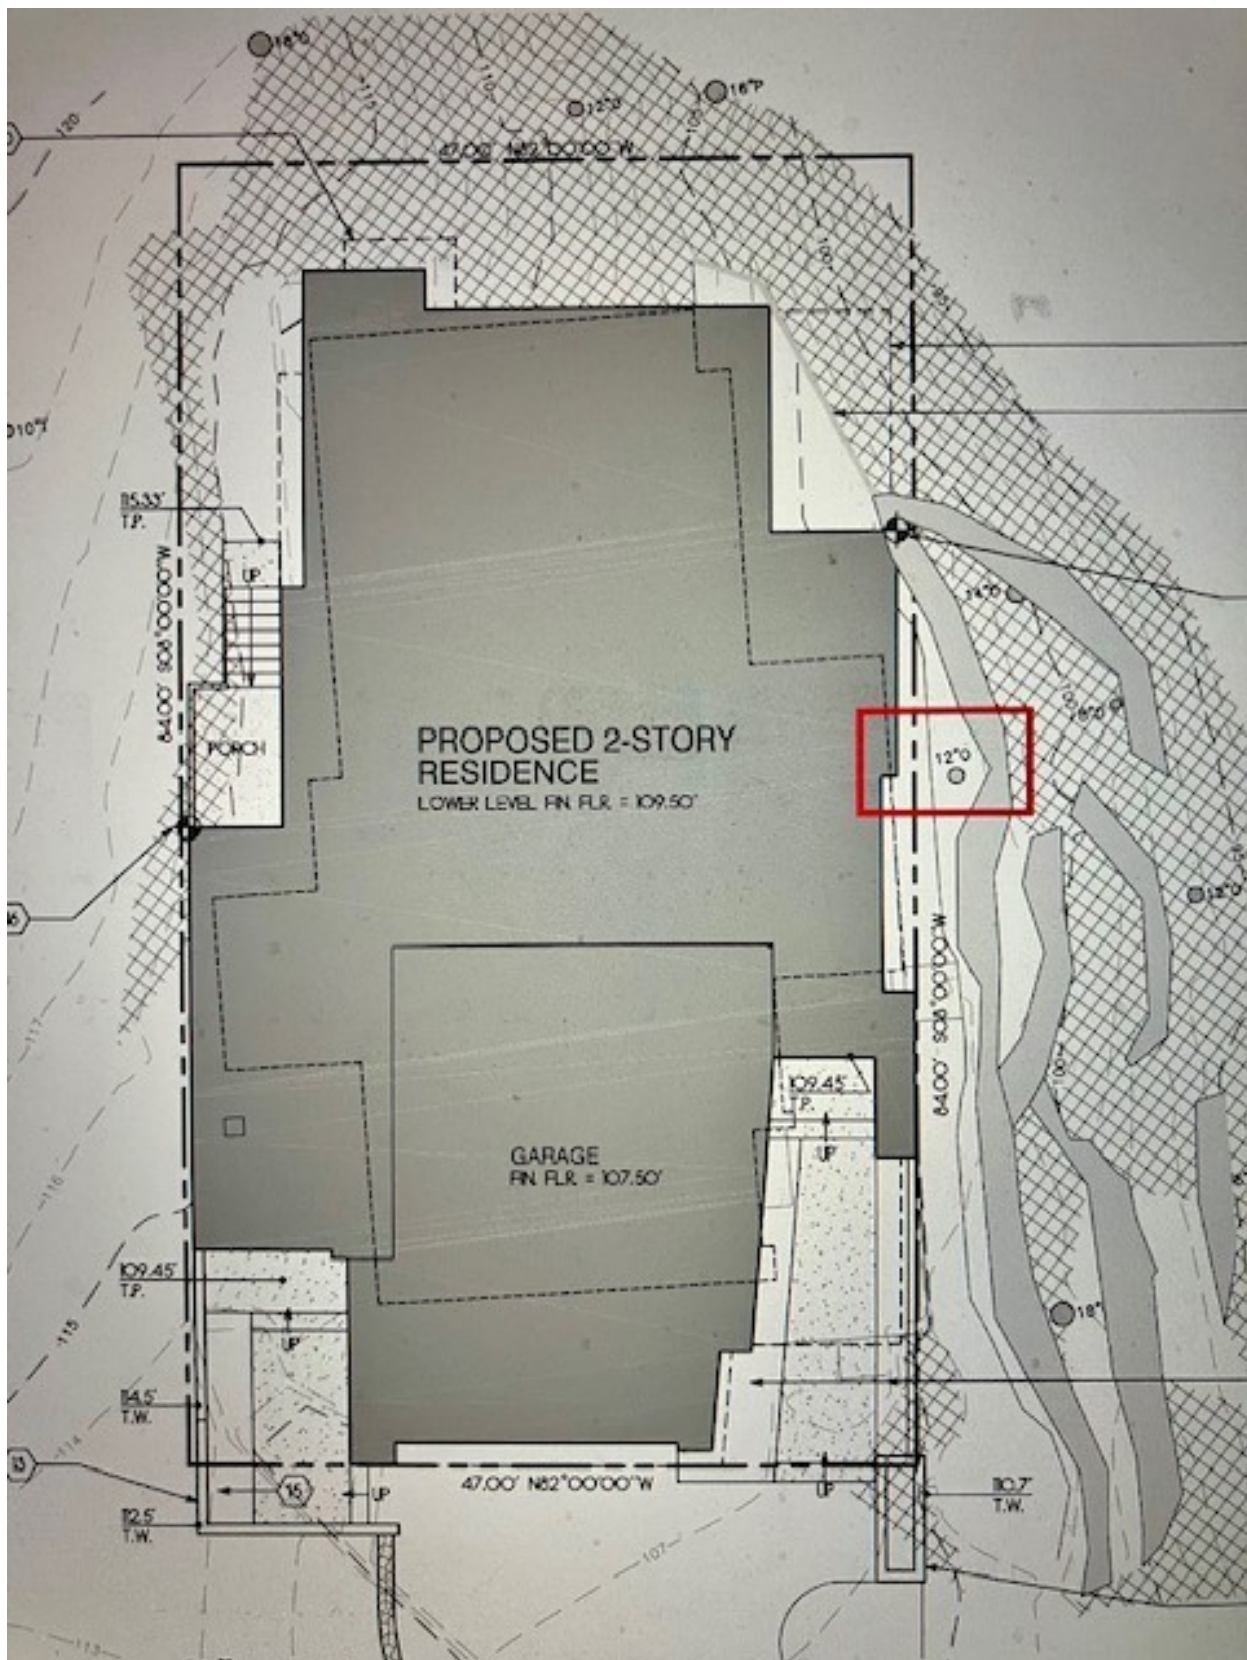
Exhibit A: Red square identifies the location of the subject oak tree that is recommended for removal.

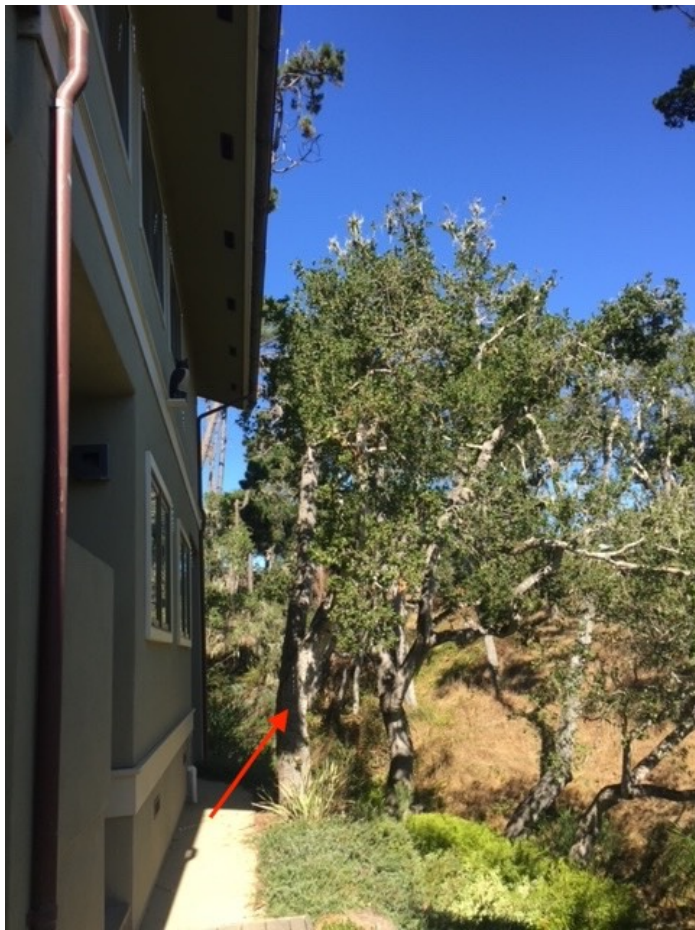
Per the assessment, it has been determined that a 12 inch DBH (diameter at breast height) Coast Live Oak is recommended for removal prior to construction activities commencing due to it being too close to the proposed structure and construction footprint. This oak is located approximately 3 feet from the existing home and has a height of approximately 20 feet and an asymmetrical canopy spread of roughly 15 feet.

Figure 1. Subject oak recommended for removal is identified with red arrow.

Other than removal, there are no good alternatives or reasonable mitigation actions that will effectively address concerns and potential problems associated with this oak being too close to the existing building and proposed construction activities, so unfortunately tree removal is recommended and appears to be the most appropriate course of action. Consequently, the property owner and project design team is requesting approval to remove the subject oak tree in preparation for planned home construction activities.

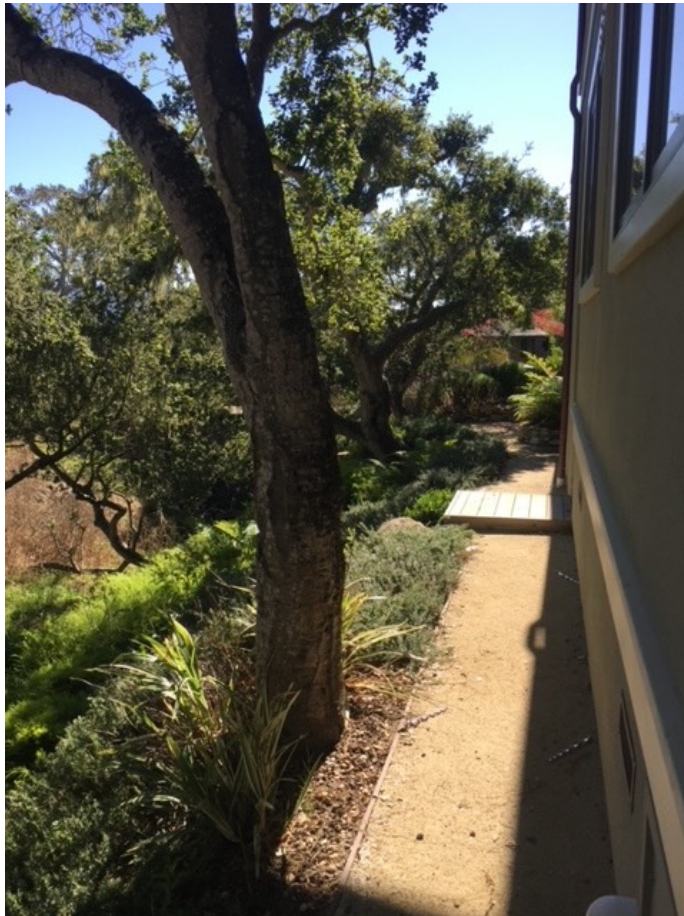
Figure 2. Another view of subject oak that is located too close to existing structure and proposed construction footprint.

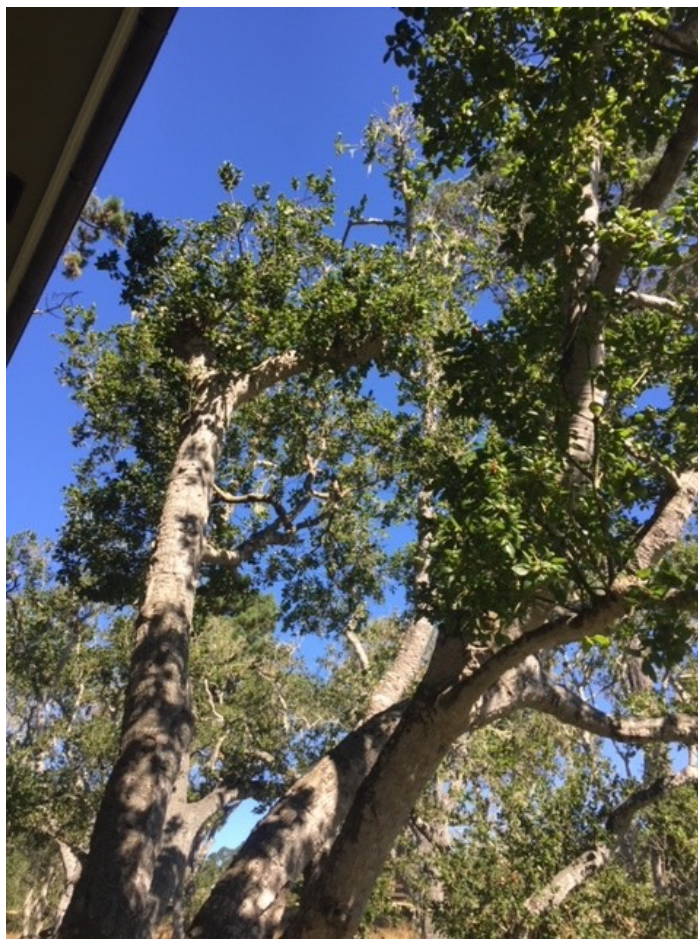
The subject oak currently appears to be in fair physiological health, but has signs and symptoms of a declining tree. These include a thinning canopy and water sprouts (i.e., suckers that are also known as epicormic shoots) occurring along the upper stems, which is a stress indicator that is commonly seen in declining trees that are in poor and declining health and condition. The close proximity of the tree to the existing home is likely a contributing factor to its declining condition, which will be further compounded by new construction and grading activities associated with the home remodel project. Additionally, the subject oak has poor form and structure (i.e., poor candy balance and

Figure 3. Oak has poor form and structure due to its close proximity to the existing home and has a thinning canopy that indicates declining health.

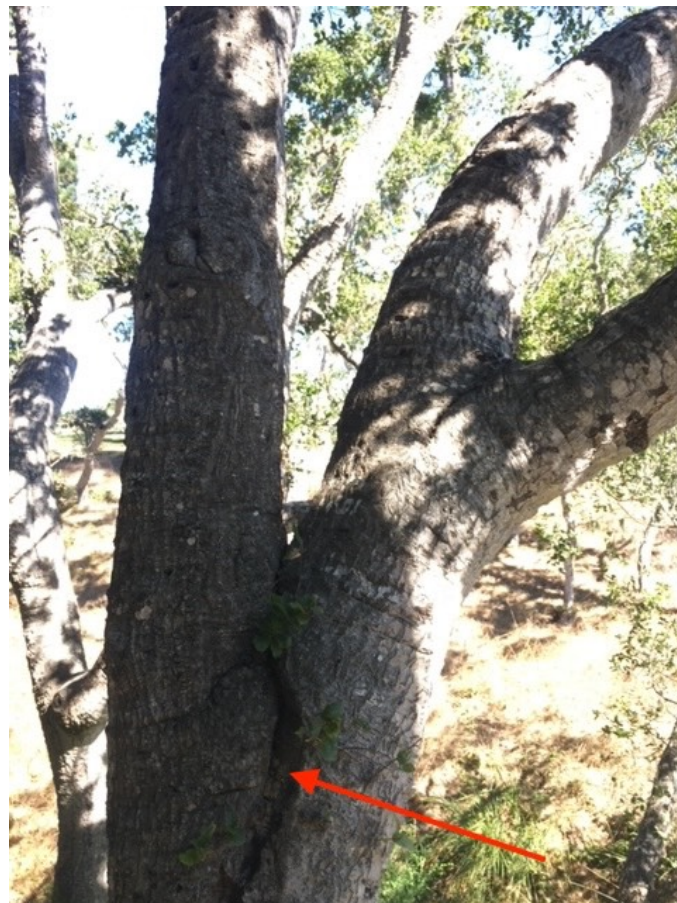
symmetry), which is primarily due to its close proximity to the side of the existing structure. This oak also has structurally deficient co-dominant stems in the lower and mid-stem section, one of which appears to have included bark in the co-dominant stem attachment, which can compromise structural integrity.

Figure 4. Co-dominant attachment in lower stem appears to have structurally compromising included bark (red arrow).
