Fungal Assessment Report

1441 Schilling Place
Salinas, California

Prepared By:
S Tech Consulting, LLC

Date: May 18, 2015

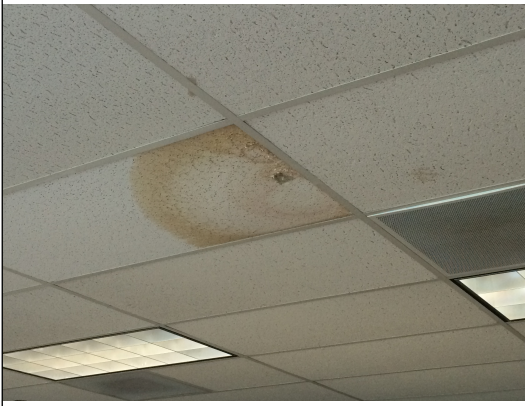
Visual Inspection			
South Building, Floor 1 (SB1)			
Area	Location	Identified Moisture Intrusion	Moisture Intrusion Condition Photo
SB1	Lobby, Cubicle & Office Area	Minor areas of ceiling tile staining, all were within acceptable 'dry' ranges as measure on the BD-2100. Leaks appear to originate from chiller line condensation above suspended ceiling, though past roof leaks may have contributed

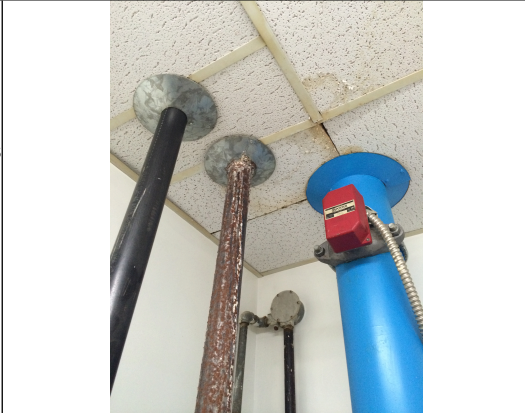
SB1	Kitchen Restroom	Signs of past moisture intrusion on water line pipes and ceiling tiles. No indication of current moisture intrusion. Building materials in the area of the staining were within acceptable 'dry' ranges as measure on the BD-2100

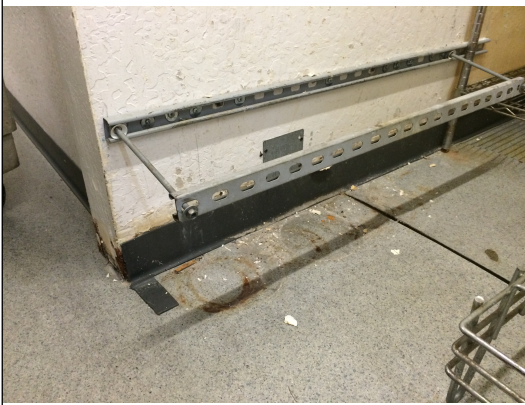
- * South Building, First Floor (SB1) - In a kitchen storage closet, a combination of repeated moisture intrusion from a faucet connection and lack of maintenance has damaged the drywall and resulted in heavy amplification of *Chaetomium* mold spores. The drywall no longer has elevated moisture content but is susceptible to future moisture intrusion based on the room's usage. Remediation should occur prior to general occupancy. Additionally, waterproofing material is recommended for the walls and floors.

SB1	Kitchen Storage Closet	Black staining at base of wall in closet, deteriorated drywall surfaces. Room has water spigot and appears to have been used for storage and not well maintained. The suspect mold growth likely occurred when the building was still in-use. Building materials within acceptable 'dry' ranges as measure on the BD-2100

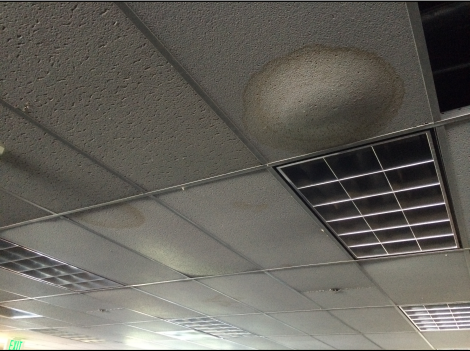
Visual Inspection			
South Building, Floor 2			
Area	Location	Identified Moisture Intrusion	Moisture Intrusion Condition Photo
SB2	Offices 2048D/ 2048C	Minor to significant ceiling tile staining mainly concentrated in the cubicle areas to the east and south of the former executive offices. All tiles were within acceptable 'dry' ranges as measured on the BD-2100. Leaks appear to be related to roof system failures, which facilities currently patches as soon as observed.

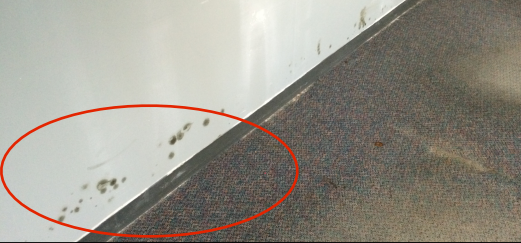
- * North Building, First Floor (NB1) - Along the open cubicle area side of the NW stairwell, circular staining is visible along the lower drywall. Microbiological examination determined the presence of heavy active fertile colonies of *Penicillium* sp.. There are no obvious signs of moisture intrusion or drywall damage. Digital moisture metering indicates dry conditions. The fungal growth may have been a result of hygiene and janitorial deficiencies in this area. Remediation should occur prior to general occupancy.

Visual Inspection			
North Building, Floor 1			
Area	Location	Identified Moisture Intrusion	Moisture Intrusion Condition Photo
NB1	N/W Cubicle Area. Cubicle side of stairwell wall.	Circular staining typical of mold colony formation. No indication of moisture when measured with the BD-2100 moisture meter.

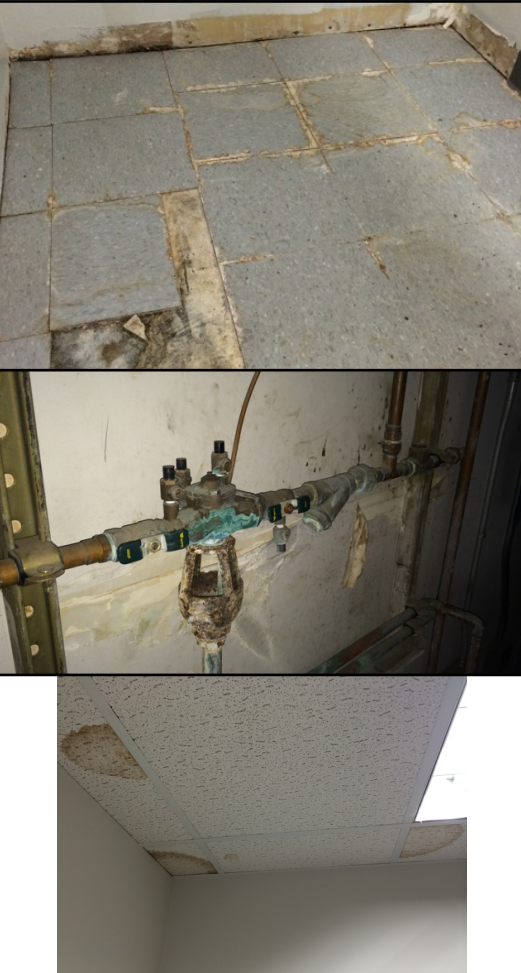
- * North Building, First Floor (NB1) - A fairly recent moisture intrusion episode occurred in boiler room 101 in the mechanical loft. A relief valve malfunctioned, resulting in the release of water for an unknown period of time. This flooding impacted the walls of boiler 101 and the offices/rooms directly below, including the mechanical loft access room and offices/storage rooms 1622-1625. Moisture remains detectable at the base of the mechanical loft access room. The only elevated airborne spore counts identified in the entire facility were from this area. Bulk microbiological analysis of the damaged drywall determined amplification of *Stachybotrys* spores in both the lower level and boiler room 101. Remediation should occur prior to general occupancy.

NB1	1622-1625 Areas Mechanical Loft Ladder Closet, Boiler Room and Associated Offices	Drywall damage to boiler room 101 and mechanical loft access closet Damage to cove base and floor tiles in mechanical loft access closet Ceiling tile staining to 1622A, 1622B, 1625A Foul odor in 1625A BD-2100 moisture meter indicates moderate remaining moisture in some locations.

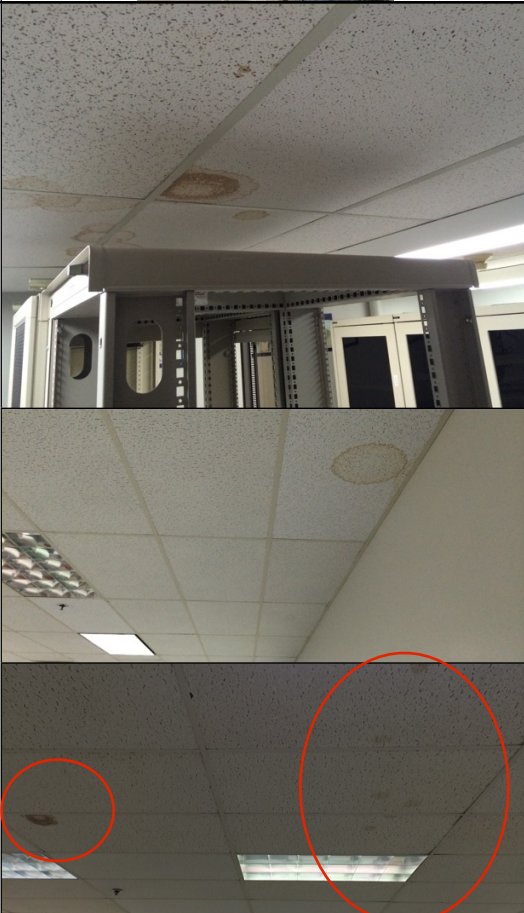
NB1	Various Locations	Ceiling tile staining from possible roof leaks and VAV chiller condensation. No indication of remaining moisture content in ceiling tiles based on individual readings collected on BD-2100. See plan for specific locations but most notable in north east addition, server room alcove, open office area south of vault rooms, and former employee lounge

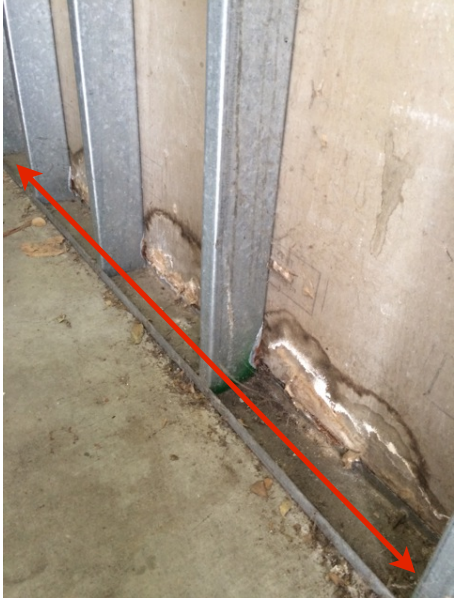
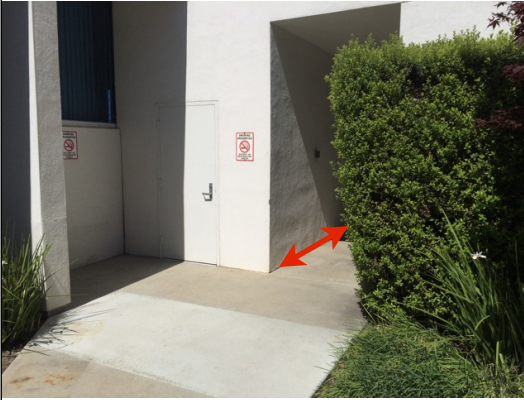
- * North Building, First Floor (NB1) - In the patio/courtyard area, moisture intrusion is actively migrating from the stucco siding into the small storage closet, along the breezeway to the east patio. The moisture is damaging the wallboard, behind the stucco, and resulting in heavy amplification of *Claudosporium* spores. A waterproofing consultant or licensed contractor should be consulted to determine the corrective measures necessary to stop the moisture intrusion. While this is not an occupied area, remediation should occur prior to storing items in this room.

Visual Inspection			
North Building, Floor 1			
Area	Location	Identified Moisture Intrusion	Moisture Intrusion Condition Photo
NB1	Patio Storage Room	<p>Major staining along interior wallboard. Appears that moisture impacting the stucco is saturating through to interior wall.</p> <p>Moisture content of wallboard is saturated at the wall base, as measured by the BD-2100</p>

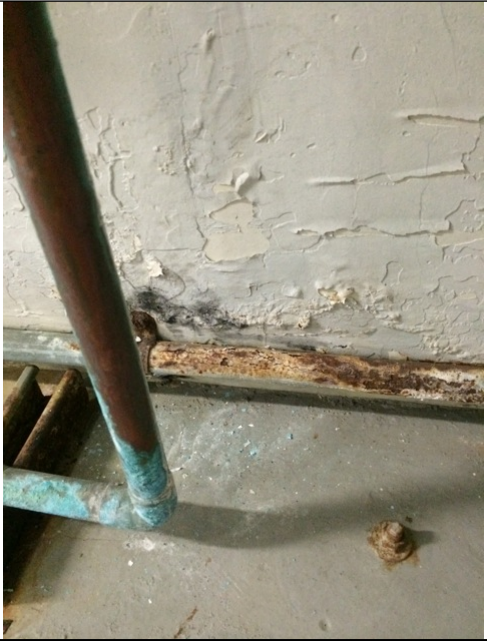
- * North Building, Second Floor (NB2) - In boiler room 102, a past moisture intrusion event occurred near a plumbing connection, damaging the drywall and resulting in the heavy accumulation of *Stachybotrys* spores. While the area impacted is minor, remediation should occur due to the type of mold spores identified.

Visual Inspection			
North Building, Floor 2			
Area	Location	Identified Moisture Intrusion	Photo of Typical Moisture Intrusion Condition
NB2	Facilities Floor, Boiler Room 102	Evidence of past moisture intrusion around plumbing valve. Stained/damaged drywall. Material measure 'dry' on BD-2100

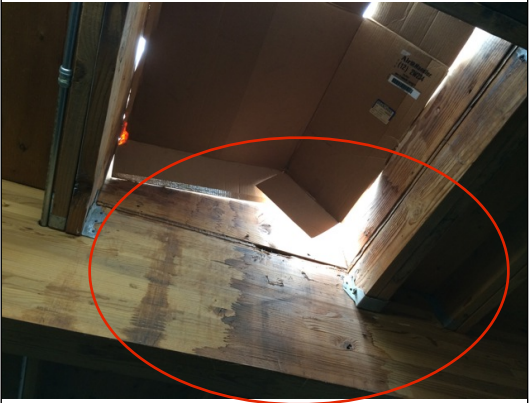
NB2	Facilities Office 'Jose's Office'	Evidence of moisture intrusion around skylight, which is now covered by cardboard. Wood measured 'dry' based on BD-2100 moisture content reading.
