April 3, 2025

RE: 25475 Hatton Proposed ADU and Redwoods

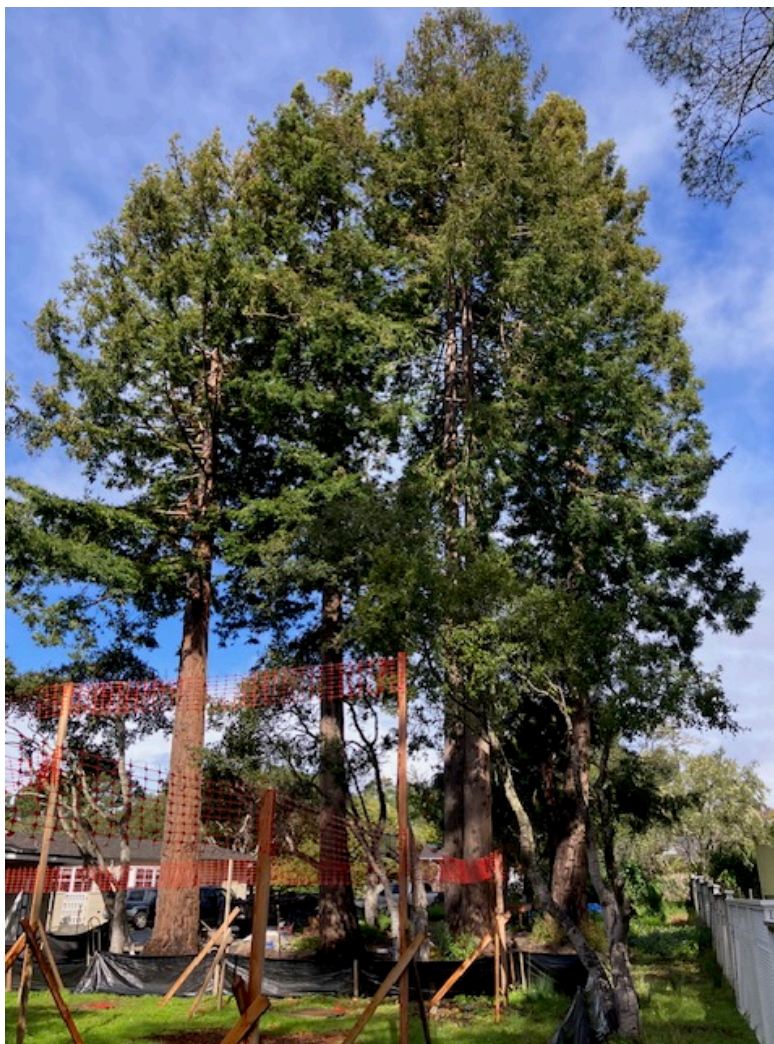
Figure 1. The proposed ADU and subject redwood trees are visible in this photo.

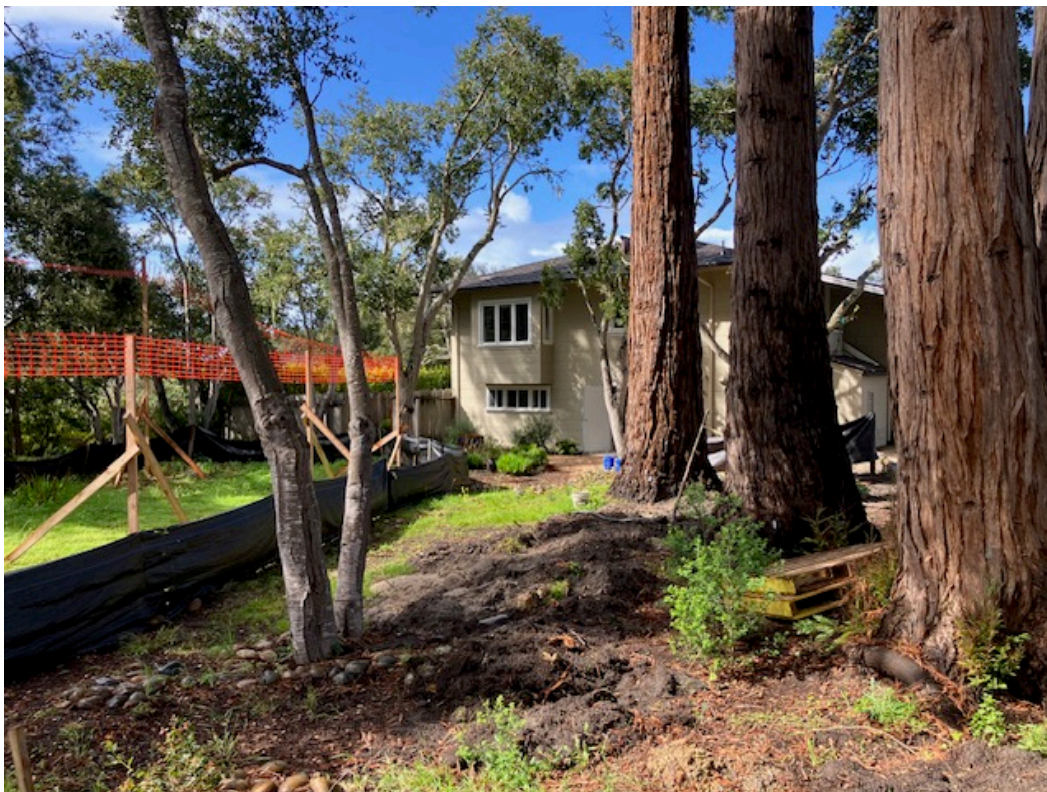
Figure 2. The ADU located a safe distance to the left of the redwoods will have a floated foundation to avoid and minimize root system impacts.

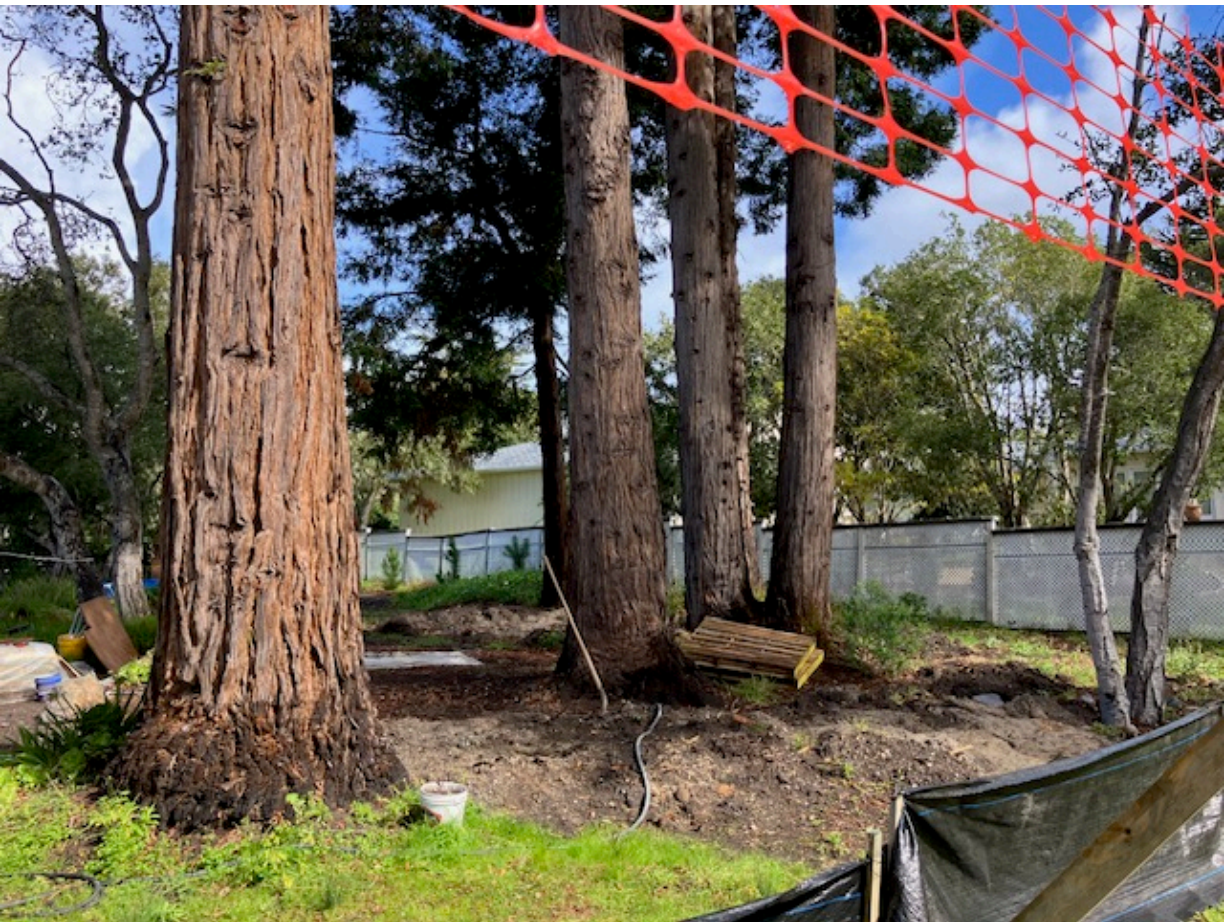
Figure 3. Another view of mature redwoods that will not be significantly impacted by ADU construction activities.

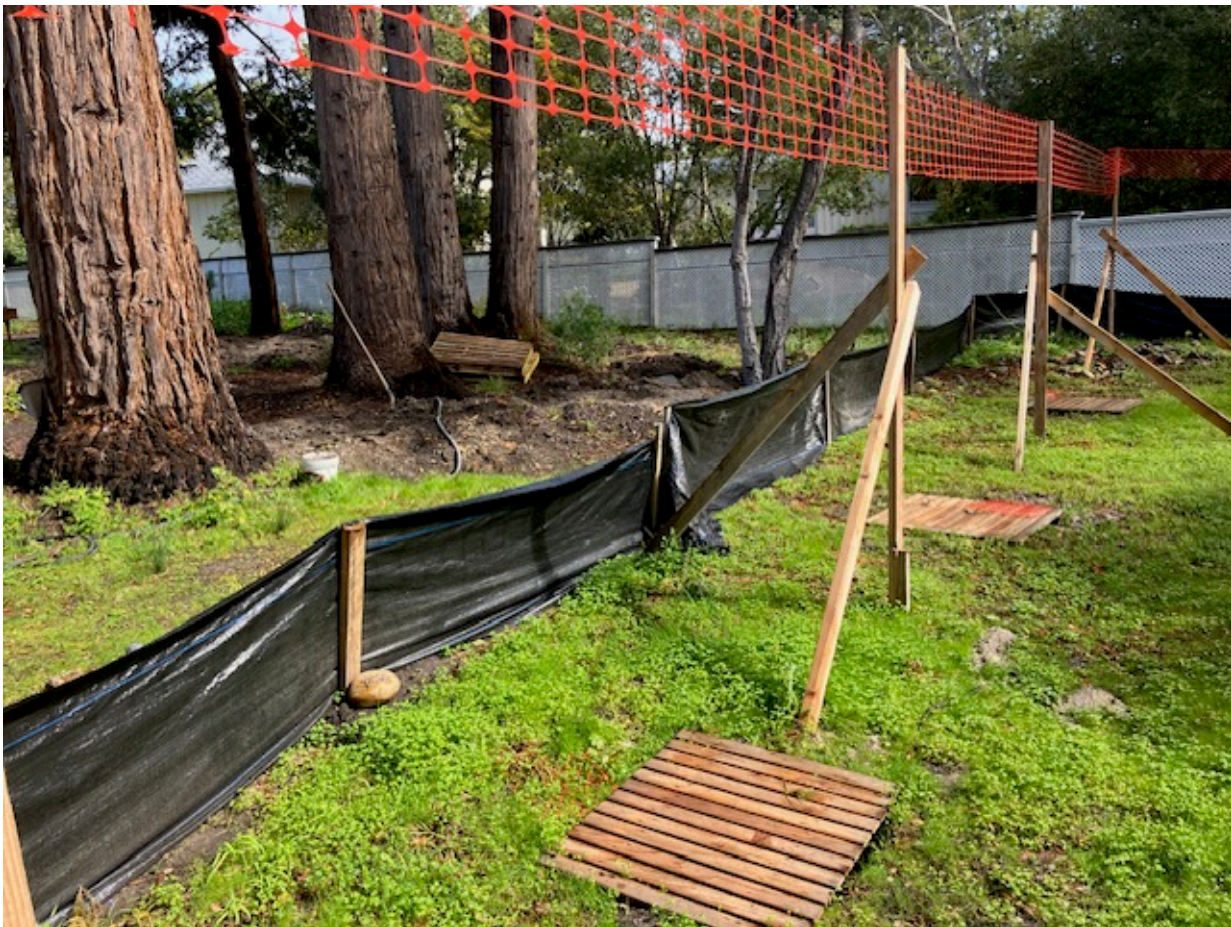
Figure 4. Three wood covers seen from lower center to upper right corner of photo identify the location of footings for the floated foundation.

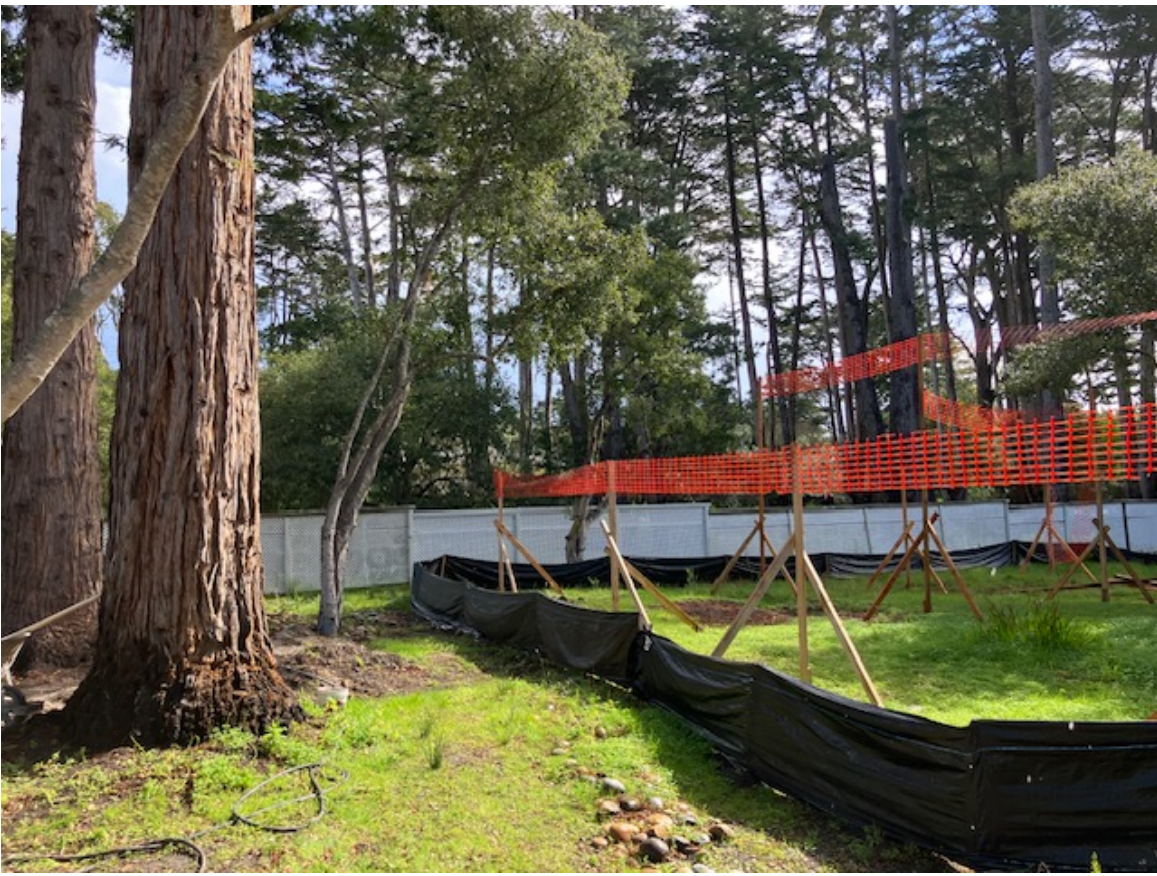
Figure 5. Another photo showing the location of the redwoods in relation to the proposed ADU. Significant tree impacts is not expected to occur due to the design (i.e., 3 small footings) of the floated foundation.

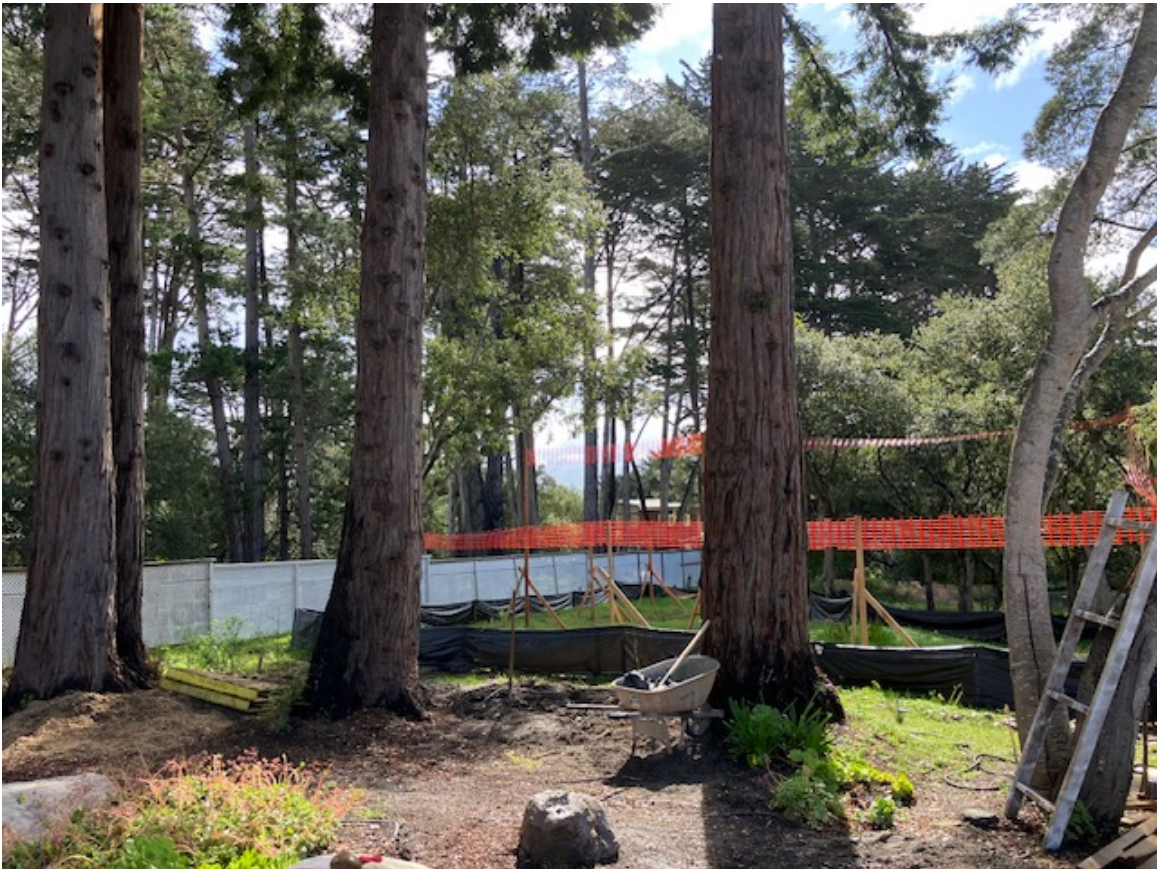
Figure 6. Per the design plans and given the proper installation, maintenance and monitoring of tree protection fencing, the health of the subject redwoods will not be adversely affected by the ADU due to a floated foundation and the trees are not expected to be a hazard concern to nearby structures.

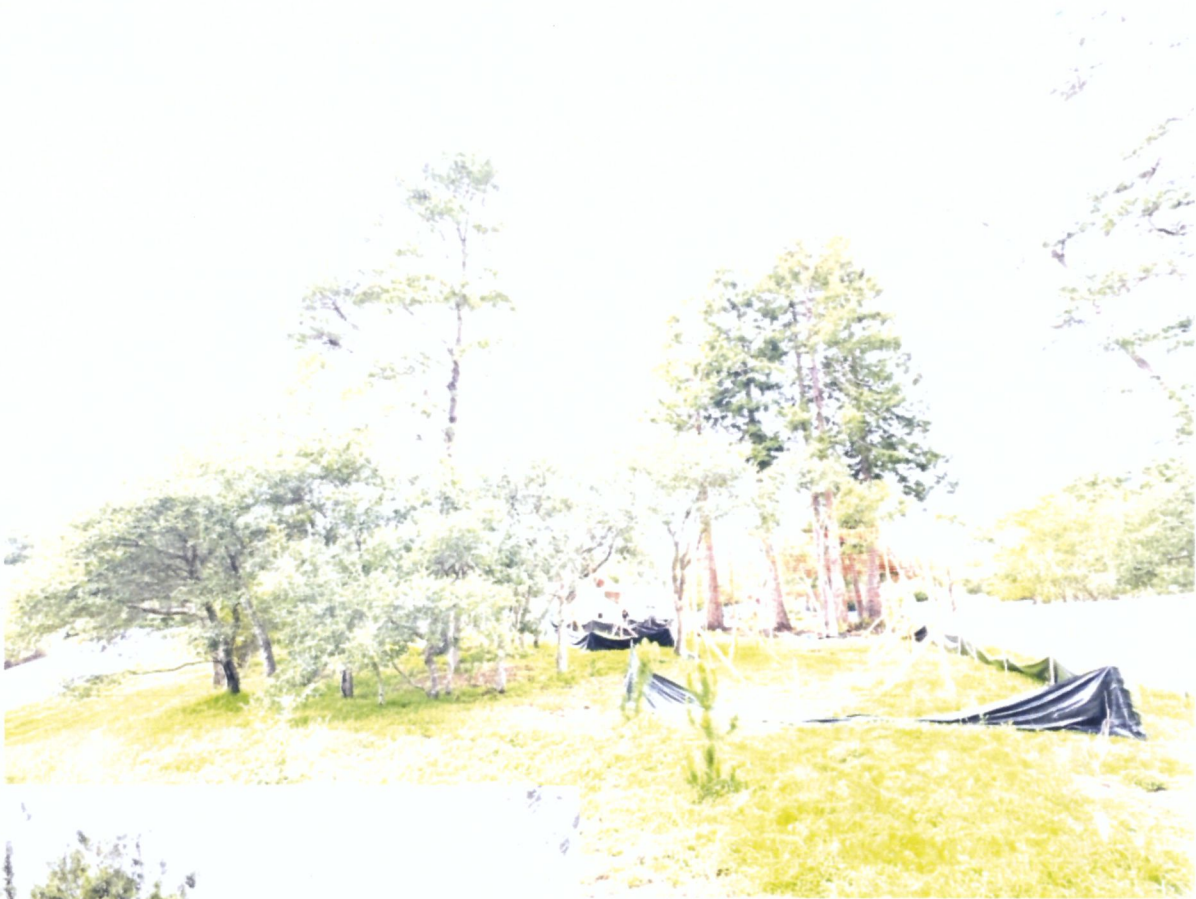
Concern was expressed on the impacts to five Sequoia sempervirens regarding potential root impacts from development. Three test sites were requested to be excavated for a visual inspection of any possibility of root impacts where the foundation is to be installed. The sites were hand dug on 2/6/25 and measured 2'x2' width and 2' in depth. The sites were viewed the following day 2/7/25 during the tree assessment and inventory. The holes are located 17' south of the redwood trees and in line with the north wall foundation based on the site plans and story poles.

S. sempervirens with 3 test sites to determine if any roots are impacted by development.

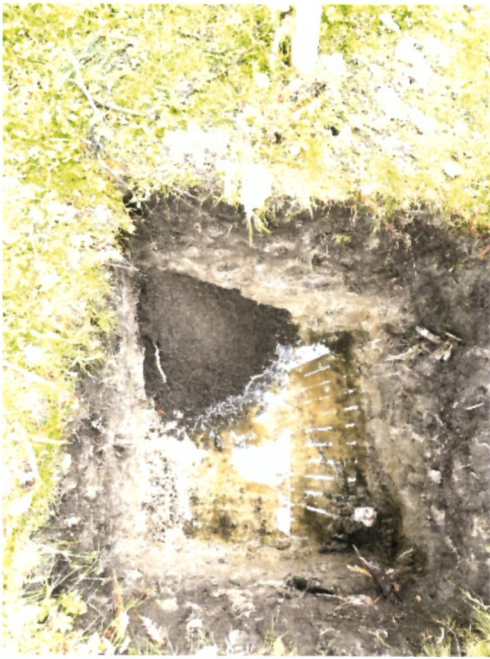
Test site 1 has minimal $\leq 1"$ diameter non-woody roots and no primary roots. Impacts are none.

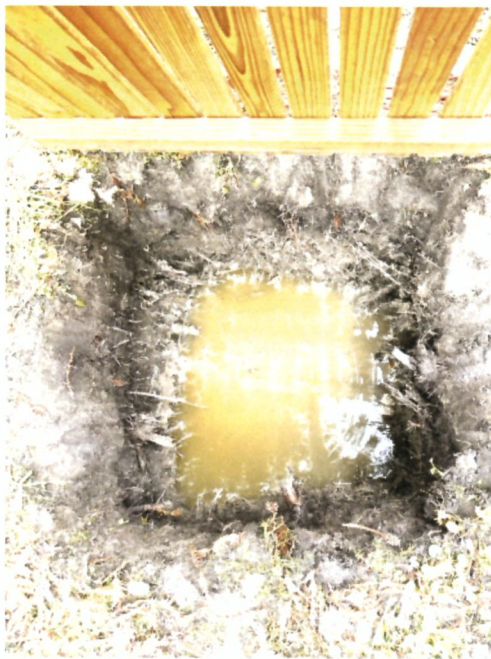
Test site 2 has minimal $\leq 1"$ diameter non-woody roots and no primary roots. Impacts are none.

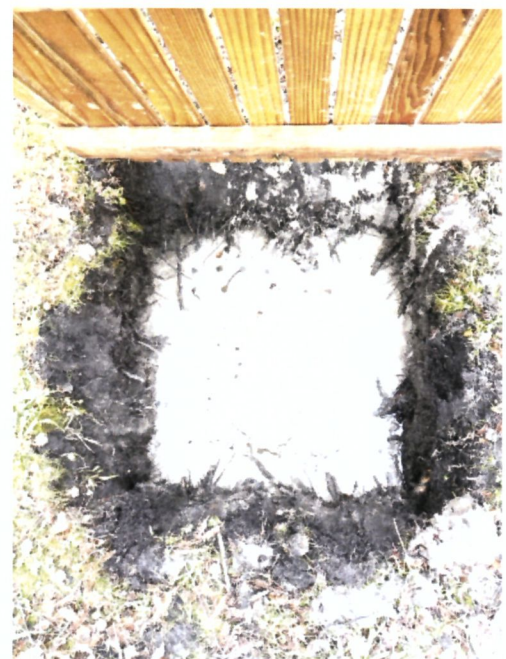
Test site 3 has minimal $\leq 1"$ diameter non-woody roots and no primary roots. Impacts are none.

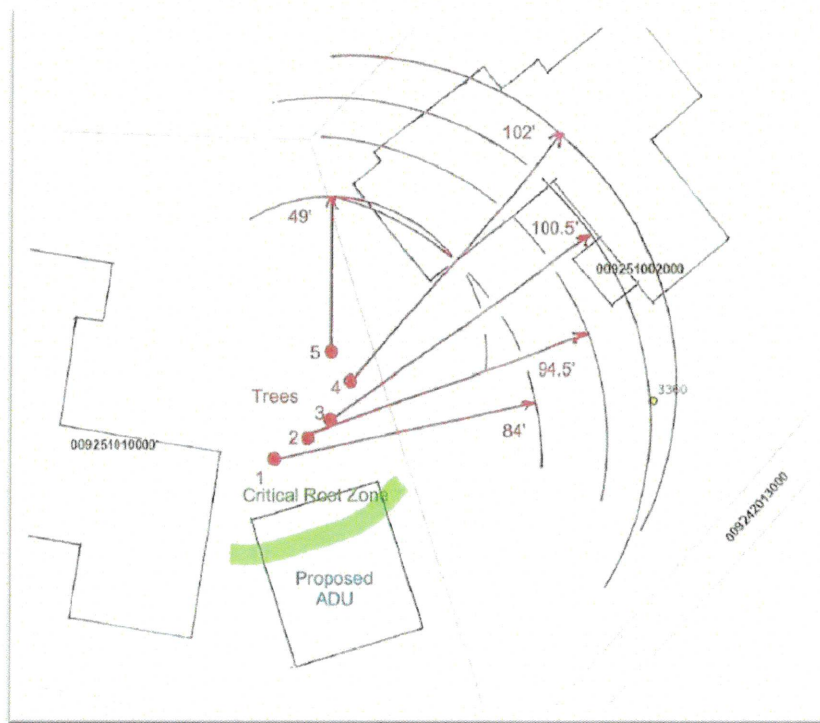
As proposed in the Application, the Project cannot be approved. Enclosed is a Report of Certified Arborist from Certified Arborist Bryan Bradford, which confirms the Project will intrude into the critical root zone of all five of the Redwood trees located on the Kitayama Property. Moreover, the Report clearly demonstrates the Russ Property is well within the fall radius of all five of the Redwood trees:

As can be seen, the Project violates Monterey County Code section 20.64.030(E)(11)(f), which specifically protects “forest health and tree resources” as it will require the applicant to cut the roots of all five Redwood trees, all of which are within the critical root zone.

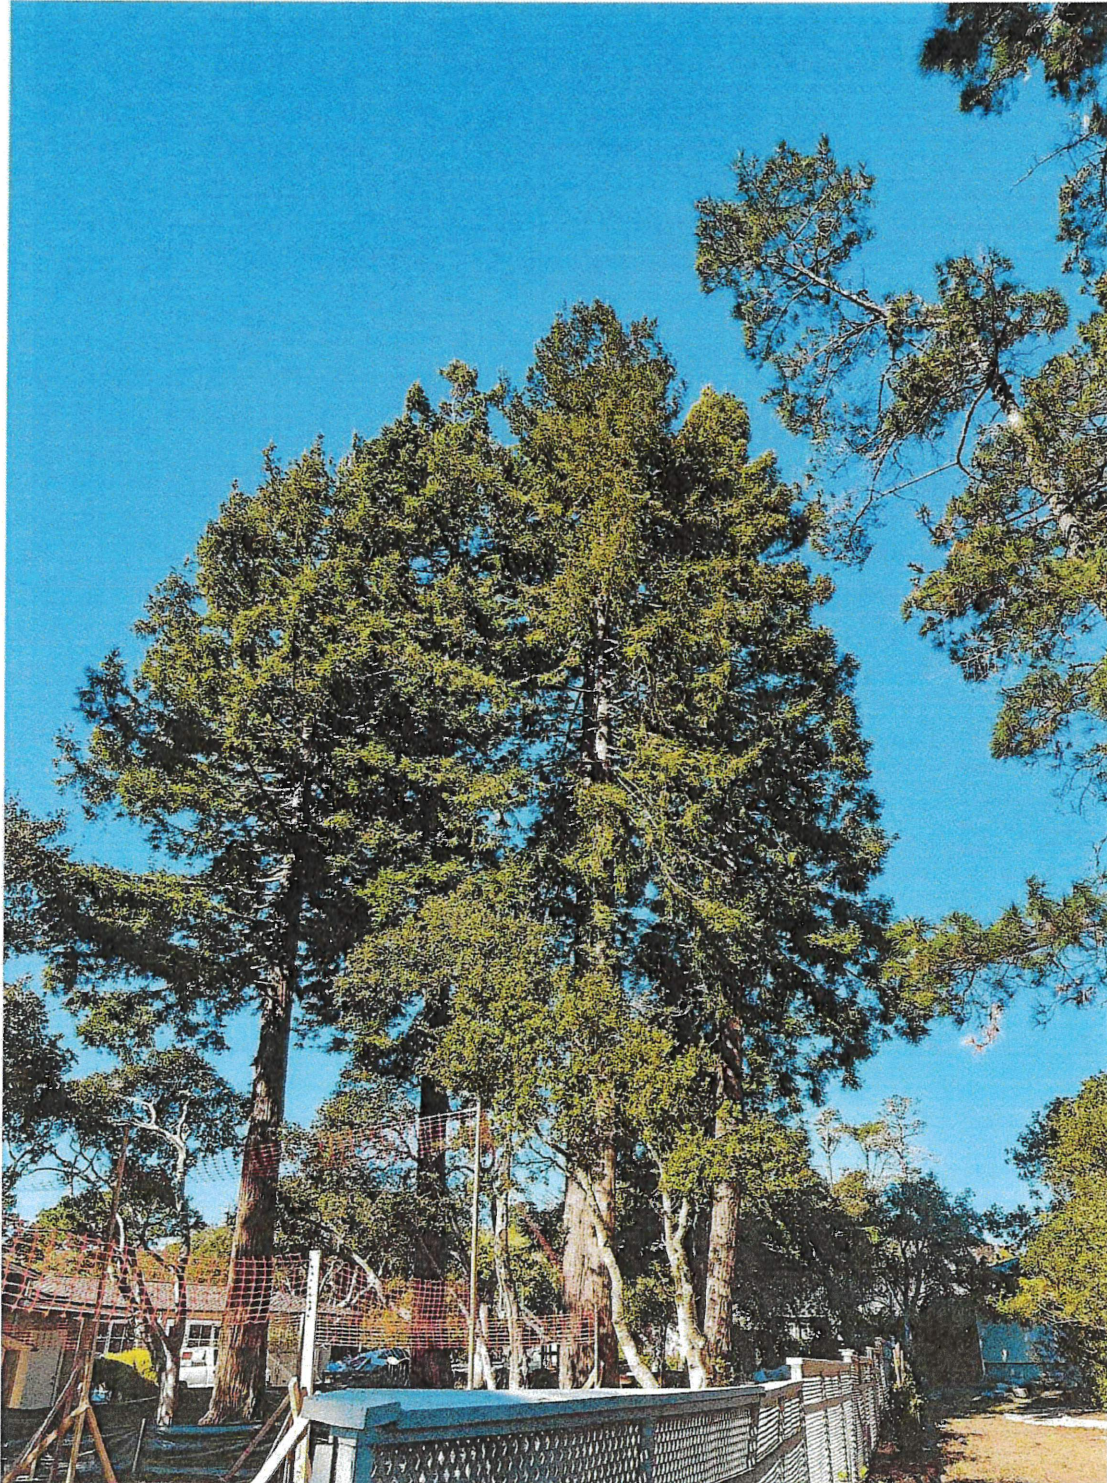
Figure No. 1: Subject grove of Coast Redwood trees showing “story poles” for the ADU and the neighboring residence (lower right corner).

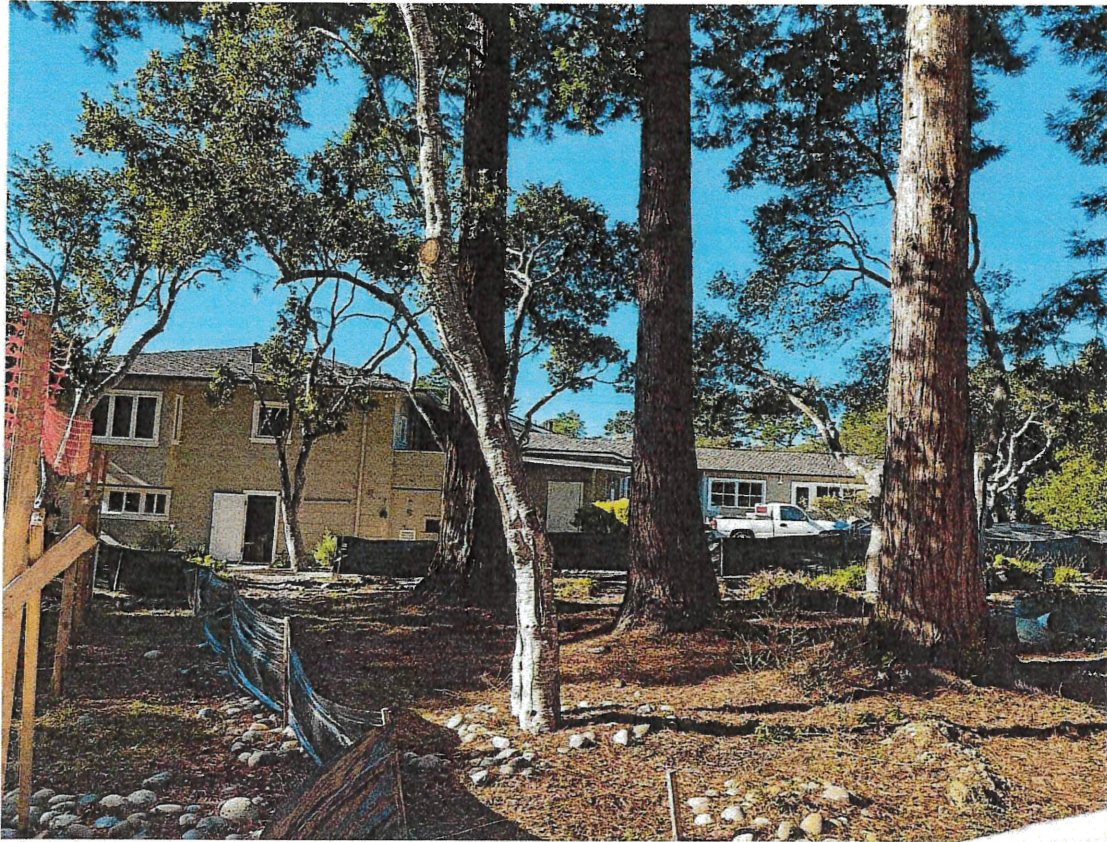
Figure No. 2: Showing critical root zone of trees numbered 1, 2 and 3 in close proximity to the proposed ADU foundation area.

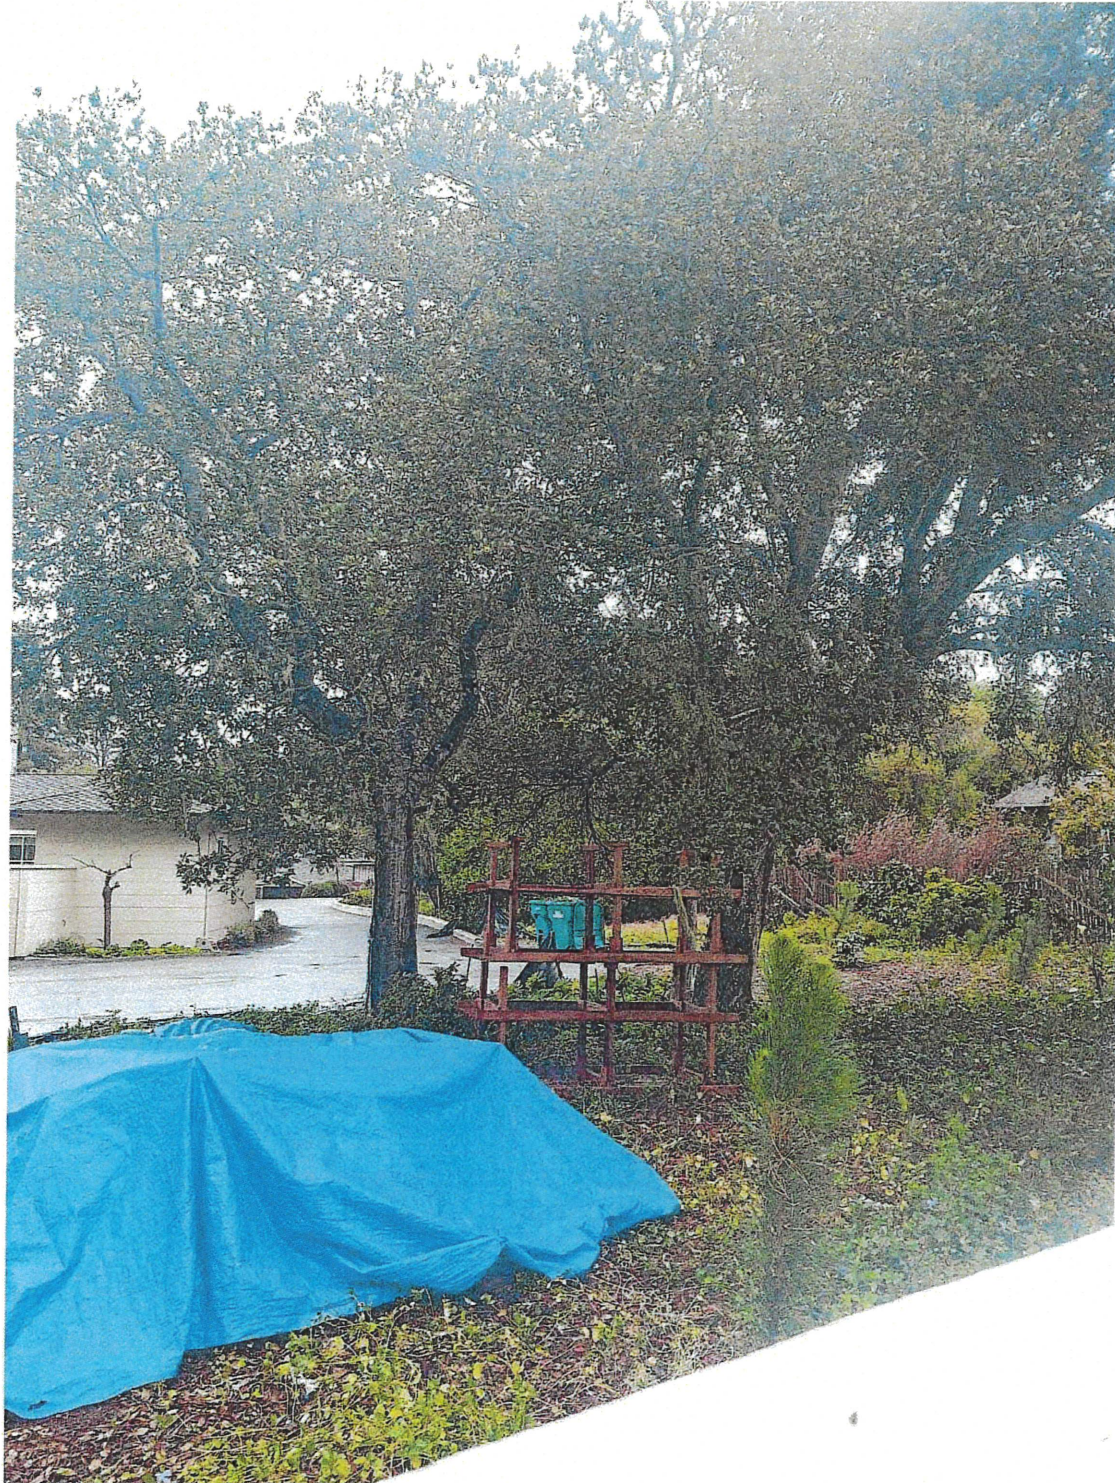
Figure No. 1: Site of northeast ADU reposition proposal, requiring removal of two maturing large oak saplings with large diameter bases and full crowns. Notice the numerous pine saplings.

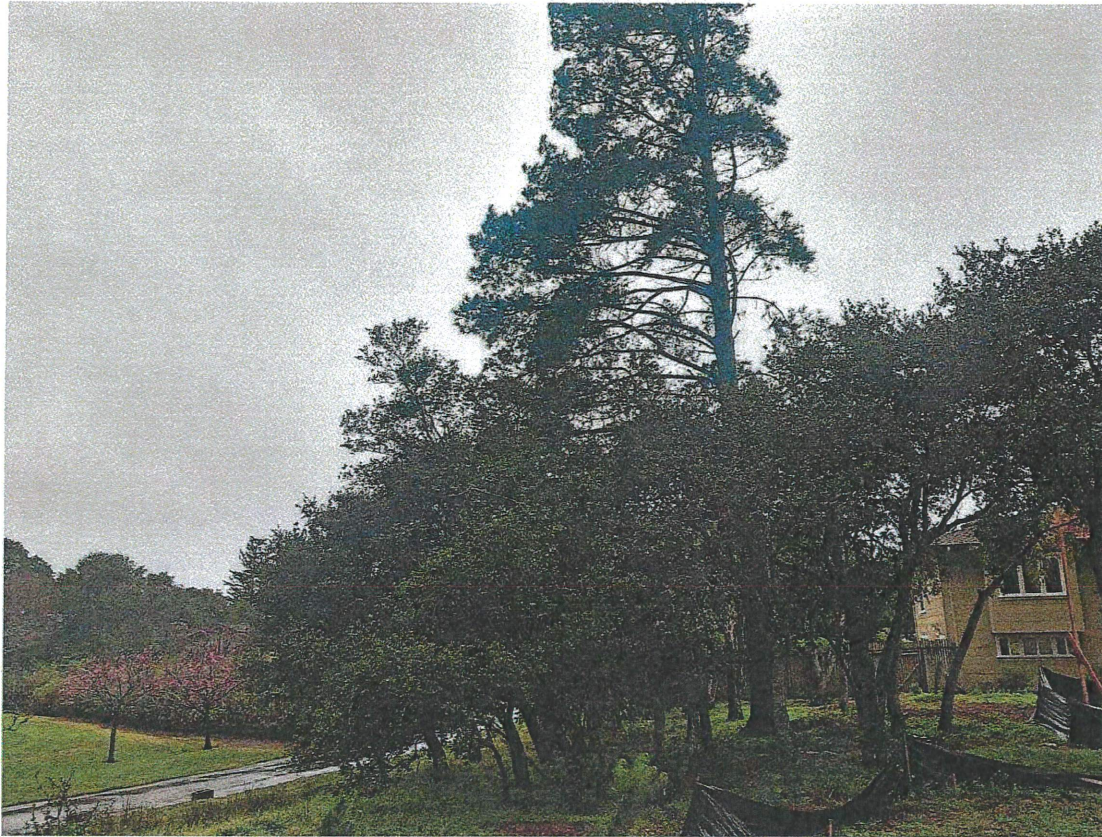
Figure No. 2: Site of southeast ADU reposition proposal, requiring removal of the senescent pine tree and small oak saplings. Notice the numerous pine saplings.

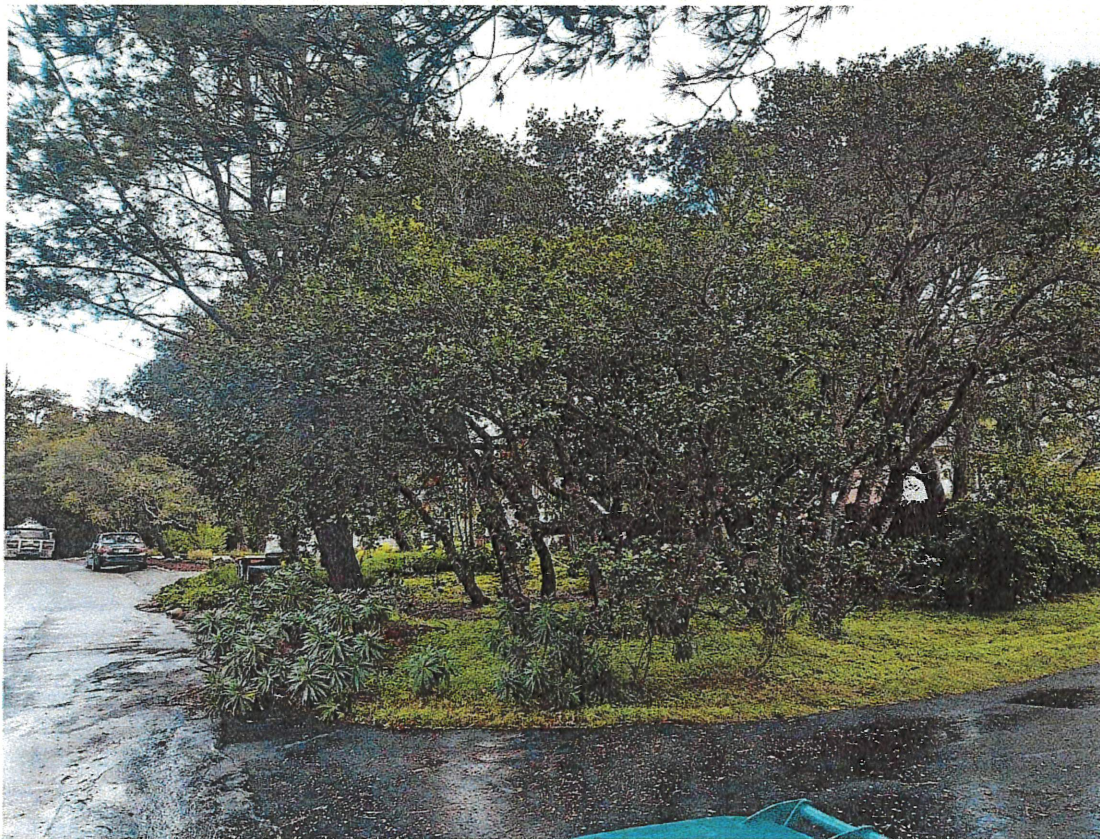
Figure No. 3: Site of southwest ADU reposition proposal, requiring removal of small and large oak saplings.
