**Boccone/Igel Residence**  
**827 Elkhorn Road, Royal Oaks CA**  
**APN 181-159-009**

**Forest Resource Analysis/  
Construction Impact Assessment/  
Tree Protection Plan**

**Prepared for**  
**Norman Boccone/Victoria Igel**  
**Property Owners**

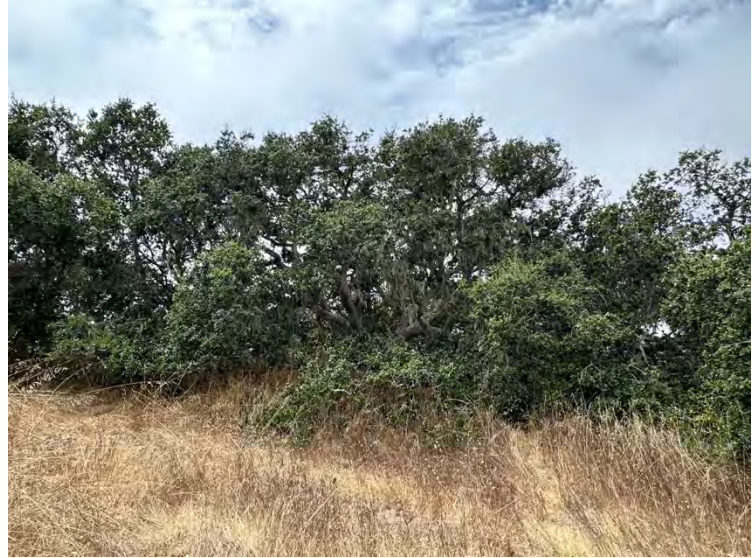
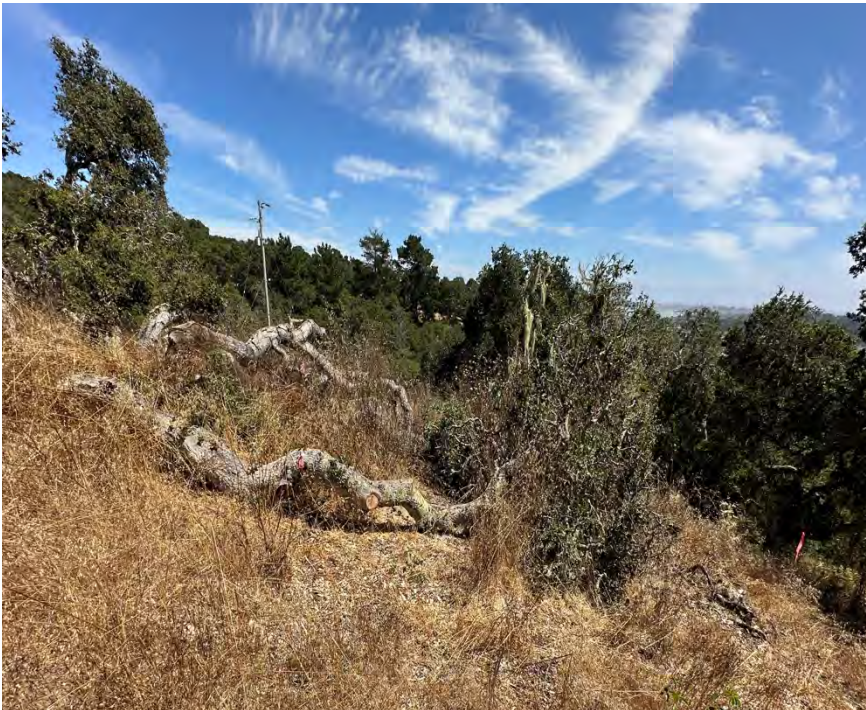
The photo at right depicts a Landmark tree which grows outside of the development boundaries.

There is a high degree of tree mortality, previous failure and suspected disease influences in the development area. Although the coast live oak species is prone to *Phytophthora ramorum* the causal agent of Sudden Oak Death (SOD), there are no visible symptoms of the pathogen on this site. However, there are symptoms consistent with other *Phytophthora* sp. strains, hypoxylon and canker diseases within the study area. Although none of these suspected pathogens were verified by laboratory analysis, visible evidence suggests that there are unidentified, active disease organisms present.

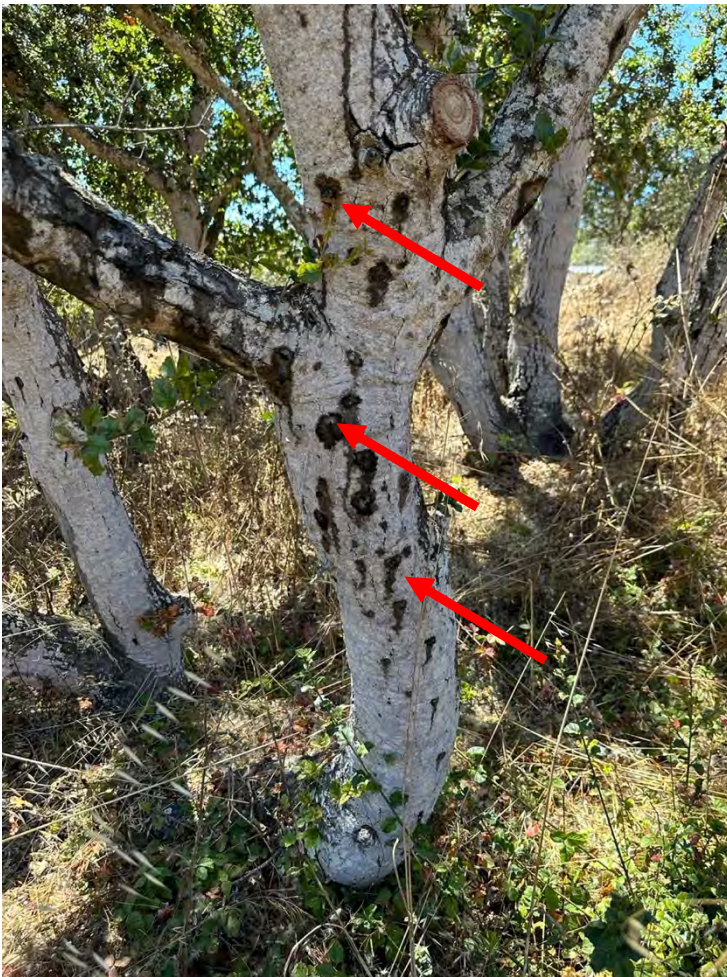
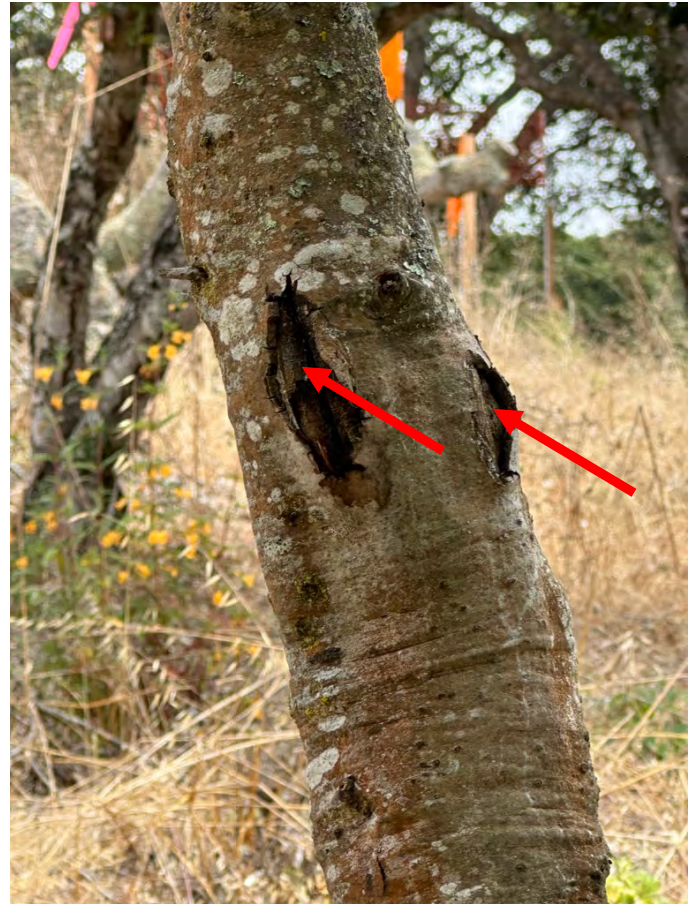
Hypoxylon canker occurs primarily on stressed trees. The fungus infects the tree through injured limbs and trunk. First evidence of the disease is from dying branches. This dieback continues from branch to branch until the whole tree dies. The fungus infects the inner bark causing the outer bark to fall off and exposing large masses of brown, dusty spores which spread to other trees. Eventually, the brown stage of the fungus becomes black, making the tree look as if the affected area was charred by fire. Symptoms of canker disease are indicated by the red arrows.

There is evidence of western oak bark beetle, (*Pseudopityophthorus pubipenis*) in a few stressed trees. This insect attacks injured and stressed trees of the *Quercus* (oak) species among others.

Points of exudation/weeping indicate ongoing insect activity.

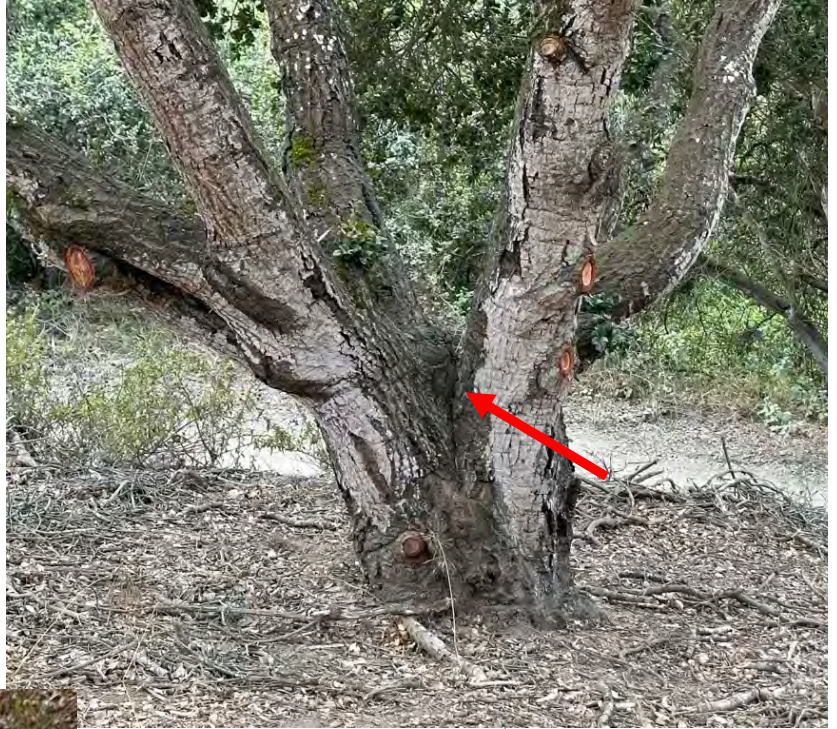
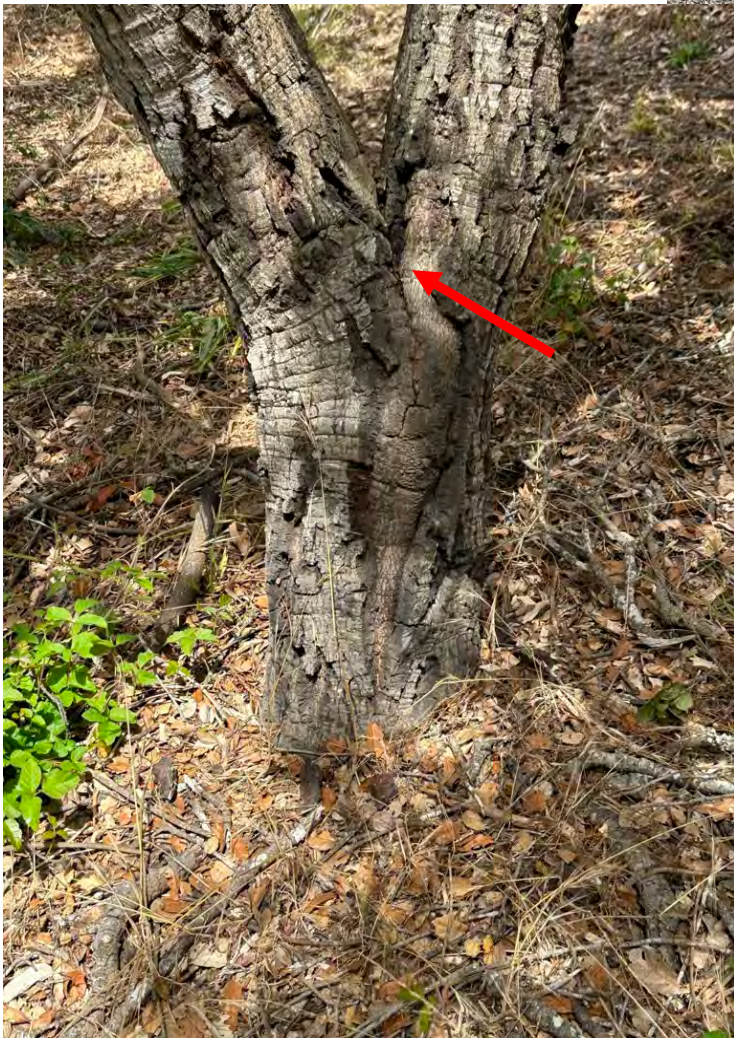
Many trees within the study are multi trunk with wide, spreading canopies and poorly attached codominant trunks and stems with included bark. These poor trunk/stem attachments (PTSA) are, by definition a structural weakness as depicted in the photo at right, Tree #1. In conditions such as these where the bark ridge turns inward, the union between the two stems is weakened.

These types of attachments do not form connective tissues between the stems. The stems push against one another as they develop. The weight of the rapidly growing canopies exerts additional stresses on the weak attachment point. Trees with PTSA are essentially “growing themselves apart” at the trunk/stem attachment point(s) as seen in the photo at left, Tree #117.

This tree has a High Failure Potential and should be continually monitored to assess stability.

- **Monitor Stability** of trees with serious structural weaknesses, severe decline and/or those with High Failure Potential
  - **Trees #41, 96 and 117**
- **Minimize grading limits** within the Critical Root Zone where possible
  - Trees #34, 102, 106-109 and 116
- The following procedures should be implemented for any excavation proposed within Critical Root Zones that cannot be repositioned:
  - **Pre-construction root exploration** is the investigation and understanding of root trajectory and depth within Critical Root Zones of subject trees through “mindful” excavation. This procedure is necessary for trees which are adjacent to trenching and/or grade reduction that require exposure or removal of soil from the trees Critical Root Zone for the driveway, utility lines and foundation construction. Specifically, **Trees #34 and 102, depicted below**

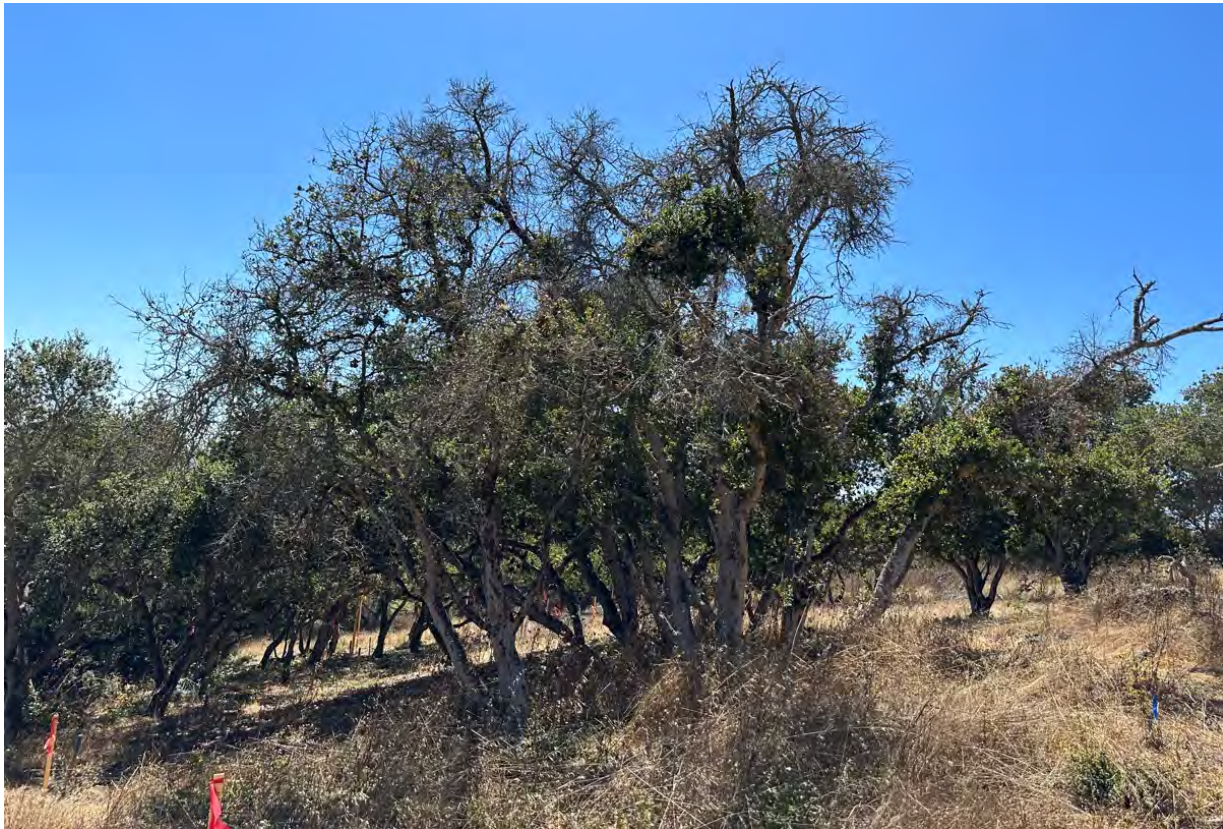
Tree #96, pictured at above is an example of a severely distressed tree that meets “Landmark” criteria . Trees in this condition will be retained for habitat value and monitored for further decline.

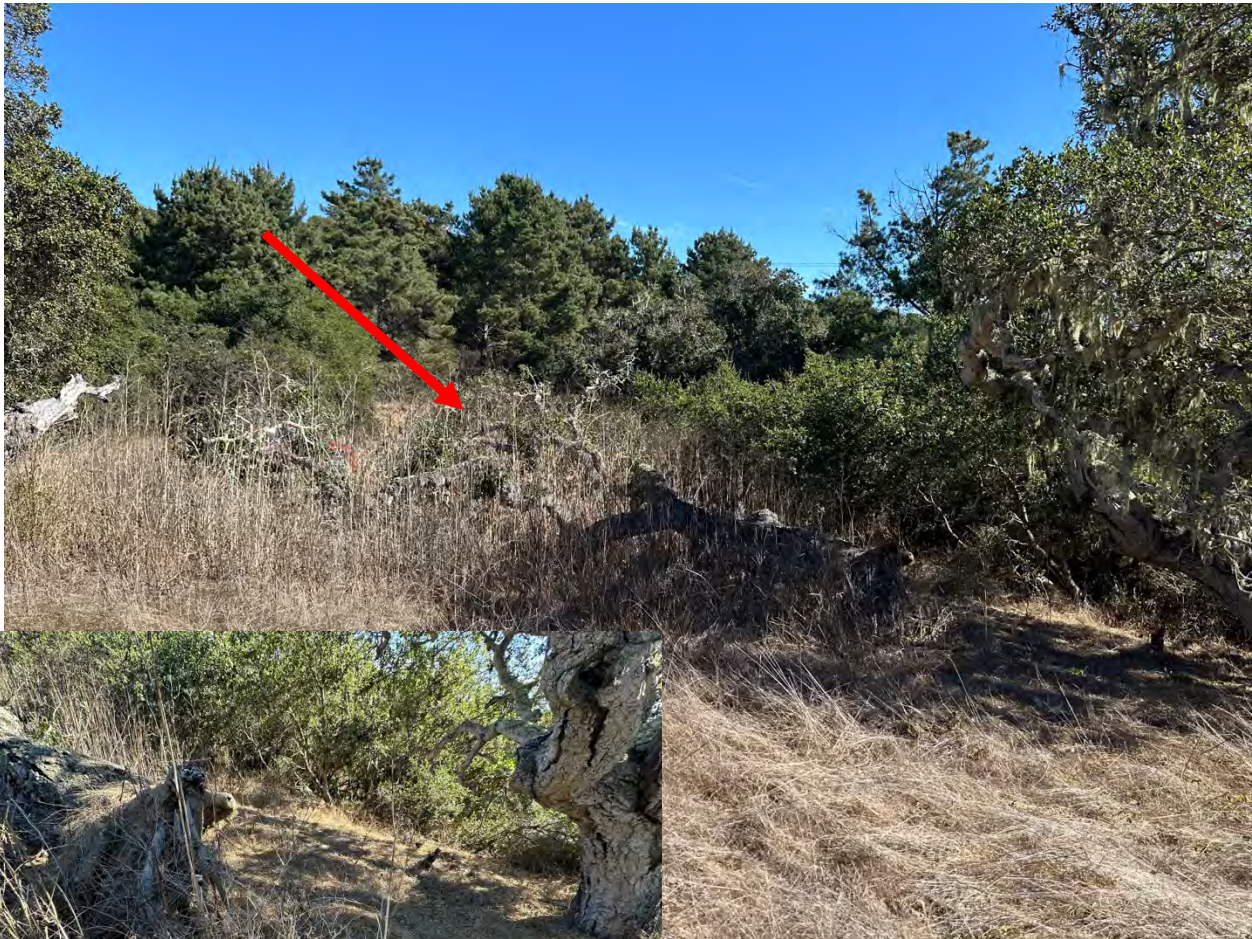
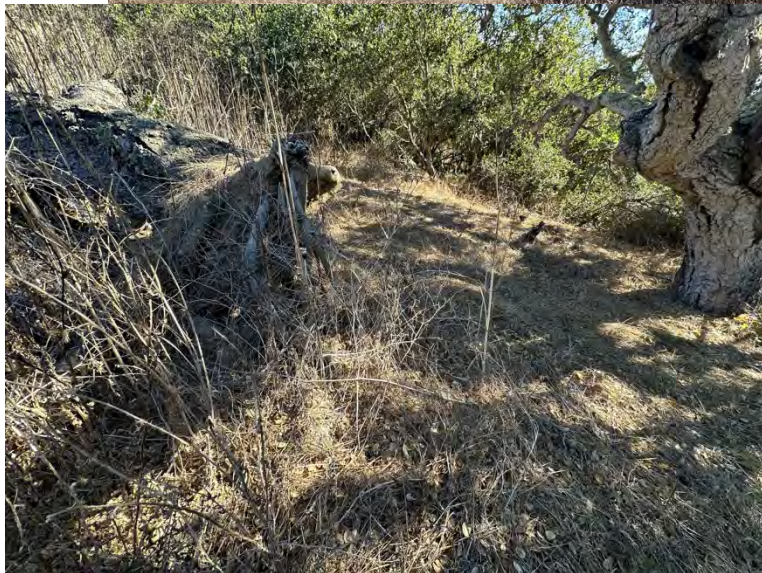
Tree #154, depicted below is required to be removed since it lies in the path of the proposed driveway.

Although this tree meets “Landmark” criteria, it has uprooted with only a small percentage of the canopy being alive and functional. This tree is another example of a “Landmark” tree that doesn’t meet the spirit of the designation.

Twenty (20) trees will need to be removed to construct the project as proposed. Fifteen (15) of the trees proposed for removal meet “Protected” criteria and one (1) Tree #154 meets “Landmark” designation and require replacement. Trees proposed for removal are within or directly adjacent to disturbance limits. Trees to be removed are identified on the attached spreadsheet, summarized in the table below and listed as follows:

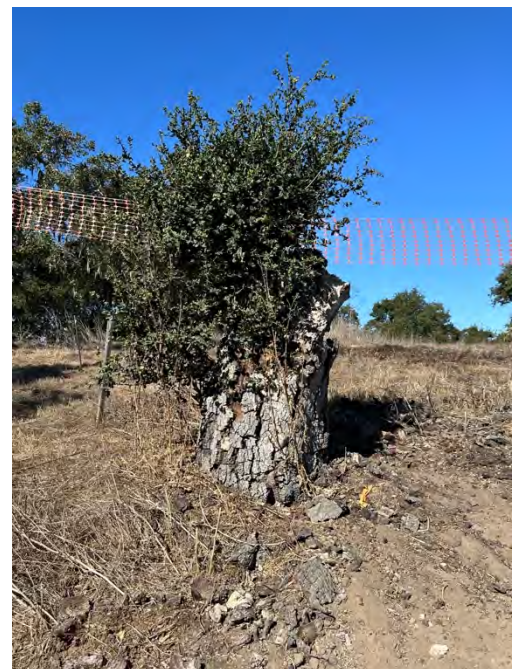
- One (1) Tree #103 with a failed trunk is growing within the proposed Guest House and will need to be removed. This broken trunk has a small amount of live sprout growth remaining
  - Tree #103

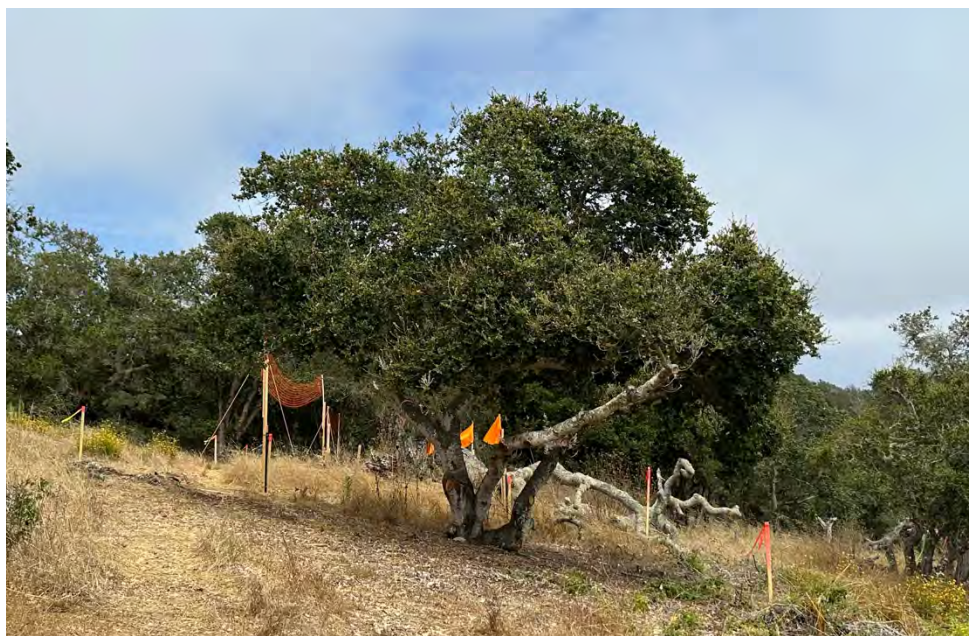
- **Trees #34, 76, 77 and 102**
- **Grading for site stabilization, driveway, parking lot and building construction as well as trenching for foundations, retaining walls, drainage, and utility line construction.** These procedures require alteration of natural grade in the form of cut and/or fill (described below) at the defined “Limits of Grading”. Roots shattered during this process provide openings for opportunistic decay causing organisms degrading tree support systems and vigor.

- Establish a “final line of disturbance” with field staking. This line represents the furthest distance from the tree trunk that will allow the proposed construction/grading/driveway construction
- Determine the depth of the cut required.
- Begin digging 8 to 10 feet from the established line in a “spoke in wheel” pattern, using the tree trunk as the hub.
- Dig to the required depth.
- Dig toward the tree trunk to determine where roots are located.
- Begin pruning roots using the techniques defined above.
- Cover pruned roots with burlap and keep moist
- Upon reaching the final line of disturbance make the final root pruning cuts.
- Install Tree Preservation fencing with straw bales to allow maximum distance from the tree while allowing construction space.

- **Pruning** to remove dead branches has been recommended to reduce potential fire hazards
  - Each tree to be preserved should have dead/broken branches greater than 1-inch diameter removed
- **Clearance pruning, Trees #34, 76, 77 and 102** be required to allow vertical space for driveway and building construction. A minimum number of branches are to be removed to provide this space. Individual trees requiring clearance pruning will be identified by the Project Arborist after the vertical clearance requirements are defined.
  - Pruning should not remove more foliage than necessary to accommodate proposed construction as determined by the Project Arborist.
