# 2025 Boat Dock Survey: Data Collection and Findings

## Annual Dock License Certification Inspection

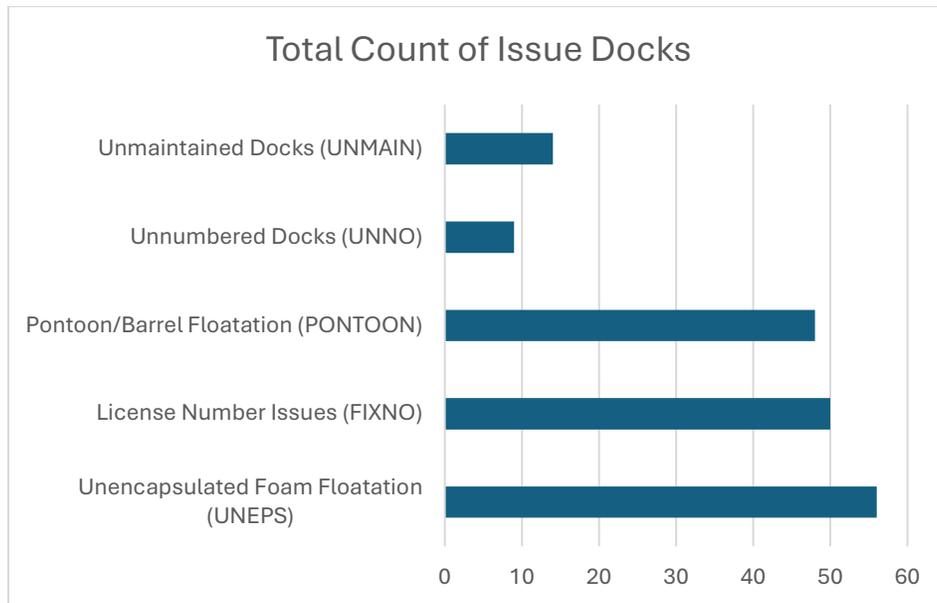
Figure 3 – Number of docks with licensing violations in the year 2025.

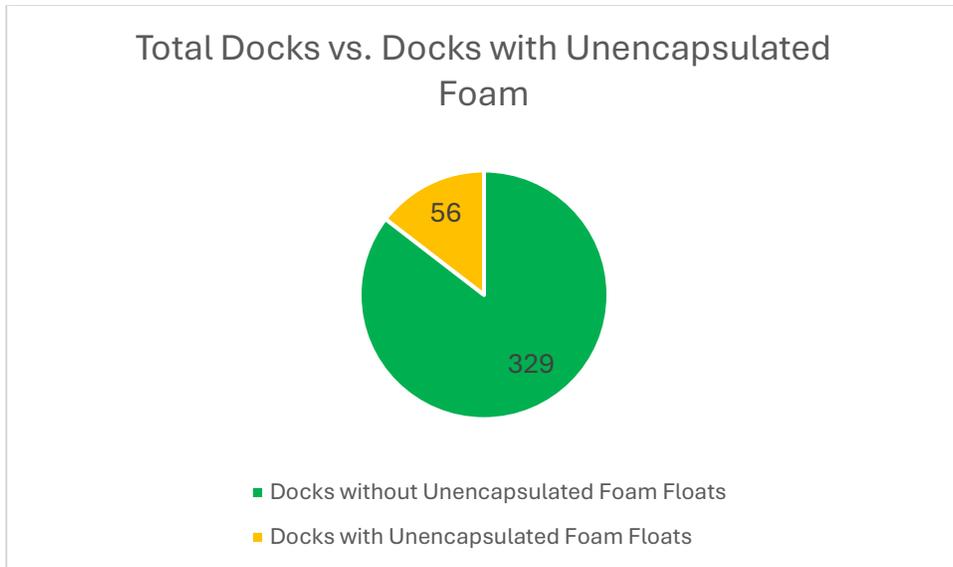
The inspection results have been compiled to summarize all findings, including the observation that 56 docks (14.5%) on the reservoir are equipped with unencapsulated foam floats. These floats disintegrate over time, releasing microplastics into the reservoir. The detailed totals are presented below:

*Figure 4 - Total number of docks containing encapsulated Styrofoam, which is prohibited by ordinance 4065 enacted in 2000.*

These docks were observed in multiple regions along the reservoir, with the highest concentrations in Cal Shasta Club, Tri Counties Club, and Nacimiento Shores Road.

1. UNEPS: Unencapsulated foam floating dock structures should be retrieved and disposed of in accordance with appropriate environmental and safety protocols.

Based on a thorough review of the photographs, all docks featuring unencapsulated foam are observed to be in poor condition and are not suitable for straightforward retrofitting. Consequently, the full removal of these docks from the reservoir will be necessary.

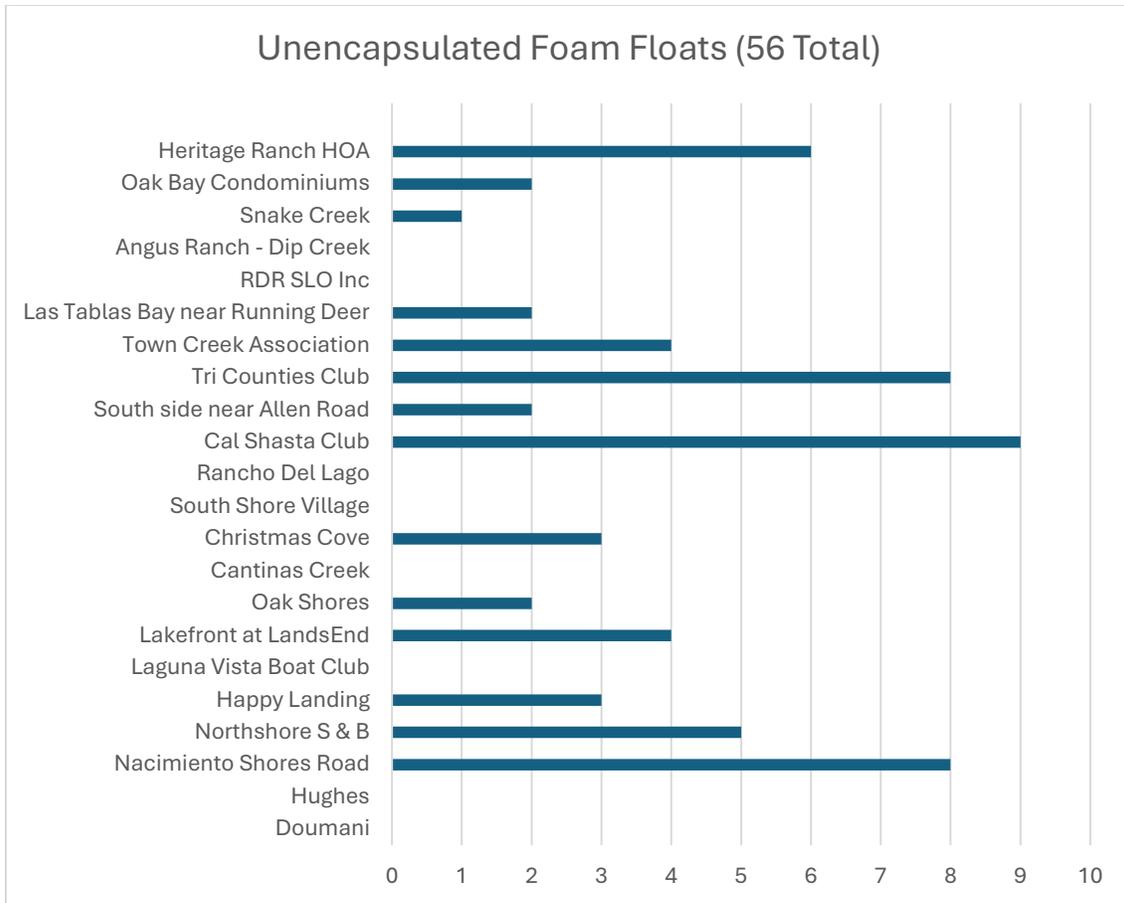
The detailed totals per each region are provided below, and these locations will be required to undertake appropriate corrective actions.

Figure 5 – Identify locations on Nacimiento Reservoir to efficiently address all instances of exposed Styrofoam.

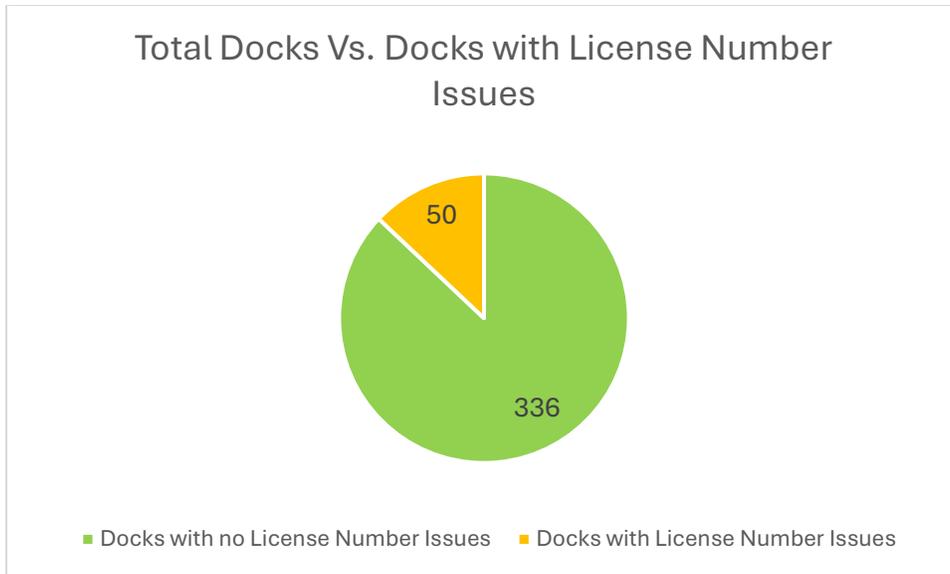
The second most common issue observed at the reservoir involved license number compliance. A total of 50 docks (13%) exhibited license number issues, including missing numbers (entirely or partially), multiple license numbers posted at a single dock, numbers that are too small, or numbers that are difficult to read due numbers to placement, color, sinking, shadowing, or other factors. Docks are required to display numerals at least 3 inches in height, clearly visible from the water. The following summary provides an overview of these docks, with inspection audit results indicating specific management concerns related to identification numbering.

*Figure 6 – There are discrepancies with dock numbering. Please utilize the findings to enhance the management of docks by ensuring that all docks display the correct license identification numbers, including the use of agency-issued plates or signs with proper ID numbers.*

2. FIXNO/UNNO. Docks owners whose docks do not clearly display their license number should be informed of this issue and advised to take the necessary corrective action.

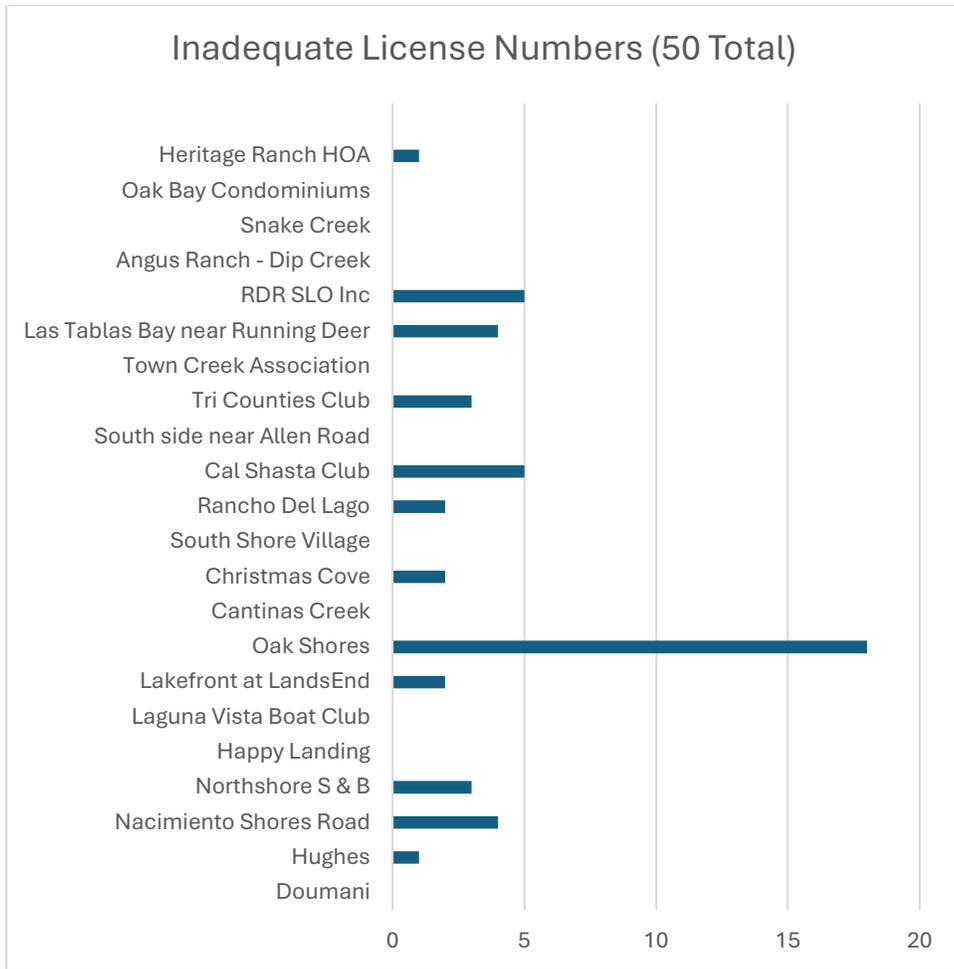
This issue was identified across nearly all the 22 geographic regions, with the highest totals being in Oak Shores, Cal Shasta Club, and RDR SLO Inc. It is important to note that these clubs also have the largest total number of docks. Detailed totals are provided below. Moving forward, the objective is to achieve 100 % accuracy in future inspection audits.

Figure 7 - Results of license identification numbering issues for each location.

The absence of properly posted boat dock license numbers significantly hampers our ability to accurately identify docks during on-site inspections. This often results in extensive efforts to review historical, cataloged photographs to establish a match, which can be time-consuming. Following the 2025 inspection, considerable time was dedicated to identifying docks with insufficient license number postings. It is essential to implement corrective measures to resolve the issue.

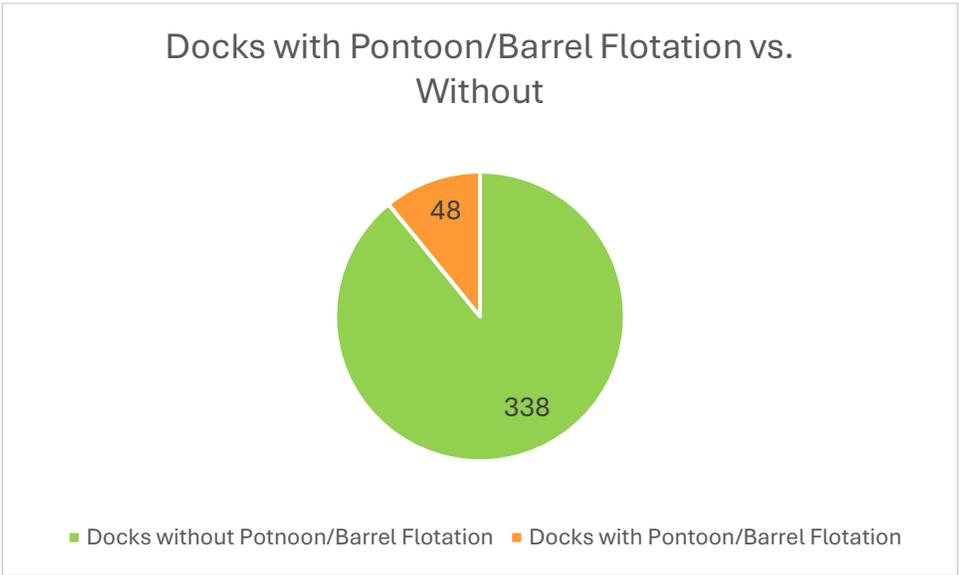
Approximately 12% (48) docks utilize pontoon or barrel-style floatation, which the Agency aims to phase out due to potential safety concerns related to dock and reservoir integrity. The following table compares these figures to the total docks on the reservoir:

*Figure 8 - Results of pontoon and barrel flotation at each location.*

3. PONTOON. Dock owners utilizing pontoon or barrel flotation are advised that the Agency will be gradually discontinuing this flotation method in the future., Please proactively plan and arrange for the replacement of such flotation systems accordingly.

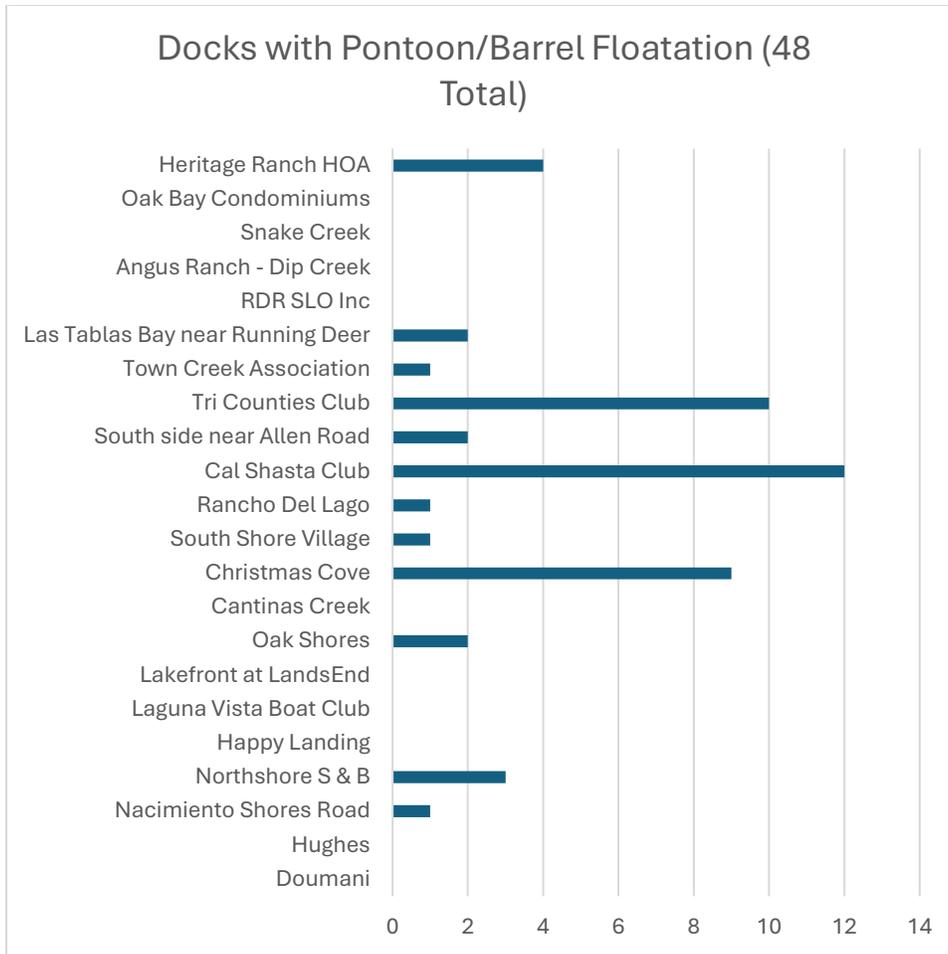
Figure 9 - Results of pontoon and barrel floatation for each location.

The highest concentrations of this type of floatation were observed at Cal Shasta Club, Tri Counties Club, and Christmas Cove. Although these locations feature some of the larger number of total docks, many of their docks are among the oldest and are in relatively poor condition, with some utilizing pontoon or barrel floatation. For example, Christmas Cove, has a total of 19 docks, of which 9 (47%) of them have pontoon or barrel floatation. In areas most affected by low reservoir levels, the docks generally tend to be of an older design, as they experience less frequent movement and therefore are not prioritized for upgrades by owners.

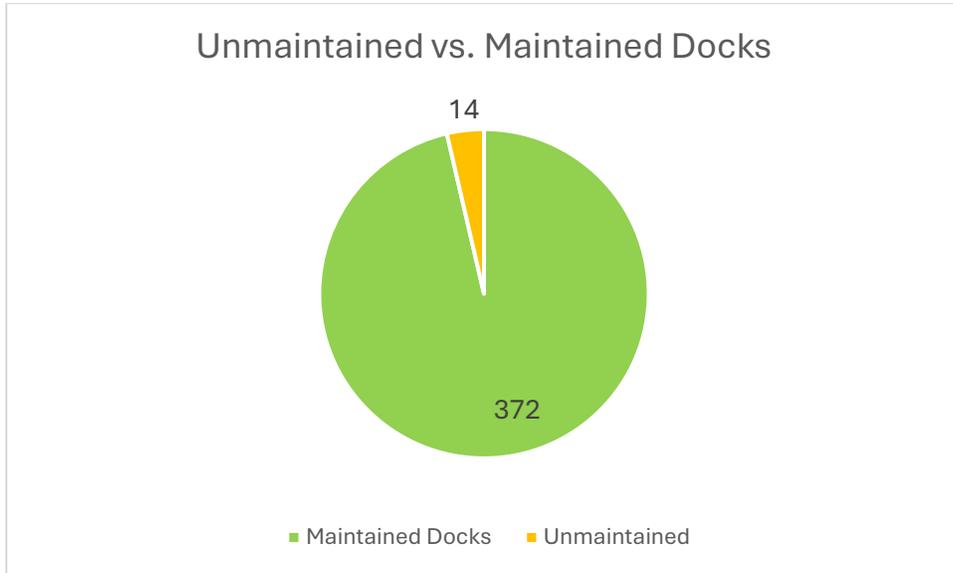
The “unmaintained” category includes docks exhibiting significant structural deficiencies, such as rotted decking, compromised floatation leading to sinking, deteriorated carpeting, severe mooring issues, or other structural problems that pose safety concerns.

Additionally, this category encompasses docks that are deemed abandoned. A total of 14 docks, representing 3.5% of those that were surveyed, were classified within this category. The detailed totals are provided below.

Figure 10 – Comparison of maintained and unmaintained docks.

4. UNMAIN. Dock structures exhibiting compromised structural integrity should be retrieved and securely dismantled. Identified issues include inadequate mooring, deteriorated decking conditions, and decayed or disintegrated materials.

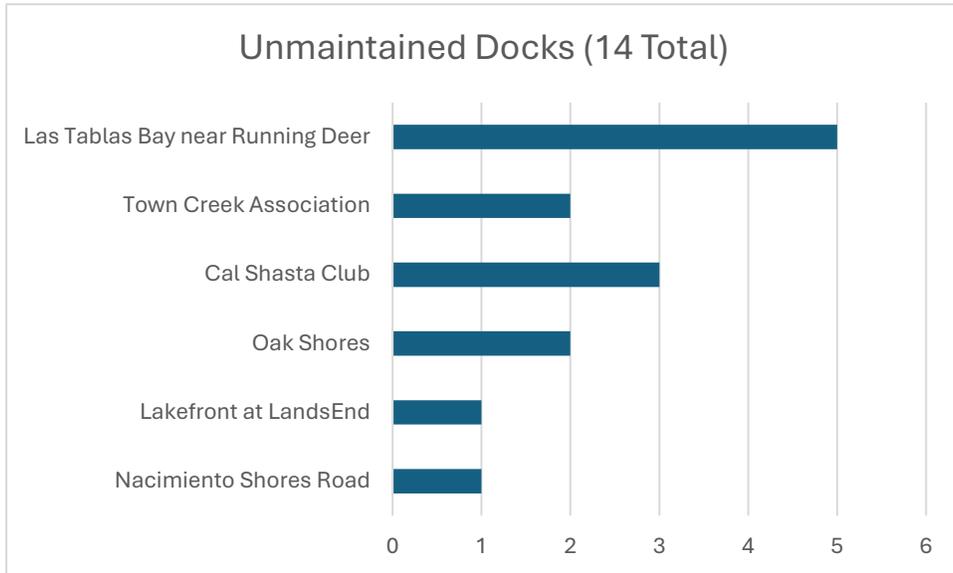
Figure 11 - Results of pontoon and barrel flotation for each location.

The highest concentration of unmaintained docks was identified in Las Tablas Bay near Running Deer, where 18.5% of the total 27 docks are unmaintained. Although this issue area has the lowest number of docks compared to locations with unencapsulated foam, insufficient licensing, or pontoon and barrel floats, these unmaintained docks still present potential risks to reservoir resources and users. Implementing corrective measures is recommended to address these concerns.

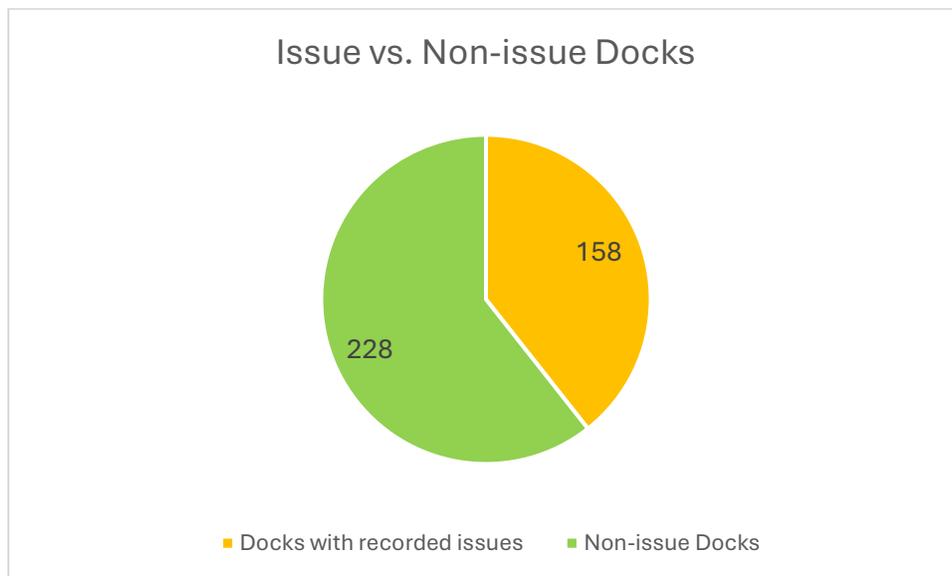
Figure 12 - Results of docks with reported issues compared to those without.

A total of 158 docks (41%) were identified as having at least one notable issue during inspection or subsequent photo review. These concerns placed the docks into one or more of the four identified issue categories. As anticipated, several docks with structural deficiencies also exhibited difficulties with, or absence of, proper license number posting, resulting in multiple category classifications. As shown in the table below, 41% of docks were identified having issues in one or more of the four categories discussed. Specifically, 28% exhibited structural concerns, while 15% had inadequate license number postings. Some docks were affected by both structural issues and license posting deficiencies, which accounts for the combined percentage 41%.
