HARO, KASUNICH AND ASSOCIATES, INC.

Subject: Geologic and Coastal Bluff Recession Assessment Report

Reference: 35700 Highway 1, Big Sur, CA 93920
Monterey County APN 418-111-012

RECOMMENDED 50-YEAR BLUFF EROSION AND INSTABILITY SETBACK MAPS

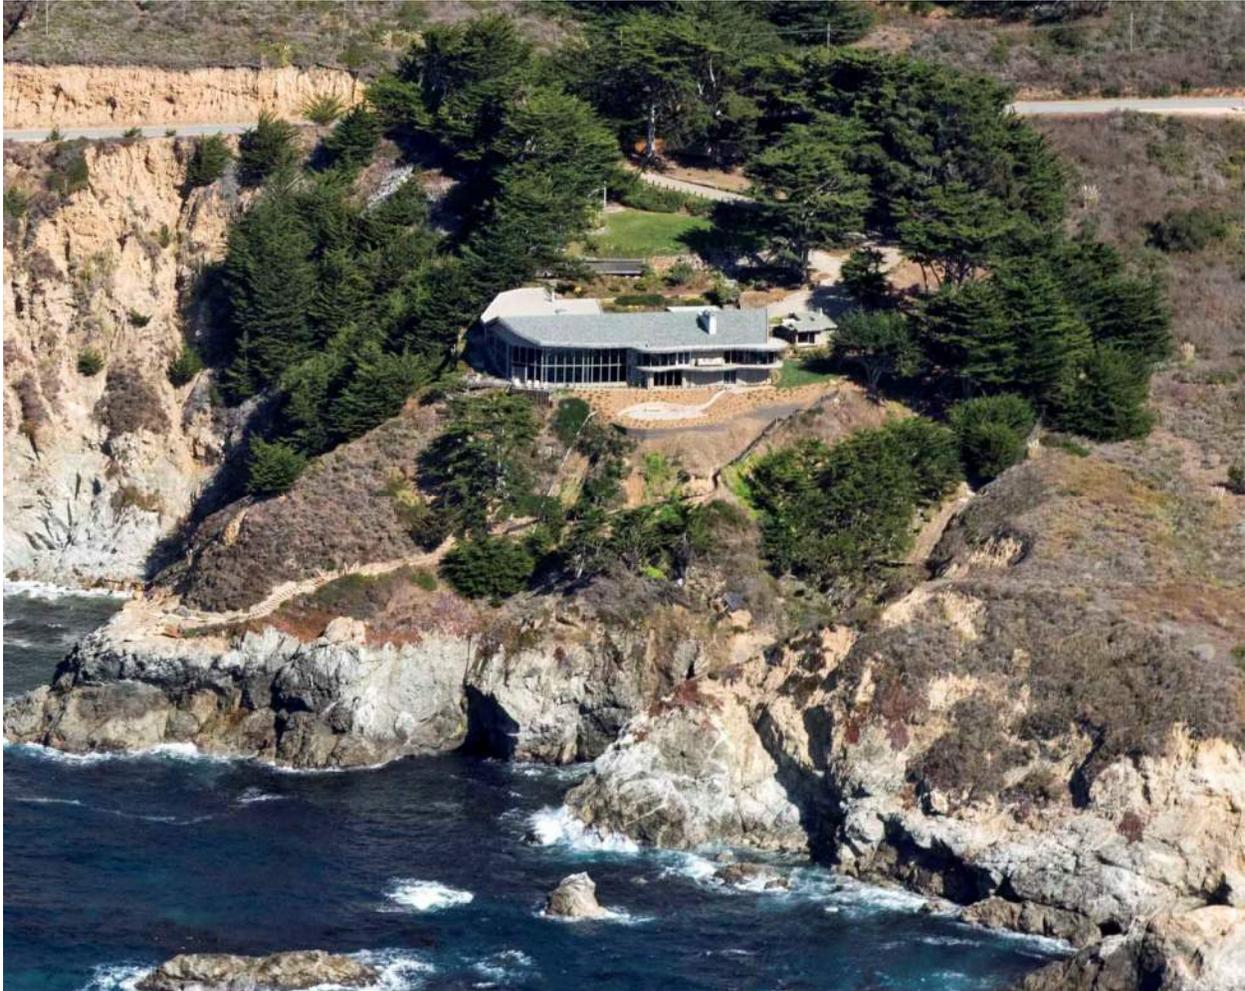
We examined the bluff face in October 2021 and find the geologic and geomorphic conditions to be virtually identical to those in the October 2019 photograph below:

**Photograph 5: Aerial Photograph from October 2, 2019
(courtesy of www.californiacoastline.org)**

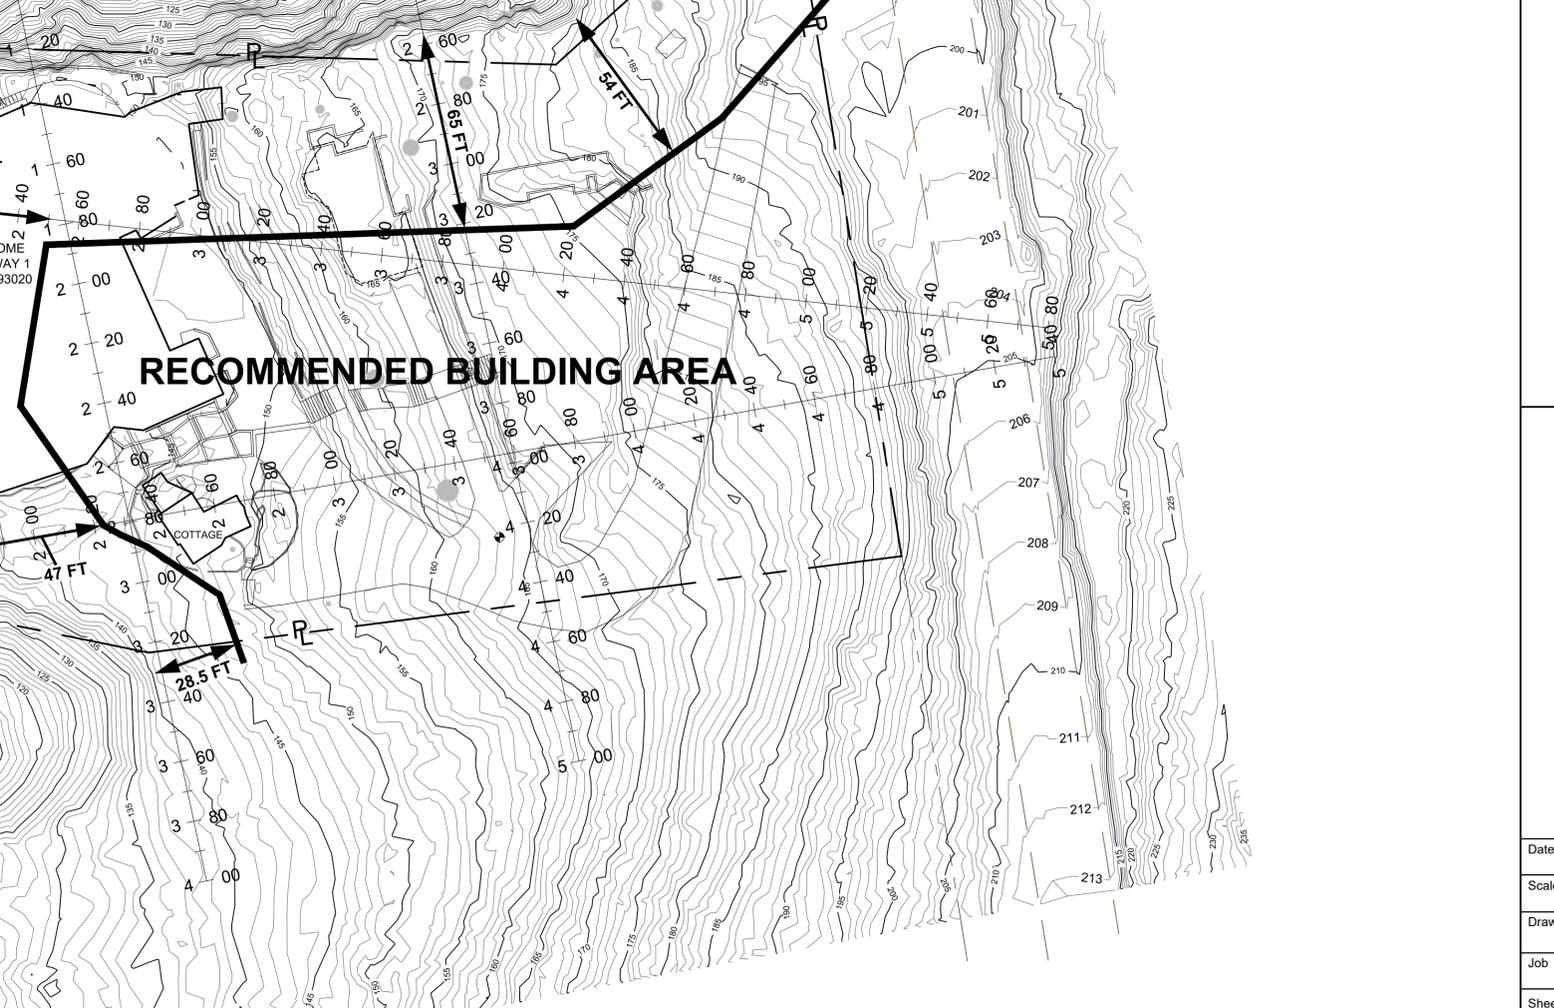
PLAN VIEW WITH TOPOGRAPHY
SHOWING RECOMMENDED 50-YEAR SURFICIAL BLUFF EROSION AND STABILITY SETBACK
37600 HIGHWAY 1, BIG SUR, CA 93020 APN 418-111-012

We transferred the results of that slope stability analysis (which is presented in an accompanying report from our firm) onto the geologic Cross Sections that are included in Appendix B to show what portion of the property is likely to remain stable for 50 years (until at least 2073) and show our RECOMMENDED 50-YEAR BLUFF EROSION AND INSTABILITY SETBACK LINE on two maps (Sheets 2 and 3 in Appendix B).

- 1) At the subject property, we recommend that areas seaward of the RECOMMENDED 50-YEAR BLUFF EROSION AND INSTABILITY SETBACK MAPS (Seven 11 X 17 inch sheets dated 4-28-2022) shown in Appendix B be considered to be at potential risk in the next 50 years (by 2073). We recommend that new habitable development only be constructed inland of this setback. It is possible that any development or improvements seaward of this setback may be damaged by coastal erosion, bluff retreat and/or bluff instability during the next 50 years.
