Nacimiento Dam Hydroelectric Power Plant Unit 2 Repair Update

Manuel Saavedra
Associate Water Resources Engineer

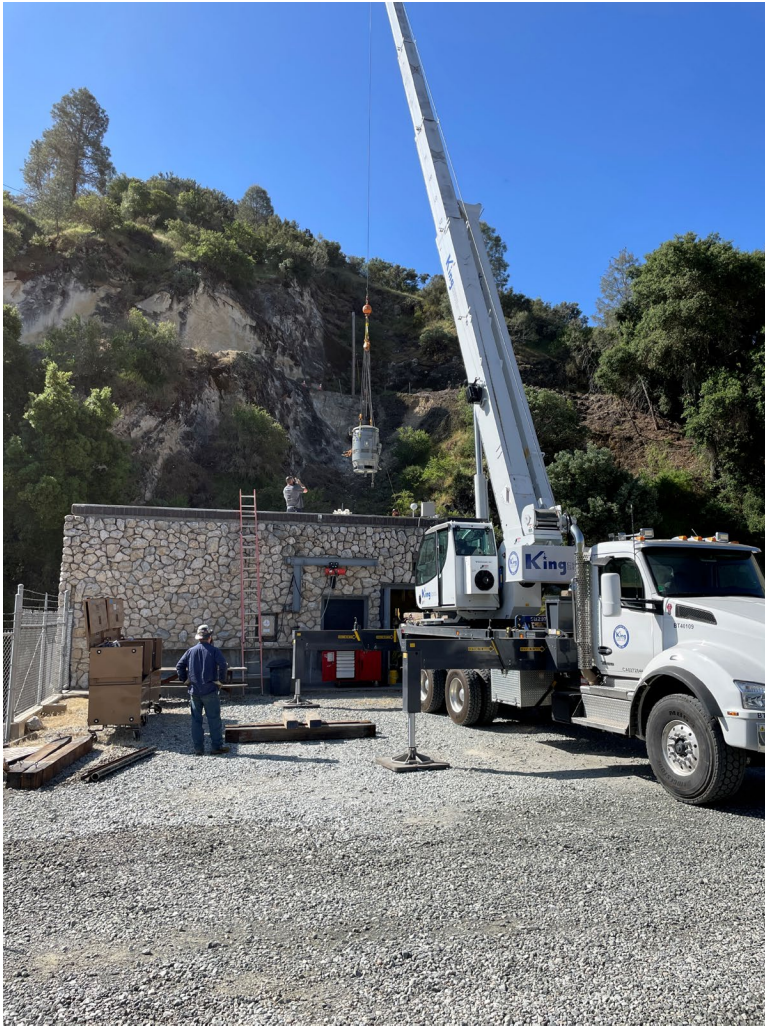
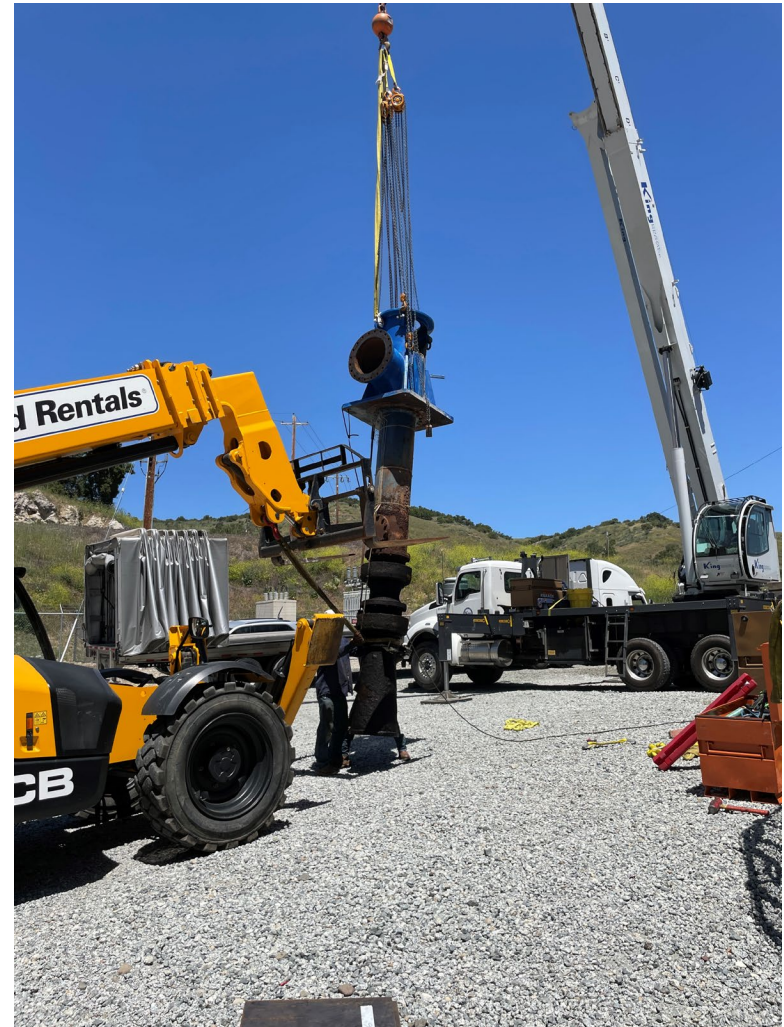
TCB Dismantling Generator and Turbine for Repair (Phase 1).

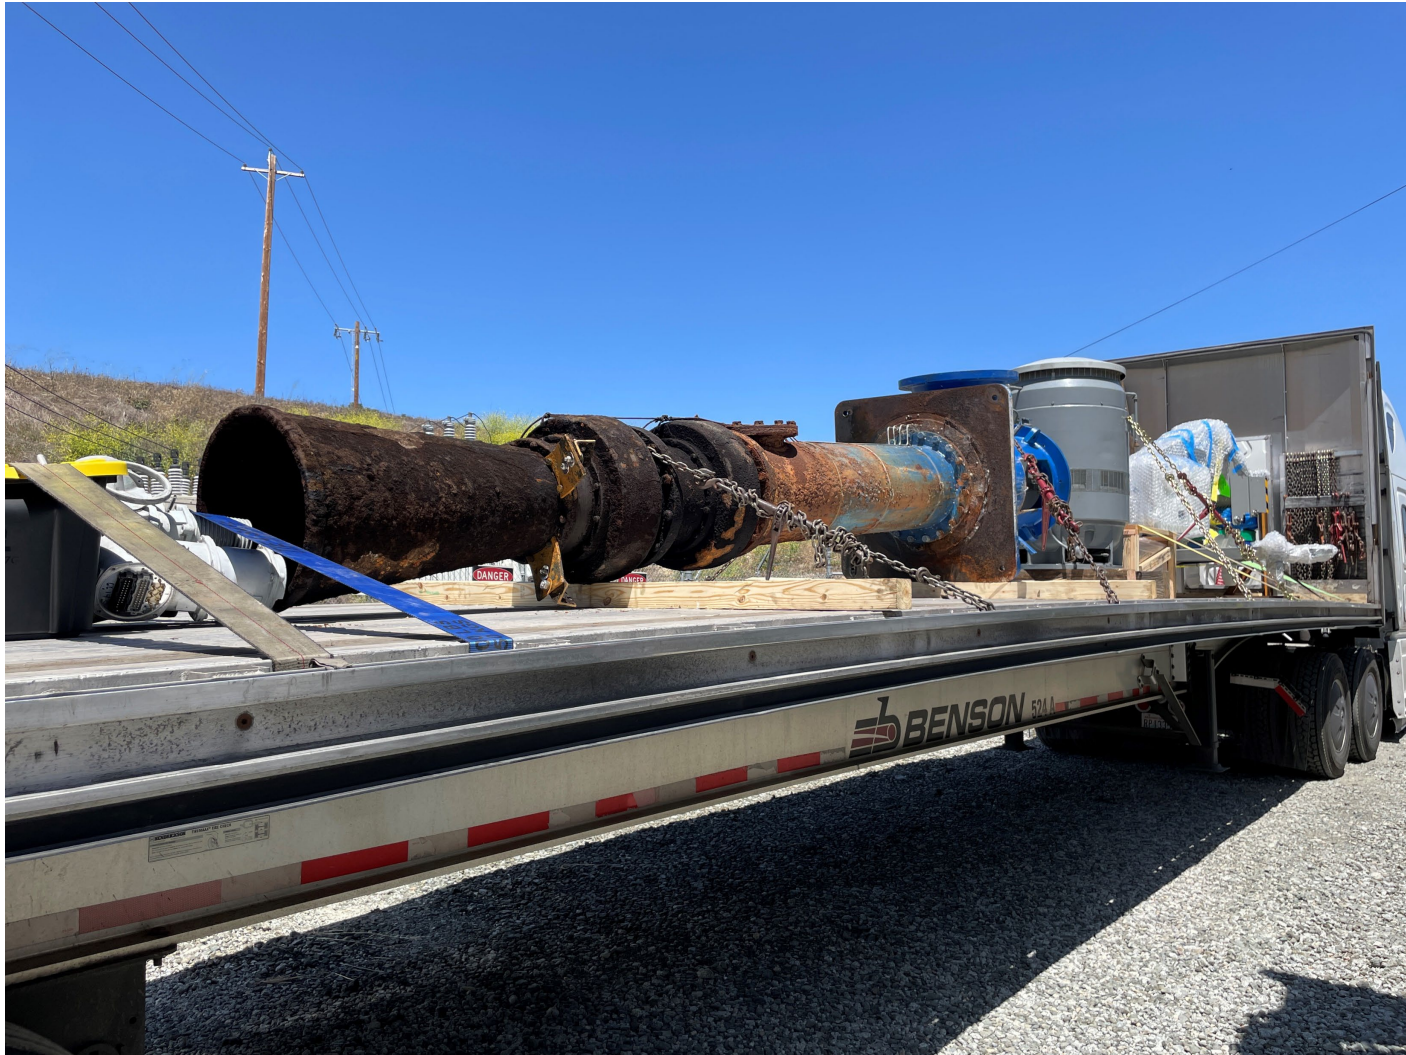
Transport of Generator and Turbine to Repair Shop (Phase 1).

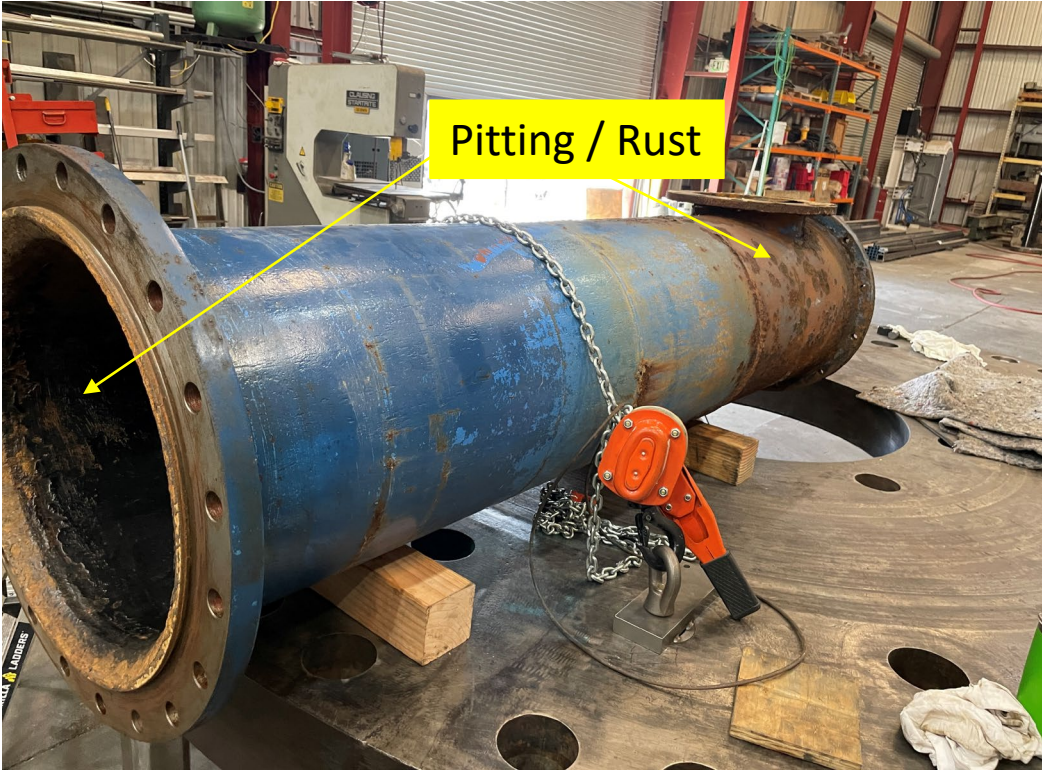
Turbine Column Housing

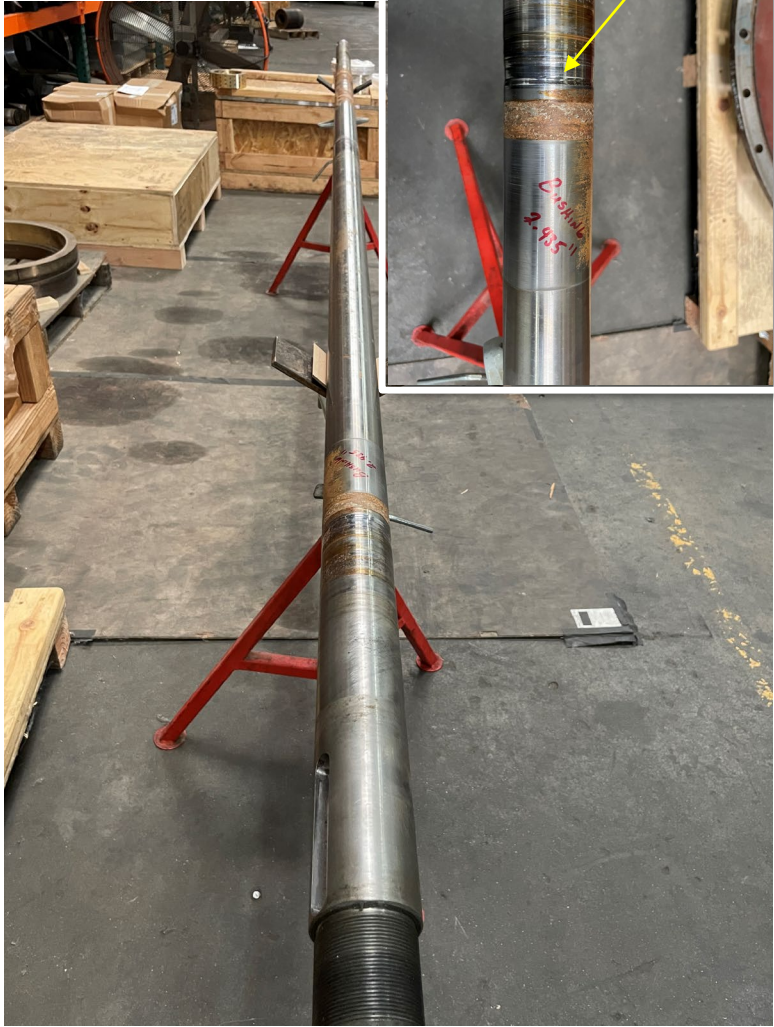
Turbine Drive Shaft

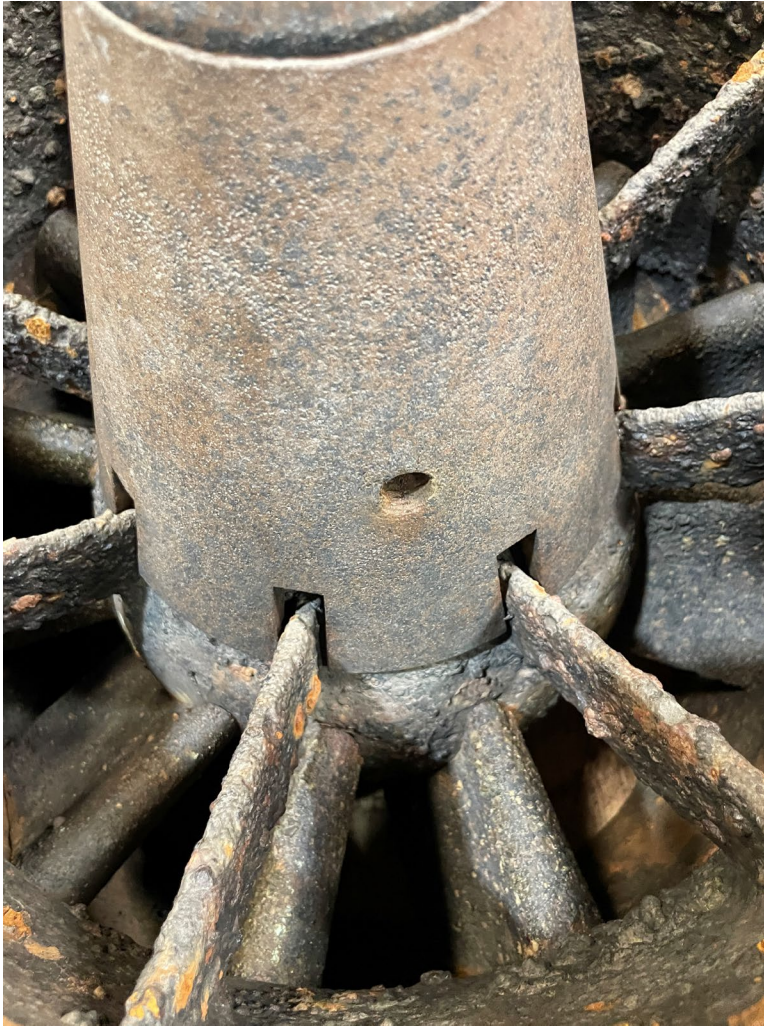
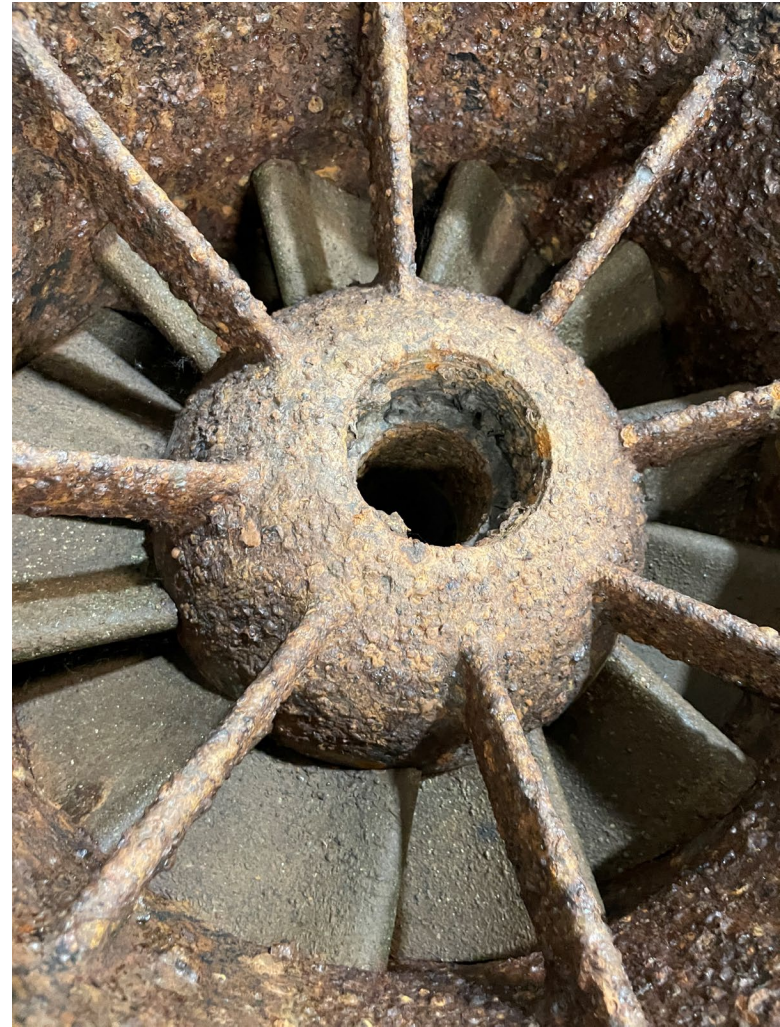
Corroded Wicket Gates

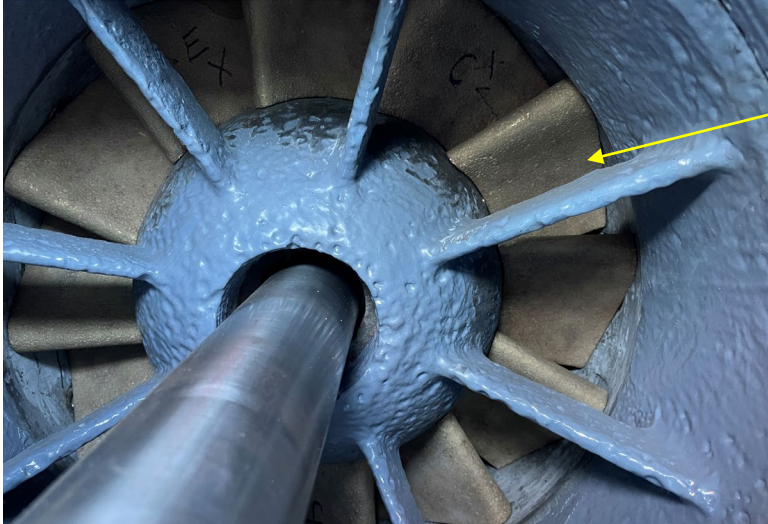
Cleaned and repaired wicket gates vanes/stems.

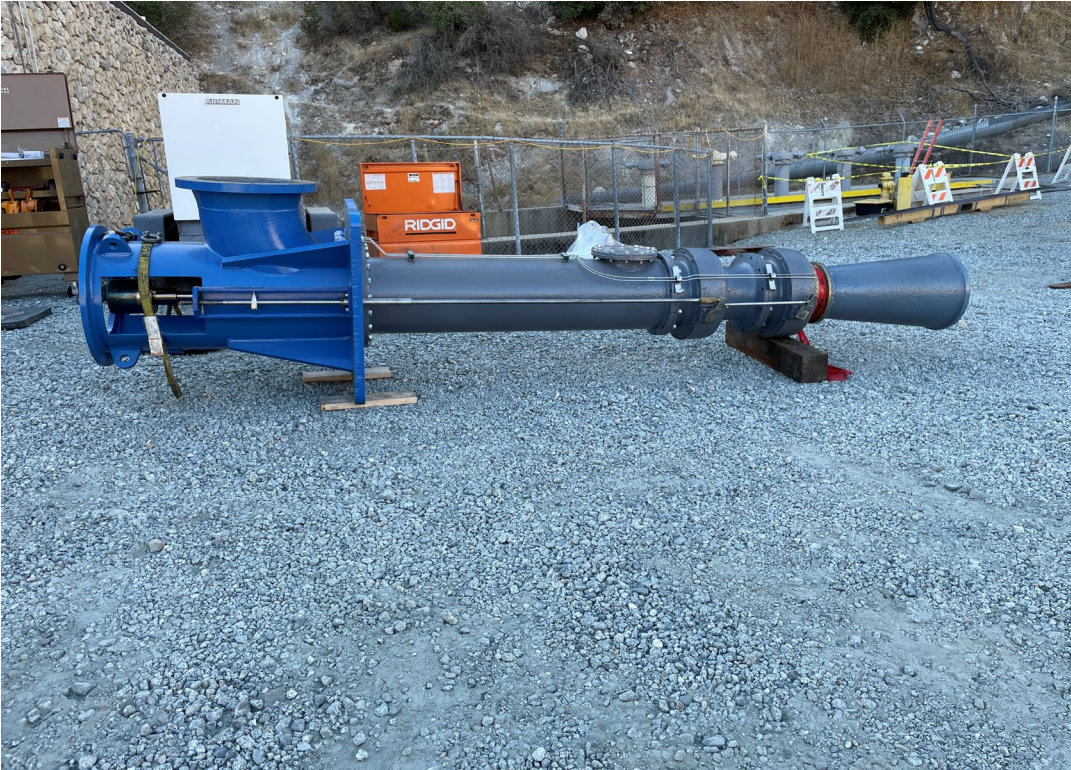
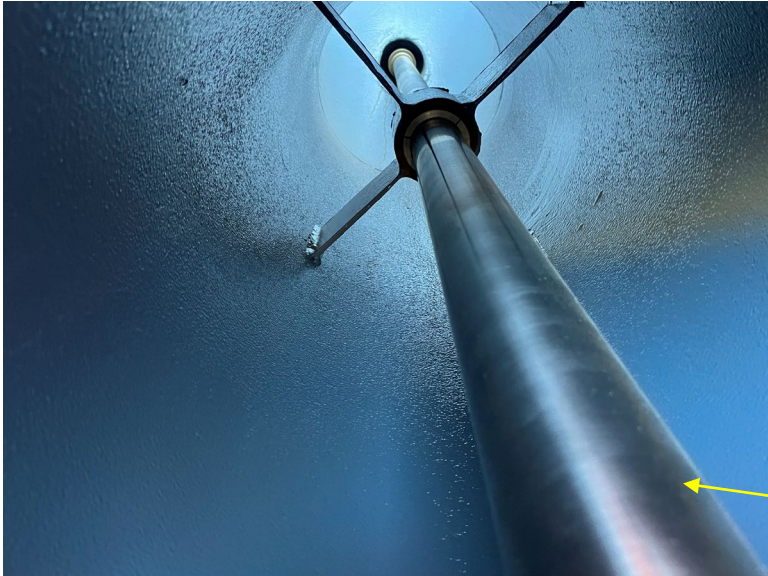
New Turbine Drive Shaft

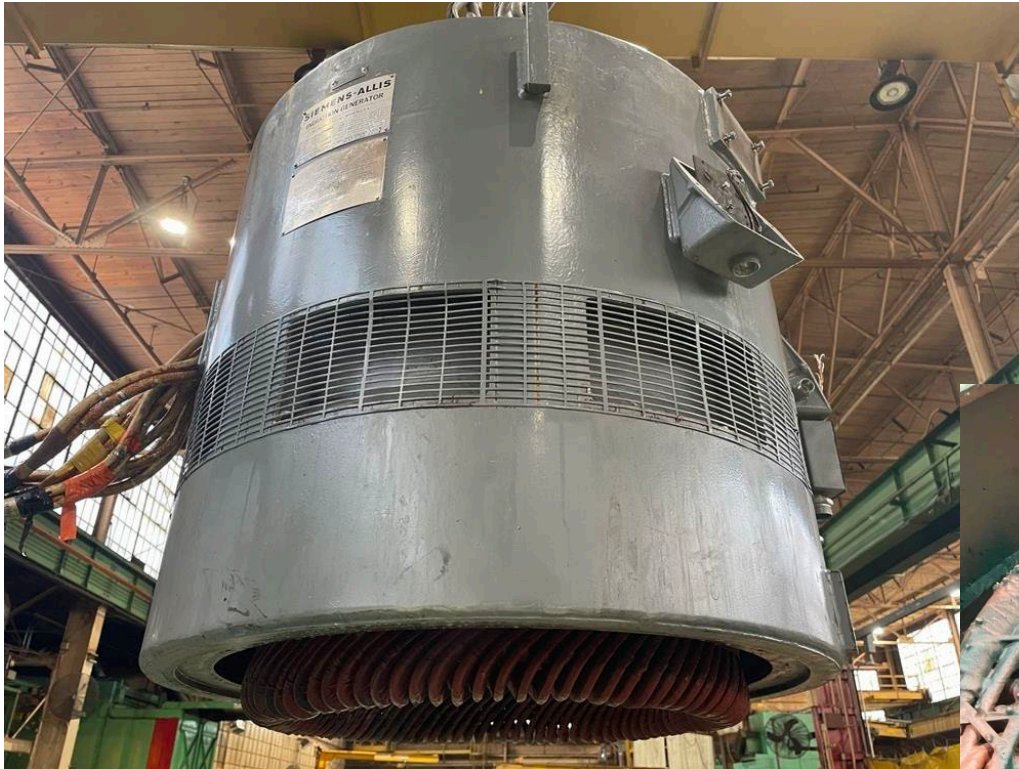
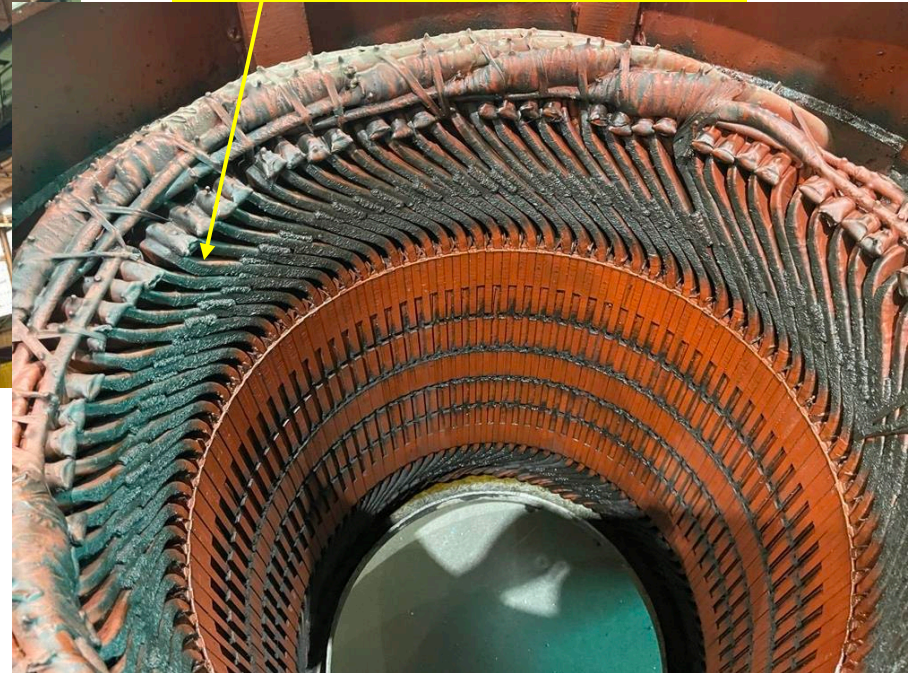
Oil/Junk on stator windings

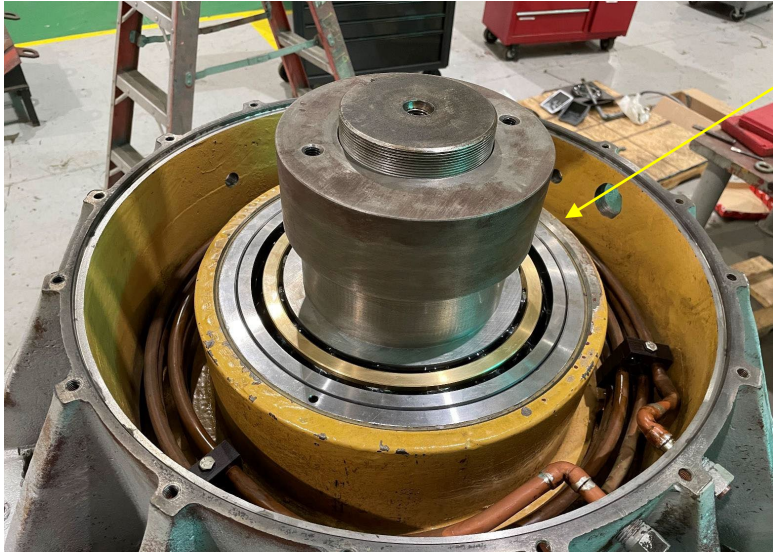
New Bearings

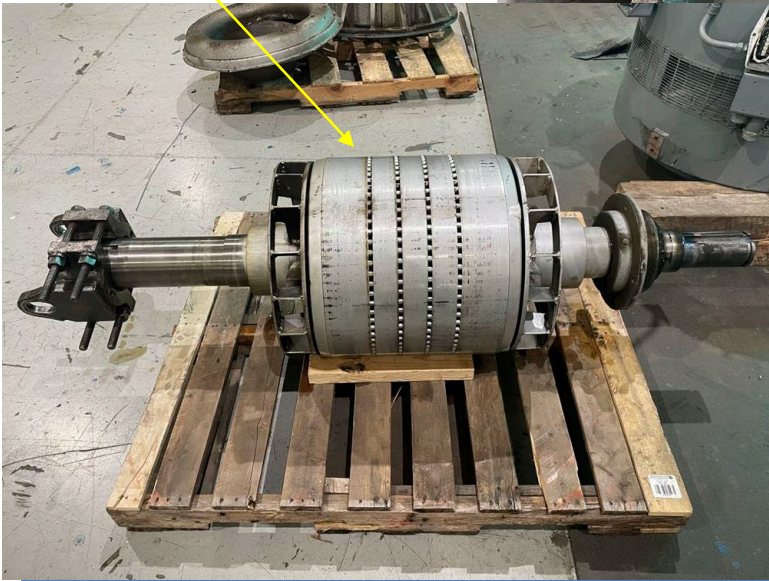
Rotor Cleaned

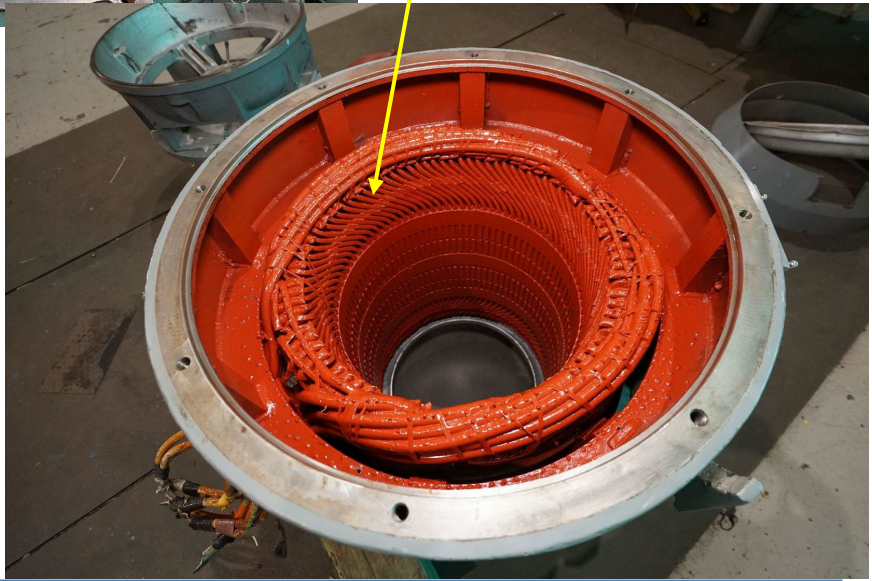
Stator cleaned and baked.

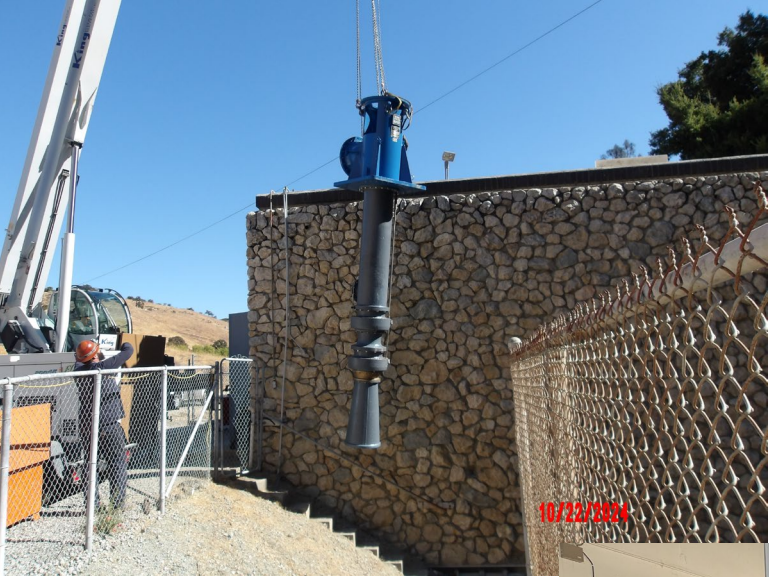
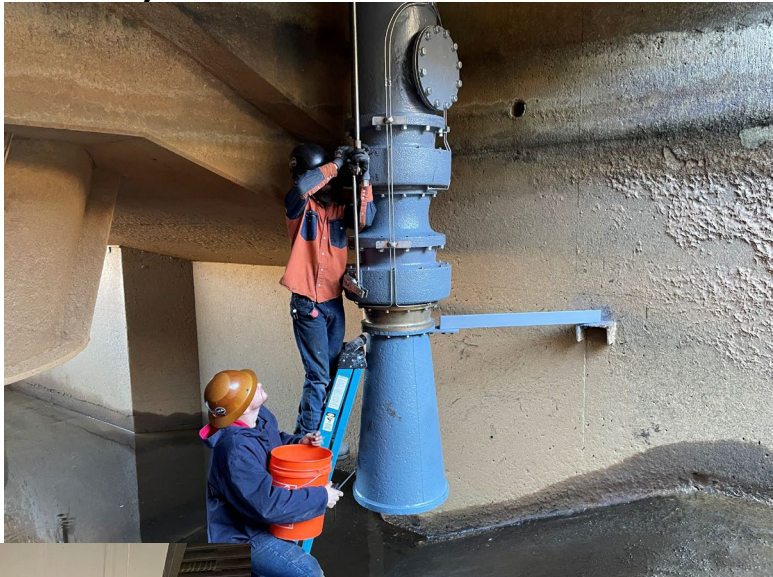
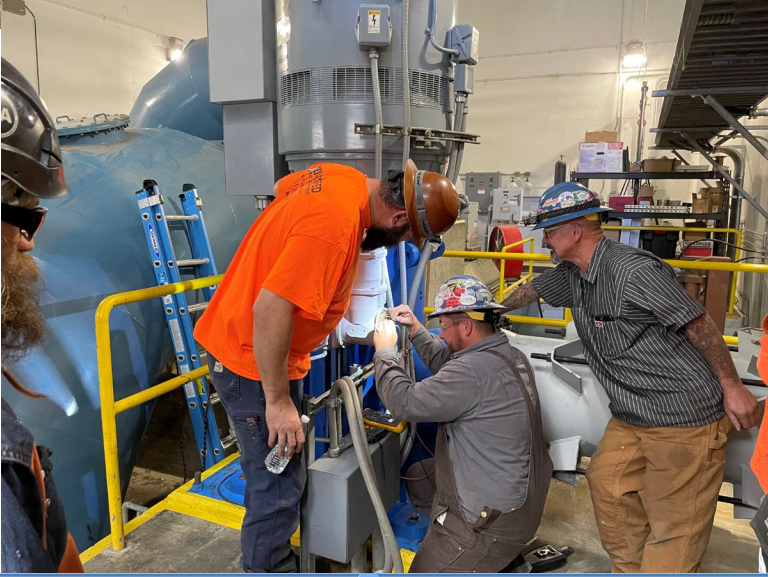
Unit 2 Installation (Phase 2).
