## Asbestos Survey Report

*County Facility*

1441 Schilling Place  
Salinas, California

Date: May 15, 2015

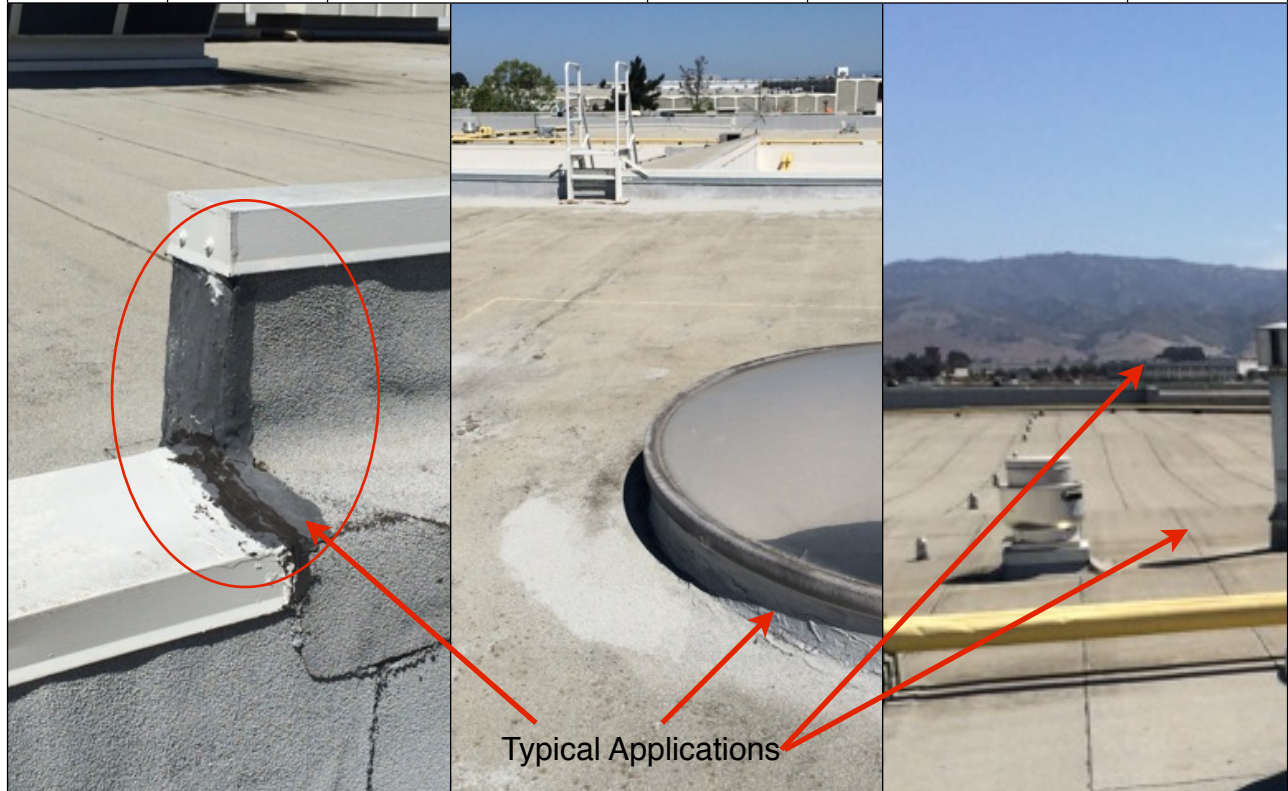
- \* Asbestos was not identified in any of the accessible, interior building materials associated with the North or South buildings.
- \* The roofing penetration, flashing, and patch mastics contain between 2%-8% Chrysotile asbestos. The material is applied over the non-asbestos roofing and appears grayish black in color, as it has weathered. Roof mastics are asphalt bound and therefore classified as Category I, Non-Friable Asbestos Containing Materials (ACM). Any disturbance of the mastics would require the work be performed by trained personnel, in correct personal protective equipment. If the mastics will be completely removed, the work must be conducted by a contractor with a Division of Occupational Health & Safety (DOSH) Asbestos License. There is approximately 2,000 square feet of material, distributed in 1-3 square foot applications, over the entire North and South Building roofs.

| <b>A s b e s t o s   S u m m a r y   T a b l e</b> | | | | | |
|--|---|---|---|---|--|
| Roofing Mastic Penetration, Flashing, Patch | North / South Roofs | Distributed over many locations of roofing where patches have been made, penetrations, flashing and parapet seams | 2%-8% Chrysotile | Category I, Non-Friable ACM | 2,000 SF dispersed over multiple locations |

- \* While the identified asbestos containing mastics are non-friable in classification, they must be correctly managed in-place if they are to remain. The data included in this report must either be incorporated into the County of Monterey's master Asbestos Operations & Maintenance (O&M) Program or an O&M program for the buildings on the property should be developed.

- \* Should removal of the identified asbestos containing roofing and duct mastics be slated, the work should be completed under the oversight of a third party Certified Asbestos Consultant (CAC). Ambient air monitoring and clearance inspections are recommended anytime asbestos removal will occur, to ensure an airborne asbestos hazard is not created during the course of asbestos removal.

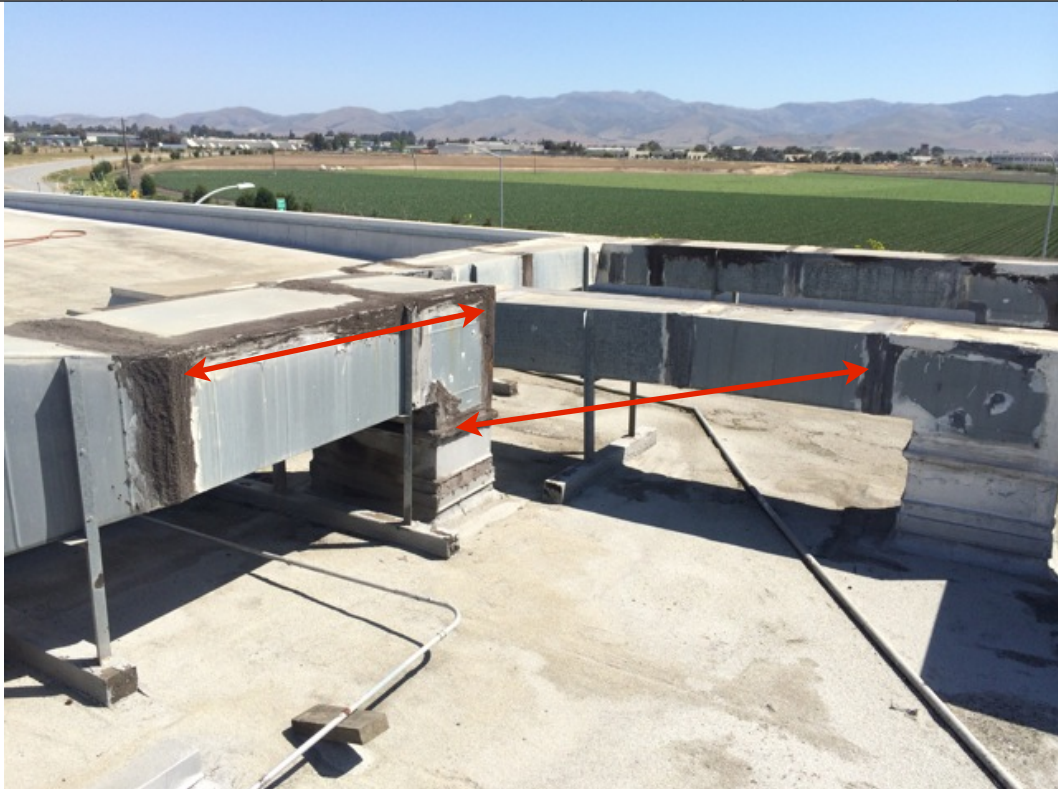
- \* A grayish mastic has been applied over roof mounted, metal HVAC ducting to protect the ducts from moisture intrusion. The mastic contains 10% Chrysotile asbestos and is classified as a Category I, Non-Friable ACM. There is approximately 250 square feet of mastic applied over the various HVAC ducts on the North and South Building roofs. The same compliance requirements apply to this material as noted above for the roofing mastics.

| <b>Asbestos Summary Table</b> | | | | | |
|---|---|---|---|---|--|
| HVAC Seam Mastic | North / South Roofs | <p>Various roof locations where roof mounted HVAC metal ducting is present.</p> <p>Note: Heavily applied on ducting adjacent to cooling tower</p> | 10% Chrysotile | Category I, Non-Friable ACM | 250 SF dispersed over multiple locations |
