Seismic Evaluation Report

Monterey County Courthouse, Annex & Parking Garage

1200 Aguajito Road, Monterey, CA 93940

Final Seismic Evaluation Report **Monterey County Courthouse, Annex, and Parking Garage**

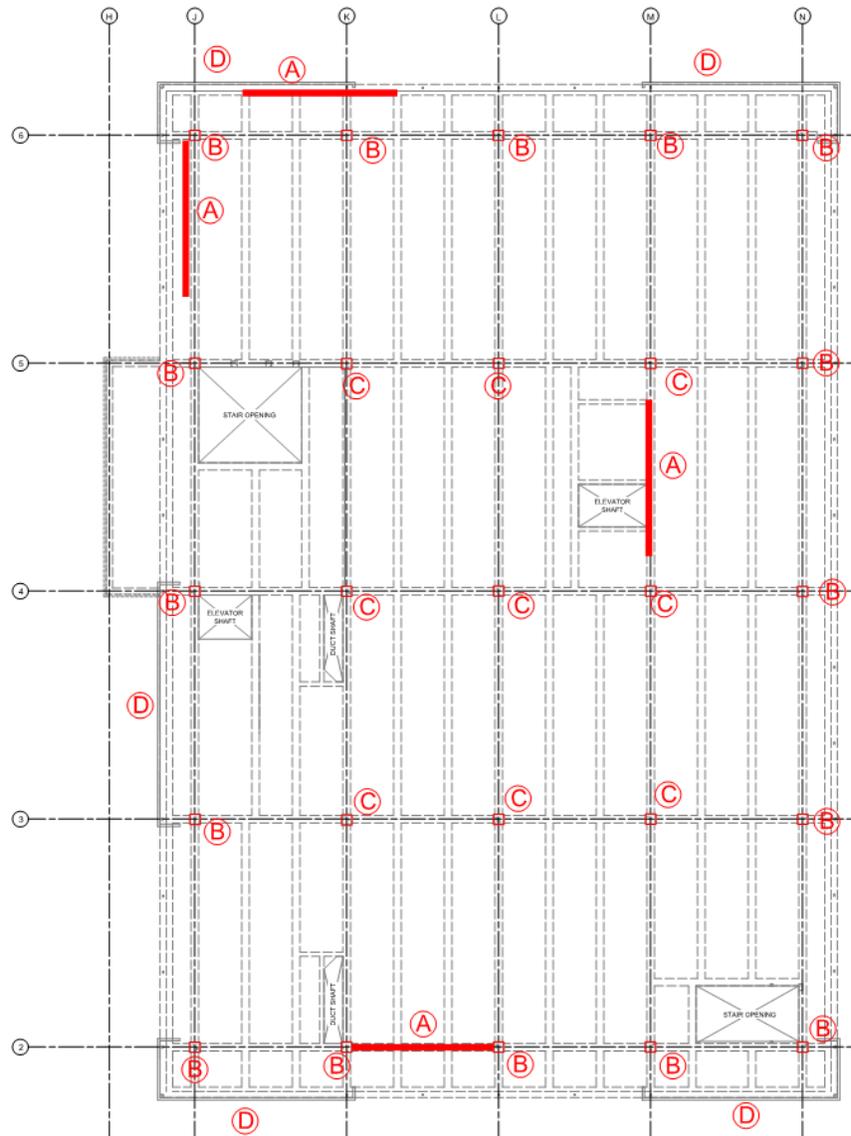
Figure 7: Typical floor plan at Courthouse indicating: A=proposed locations of retrofitted shear walls; B=exterior concrete columns; C=interior concrete columns; D=exterior precast concrete façade panels

RECOMMENDATIONS: Because columns were found to be inadequate to resist the BSE-1E seismic demands at the Life Safety performance level, a retrofit of the building is recommended to improve seismic performance. The recommended retrofit scope includes the addition of concrete shear walls in both directions at all levels. This new lateral system will significantly reduce building drifts and seismic demands on the concrete columns and provide the building with adequate strength and stiffness to meet the Life Safety performance objective at the BSE-1E hazard level. Additionally, we recommend “jacketing” the concrete columns at all floor levels with fiber-reinforced polymer (FRP) to provide adequate deformation compatibility with the new shear wall system.

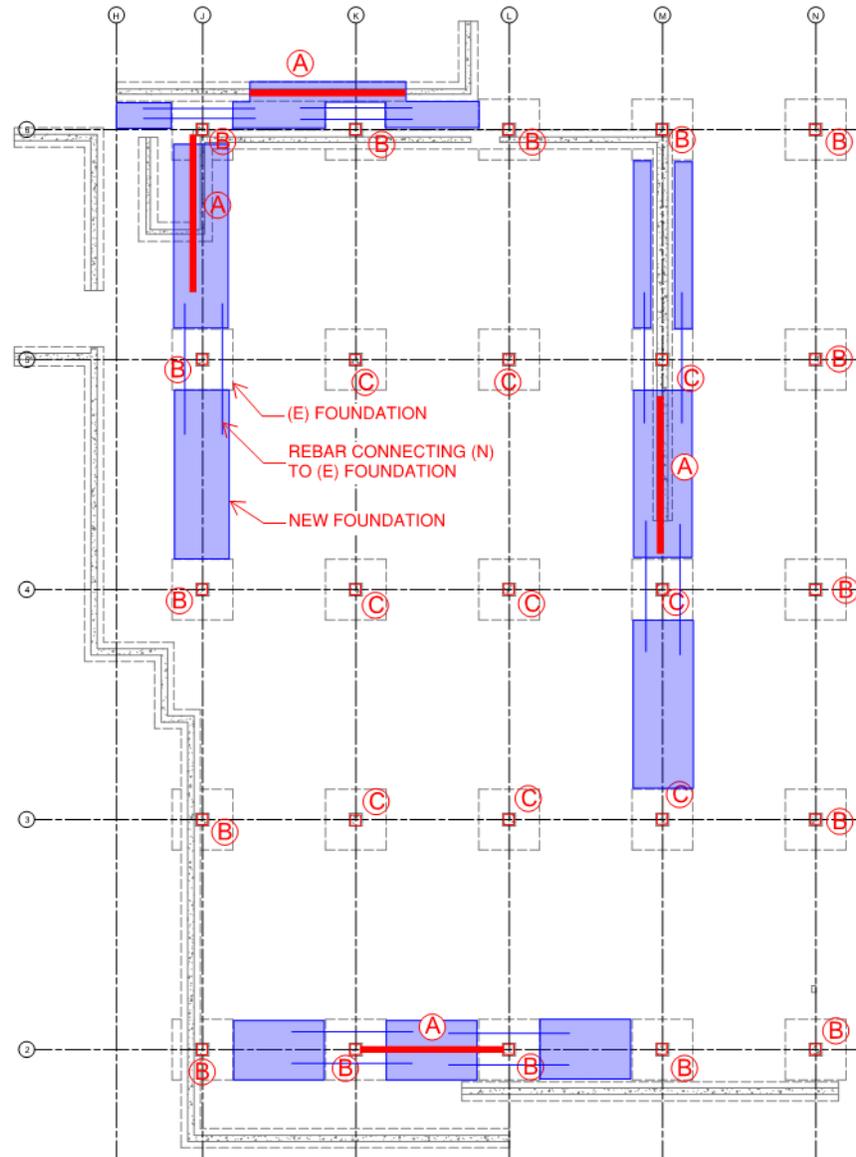
Figure 8: Foundation plan at Courthouse indicating: A=proposed locations of retrofitted shear walls; B=exterior concrete columns; C=interior concrete columns; purple boxes=new footings

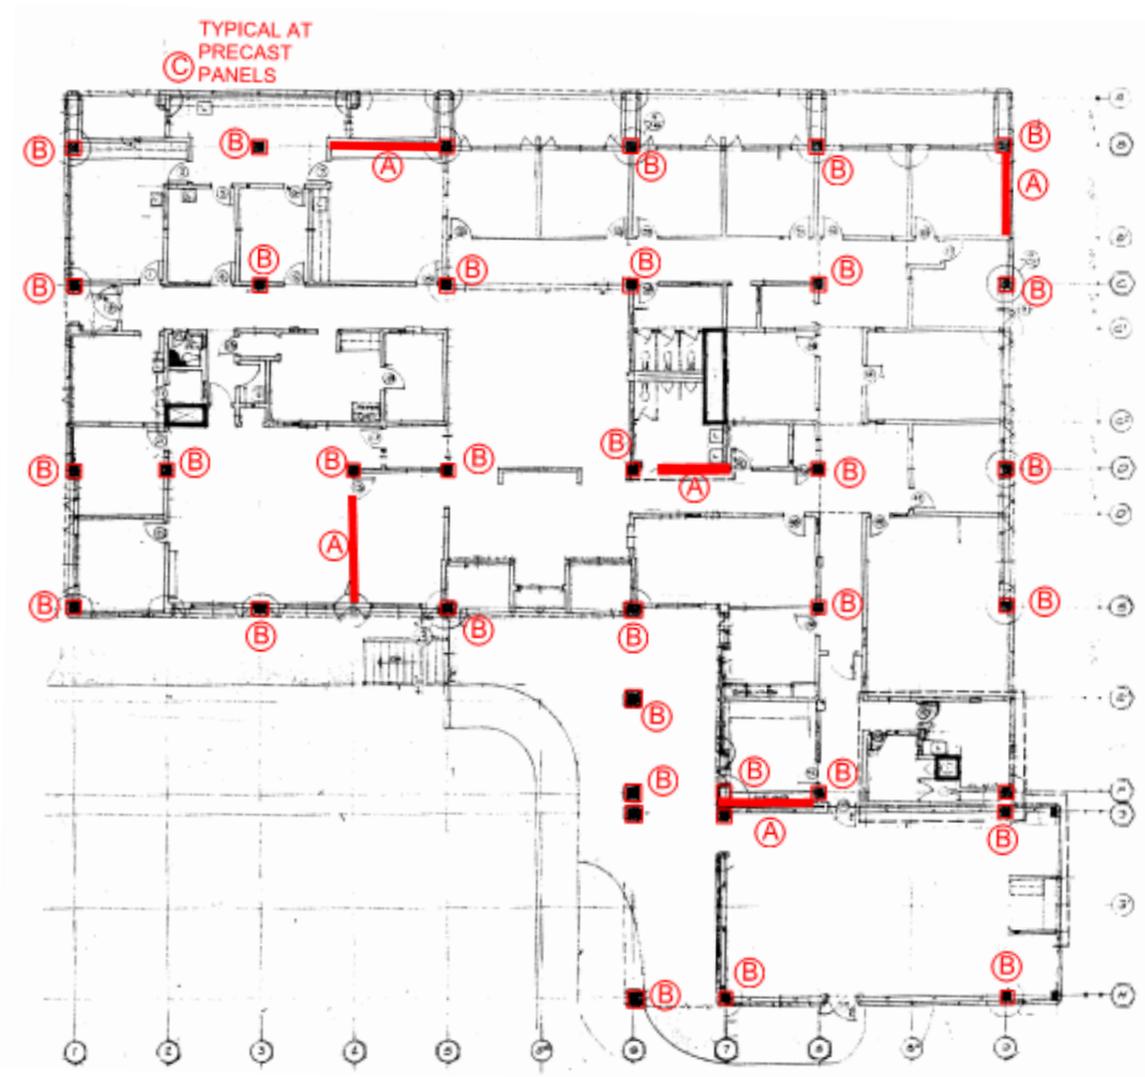
Figure 9: Typical floor plan at Annex indicating: A=proposed locations of retrofitted shear walls; B=concrete columns; C= exterior precast concrete façade panels

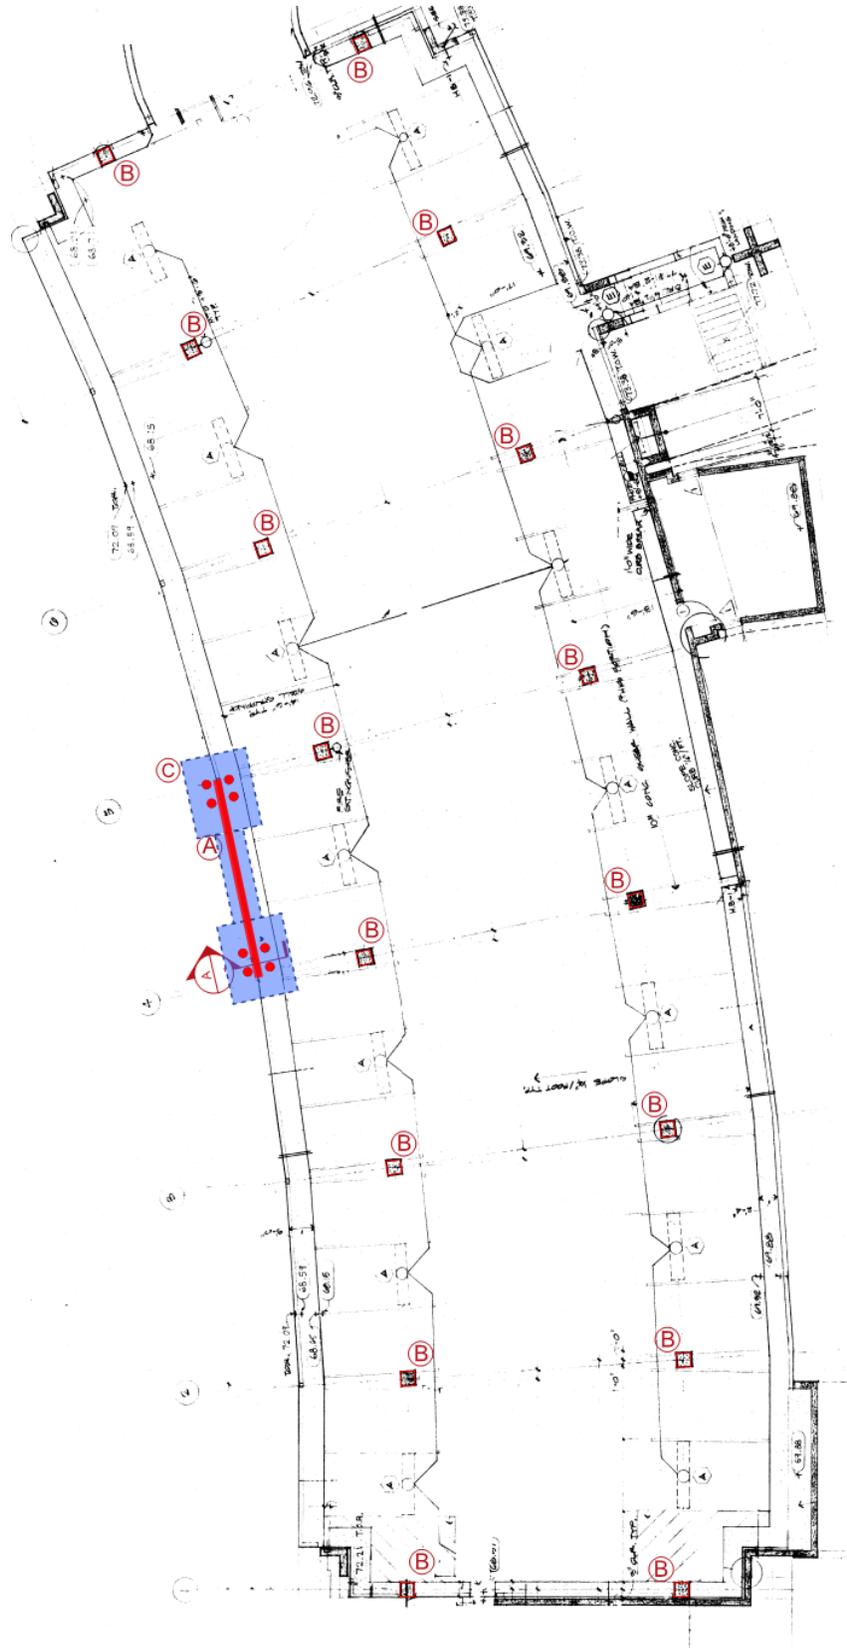
Figure 10: Typical floor plan at Parking Garage indicating: A=proposed location of retrofitted shear wall; B=concrete columns; C=new footing (also shown as purple boxes)

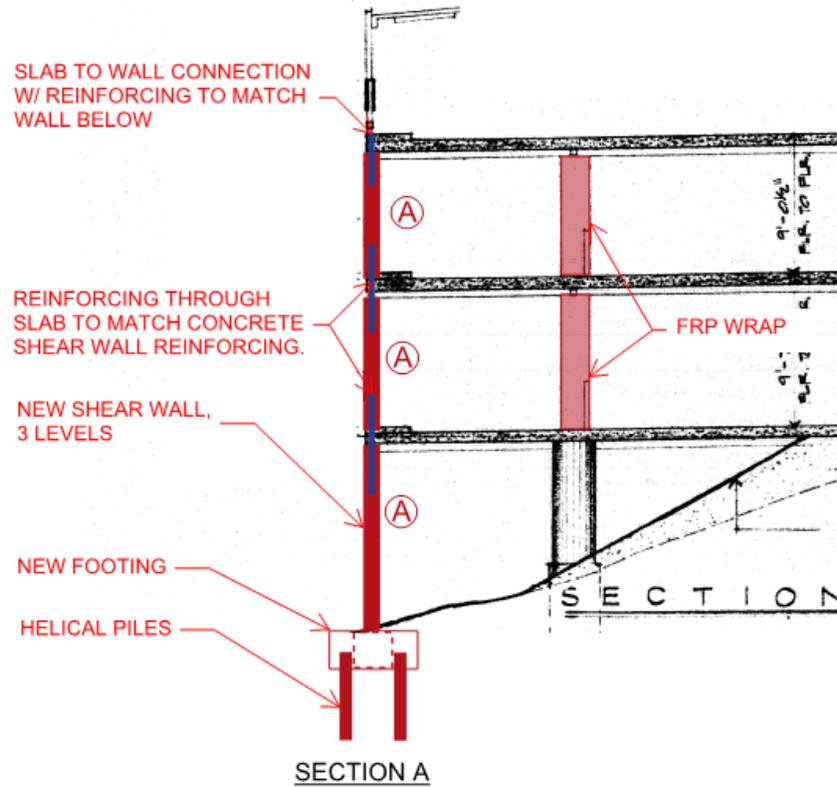
Figure 11: Section A through proposed new shear wall at the Parking Garage

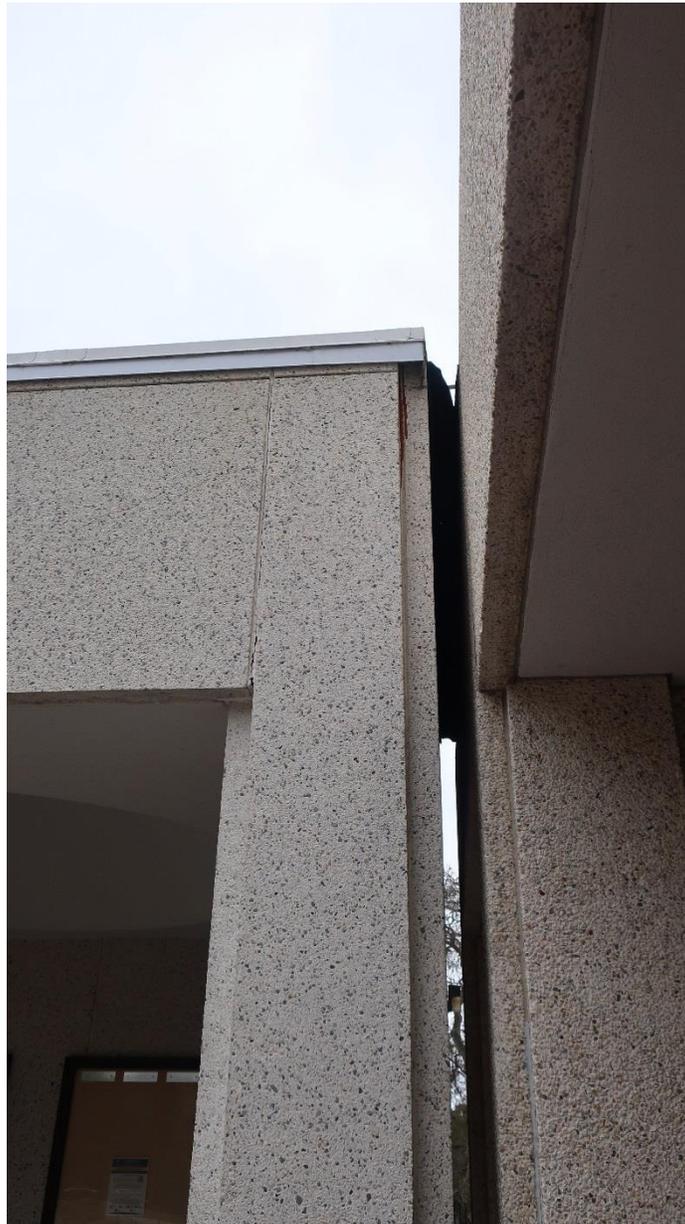
- a. ADJACENT BUILDINGS (ASCE Section 4.3.1.2): *“The clear distance between the building being evaluated and any adjacent building is greater than 4% of the height of the shorter building.”* The height of the Annex above grade is approximately 13'-6". Four percent of 13'-6" is approximately 6.5 inches. Because the gap between the Courthouse and Annex is only approximately three inches, this Tier 1 deficiency is applicable.

Photo 3: Seismic Gap Between Courthouse and Annex

RECOMMENDATION: The addition of new shear walls in both buildings will provide additional stiffness and will decrease the anticipated lateral deformations of the buildings during an earthquake. Additional analysis should be performed to estimate horizontal movement in a seismic event with the additional stiffness considered. Minor damage may occur due to pounding between structures during a seismic event; however, damage due to this condition is not anticipated to cause life safety structural concerns within the subject building. Improved anchorage of the precast panel finish at these locations may also be prudent to reduce the probability of the panels being dislodged in a seismic event.

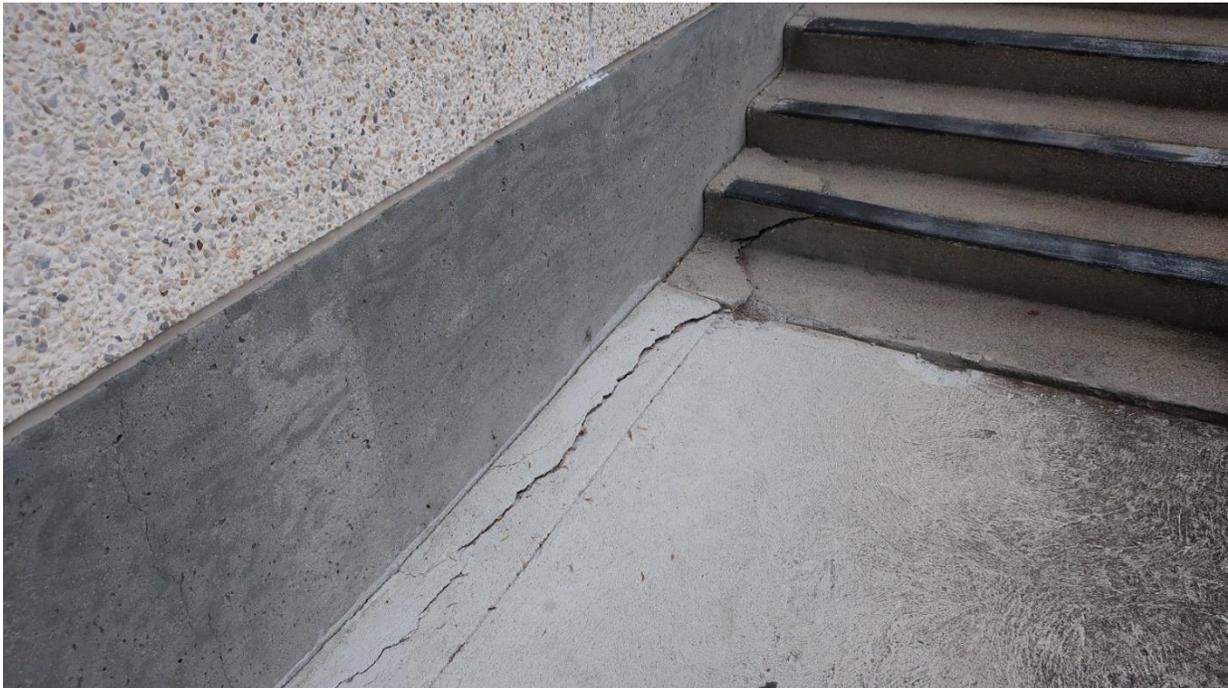
Courthouse: Localized damage to the exterior sidewalk slab and stair on the southeast side of the building was observed. The cracking appears to have been caused by settlement of the slab adjacent to the building, but does not appear to be structurally significant to the building itself. See Photo 6 in Appendix A.

Photo 6: Cracked Exterior Sidewalk Slab at the Courthouse

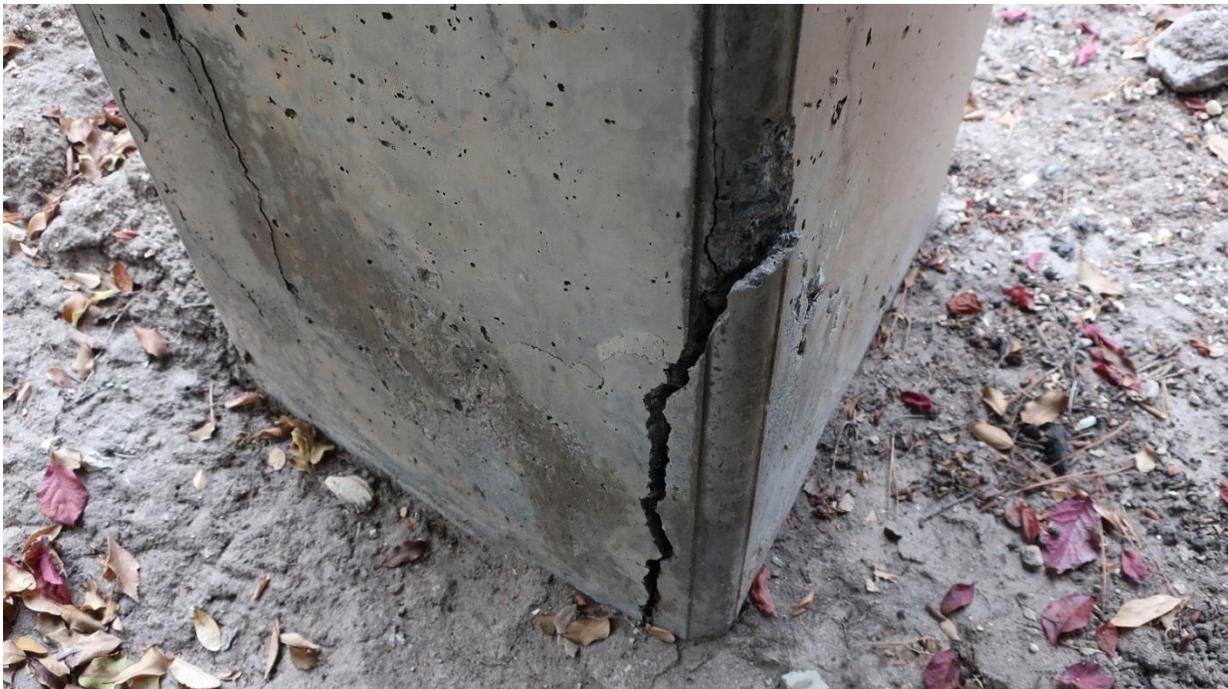
Annex: Spalling of an exterior concrete column was observed at the northeast corner of the Annex. The spalling appears to be isolated to this column and does not appear to be structurally significant. See Photo 7 in Appendix A.

Photo 7: Spalled Concrete at Existing Column at the Annex

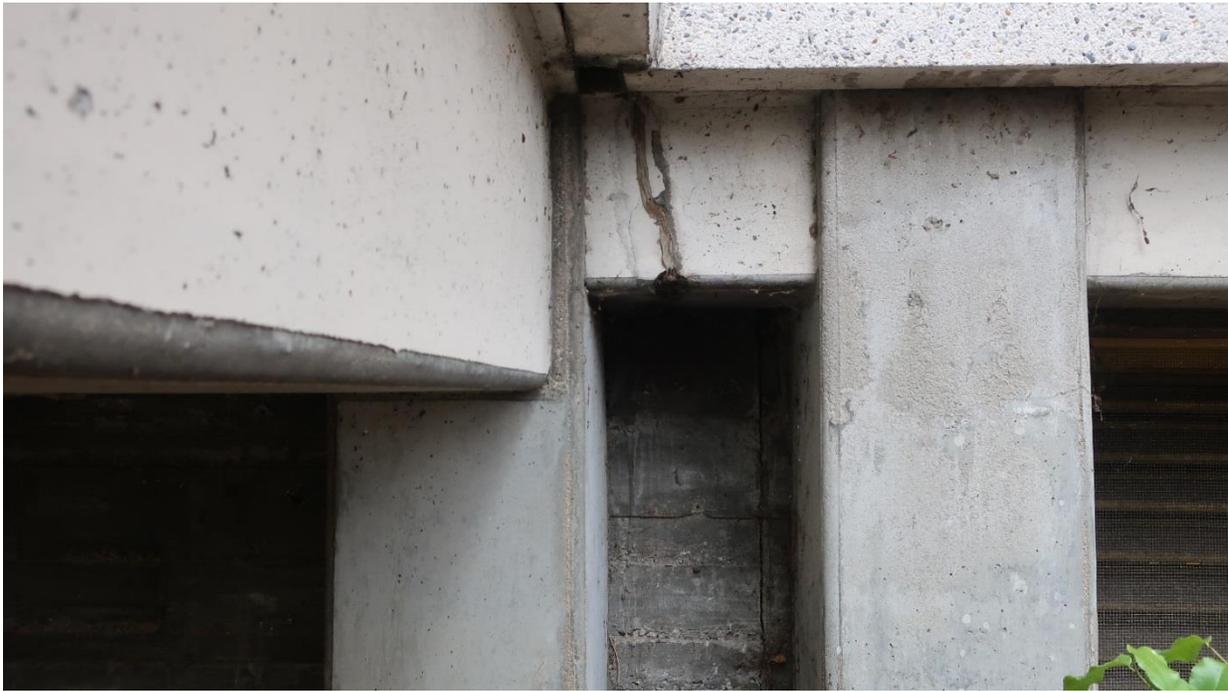
A large crack was observed in a concrete beam and exterior concrete wall at the exterior of the northwest corner of the Annex building adjacent to the Courthouse. The crack may have been caused by differential settlement between the two buildings, although no signs of settlement were readily observed in the rest of

the building. Therefore, the crack does not appear to be structurally significant. See Photo 8 in Appendix A.

Photo 8: Cracked Concrete Beam and Wall at Annex Exterior

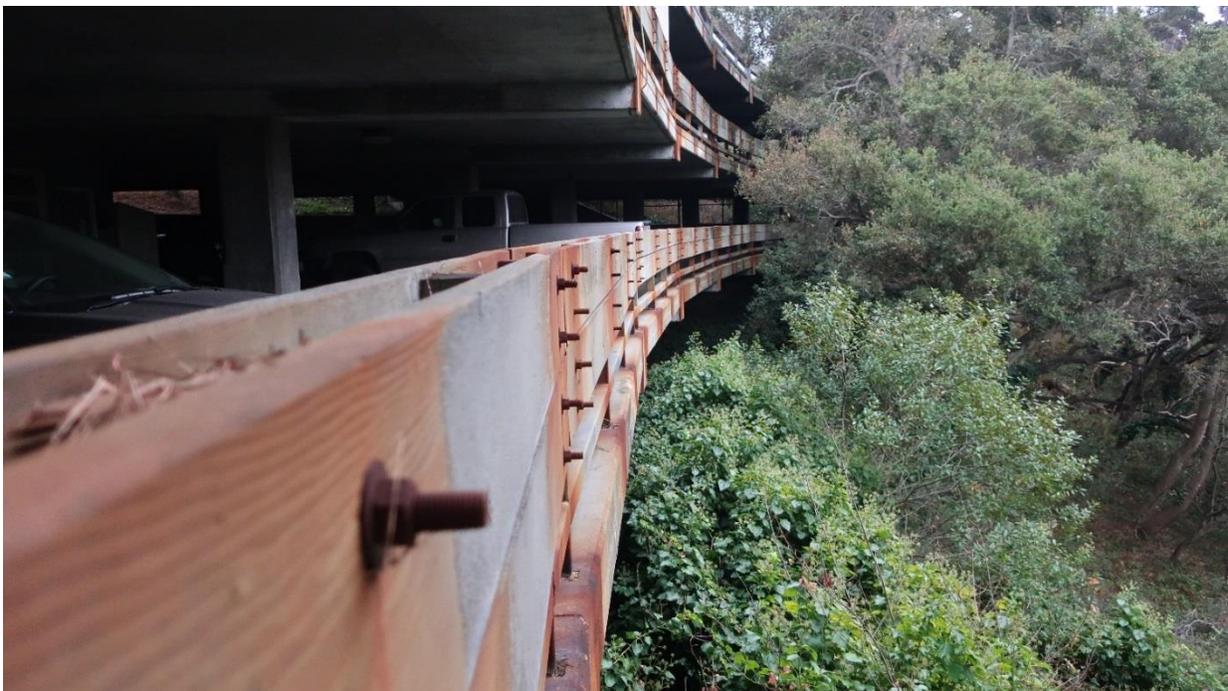
Parking Garage: Systemic corrosion was observed in nonstructural components throughout the parking garage, particularly in guardrails and associated hardware. Dry rot and or deterioration due to pests was also observed in wood members on the roof. None of these conditions are judged to be structurally significant. See Photos 9 and 10 in Appendix A.

Photo 9: Corrosion at Parking Garage Guardrail

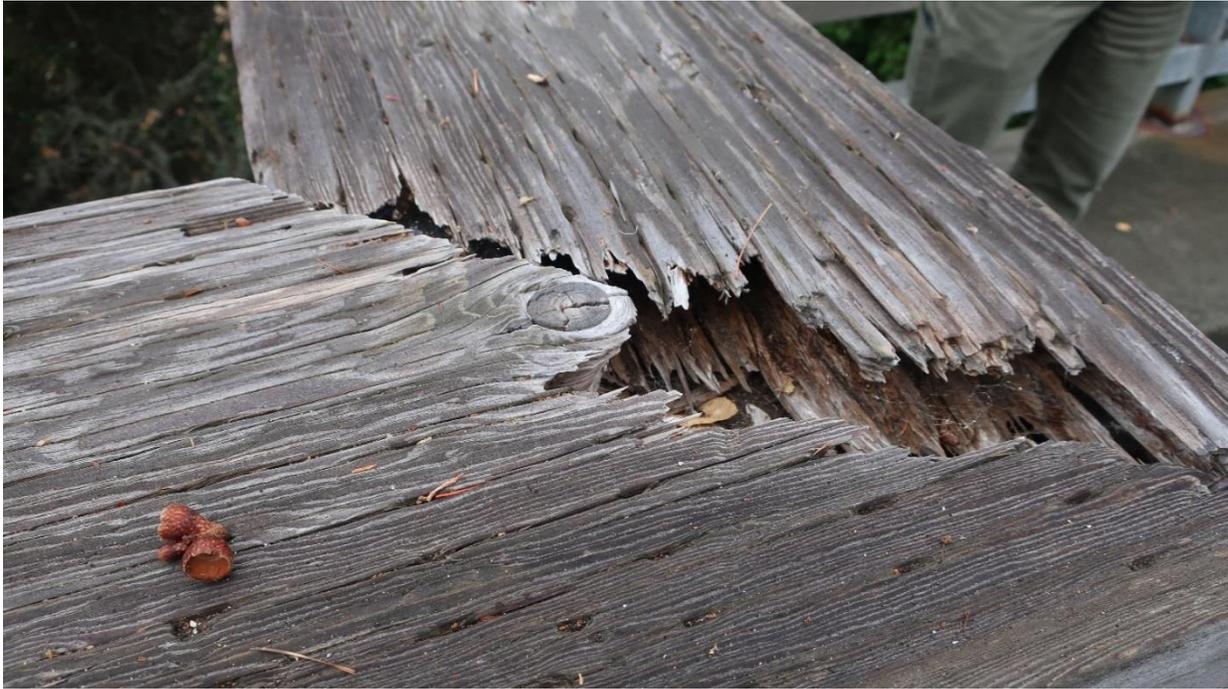
Photo 10: Deteriorated Wood at Parking Garage
