THOMPSON
WILDLAND MANAGEMENT

March 2, 2026

To: Carmel Valley Manor
8545 Carmel Valley Road
Carmel, CA. 93923
County File#: PLN240141
APNs: 169-061-012, 169-061-017 & 169-061-018

Carmel Valley Manor Community Improvement & Development Project Tree
Impact Assessment

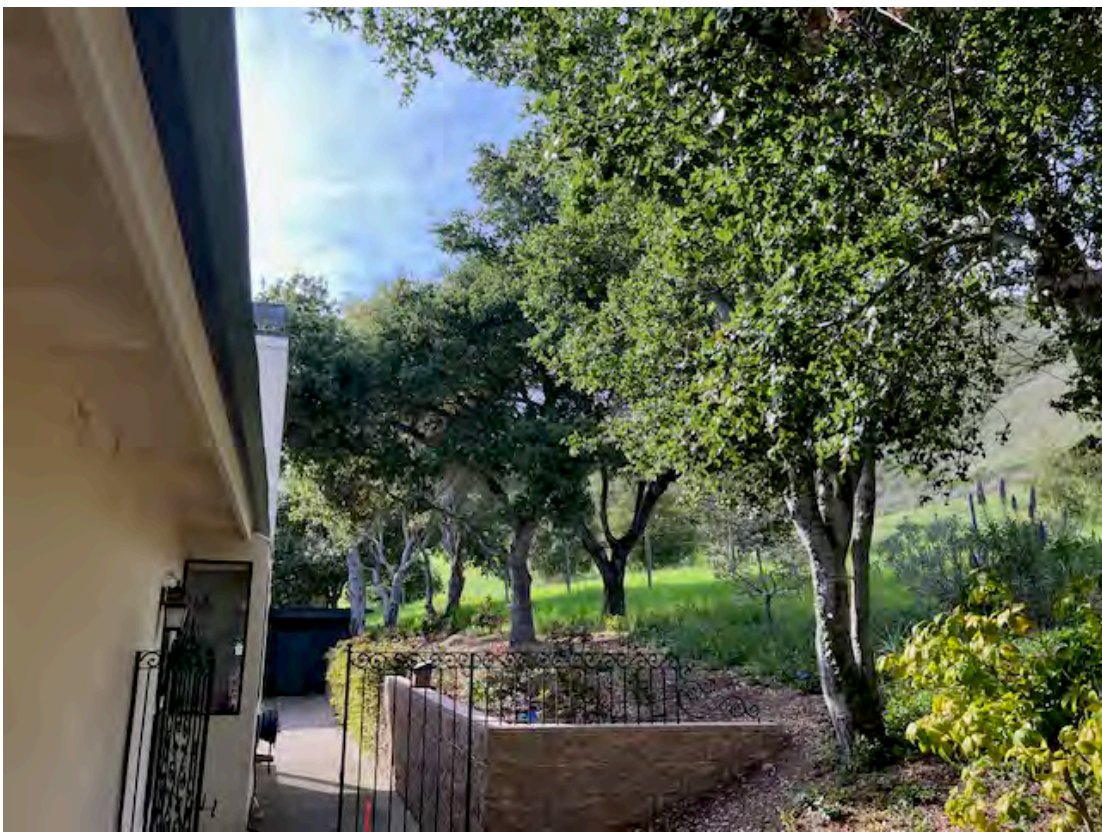
Figure 1. These coast live oaks are no longer a part of the project and will be retained.

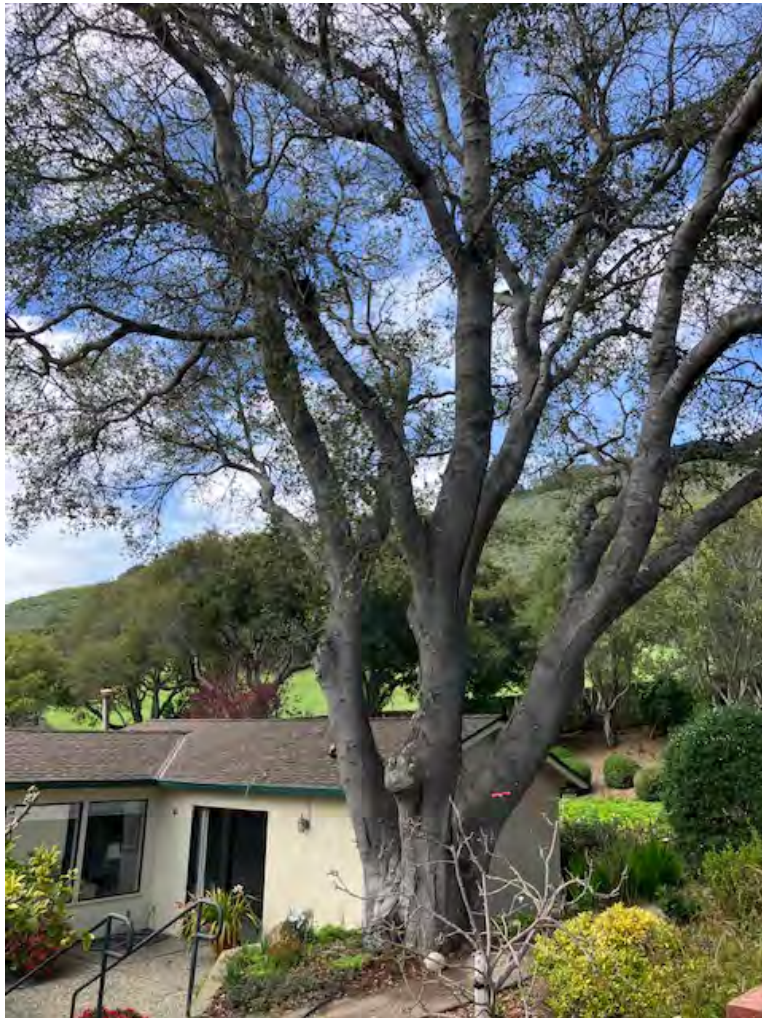
Figure 2. This large coast live oak is no longer a part of the project and will not be impacted by project operations.

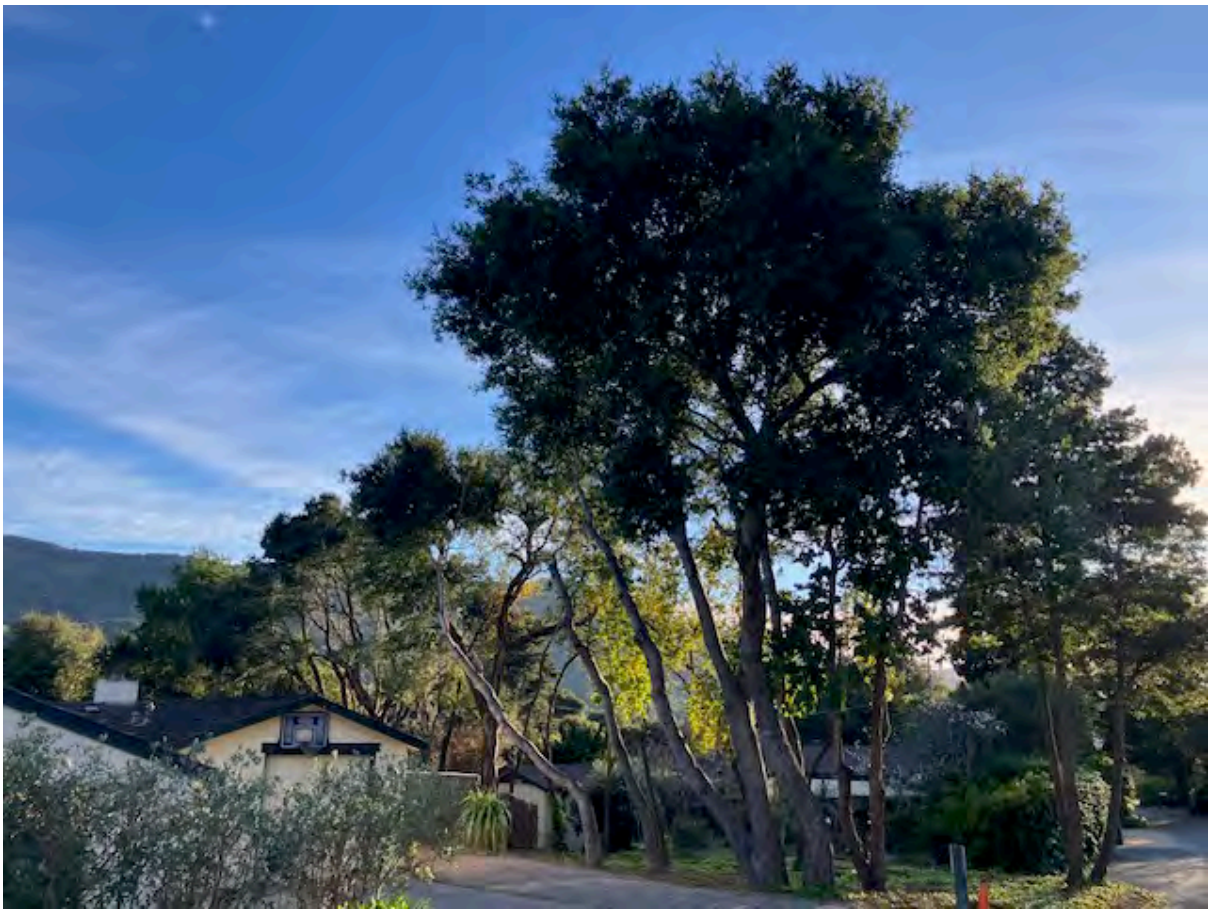
Figure 3. These 7 oaks are no longer a part of the project and will be retained.

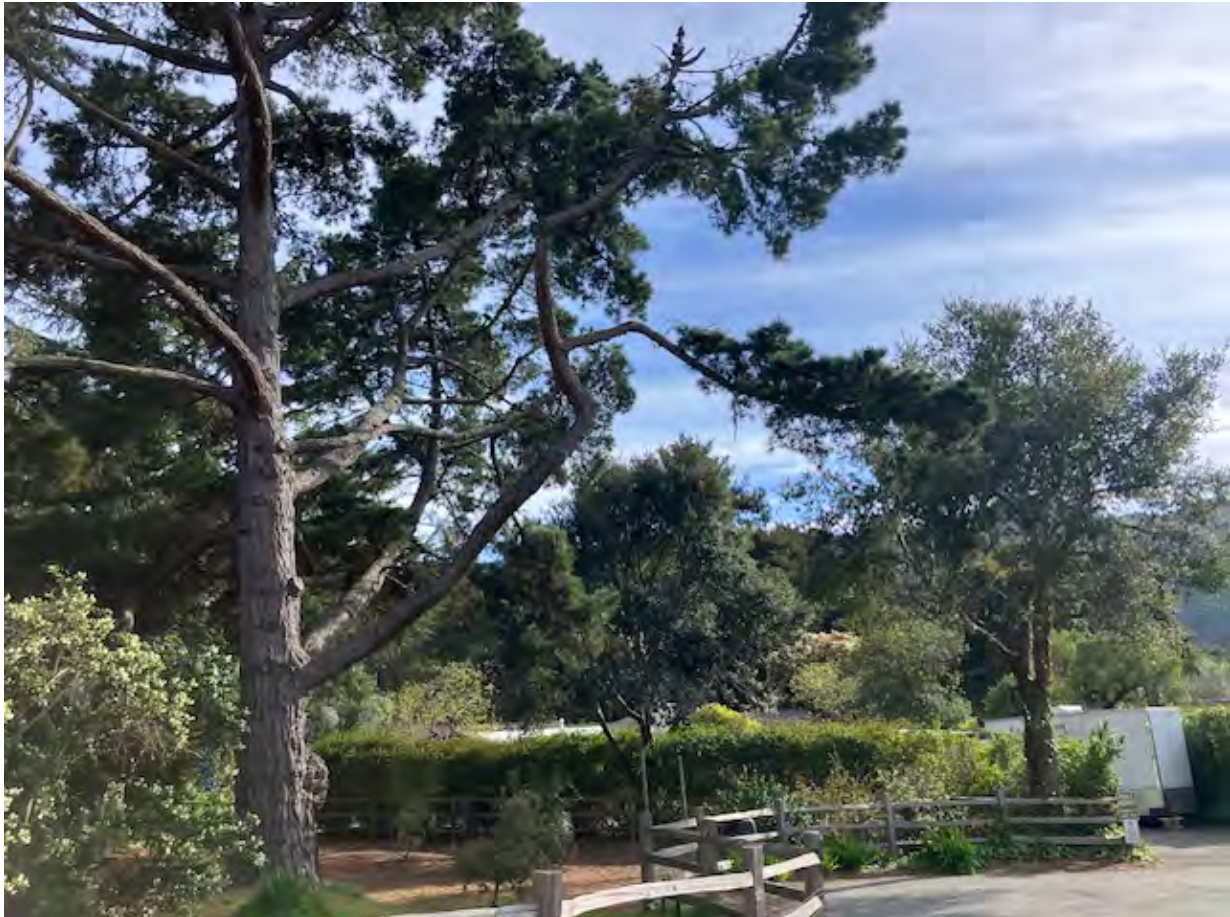
Figure 4. These oaks and pine are no longer a part of the project and will be retained.

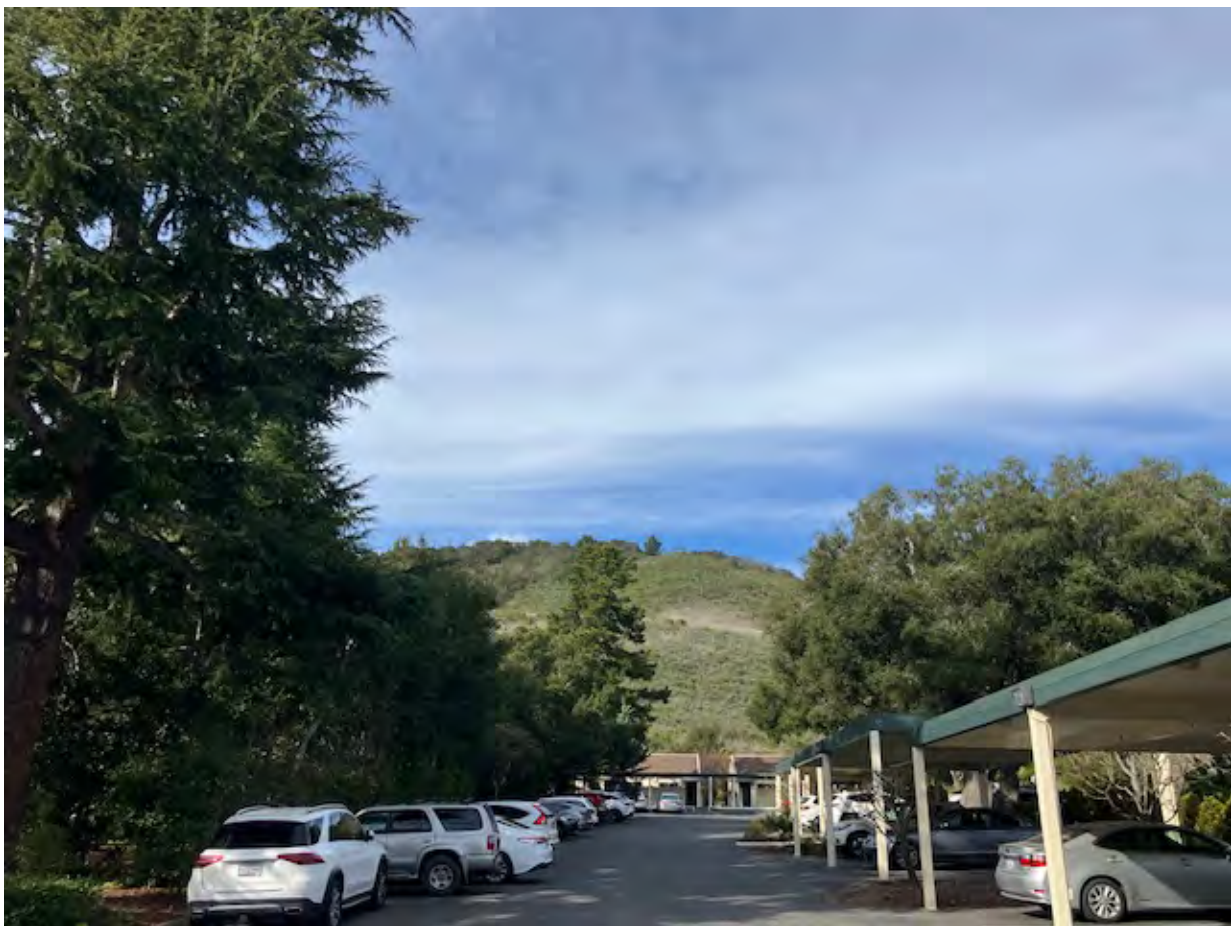
Figure 5. The F1 & F2 project site is currently used for parking. Some of this area will continue to be used for parking.

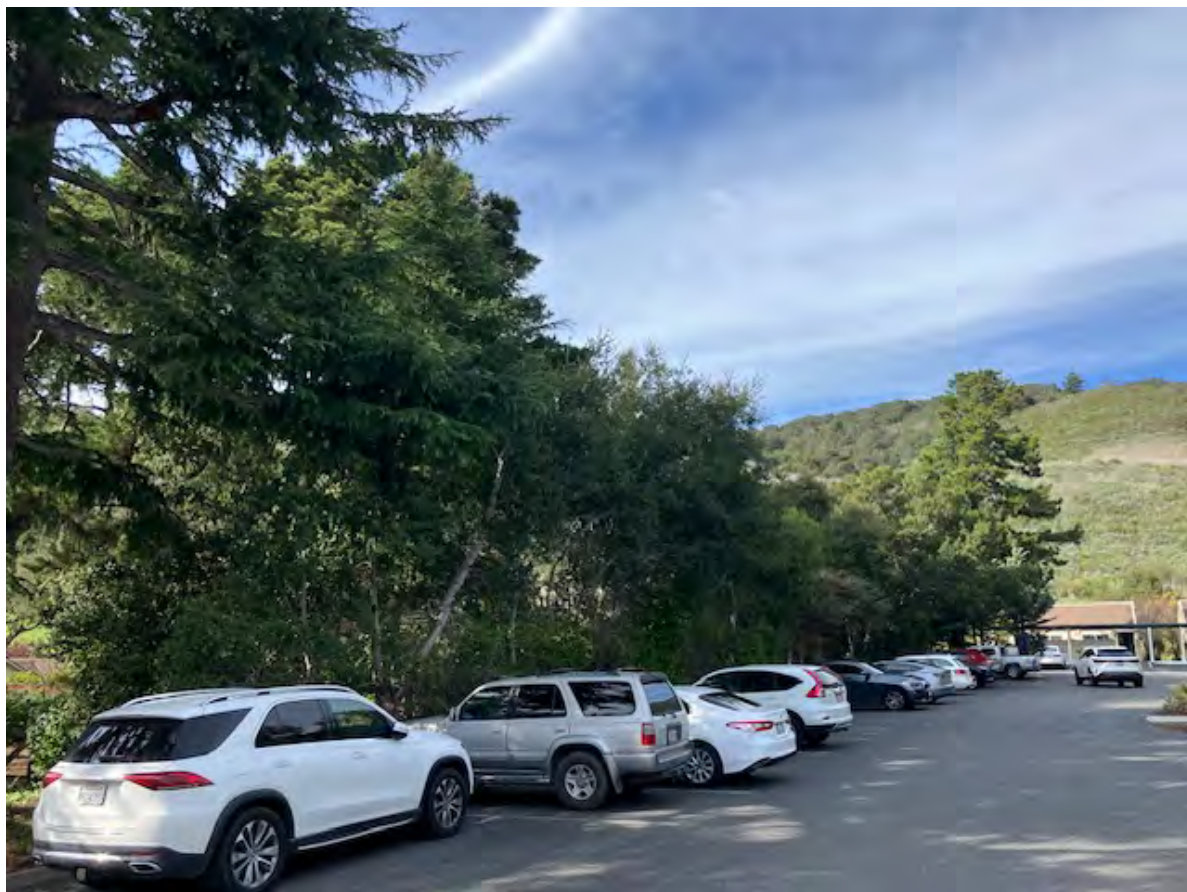
Figure 6. The oaks along the left side of the parking area will be retained and protected, but will require pruning in order to provide adequate clearance.

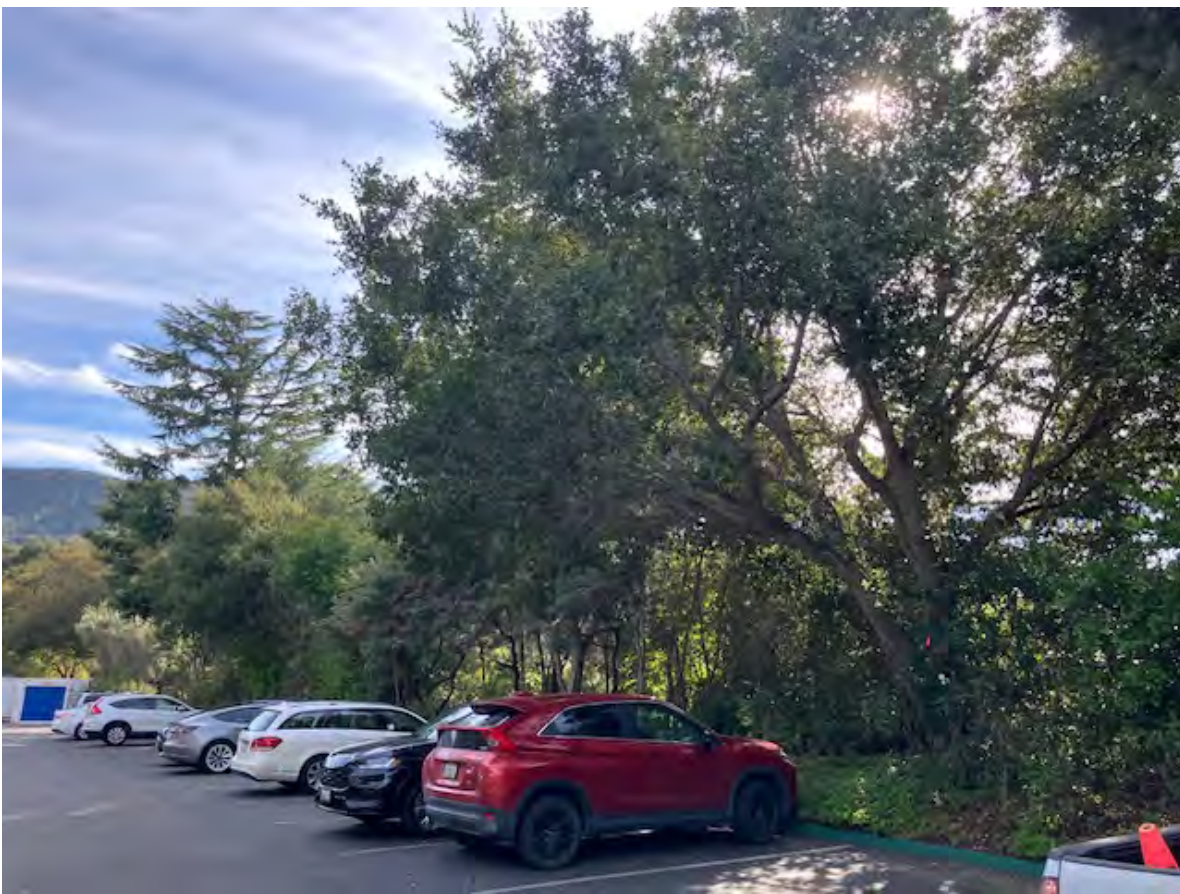
Figure 7. The oaks along parking area near the proposed F1 & F2 units will be retained and protected, but will require pruning in order to provide adequate clearance from construction activities and the future structure.

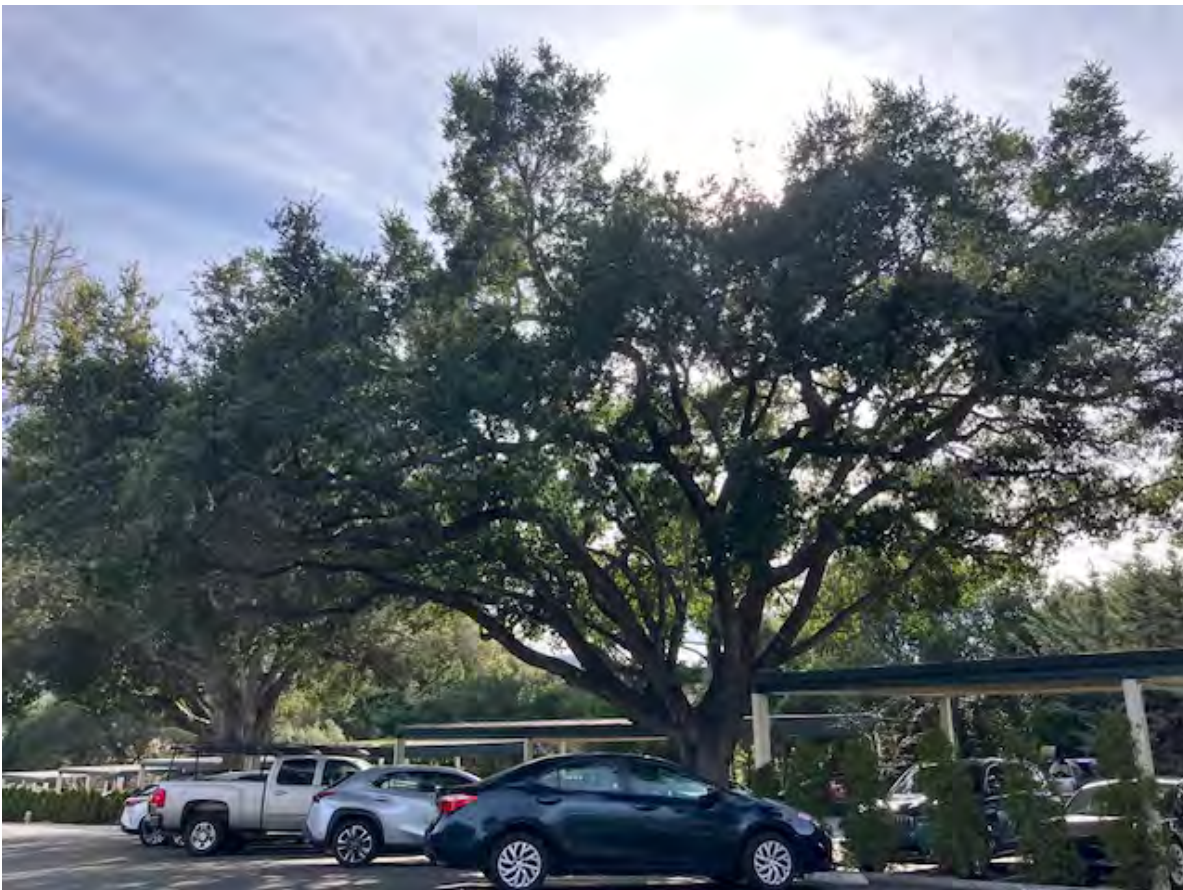
Figure 8. The large oak located in the center of photo (Tree#130) near the proposed F1 & F2 units is proposed for removal and the large oak visible to the left (i.e., Tree#129) will be retained and protected.

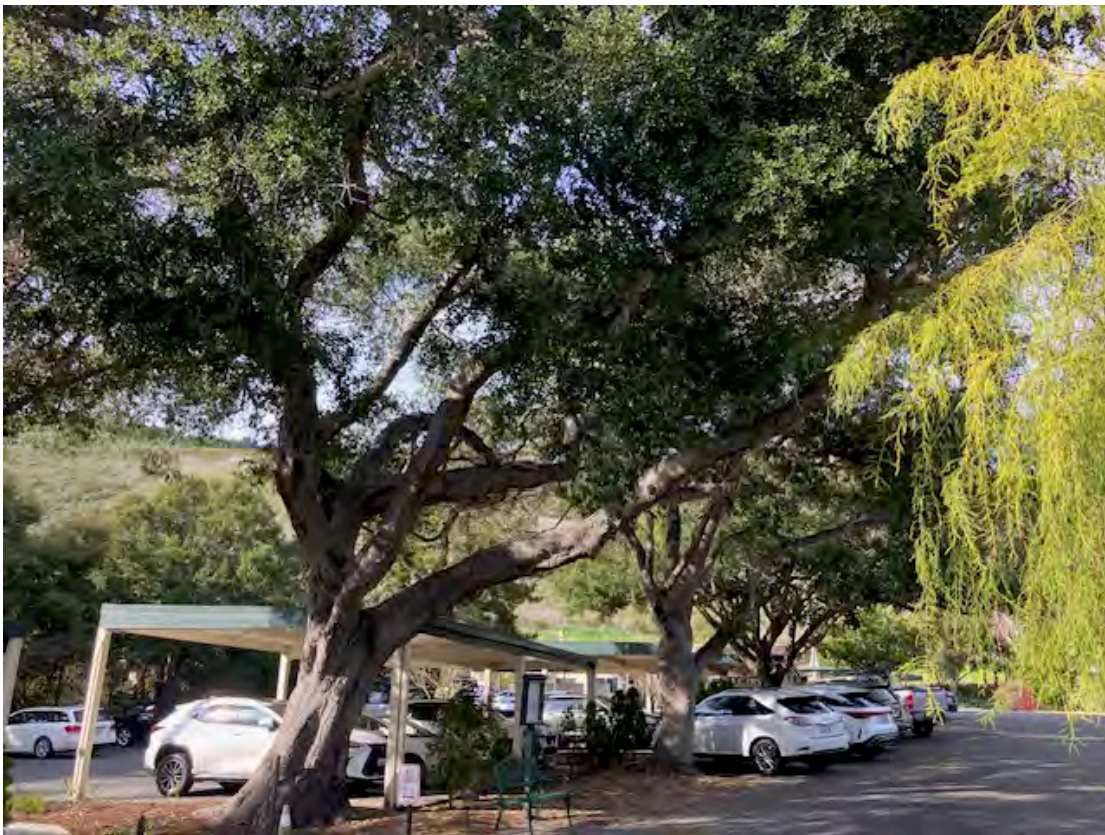
Figure 9. Another view of oaks located near the planned F1 & F2 units. Tree#130 to the left is proposed for removal and the oak in the center background (Tree#129) will be retained and protected. The oak seen in background (Tree#128) fell during a recent storm and is no longer present.

Note: One large oak identified as Tree#128 fell during a recent storm due to natural causes.

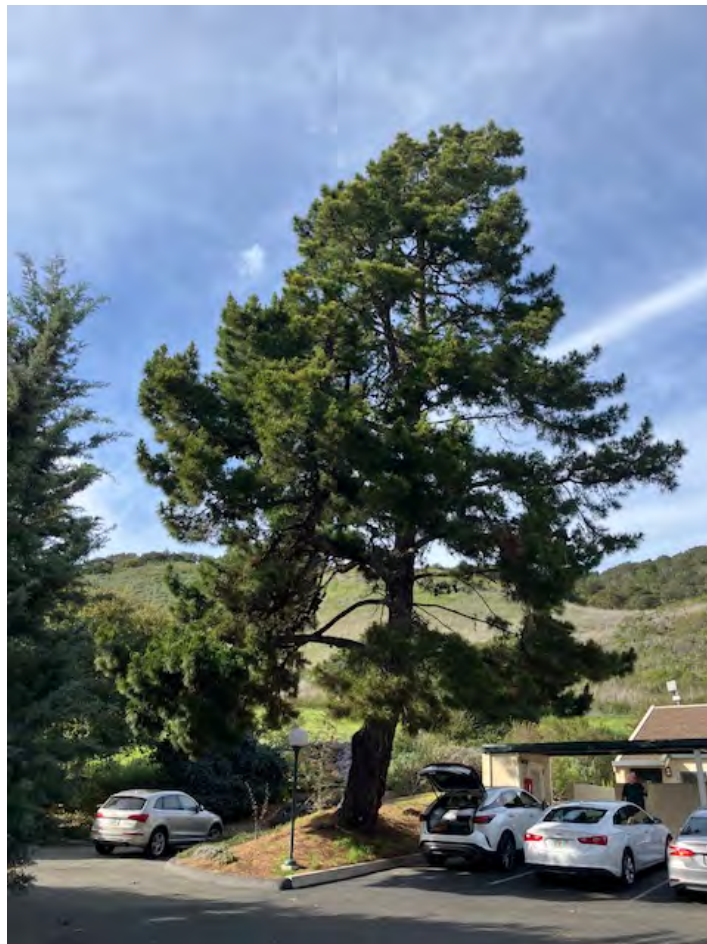
Figure 10. One of 3 aging pines recommended for removal due to construction impacts and potential hazard concerns. Pine removal does not require a County permit in this inland area of Carmel Valley.

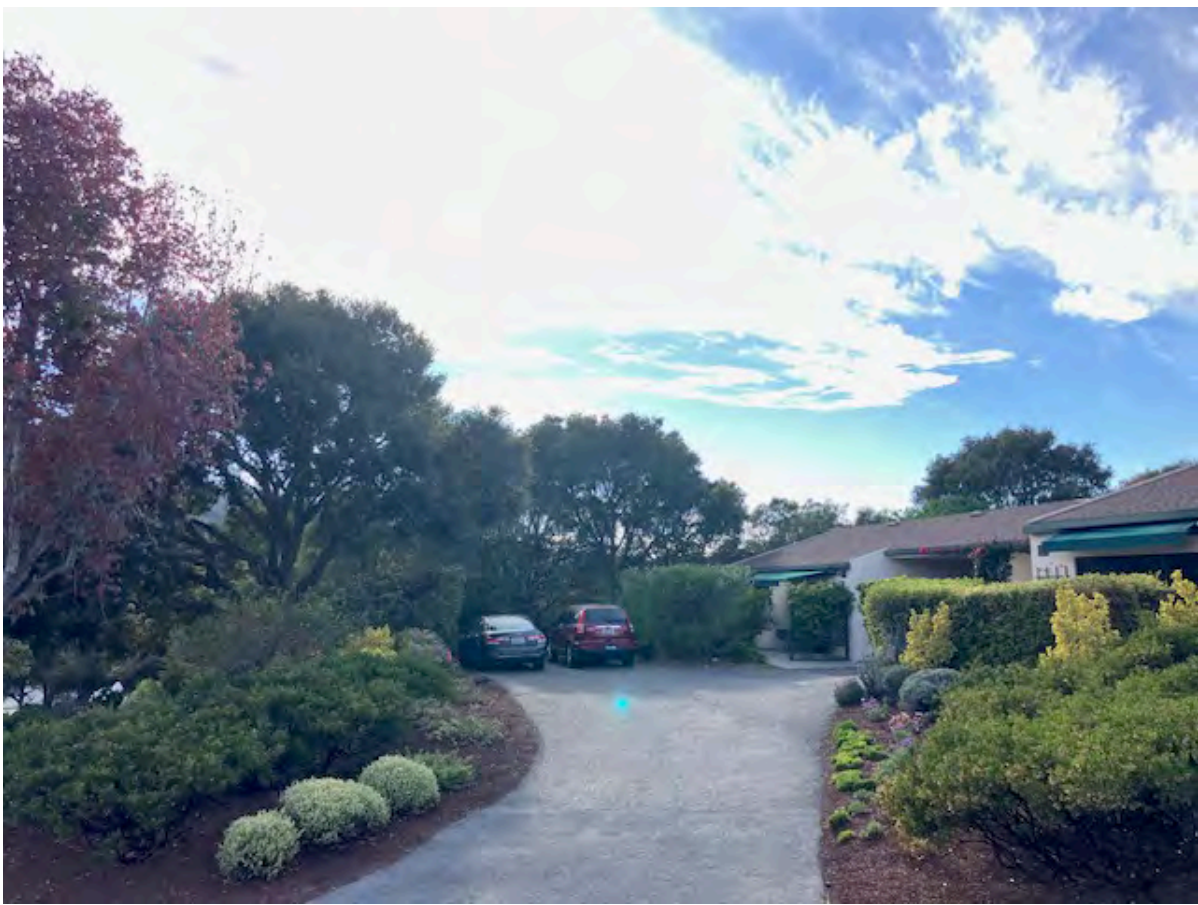
Figure 11. The proposed Building C project site. A few oaks located behind the existing units are planned for removal in preparation for proposed construction activities.

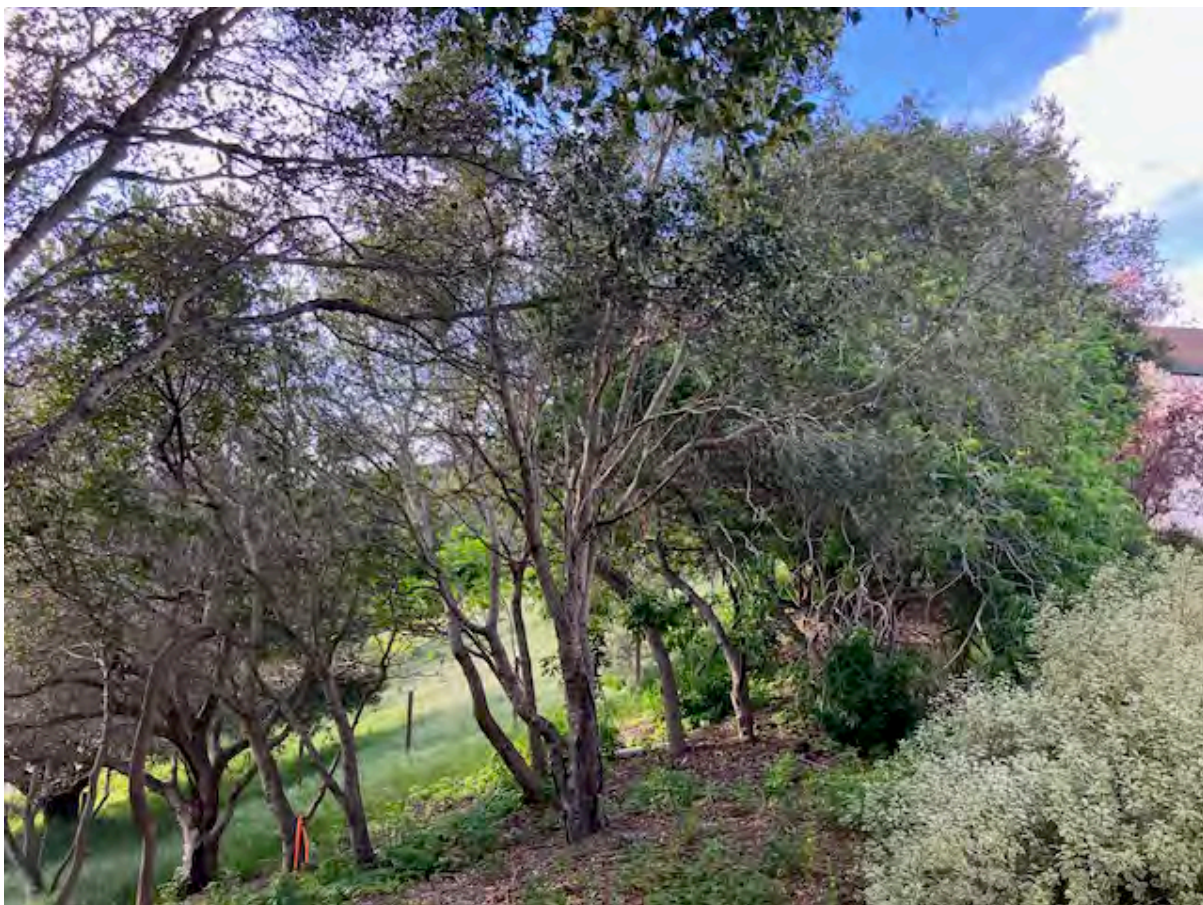
Figure 12. A few of the oaks located towards the center of the photo are planned for removal for the proposed Building C.

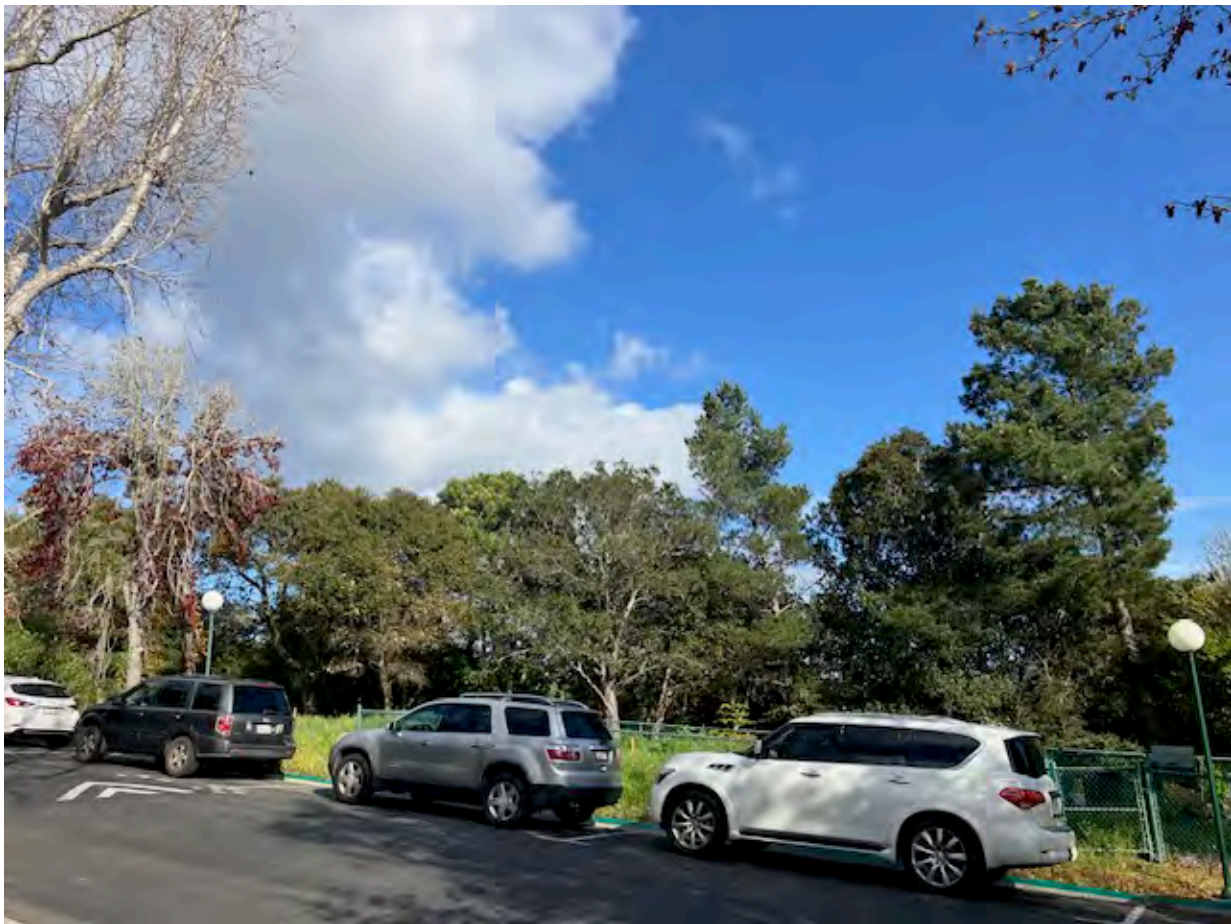
Figure 13. Area where several oaks are proposed for removal in preparation for Units A2 & A3.

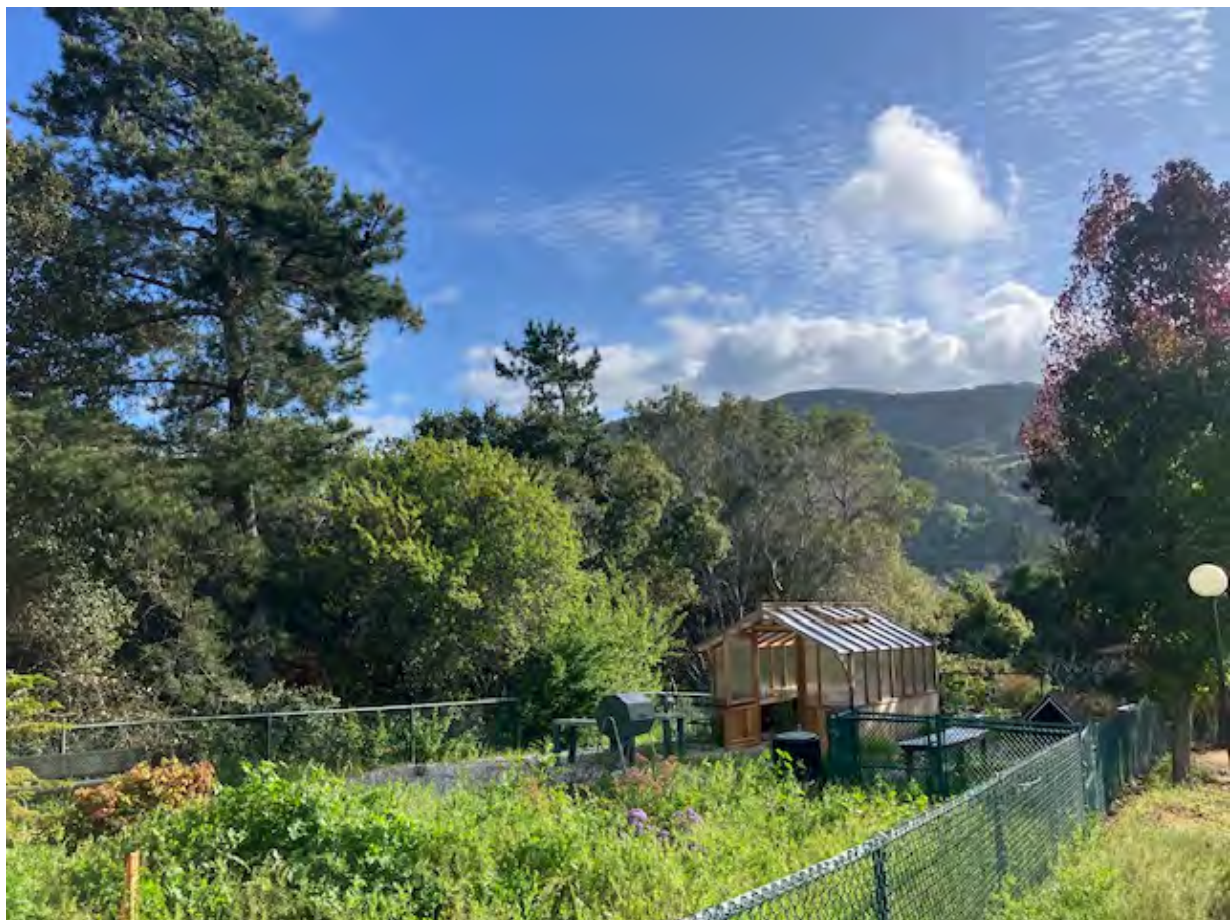
Figure 14. Existing garden area clearing where units A1 & A2 will be constructed will involve oak removal in adjacent woodlands.

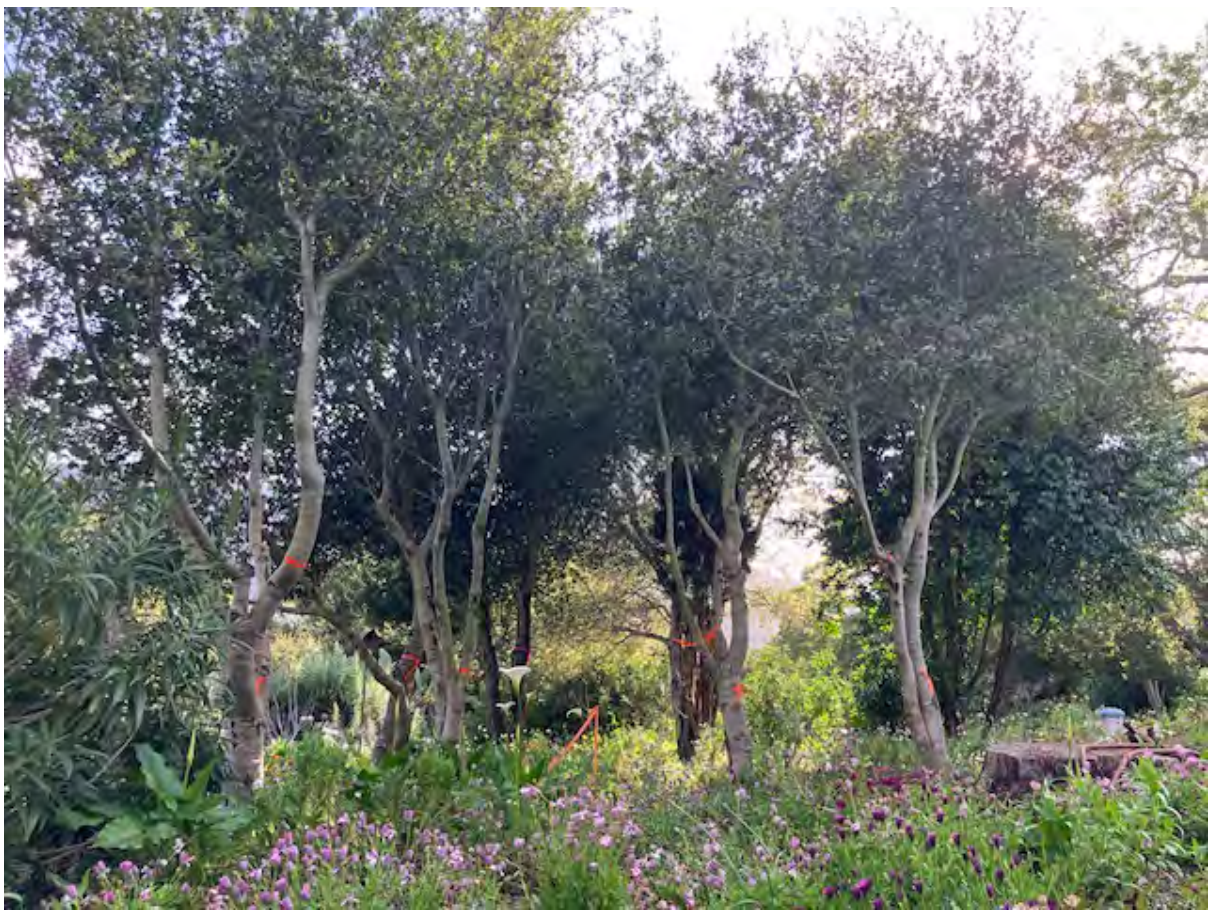
Figure 15. Grouping of small and immature oaks are proposed for removal at the A4 building site.

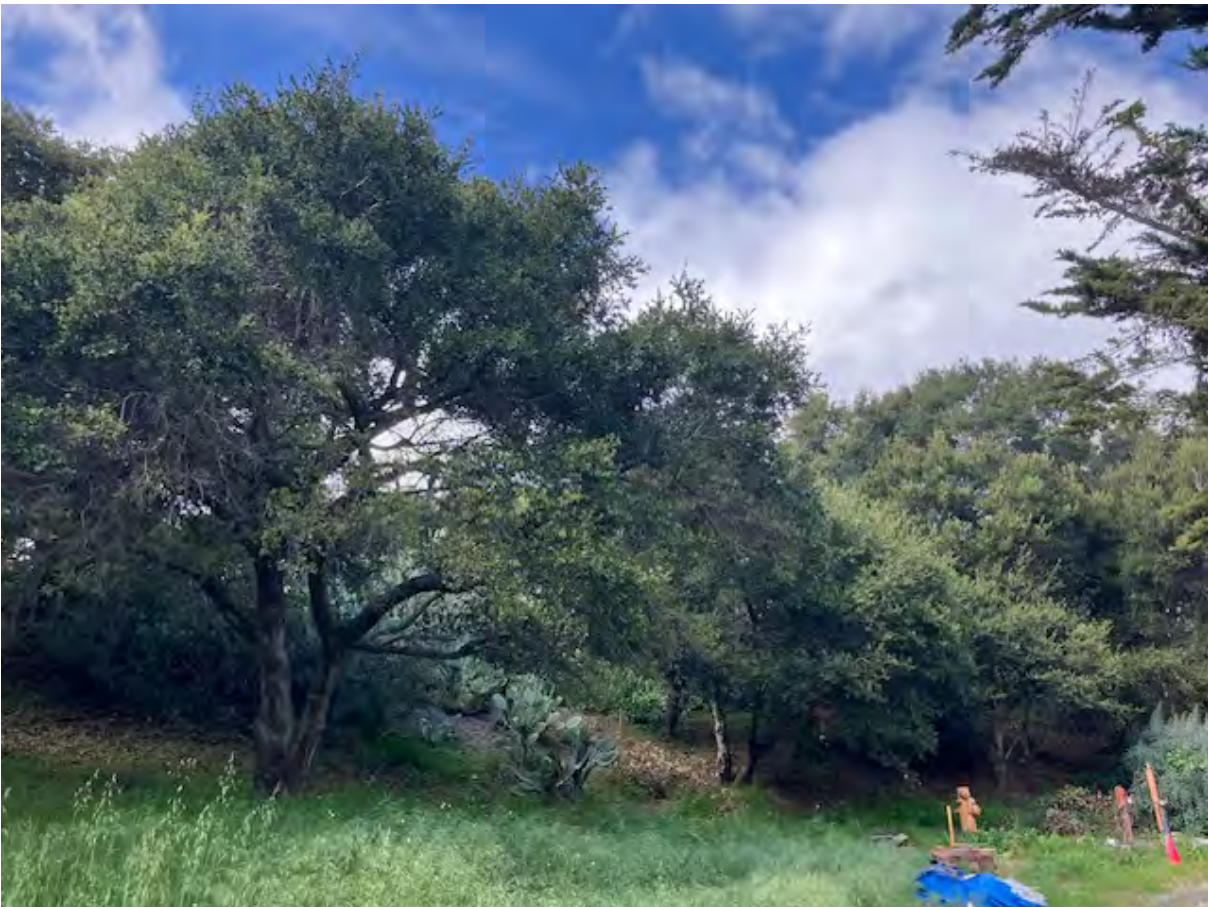
Figure 16. Several oaks in this area are proposed for removal in preparation for the A3 & A4 units. A few oaks located adjacent to the proposed units will be retained and protected.

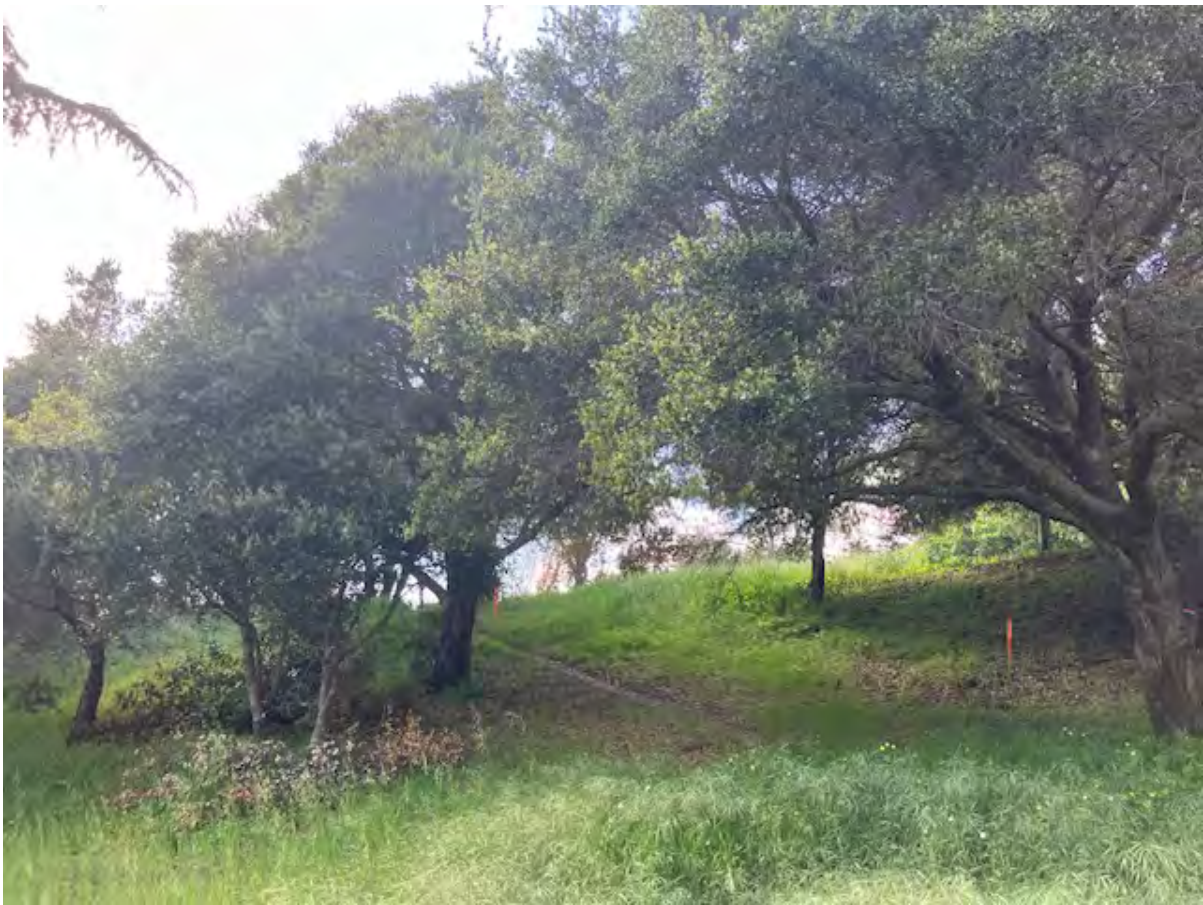
Figure 17. Several oaks located where the A3 unit is proposed are planned for removal. Some of these oaks were apparently planted years ago and are not naturally occurring.

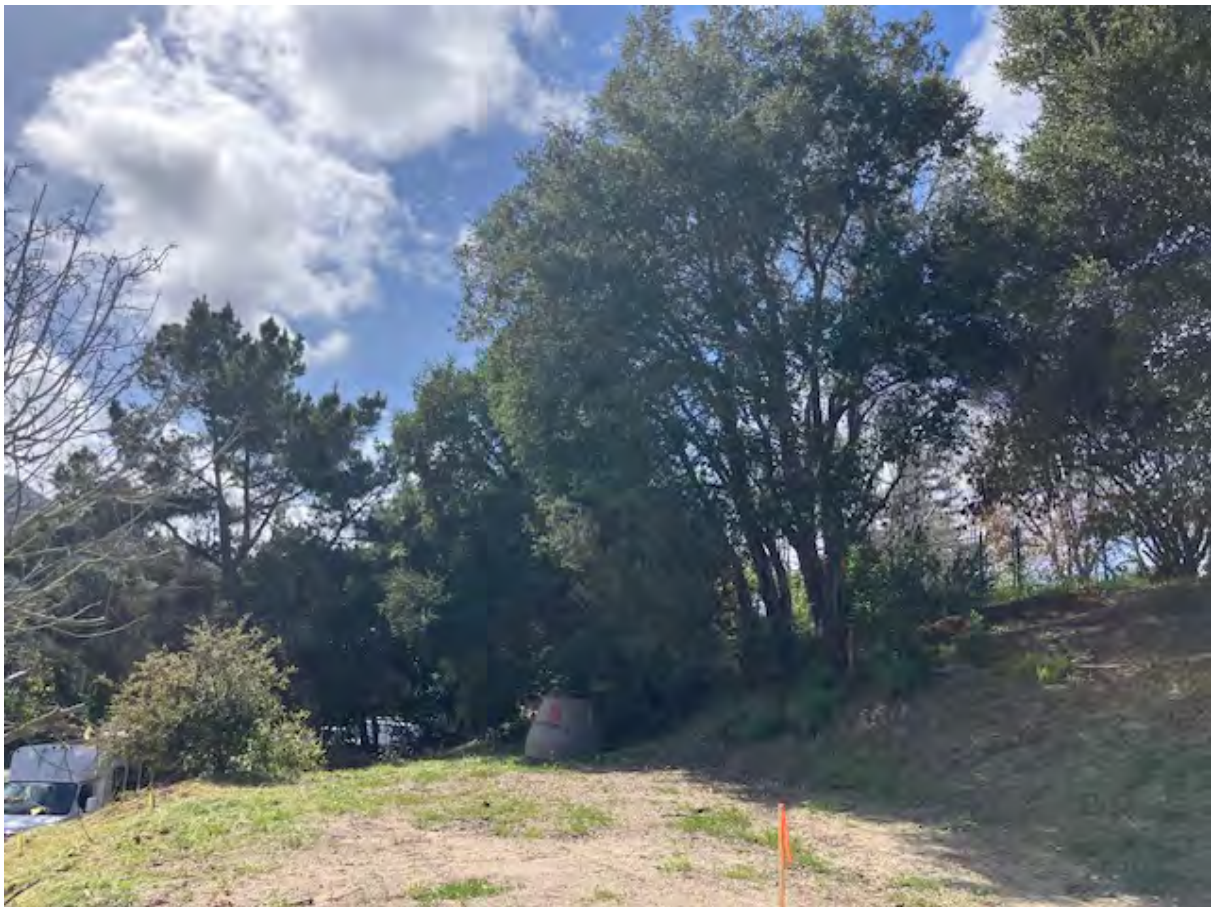
Figure 18. This previously disturbed site is where the A1 & B1 units are proposed. Several oaks are planned for removal.

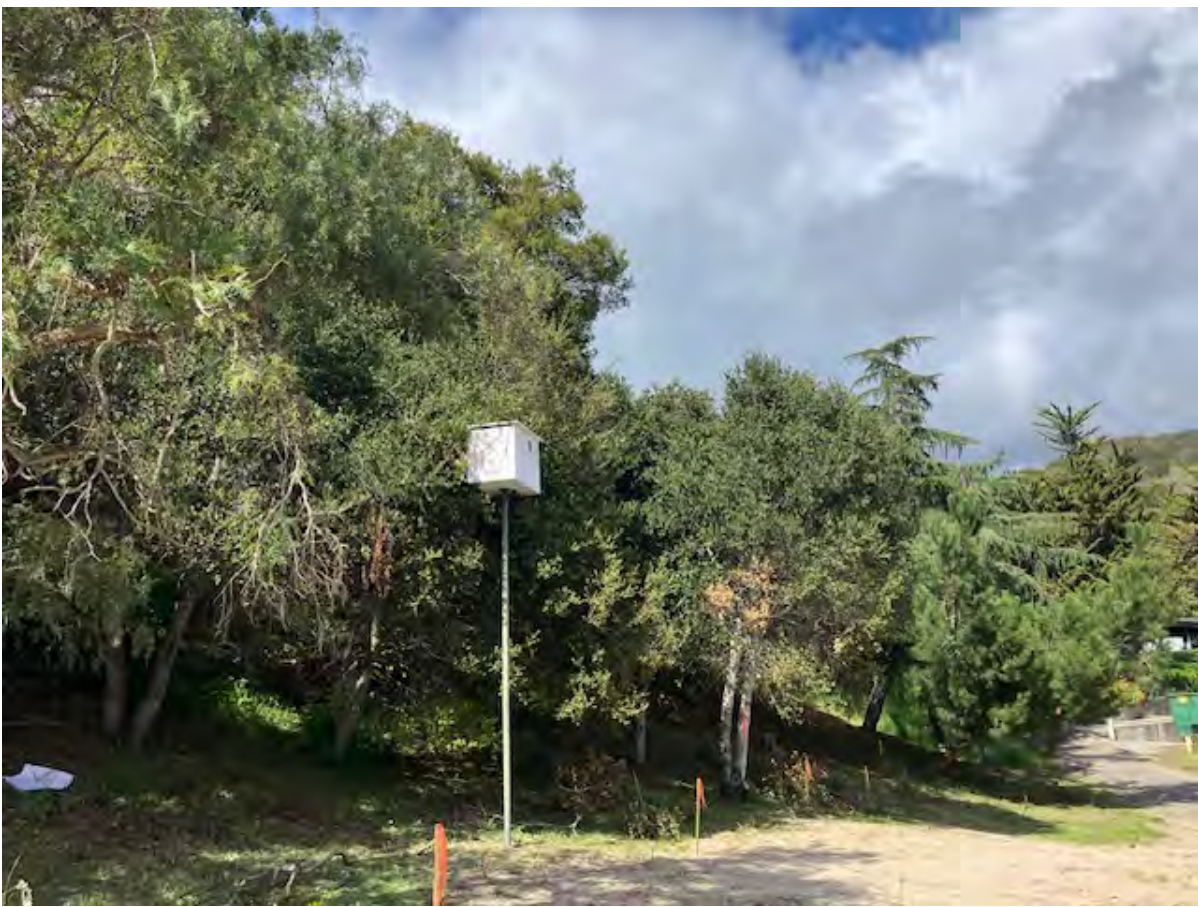
Figure 19. Several mature oaks mixed in with a few non-native Italian stone pines and deodar cedars are planned for removal at the proposed sites for the A2 & A3 units. Confirm the owl box is not occupied prior to removal operations.

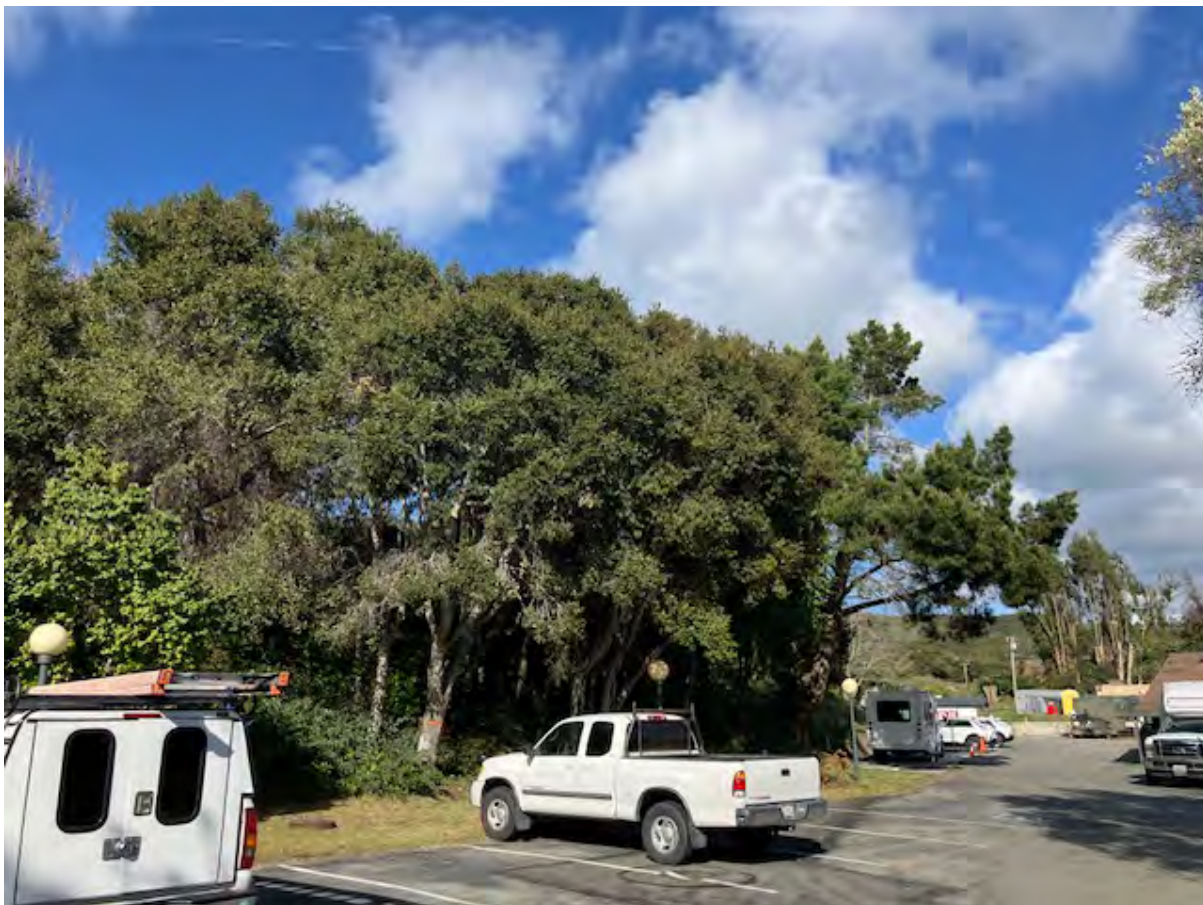
Figure 20. Several oaks visible in photo located next to the parking area and the proposed A1 unit will be retained and protected.

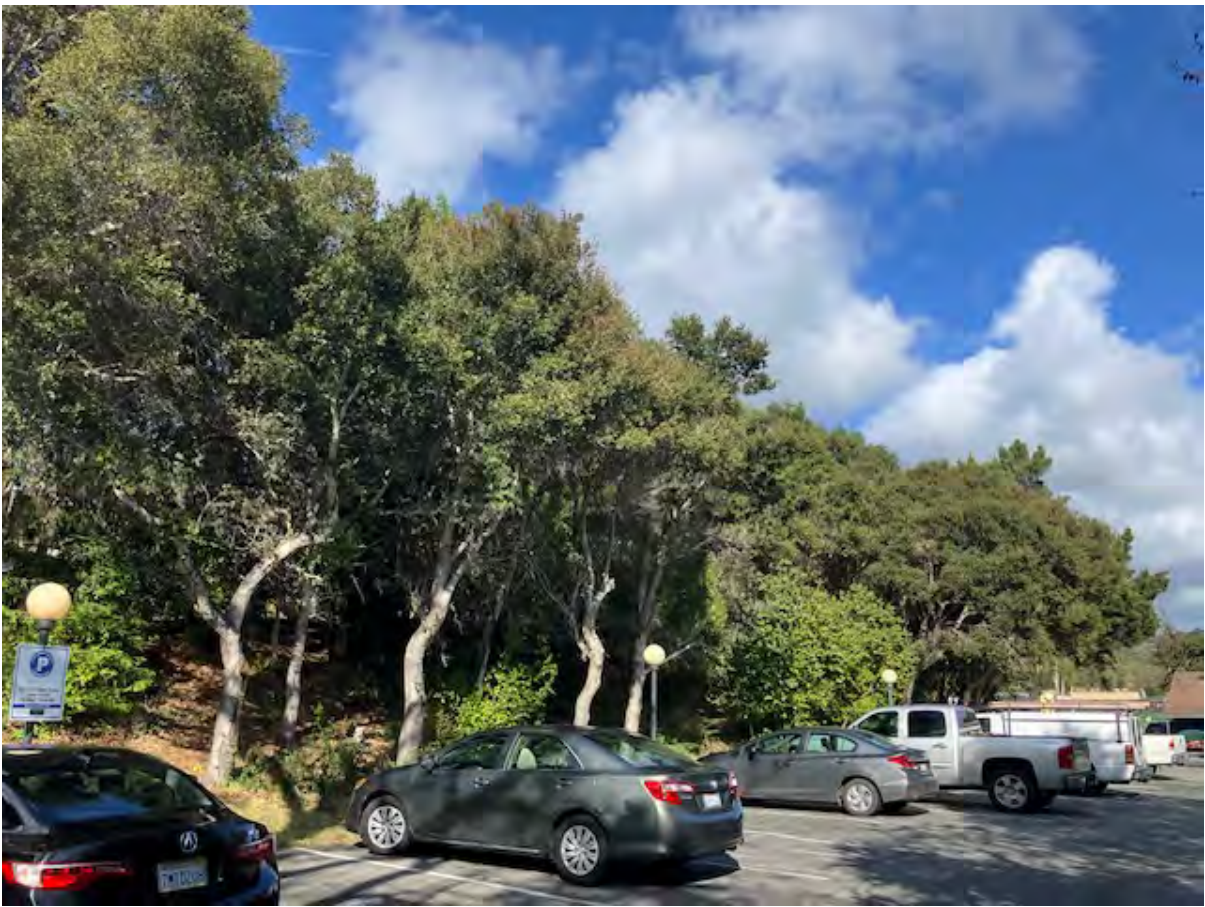
Figure 21. This oak wooded area along the lower parking area near the proposed A1 unit will not require tree removal.
