THOMPSON
WILDLAND MANAGEMENT

March 2, 2026

To: Carmel Valley Manor
8545 Carmel Valley Road
Carmel, CA. 93923
County File#: PLN240141
APNs: 169-061-012, 169-061-017 & 169-061-018

Carmel Valley Manor Community Improvement & Development Project Tree
Impact Assessment

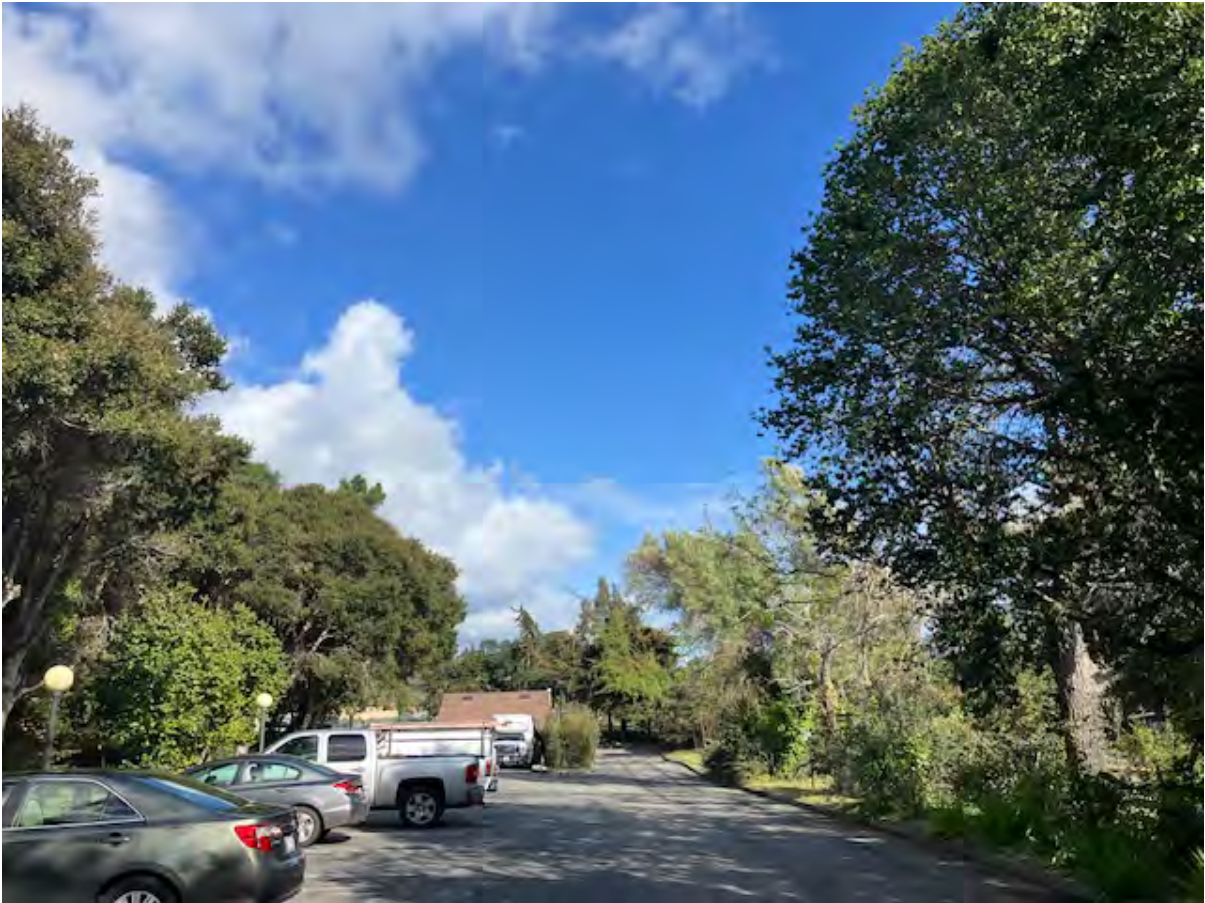
Figure 22. This area will continue to be used for parking, however, some non-native and introduced trees to the right are planned for removal due to property improvement operations.

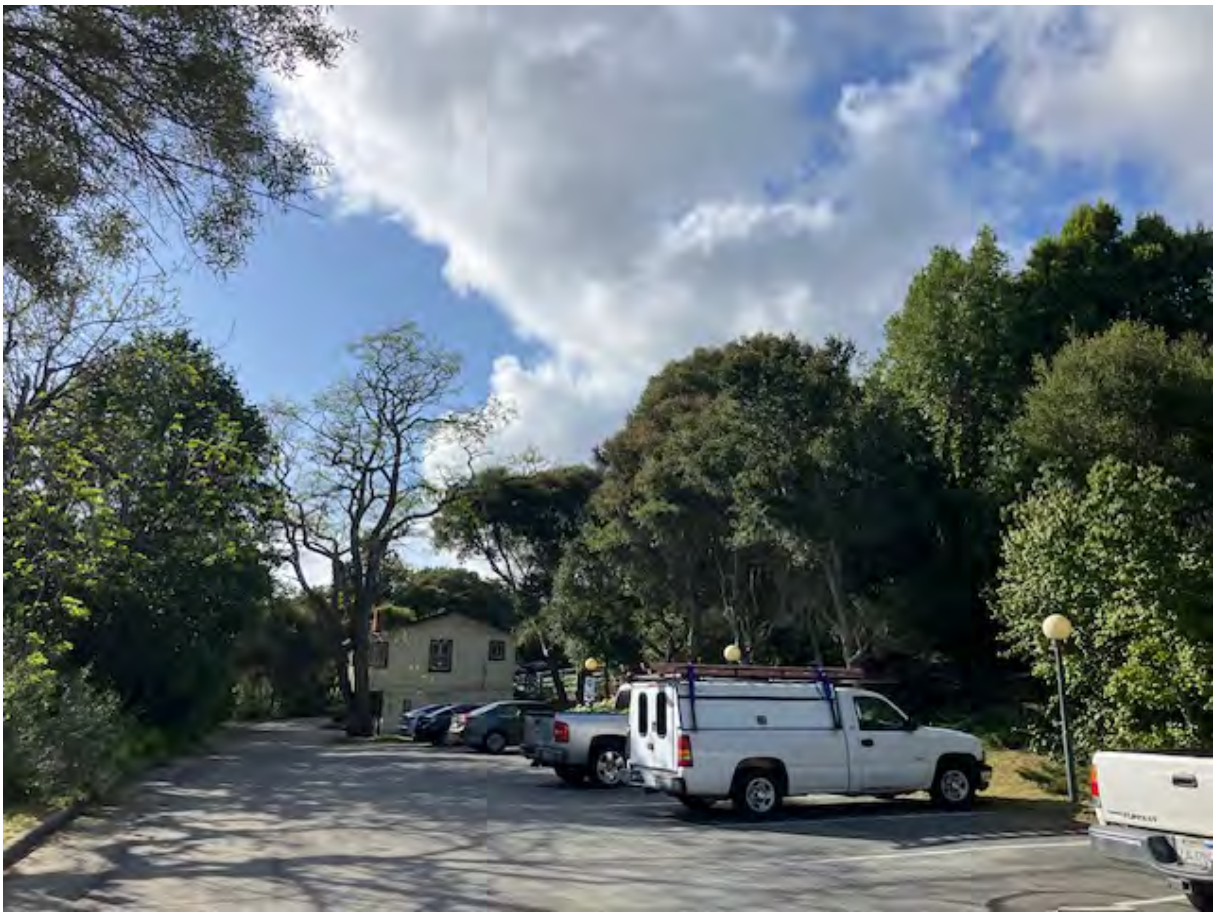
Figure 23. This area of the lower parking lot will not be impacted by project operations, including the surrounding trees.

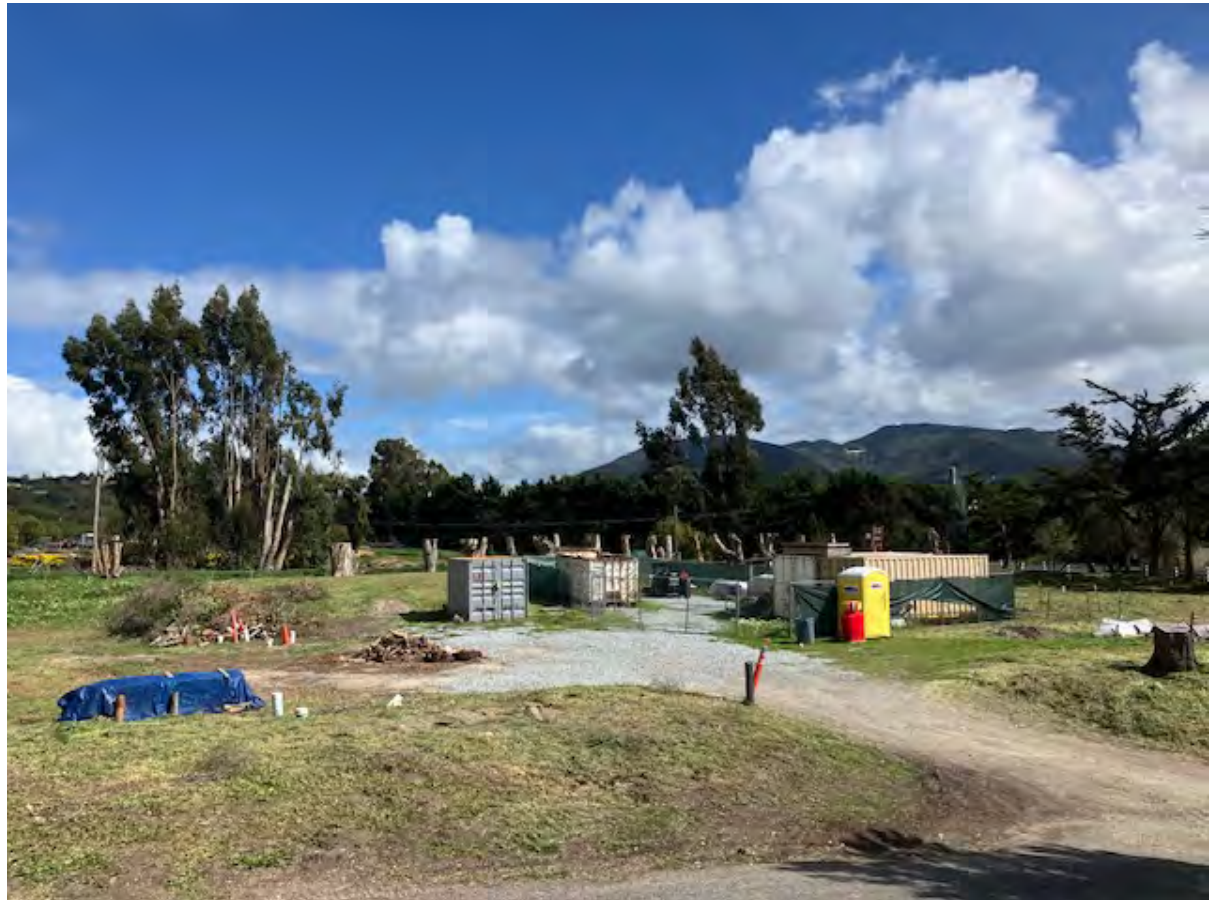
Figure 24. This impacted and disturbed area at the lower southeast end of the CVM property will be a parking area. No native species trees that have County protection status will be impacted or removed.

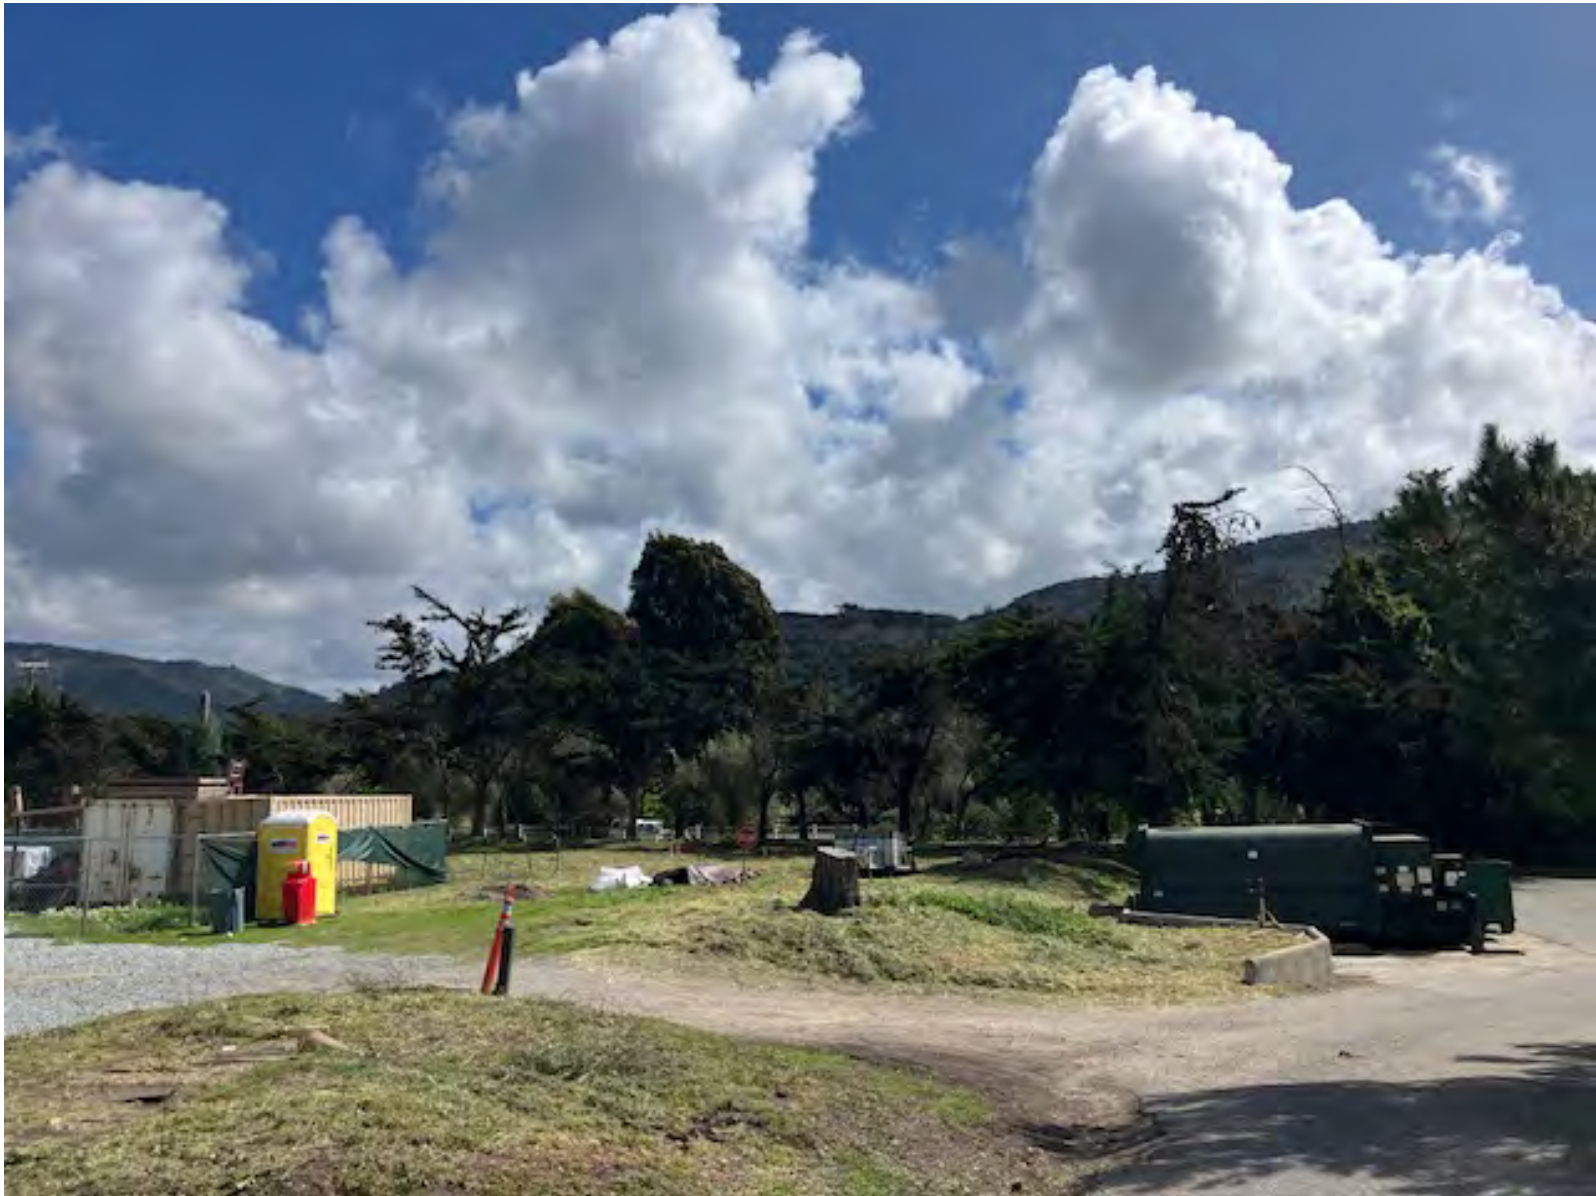
Figure 25. Another view of lower southeast end of the CVM property near Carmel Valley Road that will be developed into an area for additional parking.

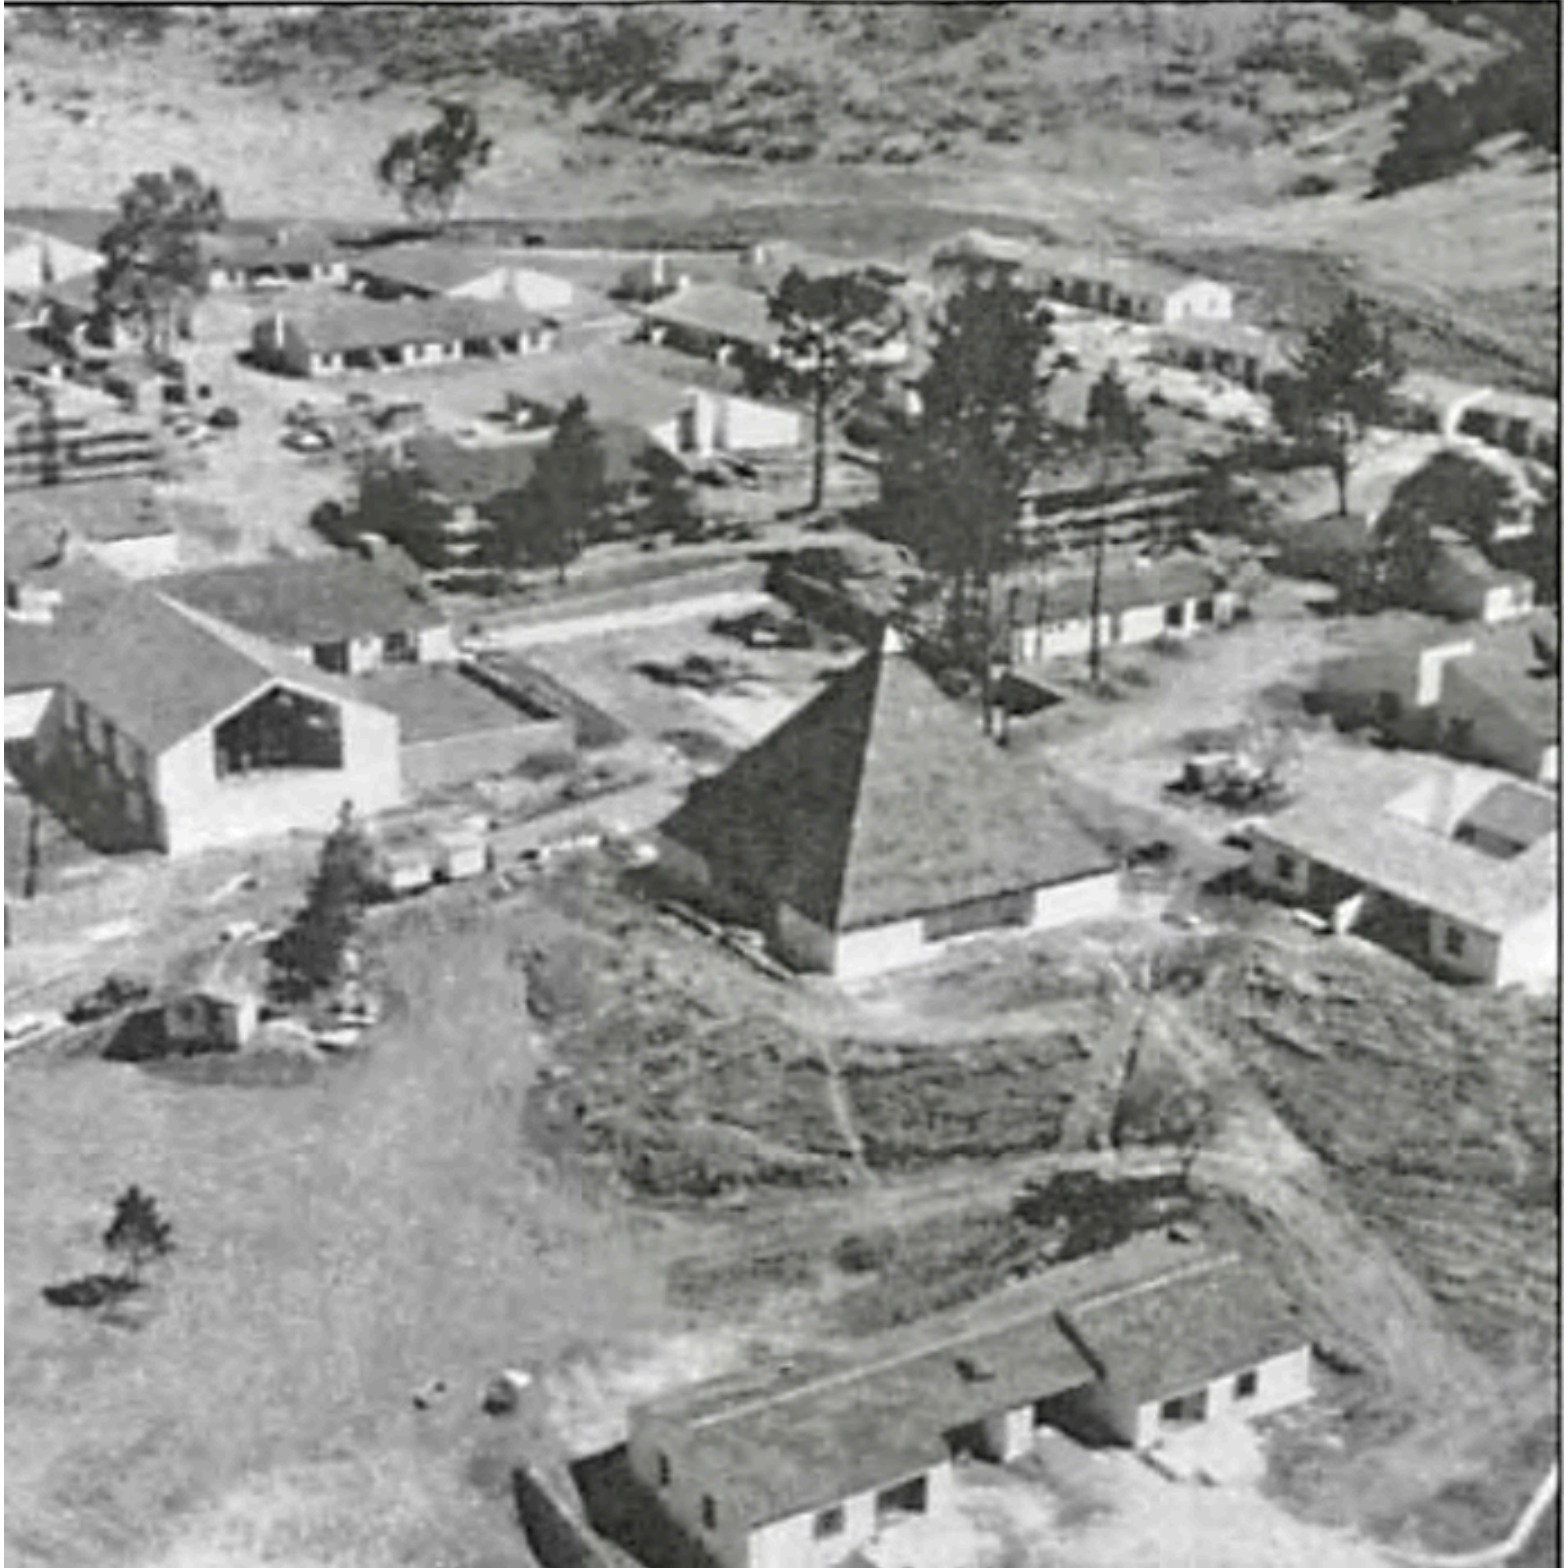
Figure 26. This historical photo taken at the time the CVM community was constructed appears to show the presence of several pine and conifer type trees, but few if any oak trees are occurring in this area of the property. As noted in the report, many of the oaks currently occurring in this community appear to have been previously planted and are not naturally occurring.
