Original September 14, 2020 Pre-  
Construction Tree Impact Assessment

Spanos Residence  
 3347 17 Mile Drive  
 Pebble Beach, CA. 93953  
 APN: 008-351-008-000

Subject: 3347 17 Mile Drive pre-construction tree impact assessment

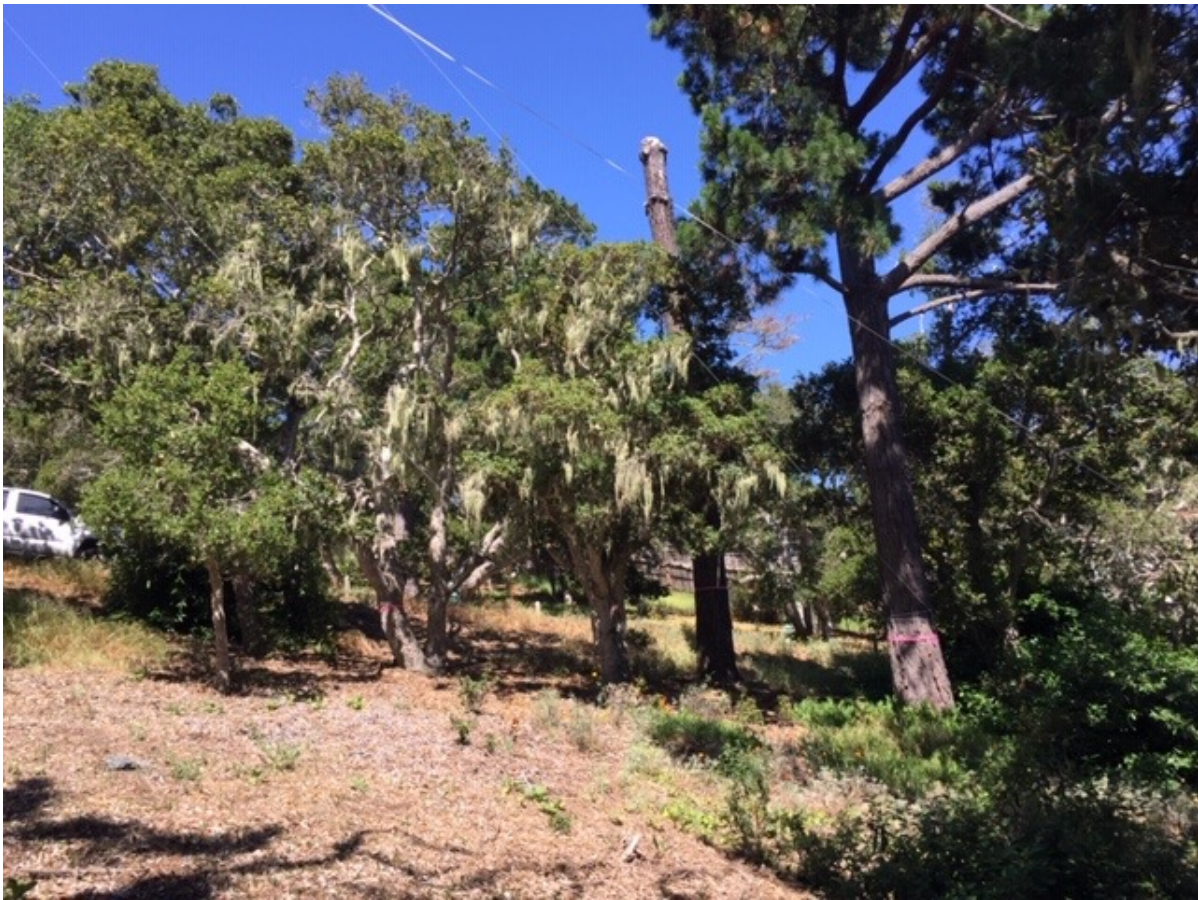
Figure 3. Another view of home construction site.

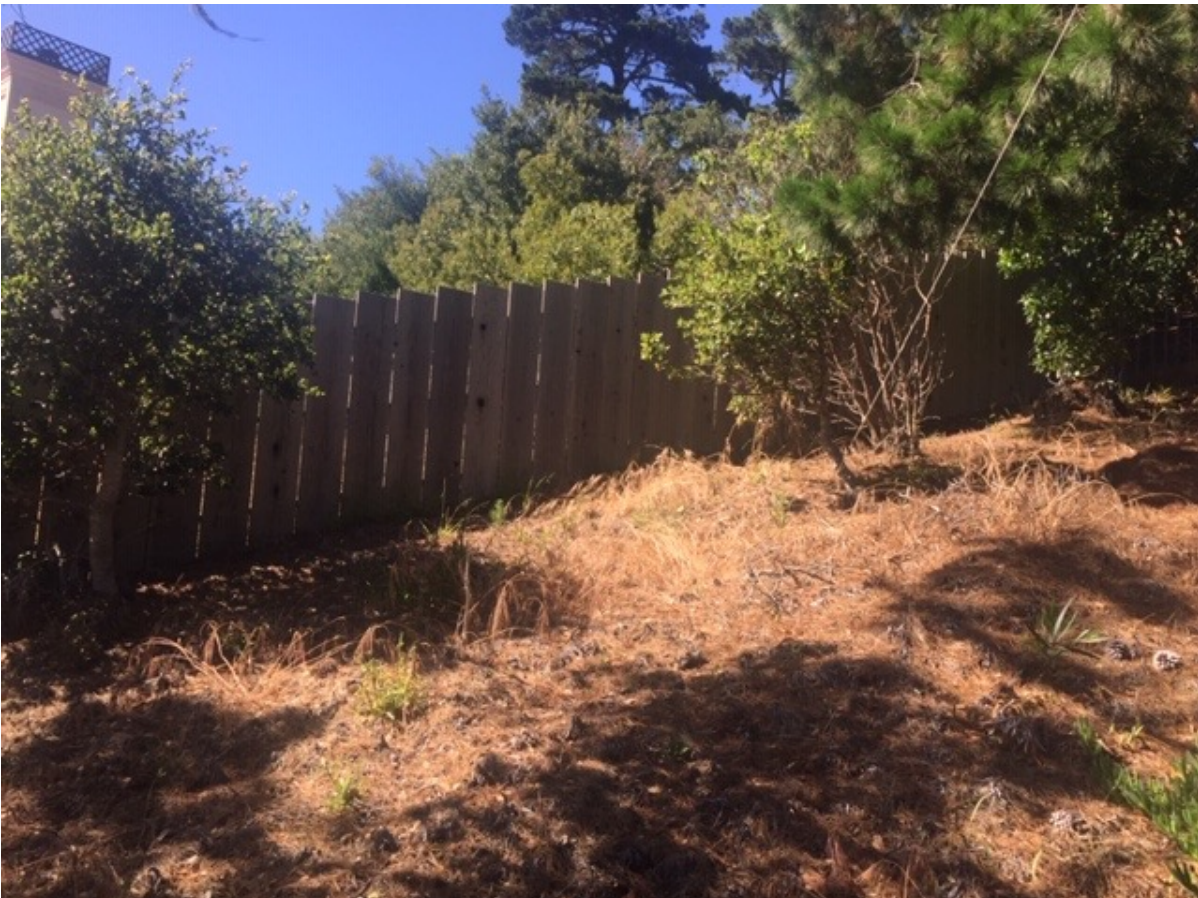
Figure 4. Example of clearing where replacement planting oaks and pines can be planted.

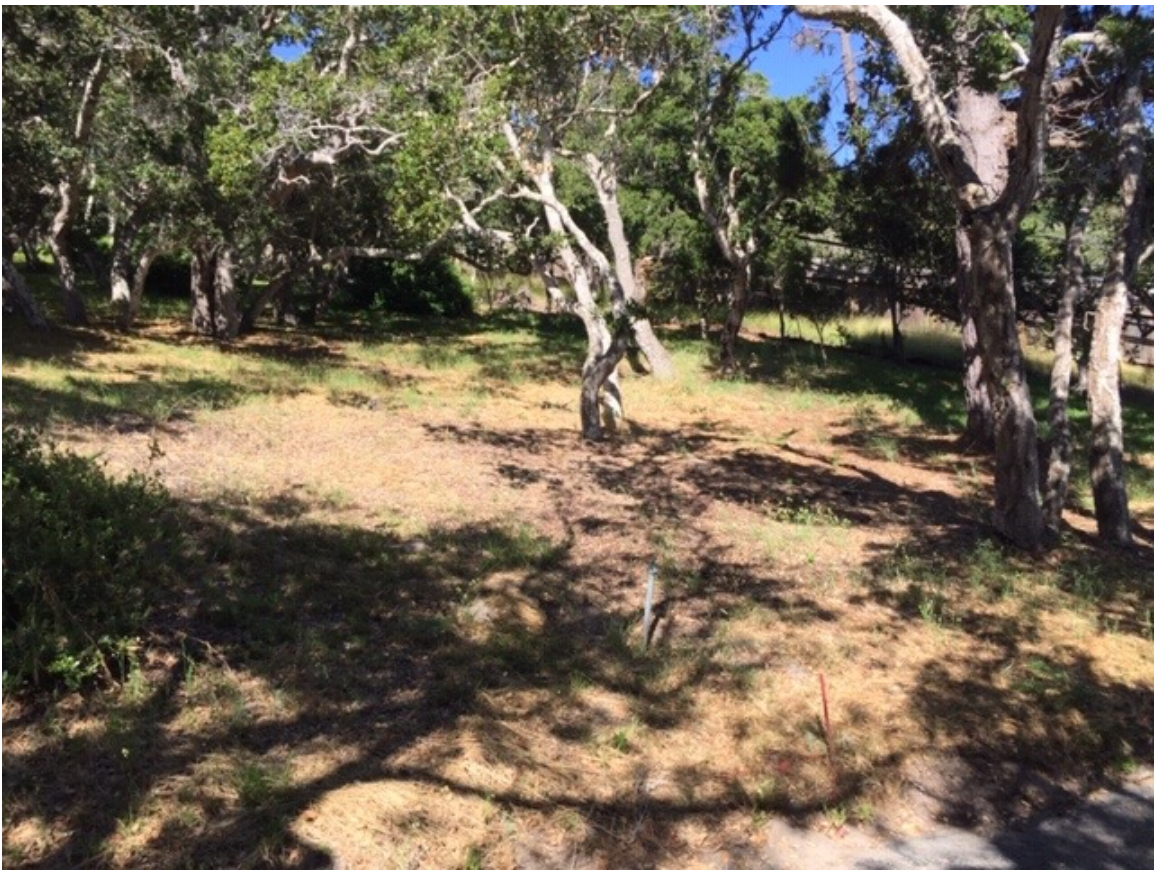
Figure 5. Another woodland clearing where replacement plantings can be planted.

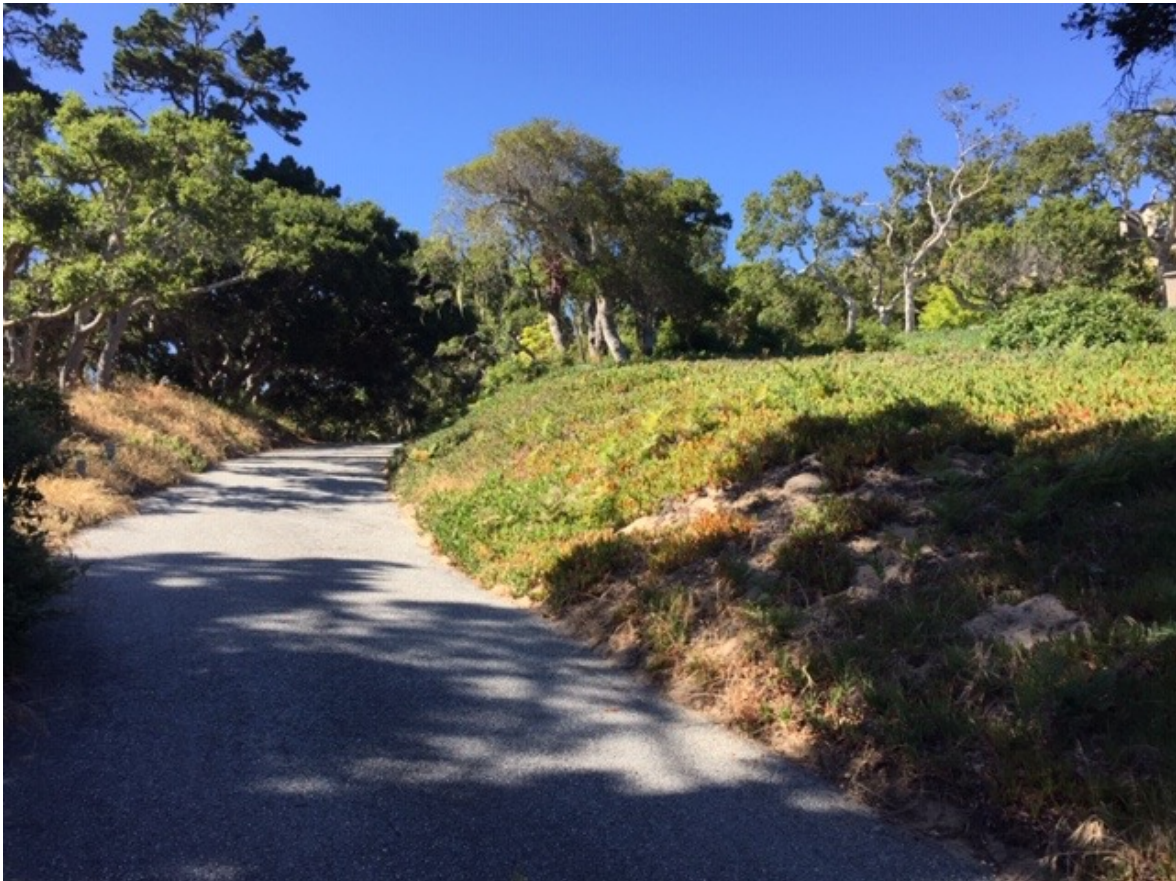
Figure 6. This upper section of driveway will be removed and this area restored. Several replacement plantings can be planted in this clearing, but non-native invasive Ice Plant will need to be removed, controlled and managed.

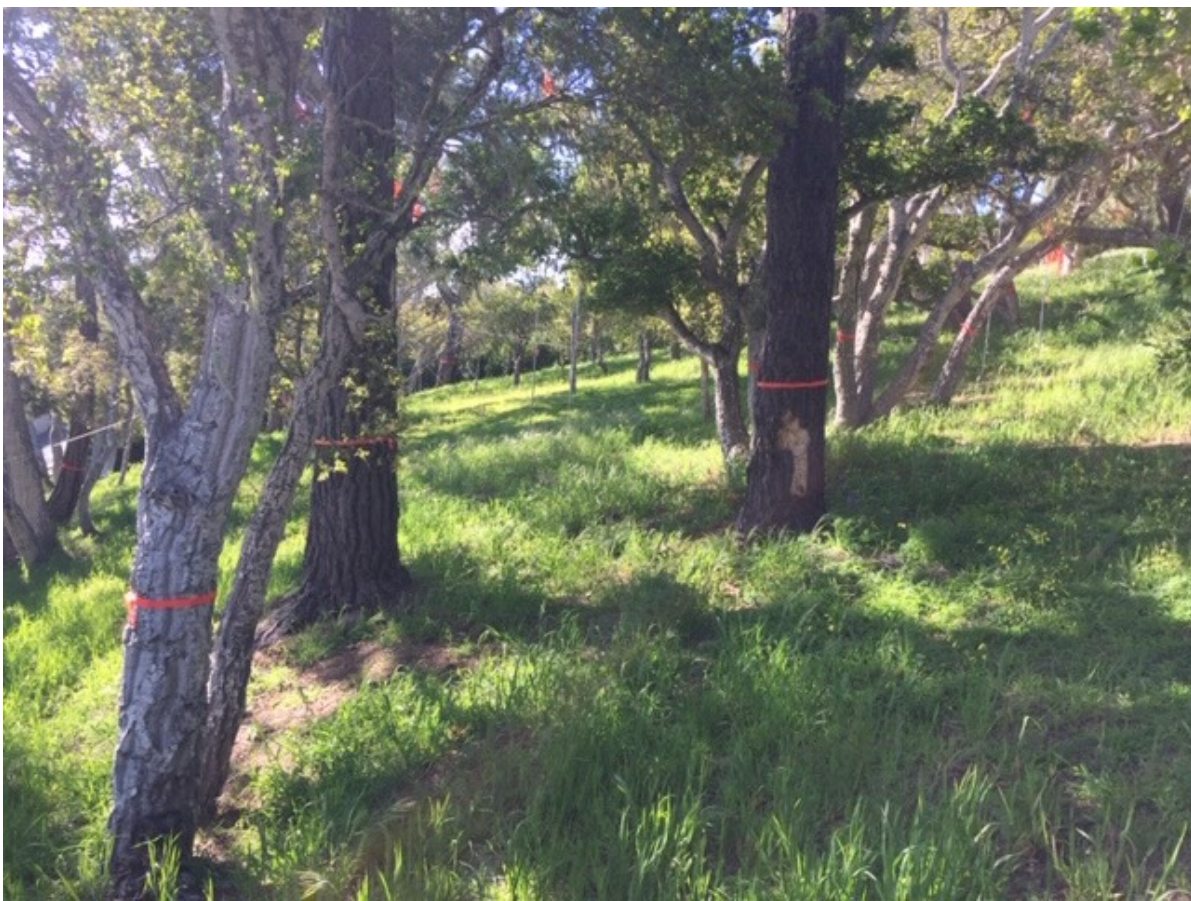
Figure 1. Combination of oaks and pines in foreground and background (marked with orange flagging tape) in proposed driveway parking area that are planned for removal due to construction impacts.

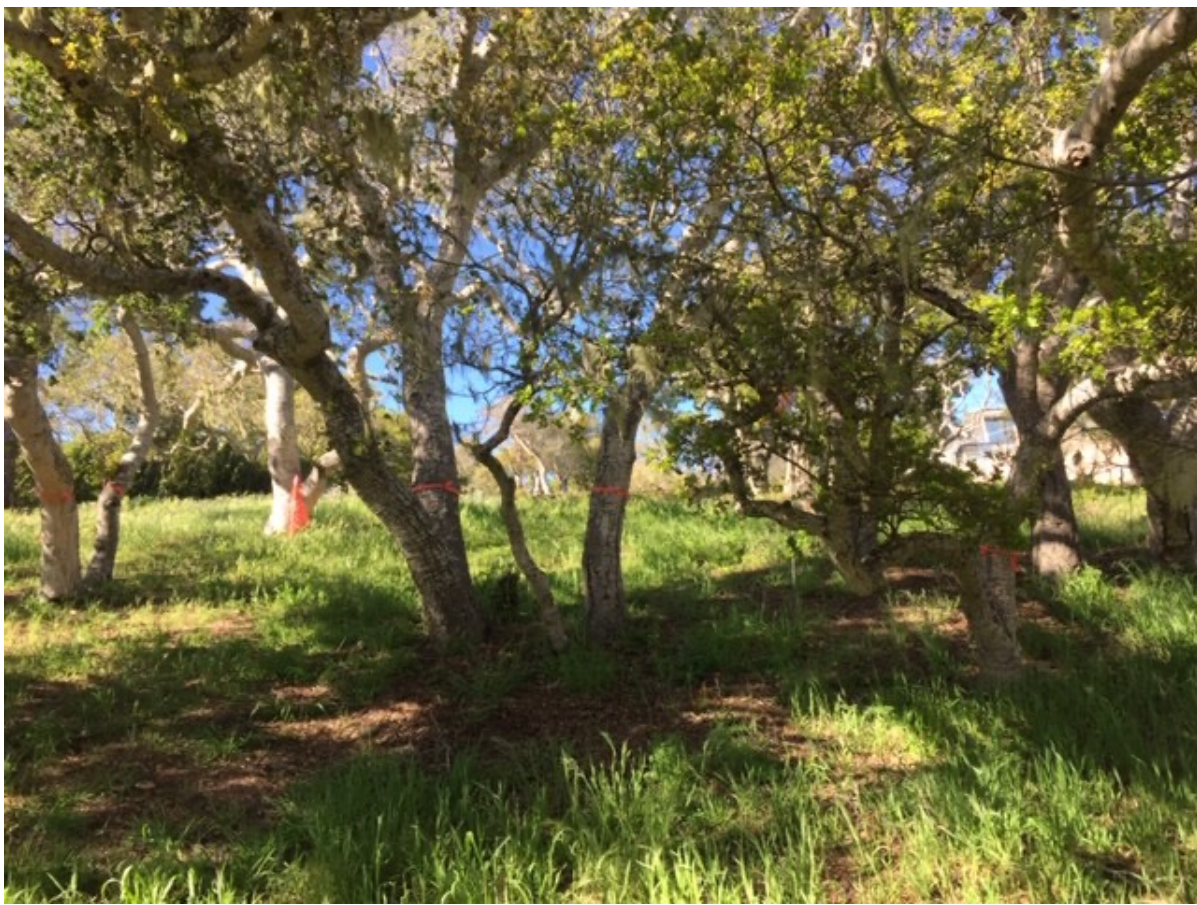
Figure 3. Several additional small to medium size oaks that will need to be removed due to location within proposed construction footprint.

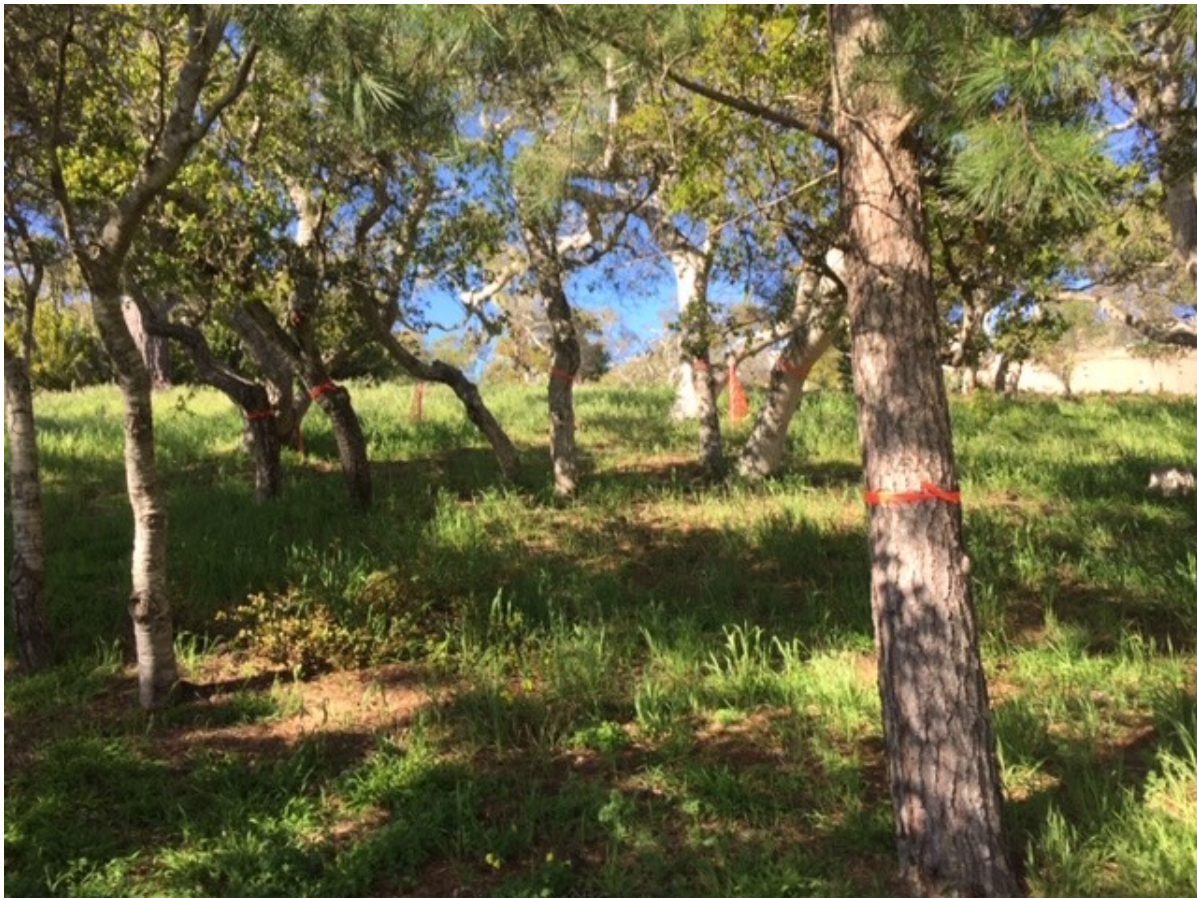
Figure 4. Small pine and several small to medium sized oaks proposed for removal due to construction impacts.

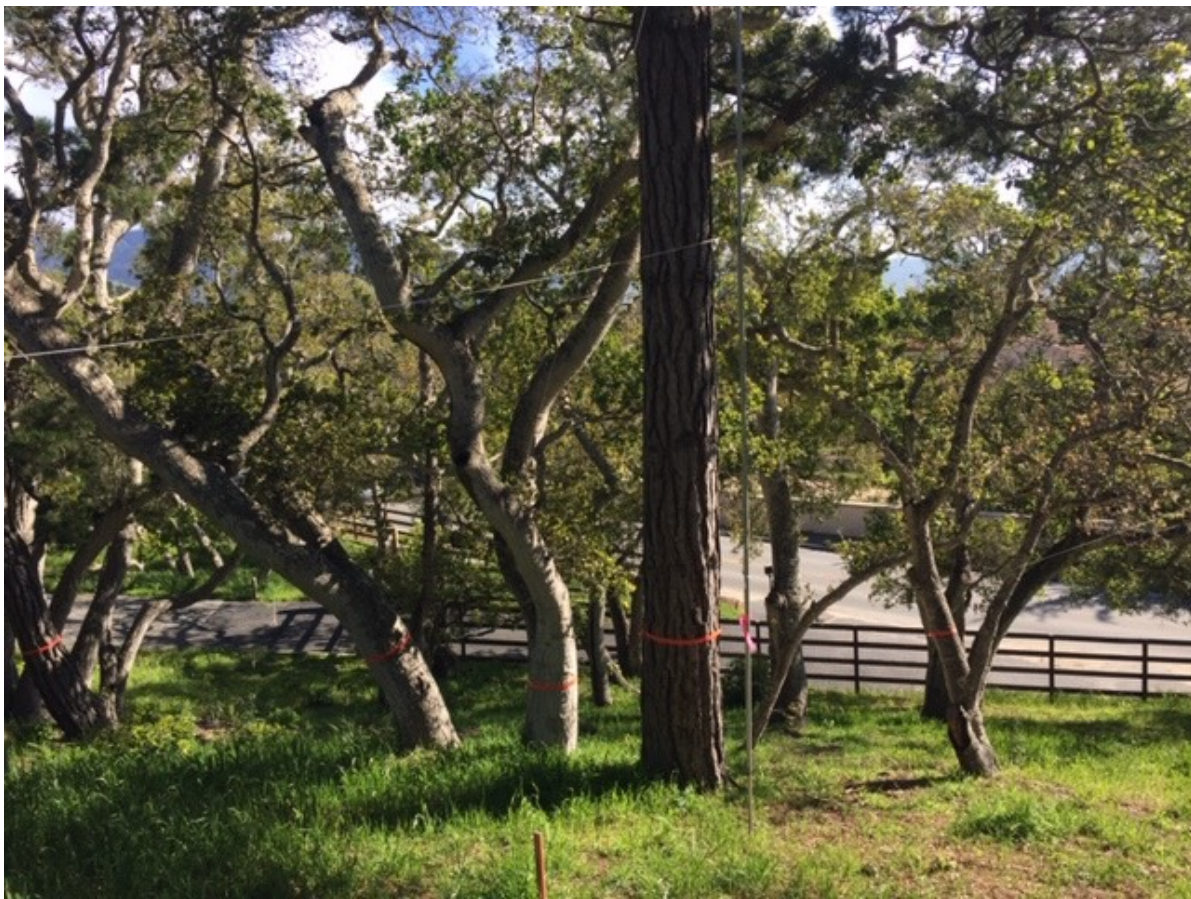
Figure 5. Additional trees in proposed pool deck area are planned for removal due to construction impacts. 17 Mile Drive is in background.

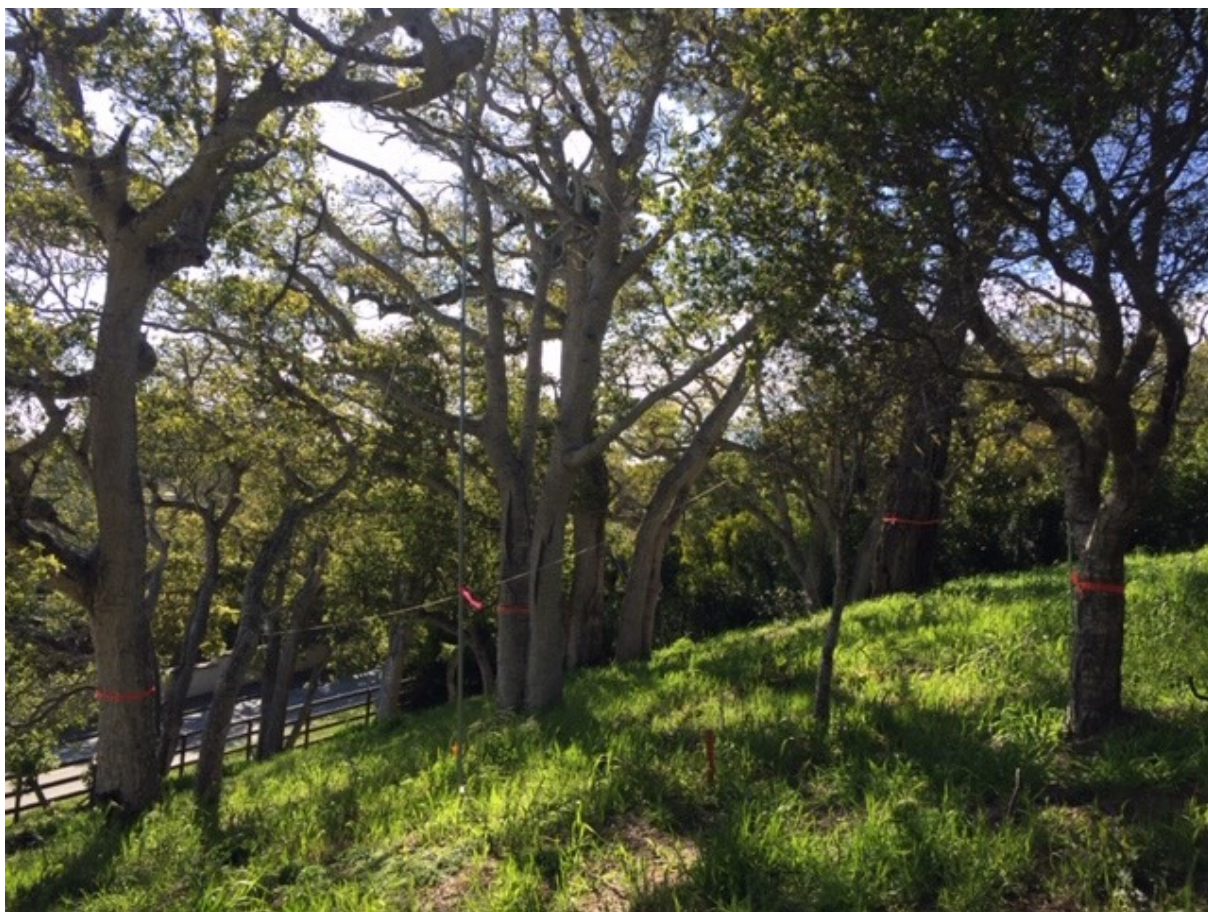
Figure 6. A few more trees in proposed pool area that are planned for removal.

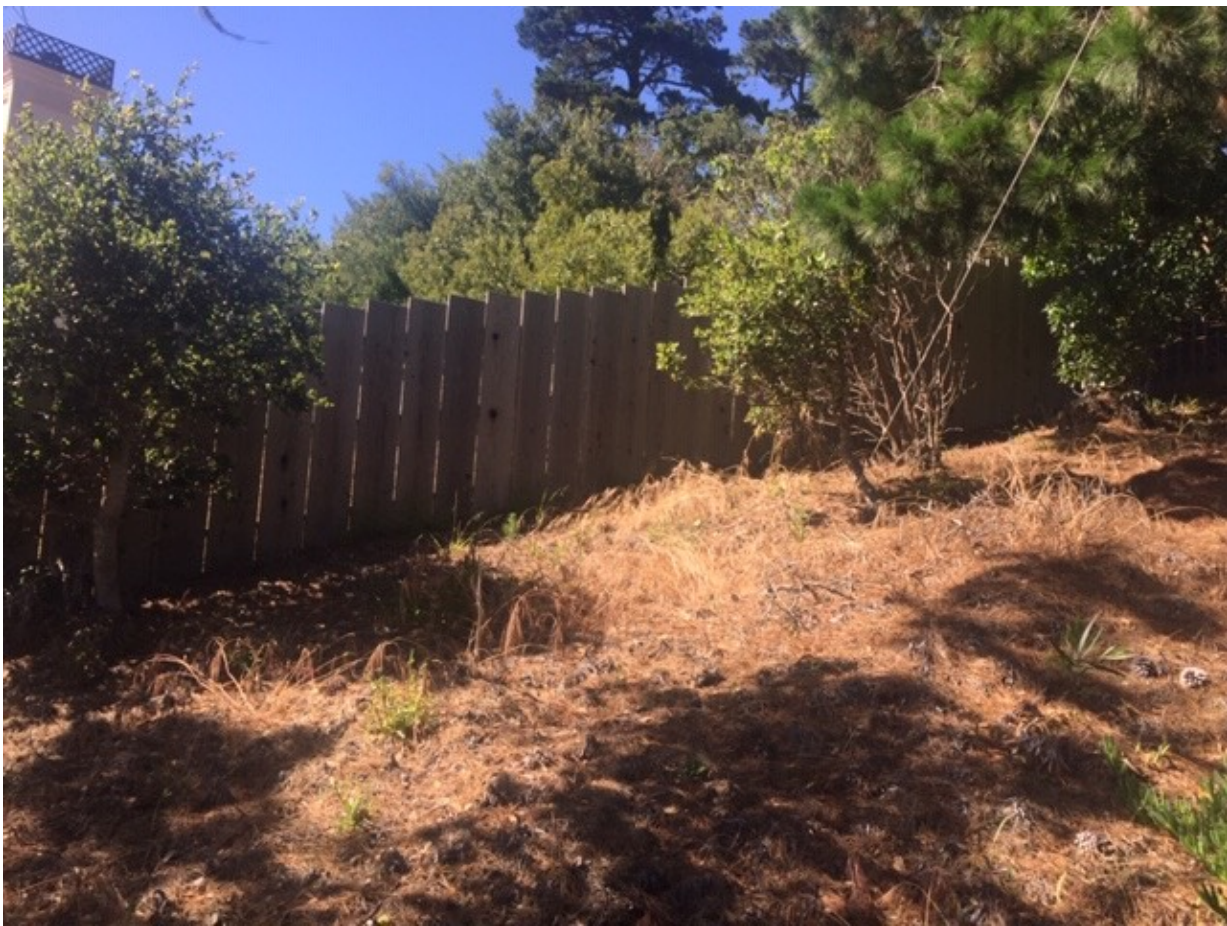
Figure 7. Example of clearing where replacement planting oaks and pines can be planted.

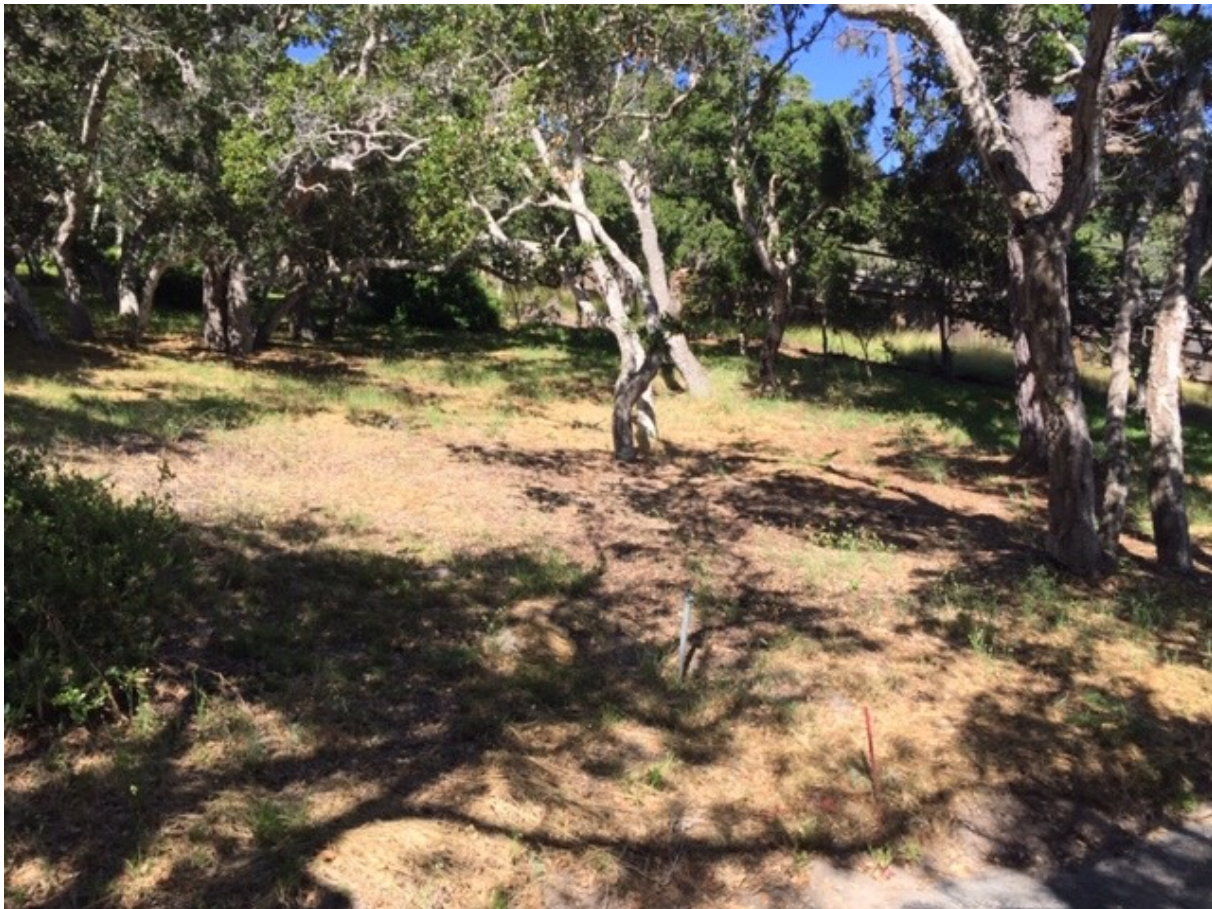
Figure 8. Another woodland clearing where replacement trees can be planted.

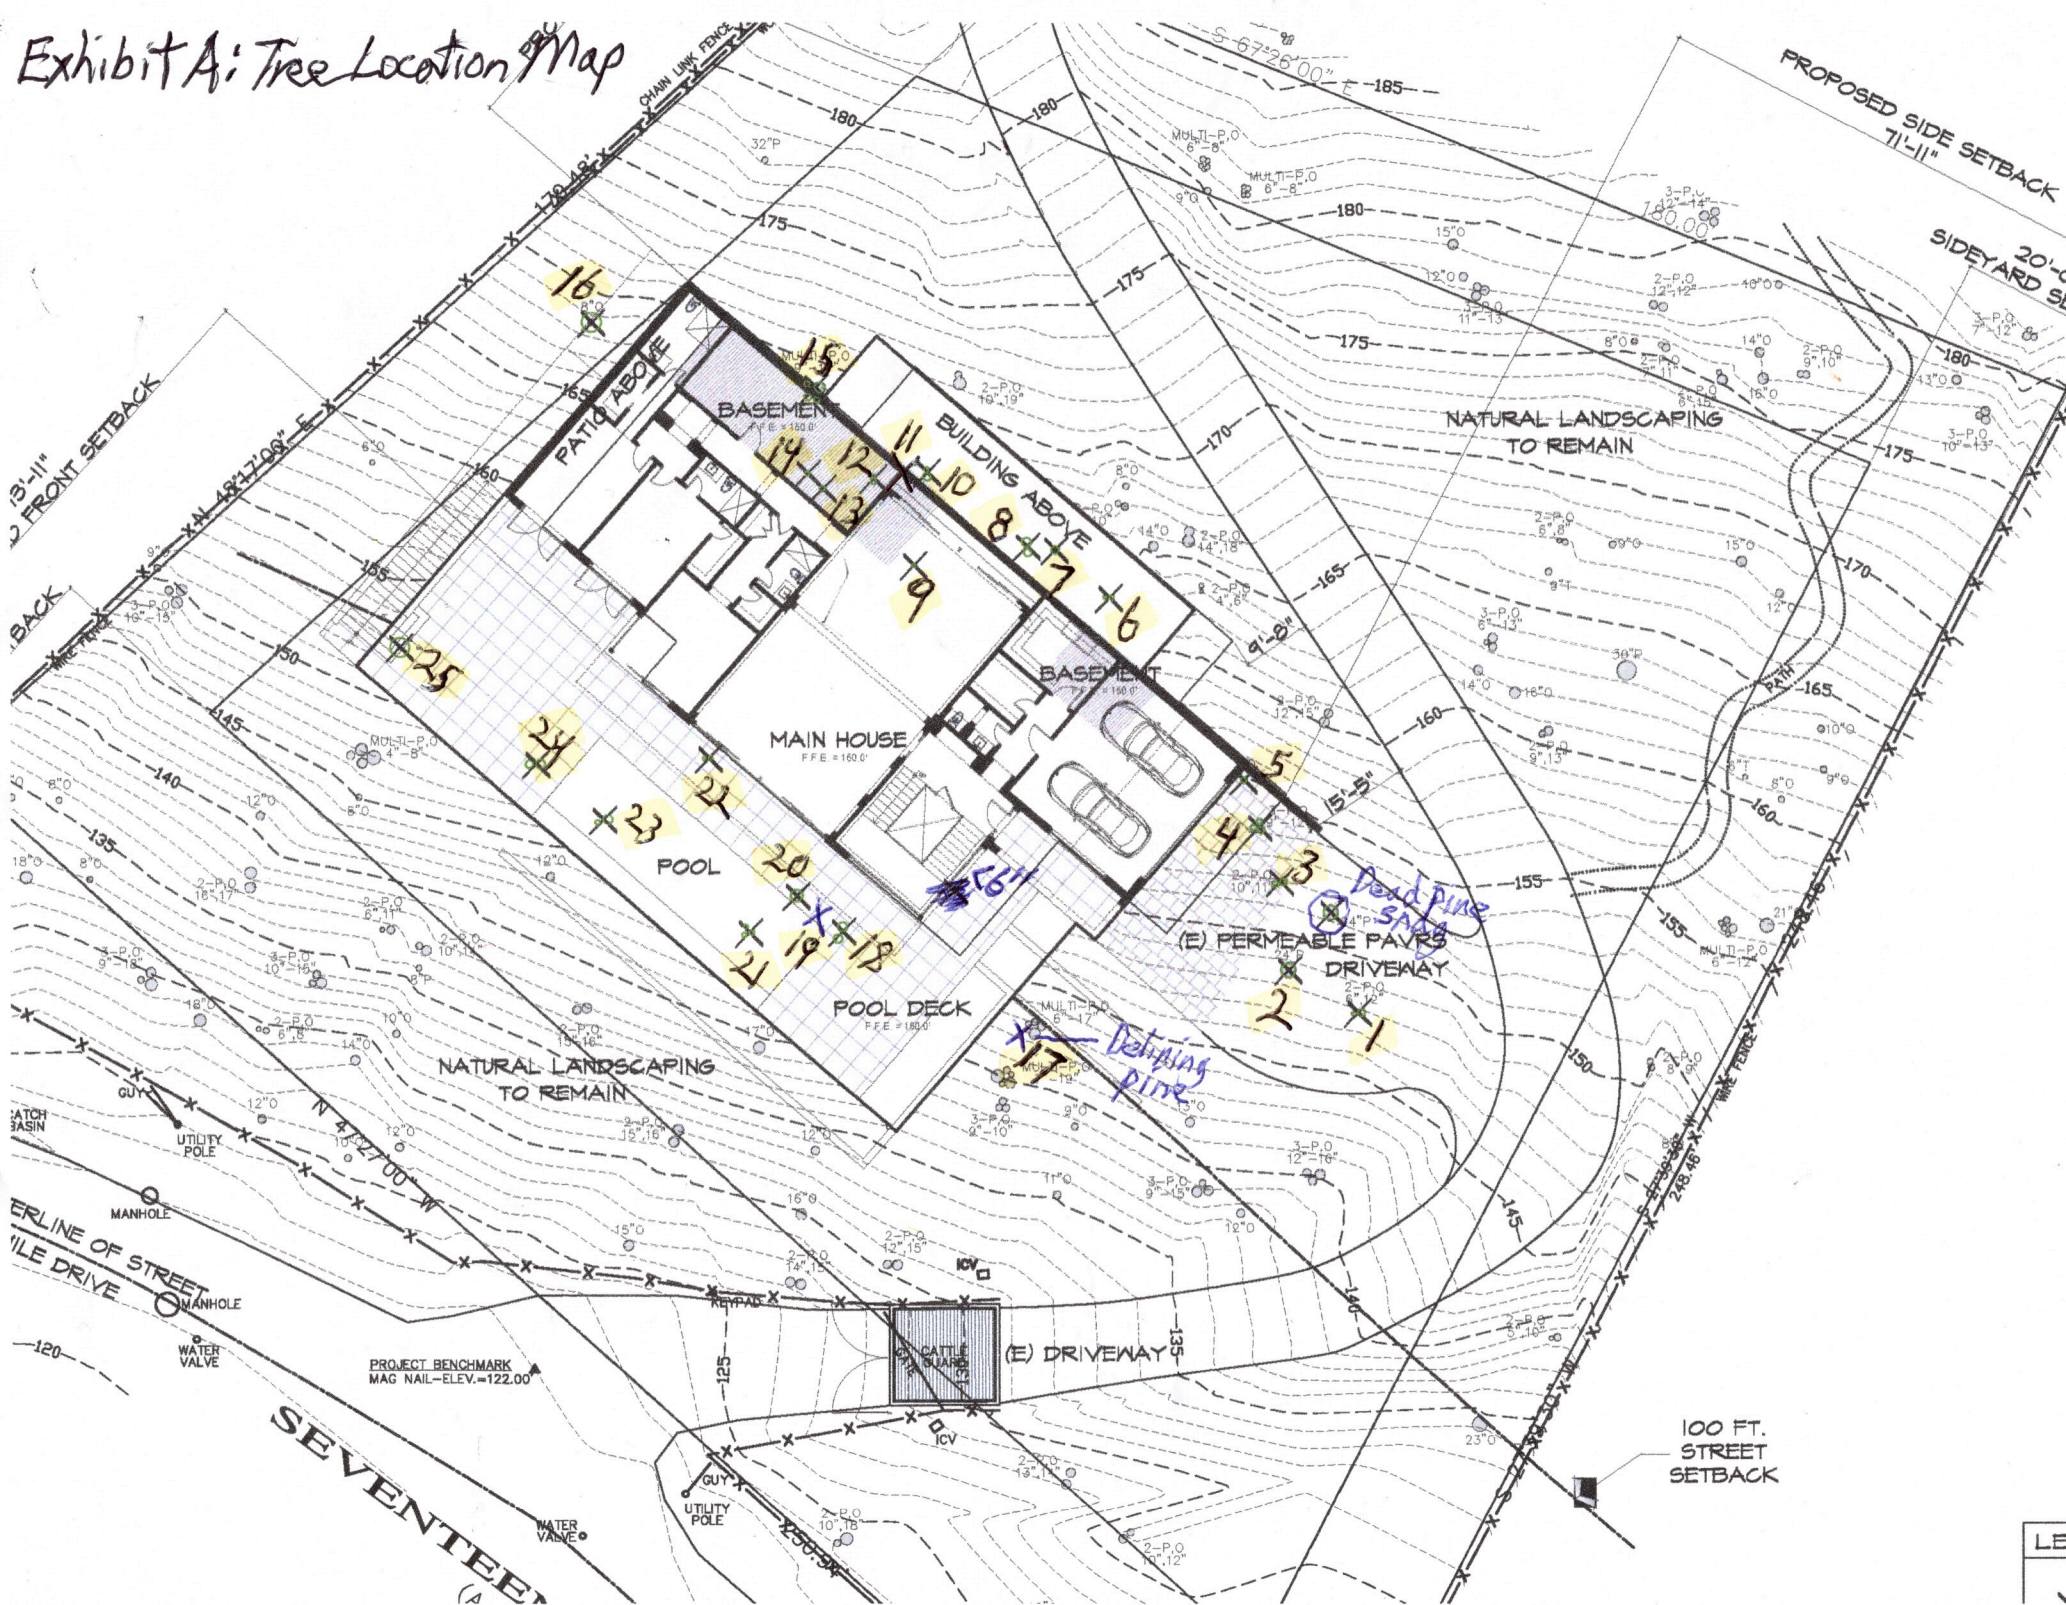
# Exhibit A: Tree Location Map

These 25 trees are identified on the property with orange flagging tape and have been assigned tag numbers 1-25 (refer to the corresponding *Exhibit A: Tree Location Map*). All of these trees (exception being one unhealthy and declining pine tree [identified as Tree#17 in *Exhibit A*] located in close proximity to the building envelope that should be removed due to construction impacts and hazard concerns) will require removal due to their location within or directly adjacent to the proposed construction footprint (refer to *Figures 1-6*). Trees located directly adjacent to construction and grading operations frequently require removal due to significant and unavoidable root system impacts that will compromise the health and structural integrity of trees.

As previously noted, tree removal is due to the subject trees being located within or directly adjacent to the proposed construction footprint, exception being the one previously mentioned large and rapidly declining pine tree (Tree#17) located in close proximity to the construction footprint that should be removed due to hazard concerns.
