# Exhibit B

Violation Location: 26425 Laureles Grade, Monterey. CA 93940  
A.P.N: 416-051-005-000  
Zoning: RDR/B-8-VS  
Case Number: 17CE00378

Subject: Biological Impact Assessment for property located at 26425 Laureles Grade

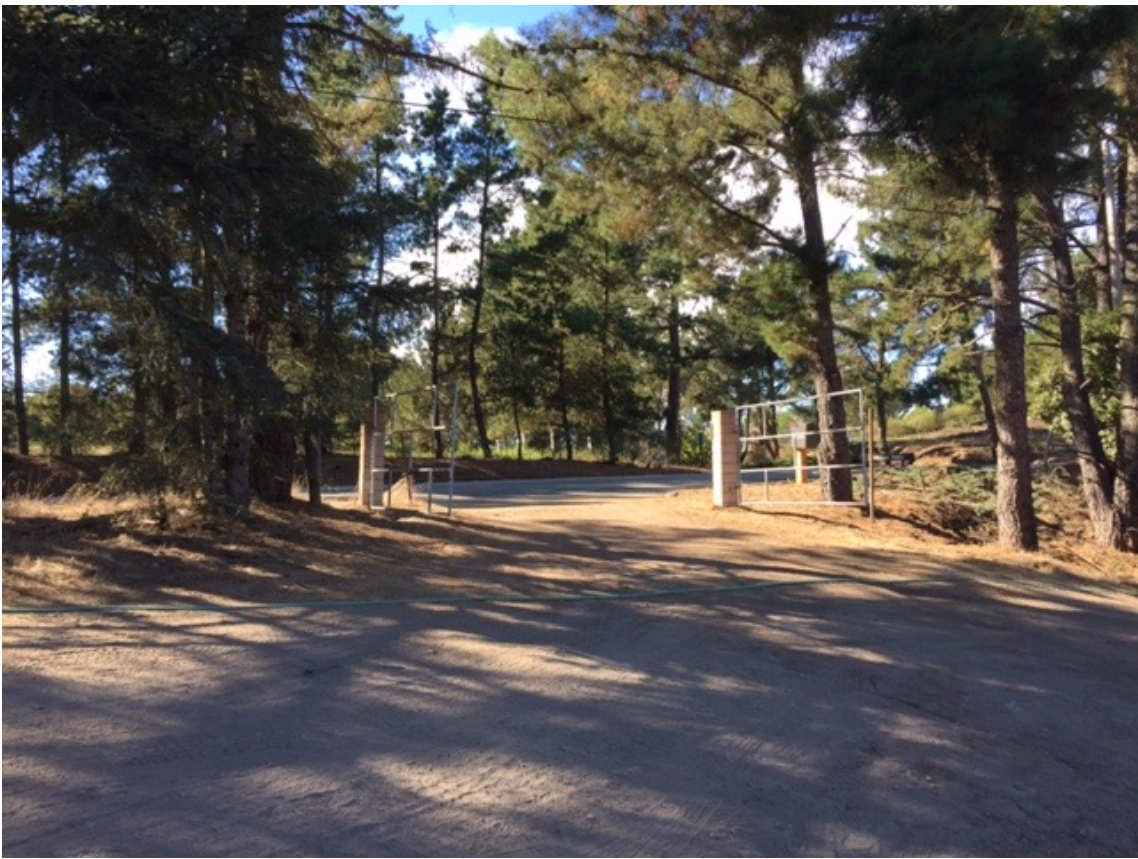
Figure 1. Entrance on west side of property along Laureles Grade is dominated by several mature and introduced Monterey Pine trees that were planted decades ago. Apply all-weather aggregate surface to entrance to prevent sediment tracking onto Laureles Grade roadway.

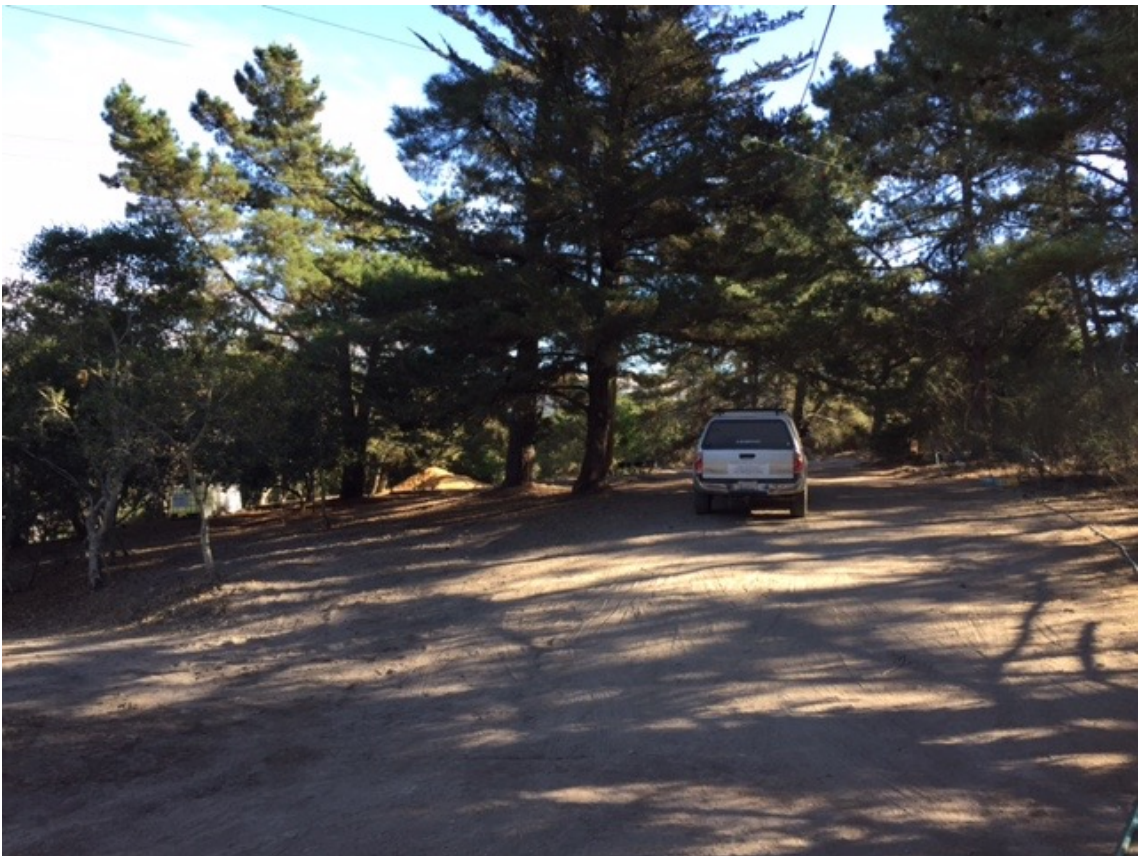
Figure 2. Disturbed area near entrance to property will have mulch applied to exposed areas that are relatively flat. Rice straw mulch and/or woodchip mulch soil protection (i.e., source protection) measures will assist in stabilizing exposed soil surfaces and reducing erosion concerns.

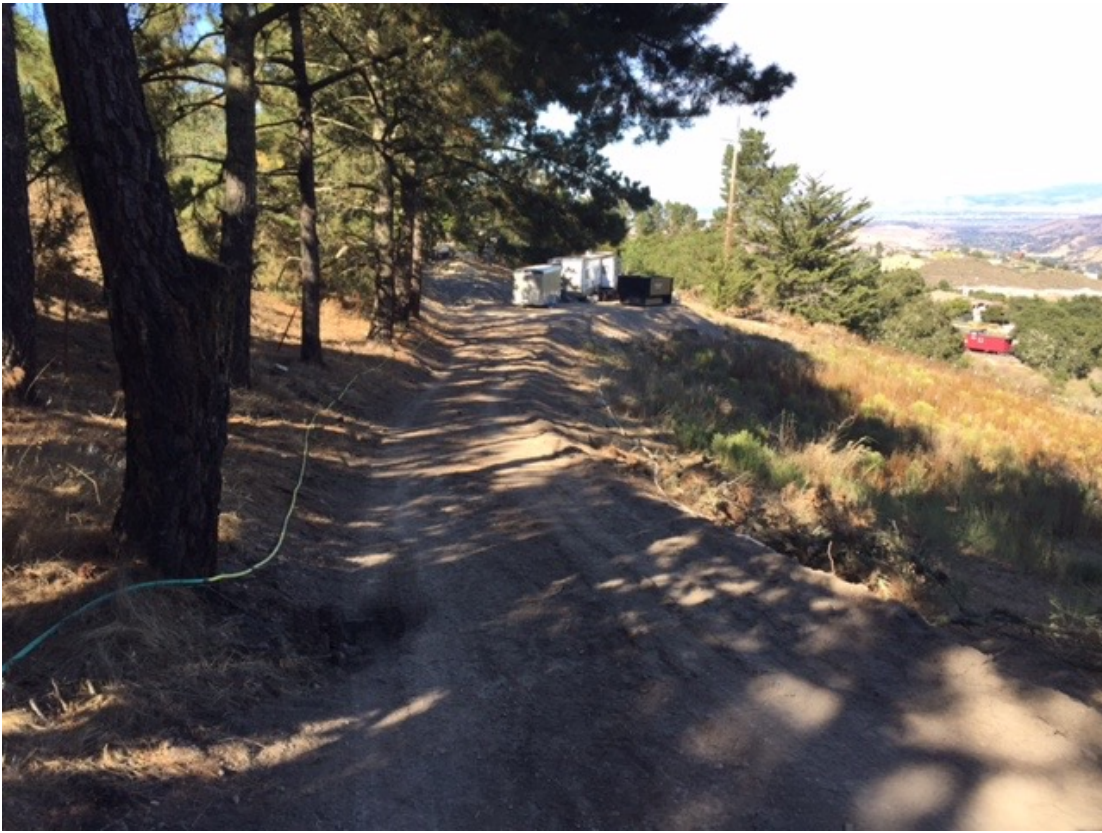
Man-made features on this undeveloped, but previously disturbed property are limited to a few trailers that are owned by the property owner (refer to *Figure 3*). Soils on the parcel appear to be stable and sufficient for supporting slope restoration and stabilization activities that are provided in this report, as well as with property development operations that are proposed for the subject parcel (refer to soils report that was prepared by *Soil Surveys Group, Inc*).

Figure 3. Graded road along upper west part of property provides access to a few trailers. It should be noted that a road existed here prior to the most recent non-permitted grading. Retain and winterize road and install silt fence along downslope perimeter of road and graded pad where trailers are located.

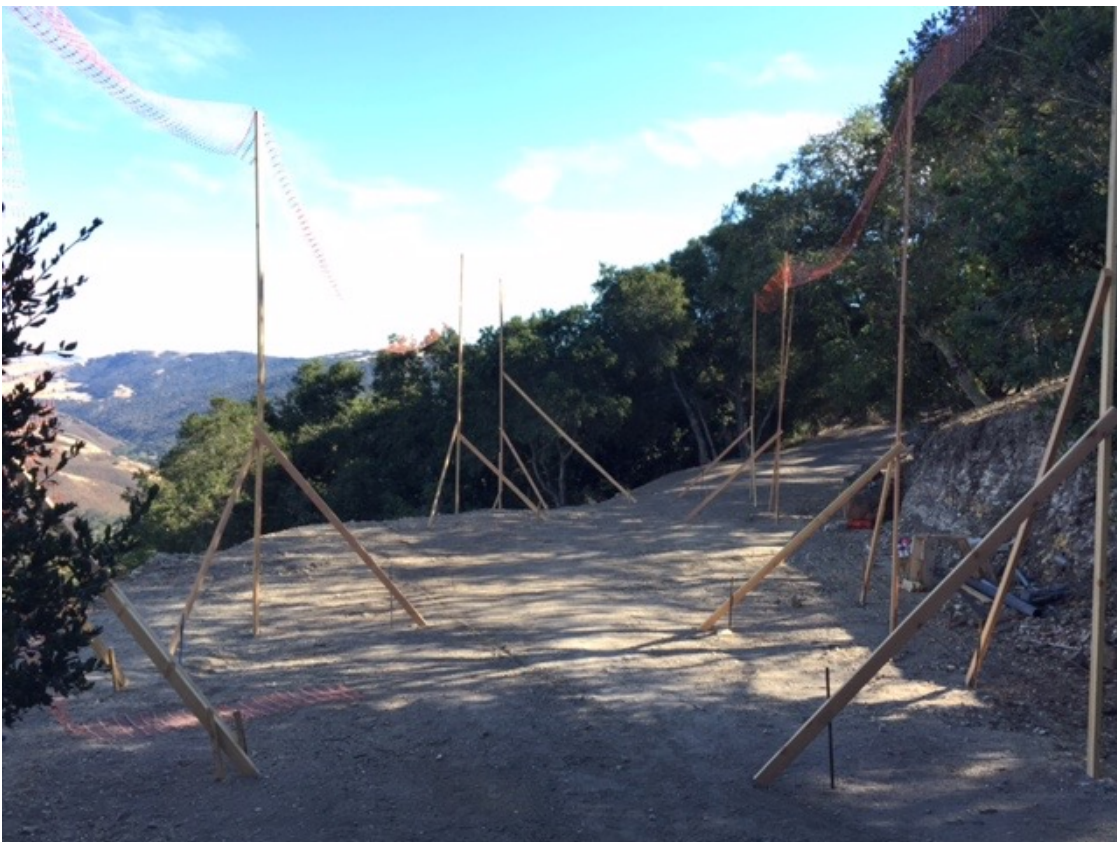
Figure 4. Building pad/terrace for proposed homesite. Retain, but apply woodchip or rice straw mulch to exposed flatter surfaces.

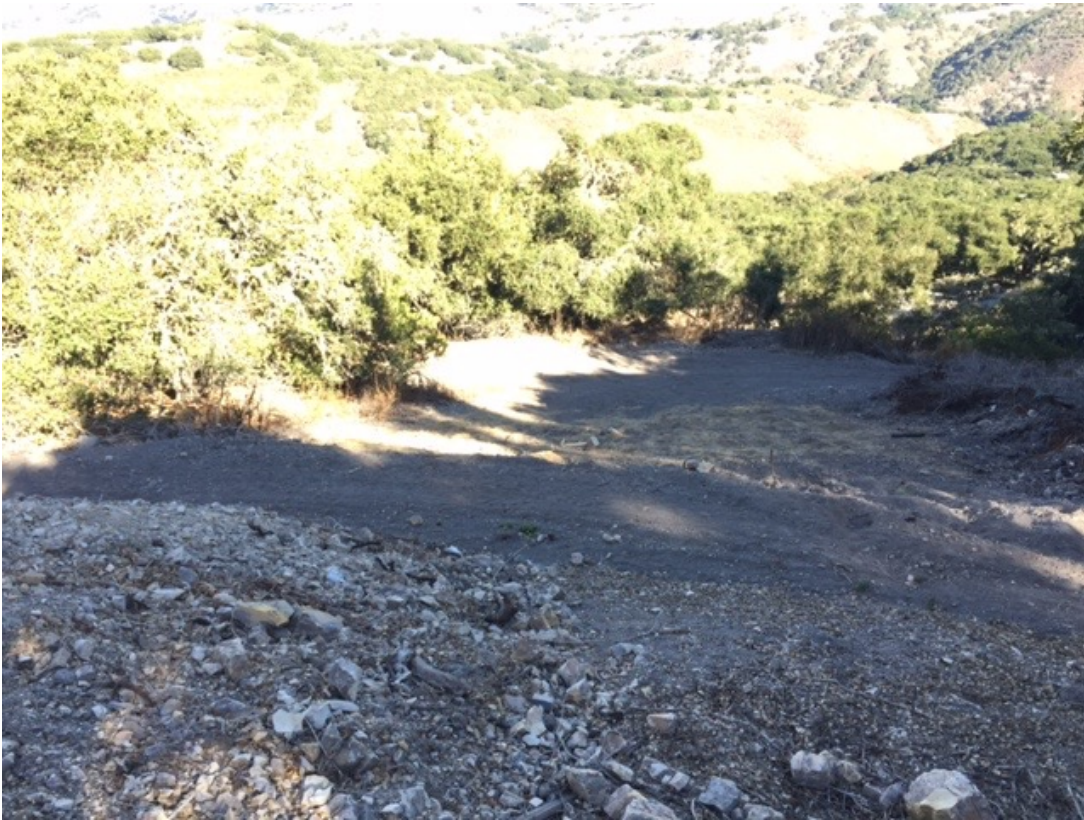
Figure 5. Steep and disturbed slope viewed from building pad seen in last photo is greater than 25% grade. A narrow road/path is located in mid slope and at bottom of slope. Properly shape and track roll slope prior to applying hydromulch and erosion control blankets. Also, install straw wattles (i.e., slope interruption measures) in upper and lower section of slope to assist in stabilizing and protecting impacted slope. The oak tree that was removed was located in foreground in lower center portion of photo.

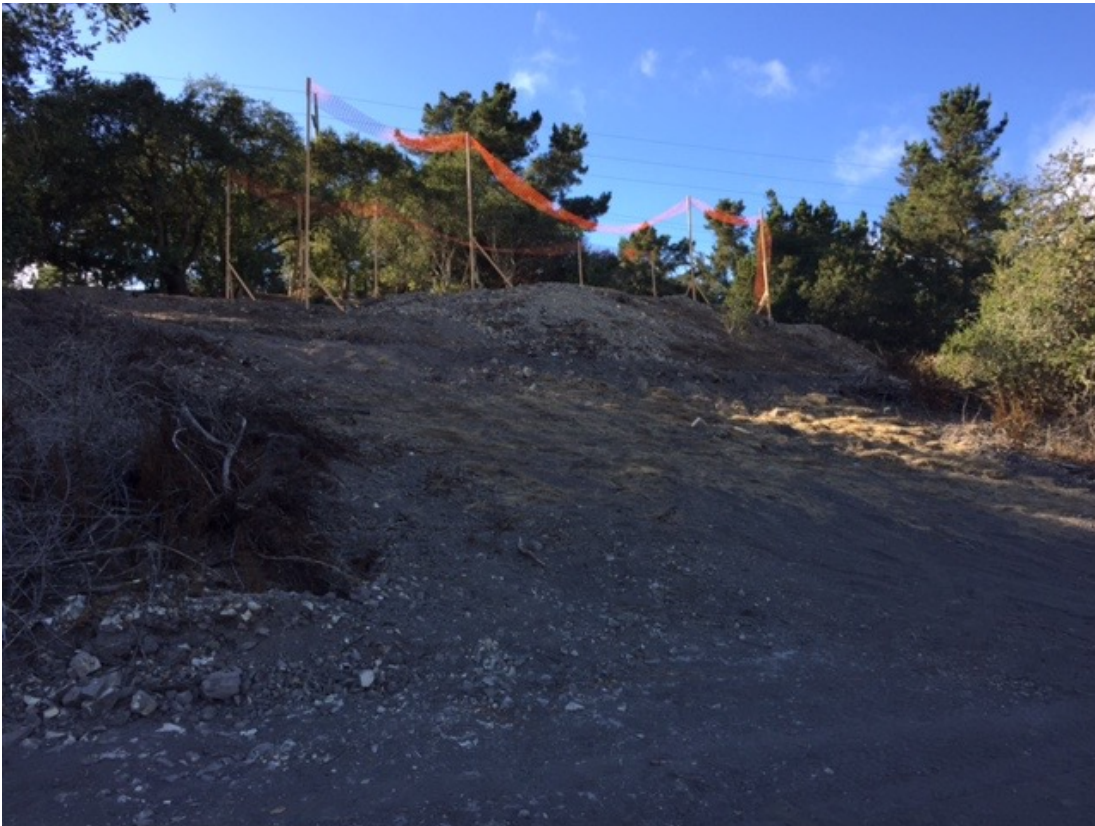
Figure 6. Another view of disturbed and exposed slope below proposed homesite that needs to be stabilized and restored. Oak that was removed was located near top of slope (center portion of photo).

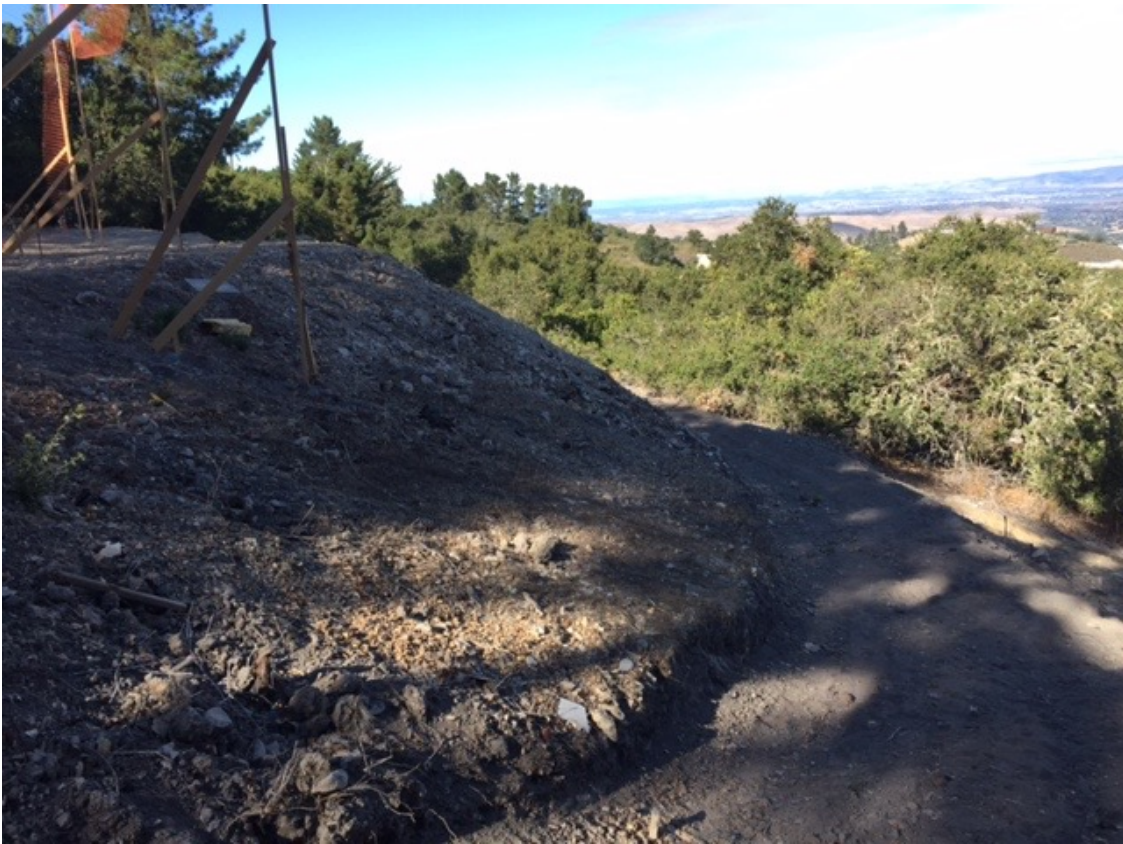
Figure 7. Another view of upper portion of disturbed slope below proposed home building site and narrow road/path that also needs to be restored and/or outsloped. Upon completion of slope shaping and track rolling operations apply native seed mix and erosion control blankets.

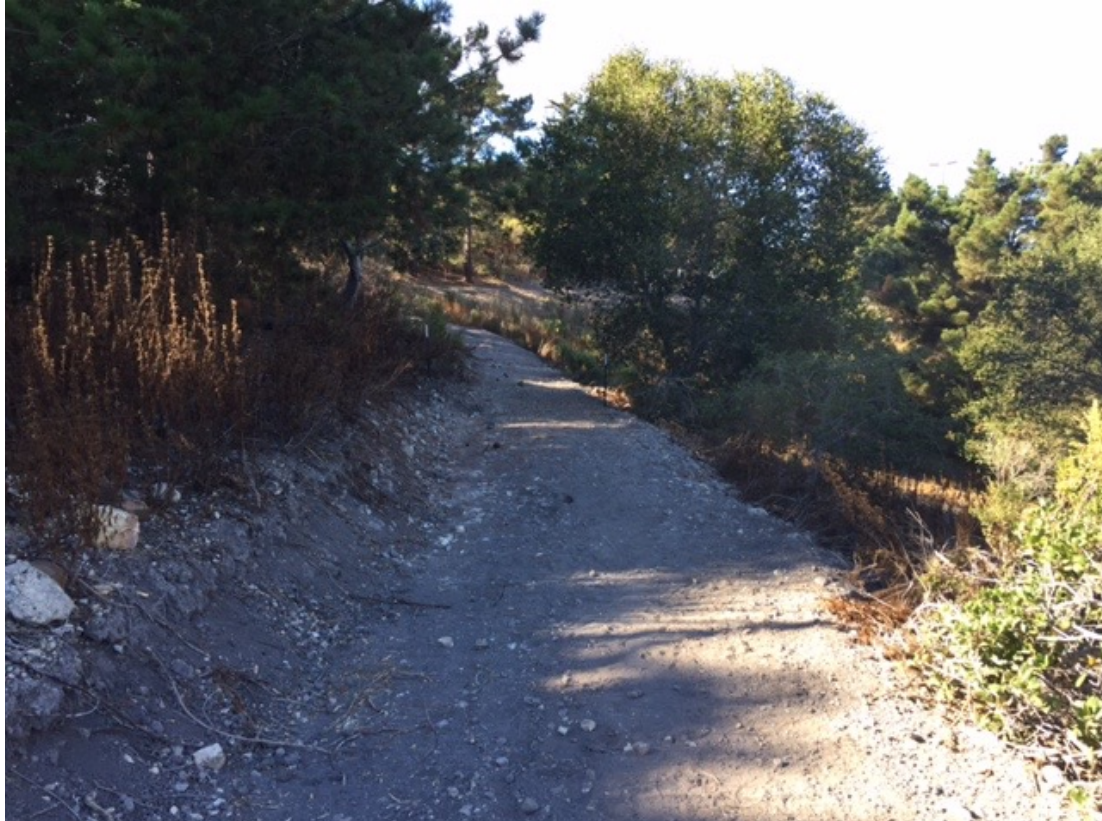
Figure 8. Outslope narrow road/path and install earthen or sand bag water bars every 50 feet to divert concentrated runoff off of exposed soil surfaces. Also apply native seed mix and rice straw or woodchip mulch to protect and stabilize exposed soil surfaces.

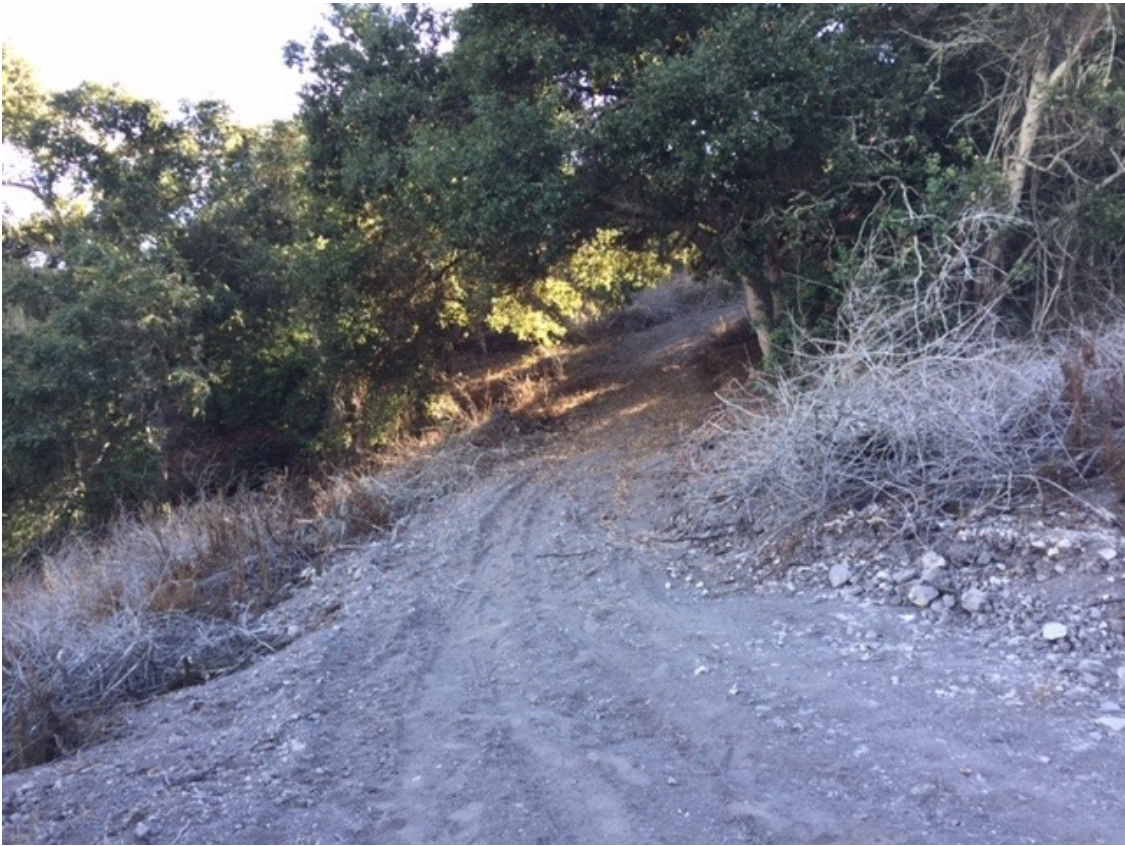
Figure 9. Vertically track roll exposed soil surfaces followed by the application of native seed mix (preferably via hydromulch) and erosion control blankets (e.g., jute net should be sufficient).

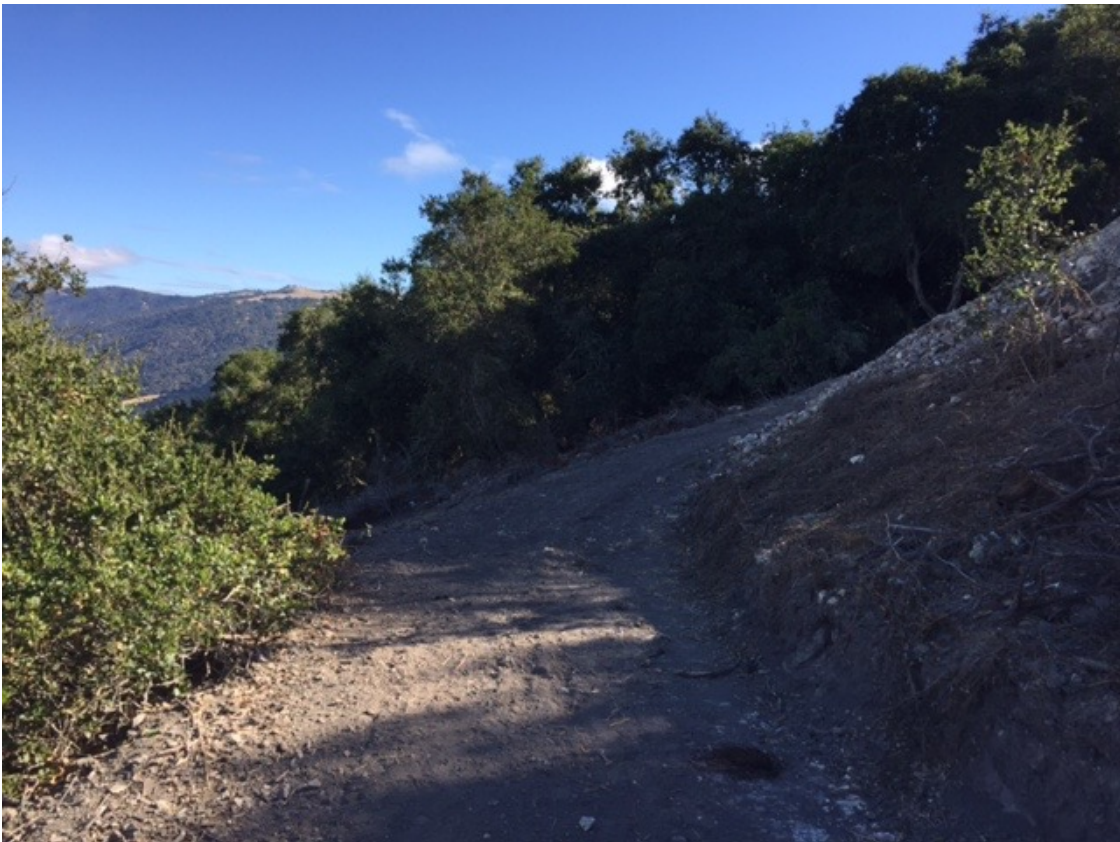
Figure 10. Shape and outslope narrow road/path into surrounding slope prior to applying and installing soil stabilization measures. Retain small oak sapling visible near right edge of photo.

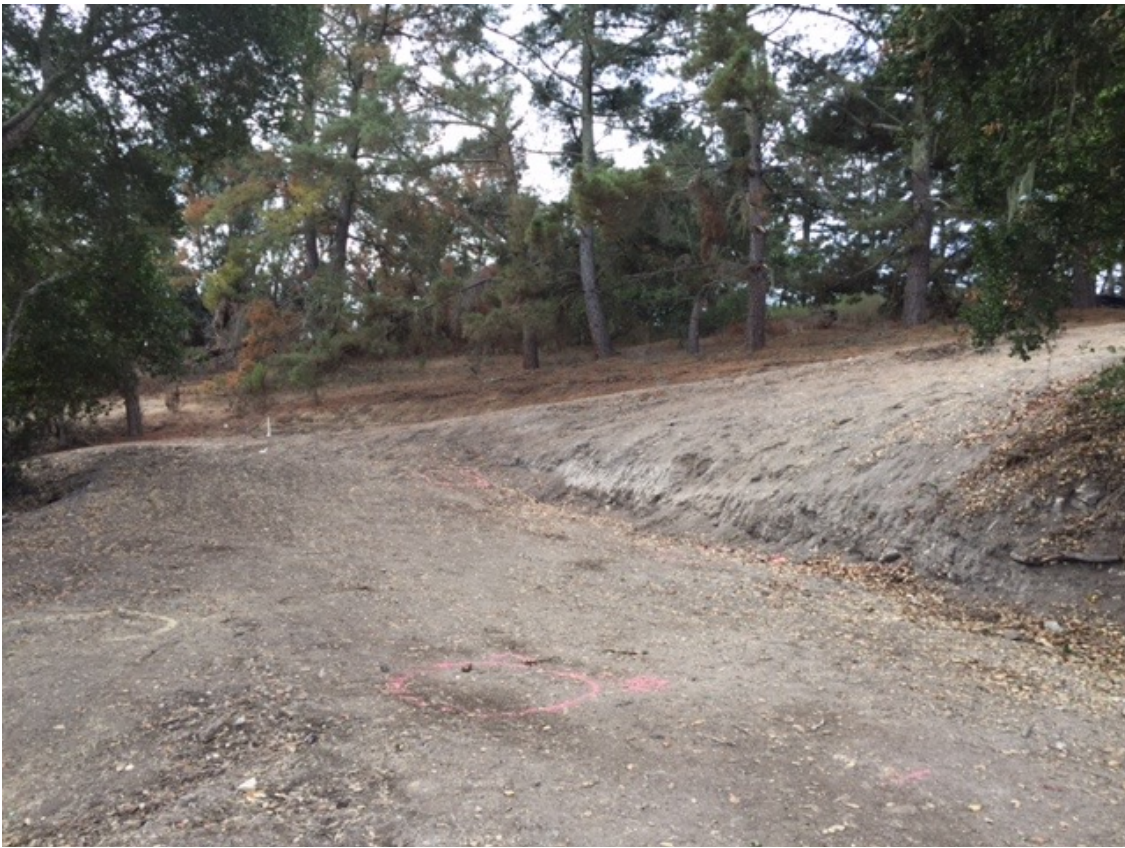
Figure 11. Install rice straw or wood chip mulch in foreground (i.e., flatter areas) and erosion control blankets (e.g., jute net) and straw wattles on steeper slopes (e.g., right of center) to stabilize exposed soil surfaces and prevent erosion problems.

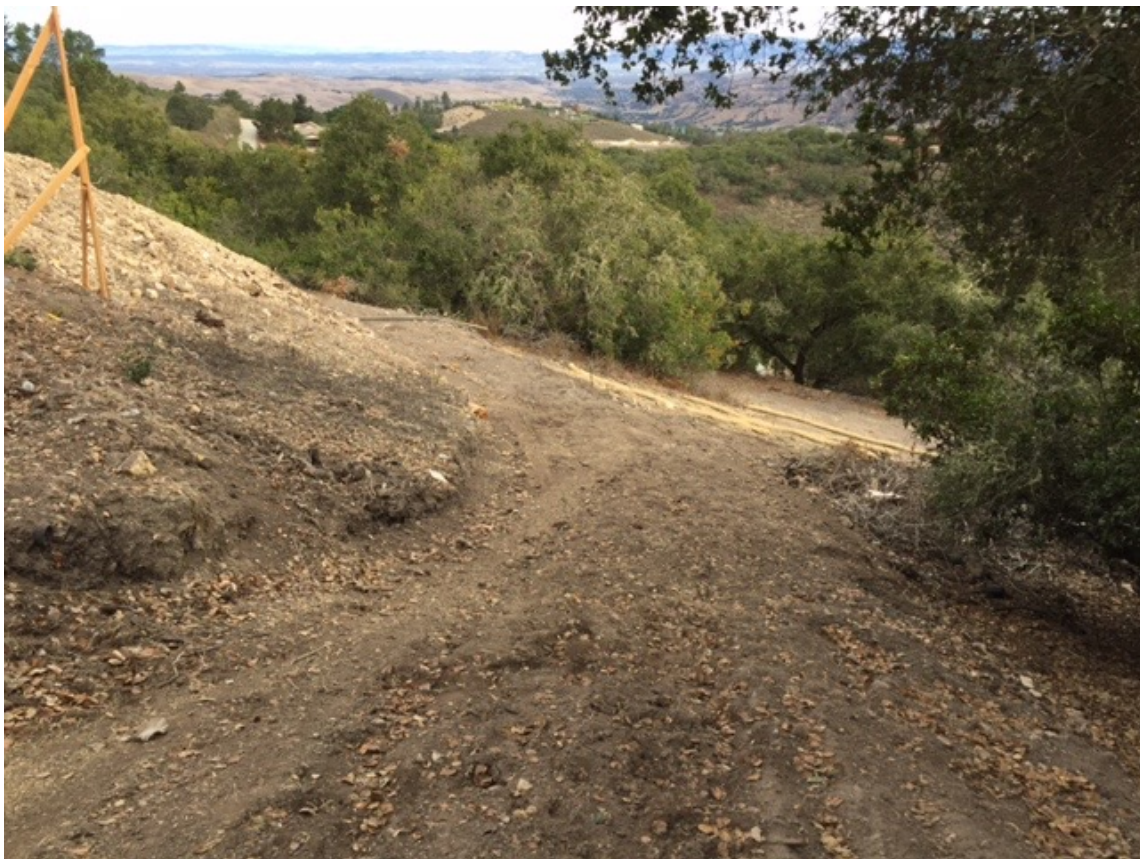
Figure 12. Restore lower road/path and apply native seed mix and soil stabilization measures to exposed slope. As of late, straw wattles have been installed toward lower section of slope (right of center).

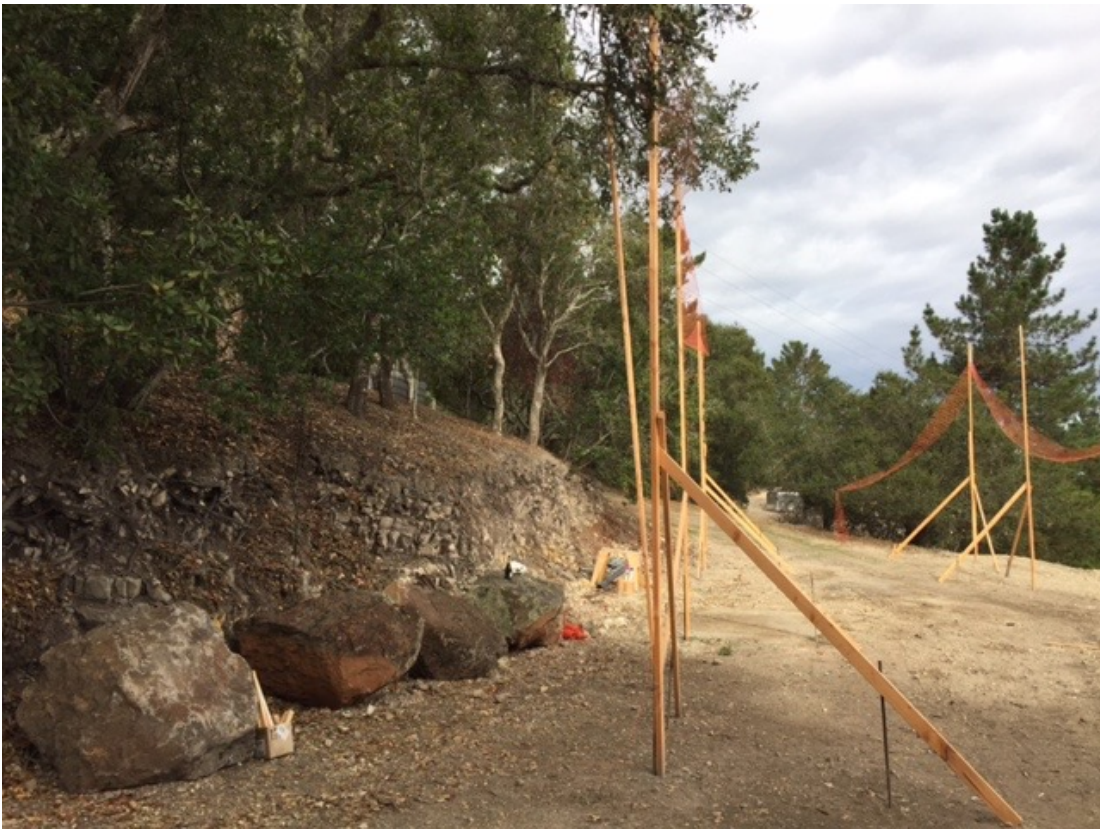
Figure 13. Proposed building pad and site was developed by previous property owner. Relatively immature oak trees located above cut slope are in generally good health and condition and have adapted to the grade change that occurred several years ago. Retain cut slope and building pad/terrace. Install root preservation measures on cut slope (refer to arborist report).

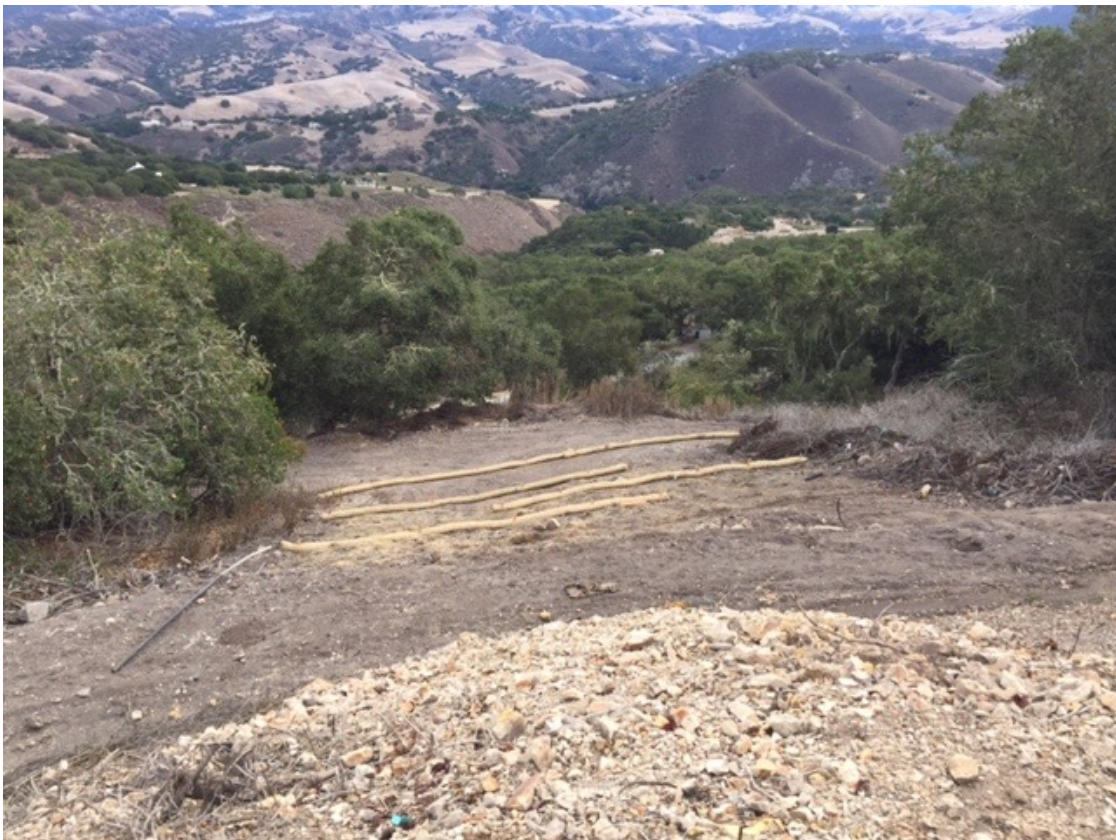
Figure 14. Straw wattles have recently been installed in lower section of slope. Additional erosion and sedimentation control and slope stabilization BMP's provided in this report should be implemented.

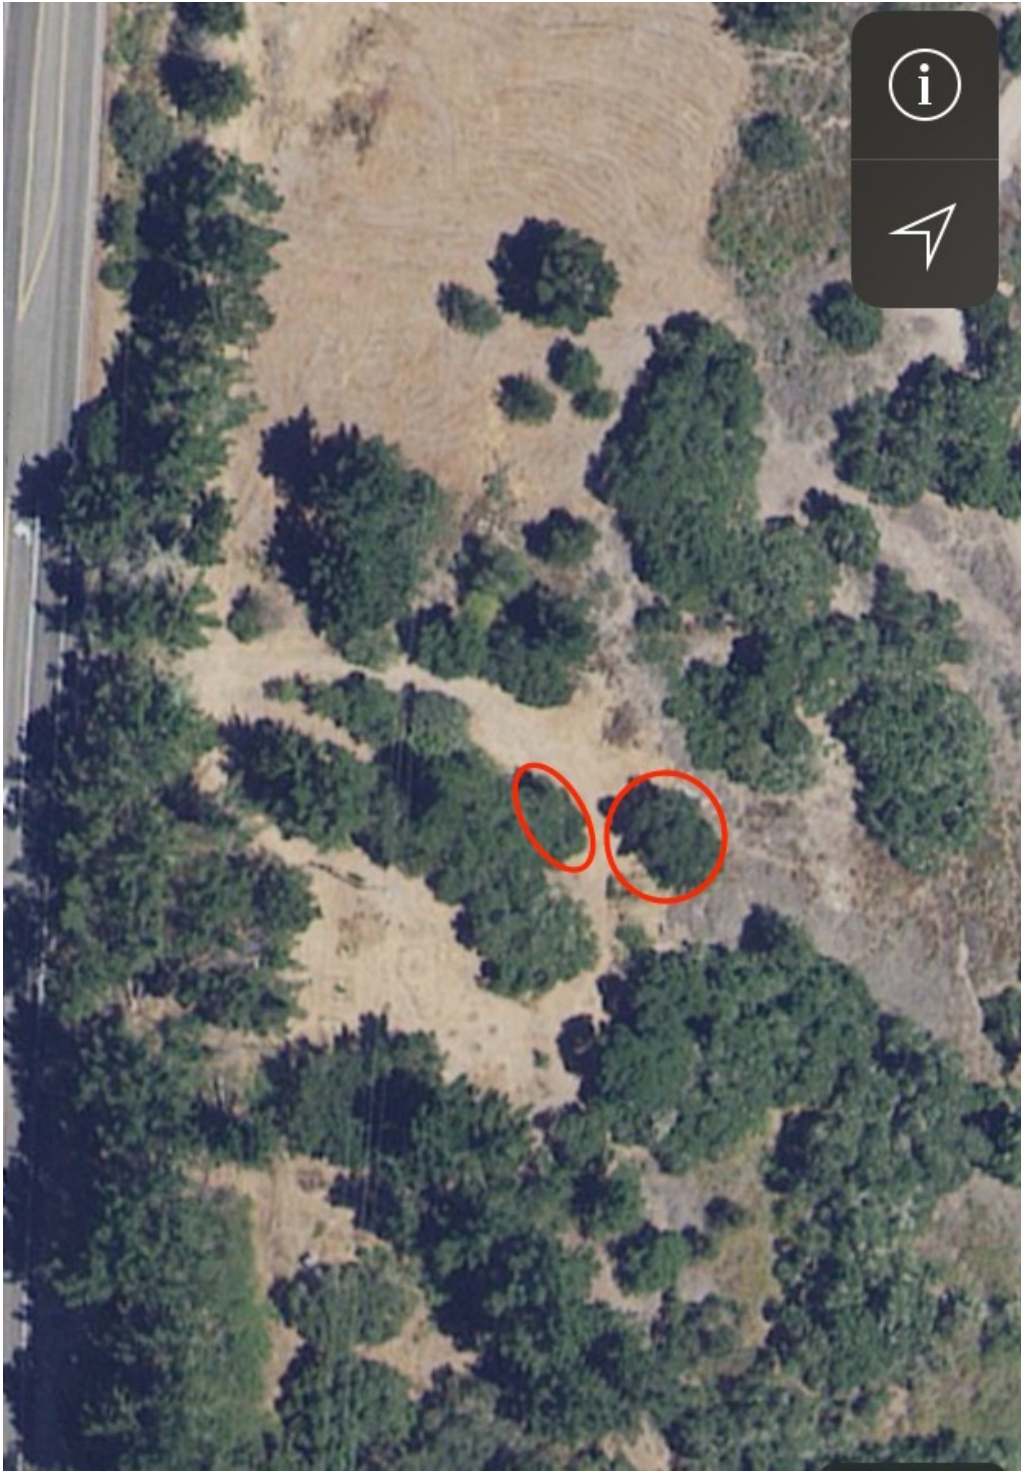
The property owner and *Monterey County RMA* have indicated that two living Coast Live Oak (*Quercus agrifolia*) trees were removed without the necessary permits, which is based on analysis of aerial photographic images. There currently are no physical remnants of the two trees that were removed nor is there visual proof as to the precise size and overall health and condition of the subject trees at the time of removal; however according to the property owner and *Monterey County RMA* (and further supported by a *Google Earth* aerial image) these living trees appear to have been larger than 6 inch DBH at the time of removal. There currently is no evidence that additional trees were removed nor is there any indication that other oak trees were significantly damaged or harmed during non-permitted grading activities. As a result of the unauthorized removal of two oak trees, the property owner has agreed to plant ten (10) 5-gallon Coast Live Oak trees (refer to corresponding Exhibits for planting locations and *Figure 15* aerial image for

Figure 15. Two mature Coast Live Oak trees that were removed are circled in photo. Numerous other trees visible in aerial image have not been removed or impacted. Per a recent assessment, surrounding oak woodland habitat is still intact and has not been significantly impacted or compromised.

location of existing trees and woodland habitat) to mitigate impacts associated with non-permitted tree removal and disturbance to oak woodland habitat. These 10 replacement plantings shall survive a 2-year monitoring period to satisfy Monterey County mitigation requirements.
