**Tree Inventory, Assessment,
and
Protection Report**

**One Old Ranch Road
Carmel By-the-Sea, CA 93923
(Unincorporated Monterey County)**

Carmel Valley Ranch

October 10, 2024

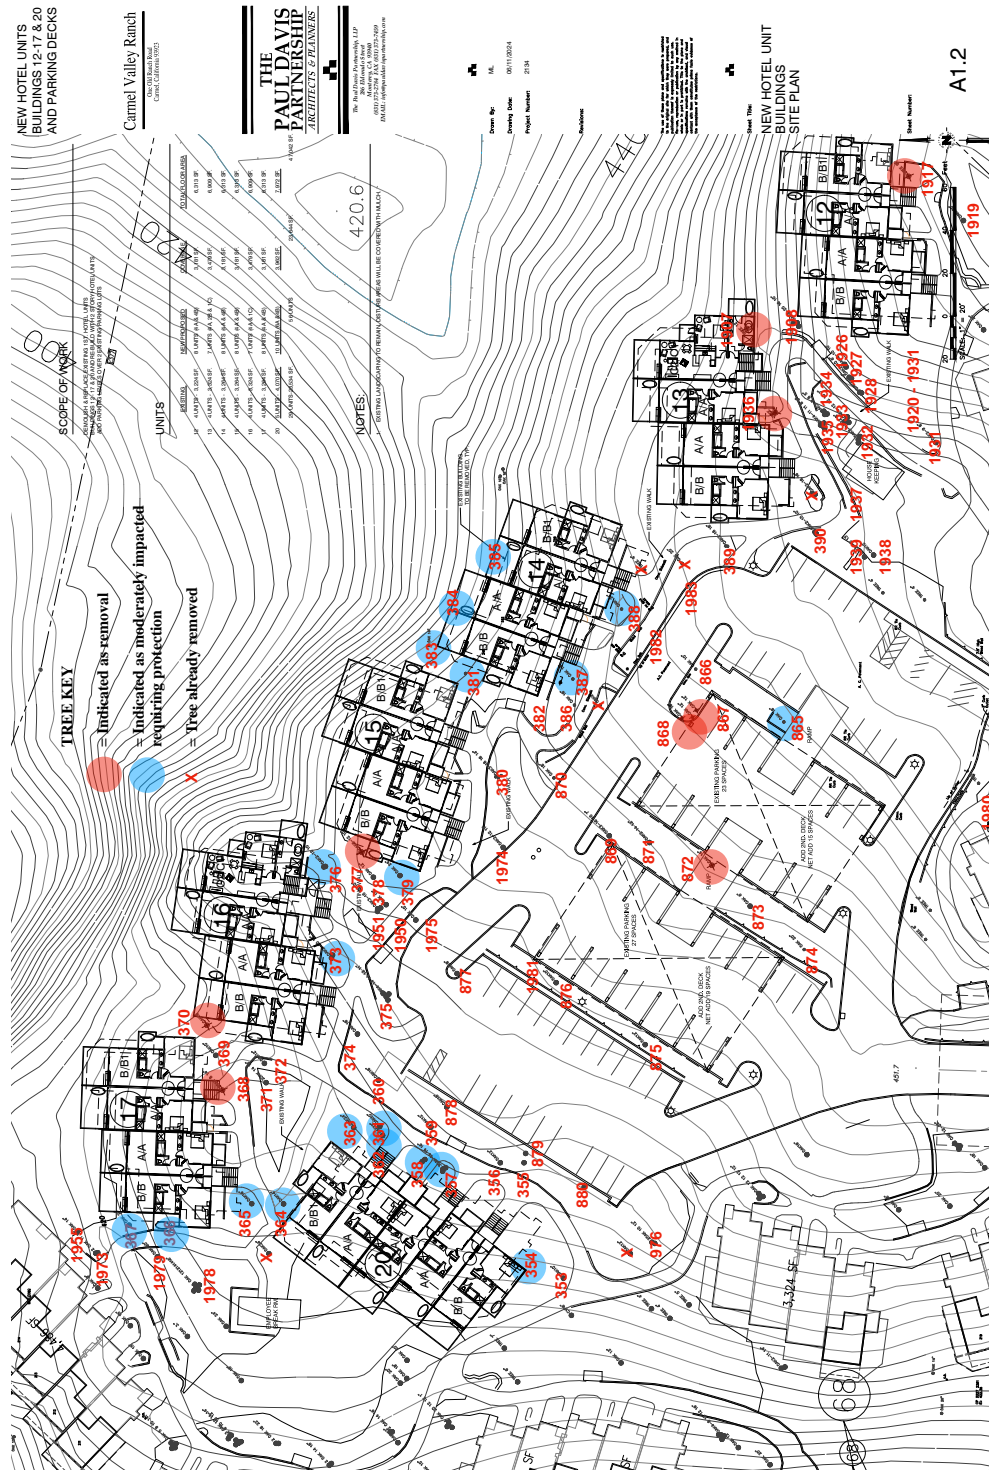
Appendix A: Tree Locations and estimated impacts

The plans indicate the renovation of several units within the footprint of existing structures and parking lot improvements (Appendix A).

There are nine (9) trees expected to be highly impacted and removed which are as follows: #368, #370, #377, #867, #868, #872, #1907, #1917, and #1936 (Chart 3). Three (3) of these trees (#377, #867, and #1907) are Landmark Trees, two (2) trees (Japanese maple #1936 and crabapple #1917) are not protected. Twenty-one (21) trees could be moderately impacted and are close to the existing structures (Appendix A and B).

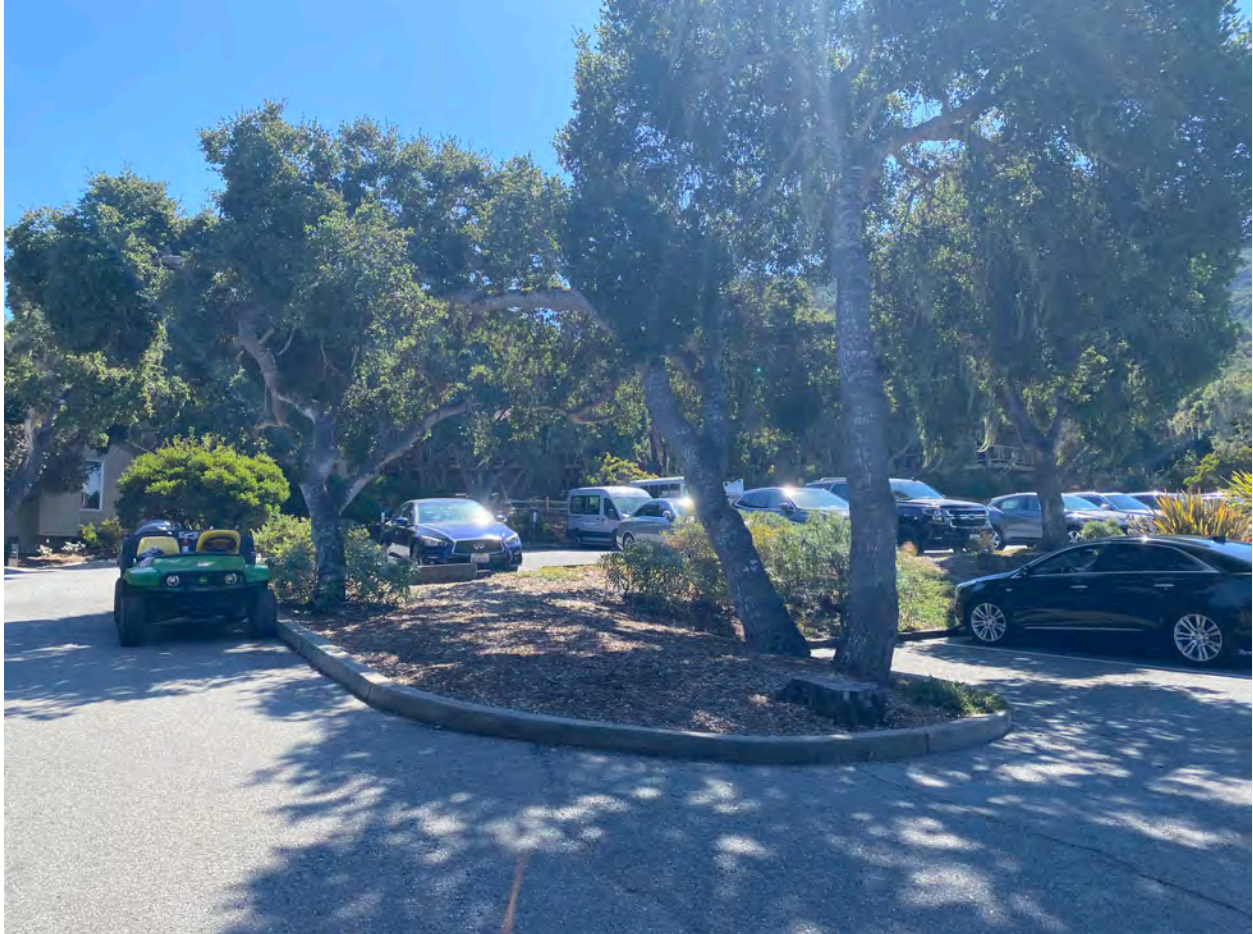
C1: Trees #867 and #868

There are nine (9) trees expected to be highly impacted and removed which are as follows: #368, #370, #377, #867, #868, #872, #1907, #1917, and #1936. Three (3) of these trees (#377, #867, and #1907) are Landmark Trees, two (2) trees (Japanese maple #1936 and crabapple #1917) are not protected. Twenty-one (21) trees could be moderately impacted and are close to the existing structures (Appendix A and B).

There are three landmark trees indicated for removal and they should be replaced with a one to one ratio of twenty-four inch box specimens or larger of the the same species (coast live oak). The smaller protected coast live oaks should be replaced with one to one ratio of four fifteen gallon specimens. The two tree not protected by the ordinance do not require replacement.
