COTTON, SHIRES & ASSOCIATES, INC. CONSULTING ENGINEERS AND GEOLOGISTS

#### MITIGATION OPTION 5C - REROUTE WATER TO NEW DETENTION BASIN

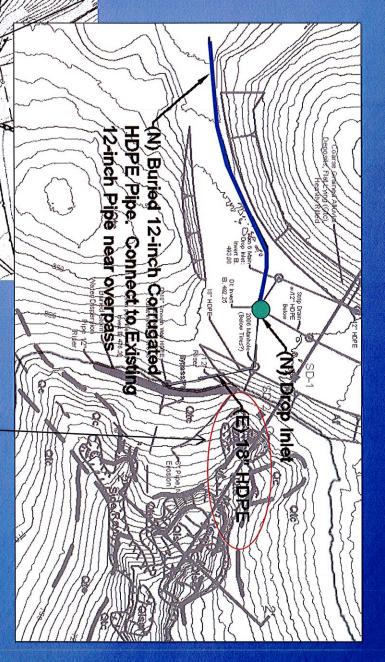
Whitson 2006, Sheet C1.4

Highly dependent on maintenance of DI's (clogged during initial mapping)

Can Turn 6 water be discharged into 12" pipe? No leaking on 12" bypass pipe to date

774 SDDI RMM 802.81 IE: 798.4

Tie into existing 12" SD

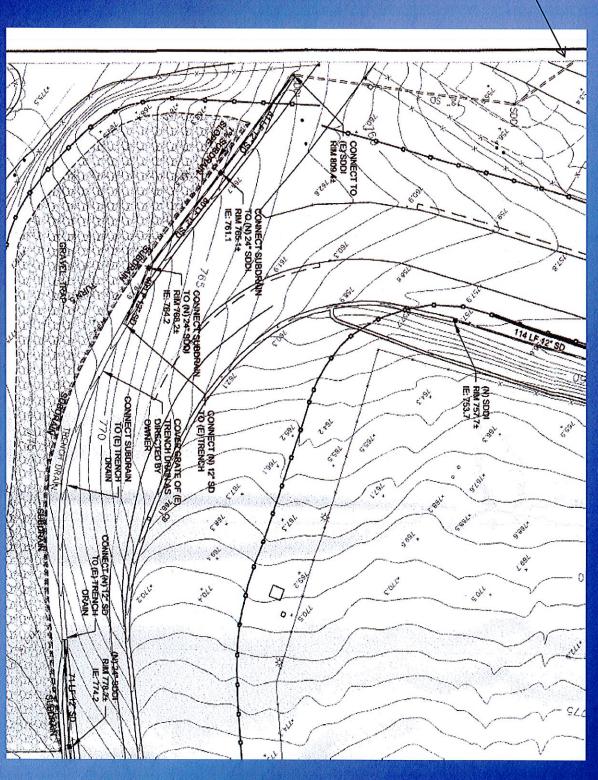
Whitson 2006, Sheet C1.4

location of 12" SD not shown on adjacent plan sheet Discharge

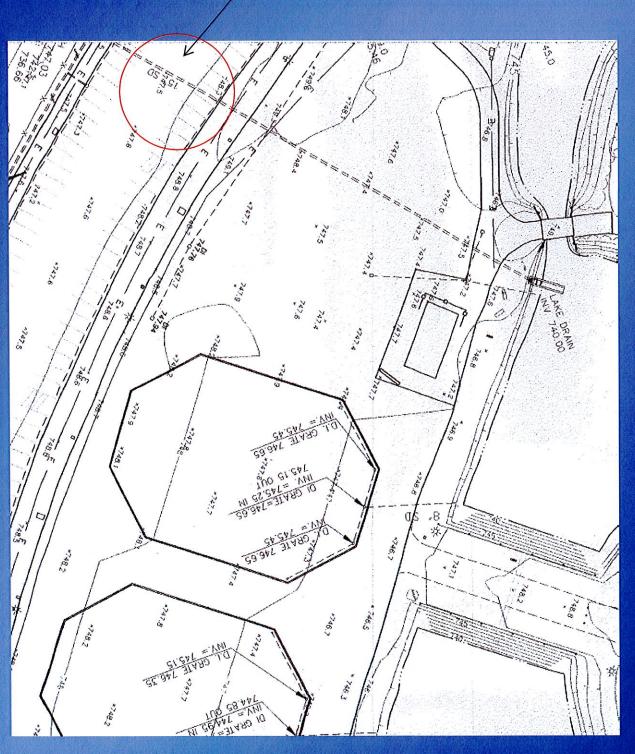
Whitson 2006, Sheet C1.3

Only lake outlet observed on plans. 15" diameter. Lake inlet pipes vary from 12"-36" diameter
