TREE RESOURCE EVALUATION
PROJECT IMPACT ANALYSIS
TREE PROTECTION PLAN

Garibaldi Residence
1030 Marcheta Lane, Pebble Beach
APN 007-342-002

March 2016

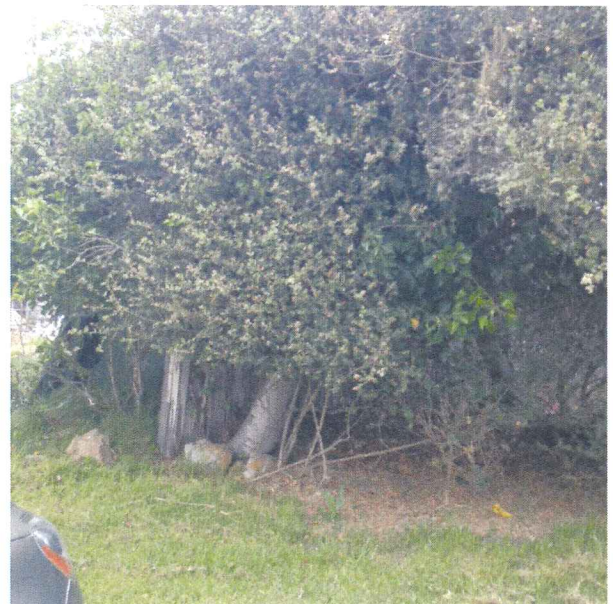
One smaller oak (tree #1) is growing at the front of the house adjacent to the existing asphalt driveway (pictured).

The canopy has been mechanically sheared and the re-growth is covered with “witches broom” a fungal infection.

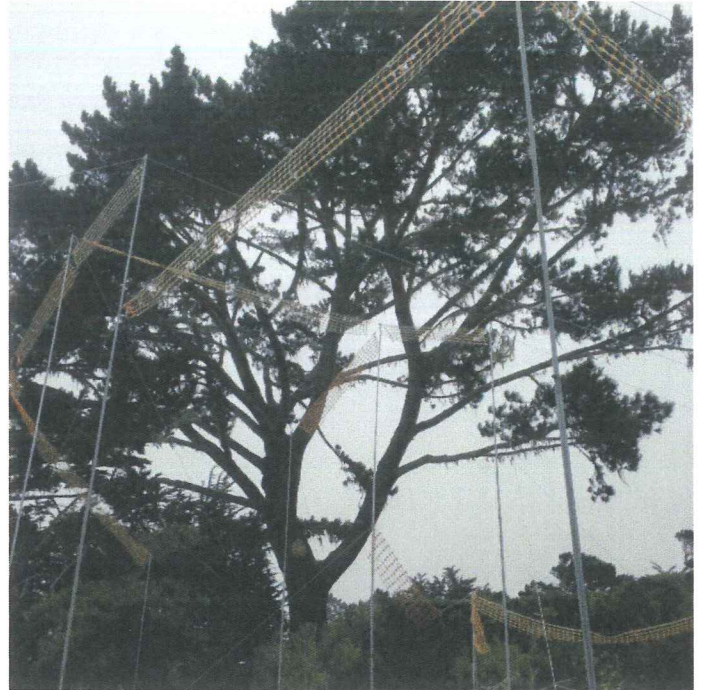
A mature Monterey pine (*Pinus radiata*) is growing at the back corner of the property (pictured at right). The broad and spreading canopy extends at least 20 feet from the trunk. The foliar canopy displays minor thinning but no signs of disease or insect infestations were observed.

Demolition of the existing structure and construction of the new residence, driveway, basement garage and landscape elements could potentially impact the root systems of tree #4, the mature pine and the three offsite Monterey cypress.

The installation of the proposed bocce court could impact the root system of the Monterey pine. If excavation is required to install this element it should be relocated or redesigned to be placed on natural grade without excavation.

The potential impacts to the mature Monterey pine can be reduced or eliminated if the proposed bocce court is relocated or placed on natural grade with no excavation into the Critical Root Zone.
