Tree Resource Assessment
1145 Spyglass Hill Road
Pebble Beach CA

October 14, 2016

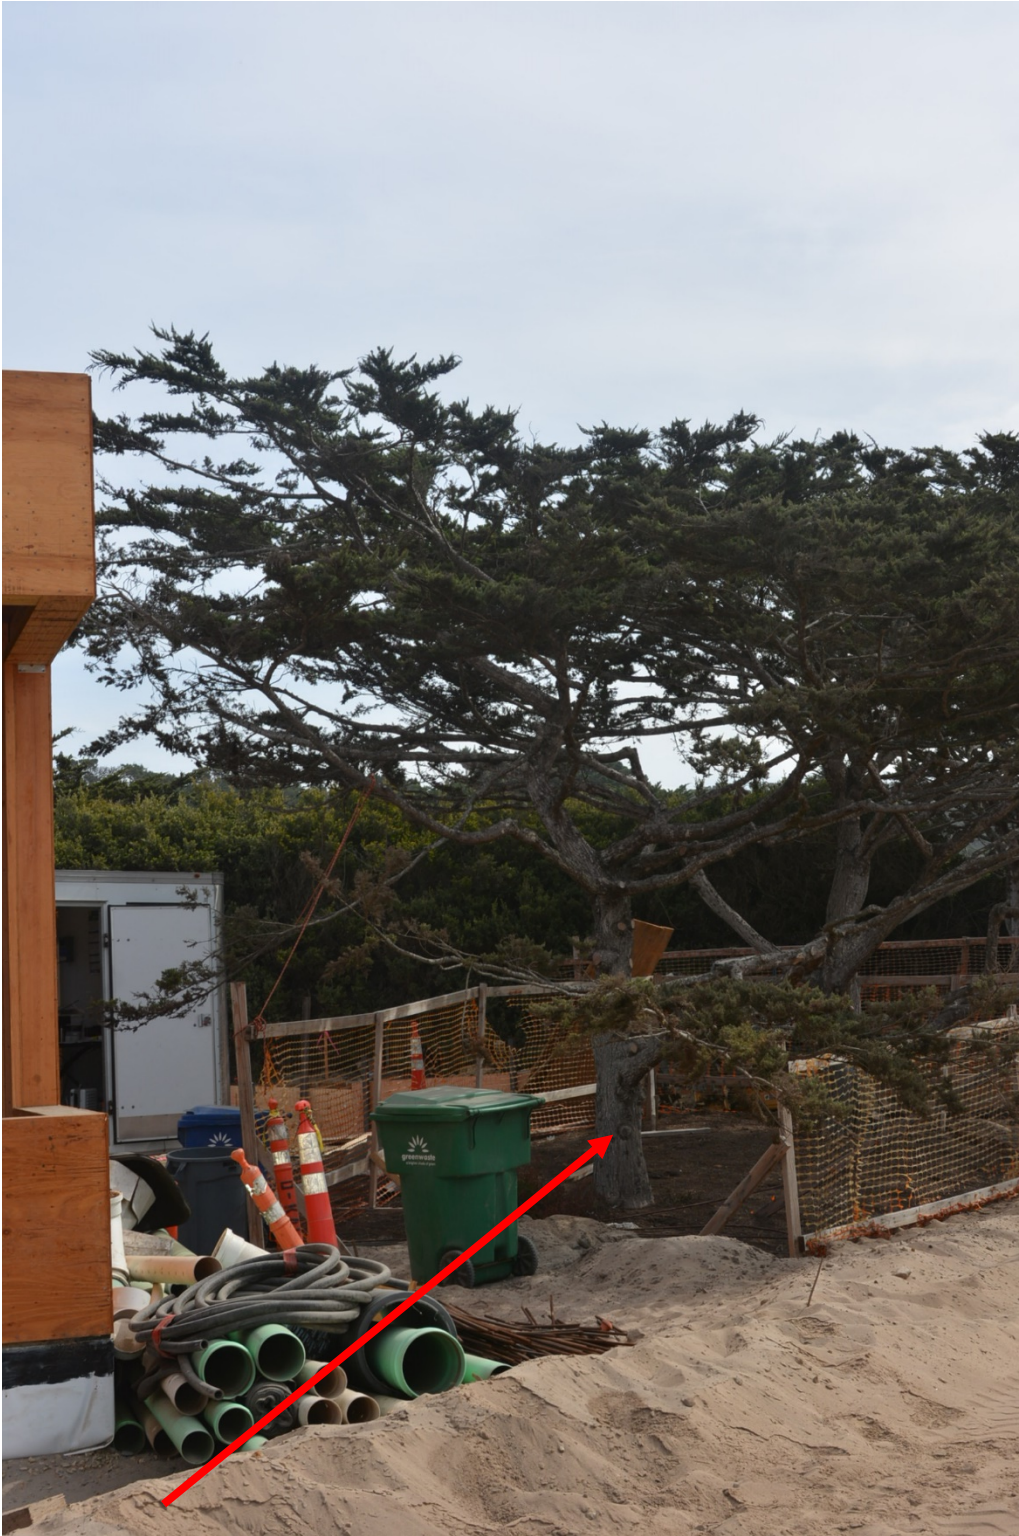
The project, as presented to me, indicates a smaller cypress (#2569 - 21" diameter Monterey cypress –*Hesperocyparis macrocarpa*) which will have its root zone encroached to install a retaining wall. The Cypress tree is not landmark sized (24" diameter or greater in diameter). Also requested for removal is a 10" planted ornamental (New Zealand Christmas tree (*Metrosideros excelsa tomentosa*)). Both trees appear to be a planted trees which were planted as part of the pre-existing landscape.

Essentially, the required foundation footing will affect over 30% of the tree's root zone due to anticipated soil sloughing of the soft sand. Treatments such as excavation expose roots and open the tree to listing over. The site, composed of sandy soils which will be disturbed and loosened most likely will affect the trees ability to effectively stand upright, especially since it is very exposed to west winds. Construction activities to work around the tree also requires pruning of at least 40% of its remaining crown to be removed; therefore, at this time my recommendation is to remove and replace the tree since much of the tree's critical root zone and existing canopy must be removed. Sustained and successful results may be accomplished by replacement tree replanting further away from the building.

Tree #2369 to be removed will be replaced by three cypress

The County of Monterey through the Del Monte Forest Land Use plan has tree replacement conditions as part of a tree removal permit when sufficient space exists to replant that does not create an overcrowded vegetated situation. Tree removal will be replaced at a 3:1 replacement with Monterey cypress replanted in locations adjacent other retained trees so as not to change the amount of square footage required for dune restoration. In addition, the County also requires independent monitoring of replanted trees to insure replanting is successful (the term of monitoring is at County discretion, typically one to three years).

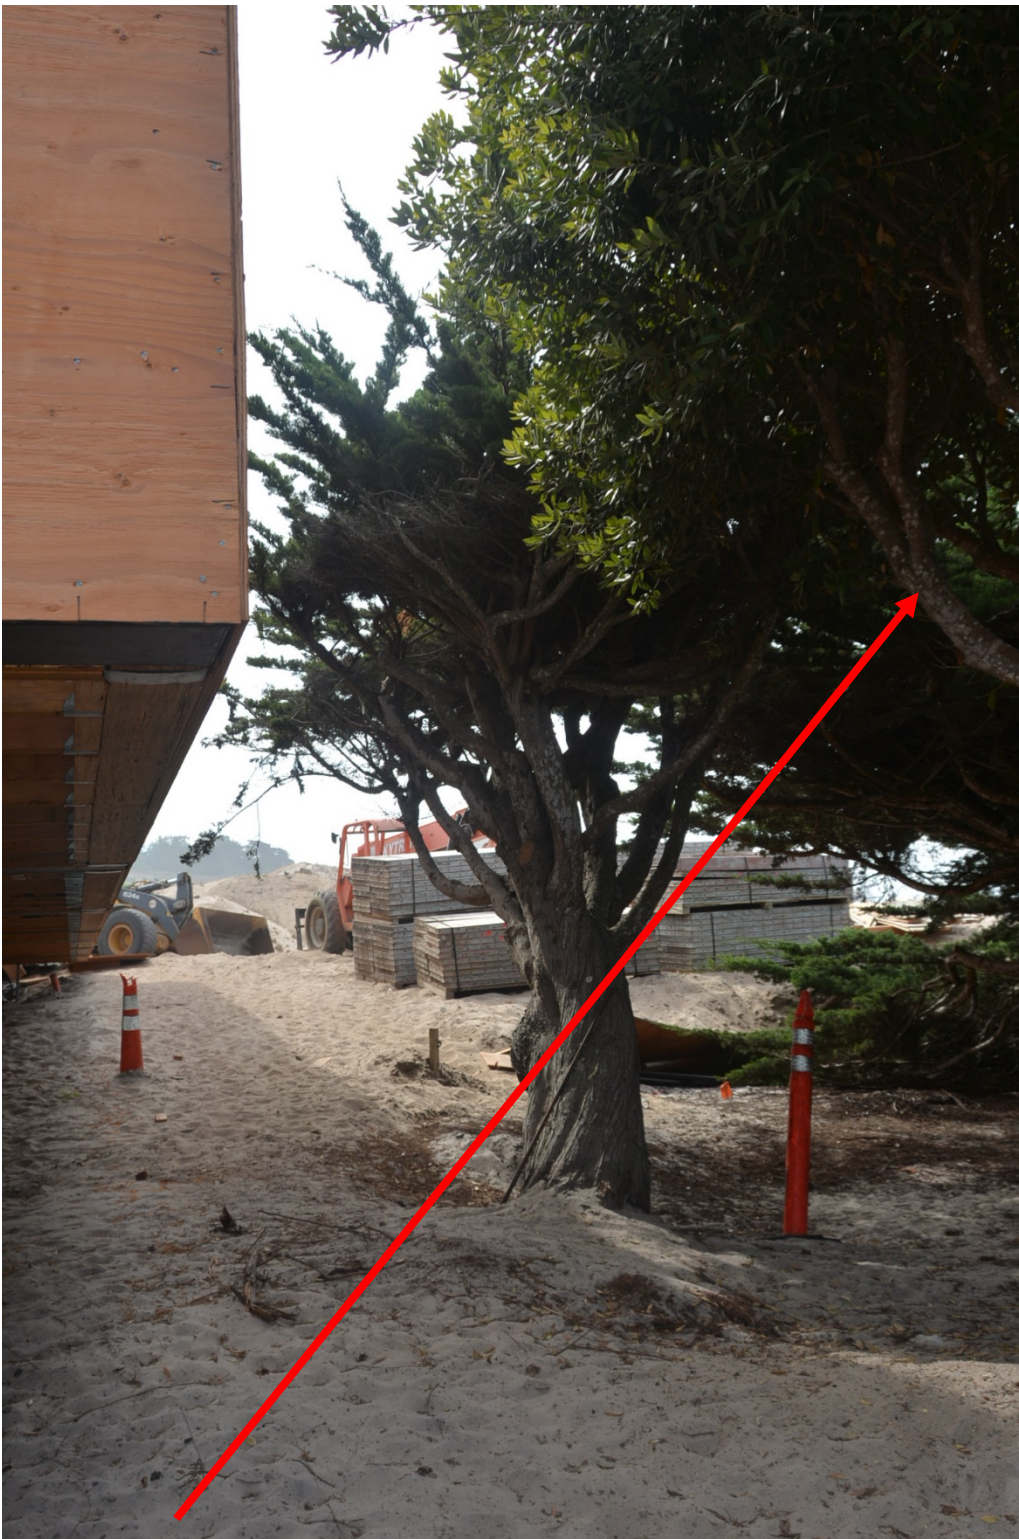
New Zealand Christmas tree
