# Exhibit F

## Report of Certified Arborist

APN: 424-051-064

Re: Blue oak tree

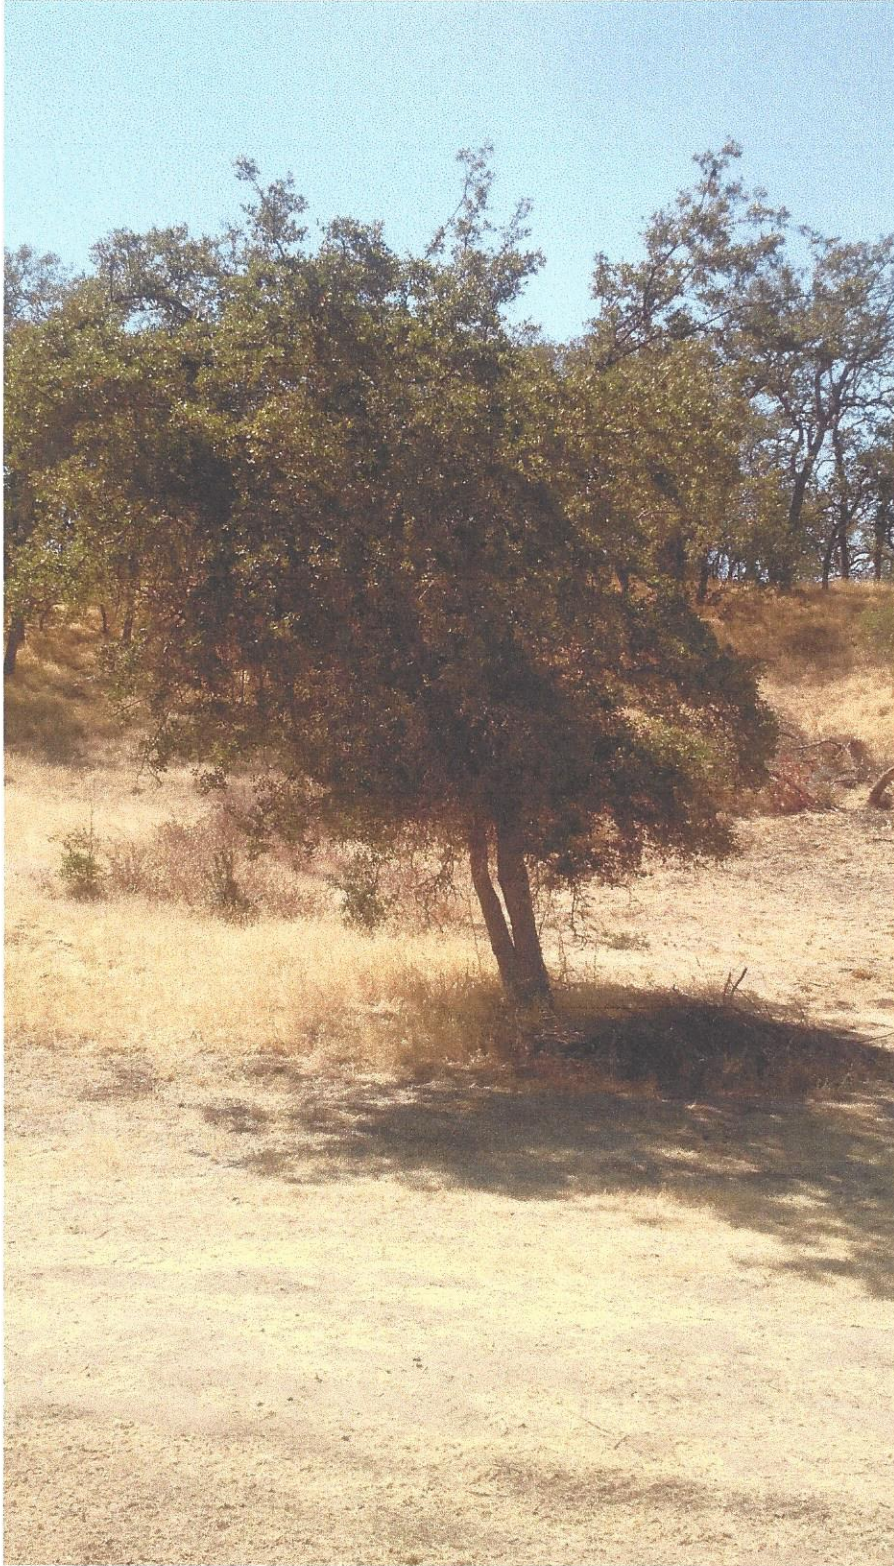
The subject tree is a Blue oak (*Quercus douglasii*), a California native common in your area. This specimen is still of sapling size, though perhaps older, with a three-stem structure measuring 4, 5 and 6 inches respectively (base diameter 2 feet above ambient grade), a height of about 13 feet and a crown spread of about 15 feet. It stands on the slope of a swale, somewhat isolated from the rest of the grove.

Figure No. 1: Subject tree; *Quercus douglasii*

I recommend removal of this specimen from the building footprint of the proposed garage, and replacement of it in a more suitable area, preferably closer to some portion of the extensive grove located on your parcel. These are the most drought tolerant of the California oaks and ambient seedlings could be used for replacement.

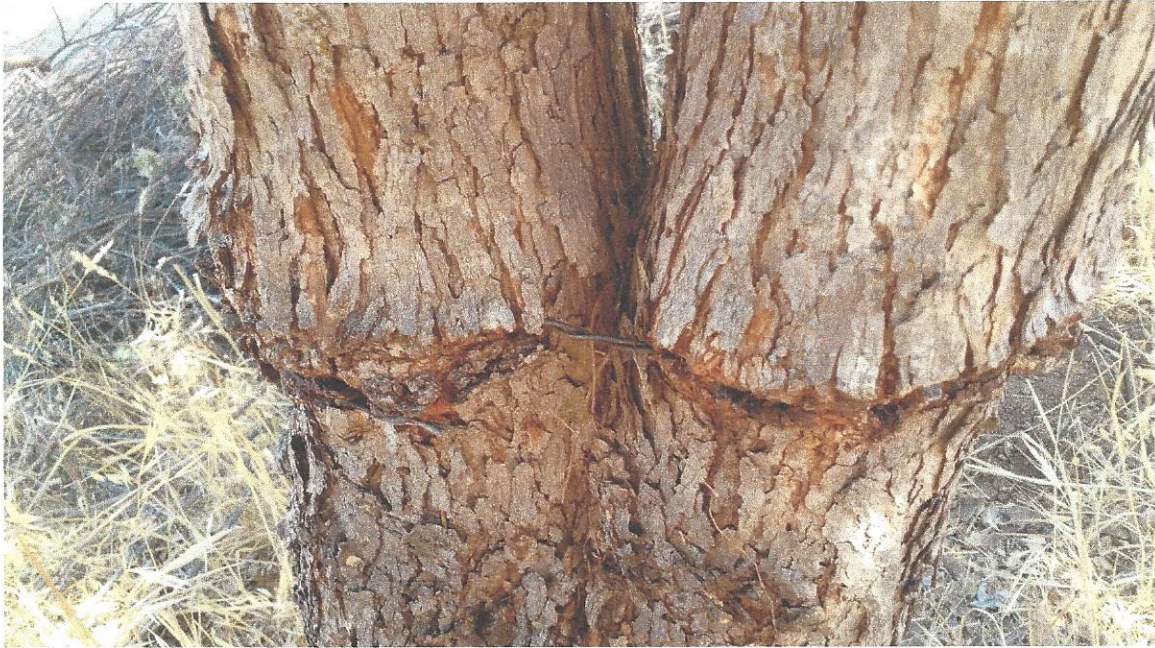
The condition of this tree is fair in terms of vigor and crown health and density, but its prospects for full development and growth are limited by some factors. All three parent stems have been girdled with barbed wire which has constricted cambium and interiorized in areas, limiting overall growth. Removing the wire now is not a good option in view of the potential further destruction of cambium. Added to this, the tree is a stand alone specimen, exposed to high heat and lack of humidity. These factors have resulted in its stunted form. (See attached photographs for illustration)

Figure No. 2: Stem girdling.

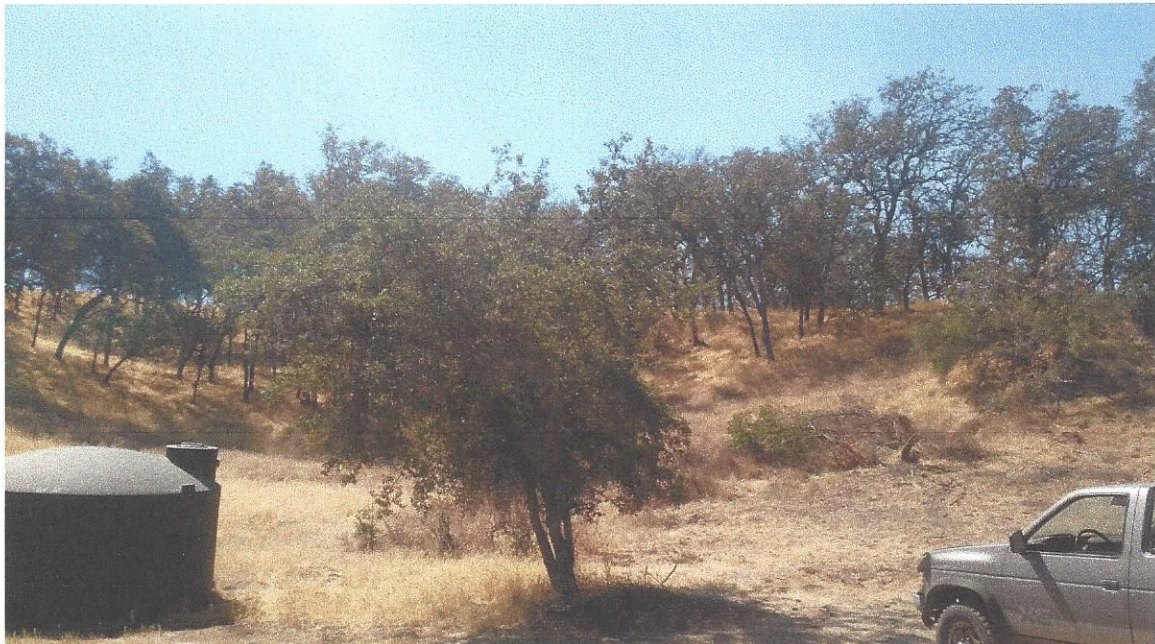
Figure No. 3: Separation from grove. Stunted form.

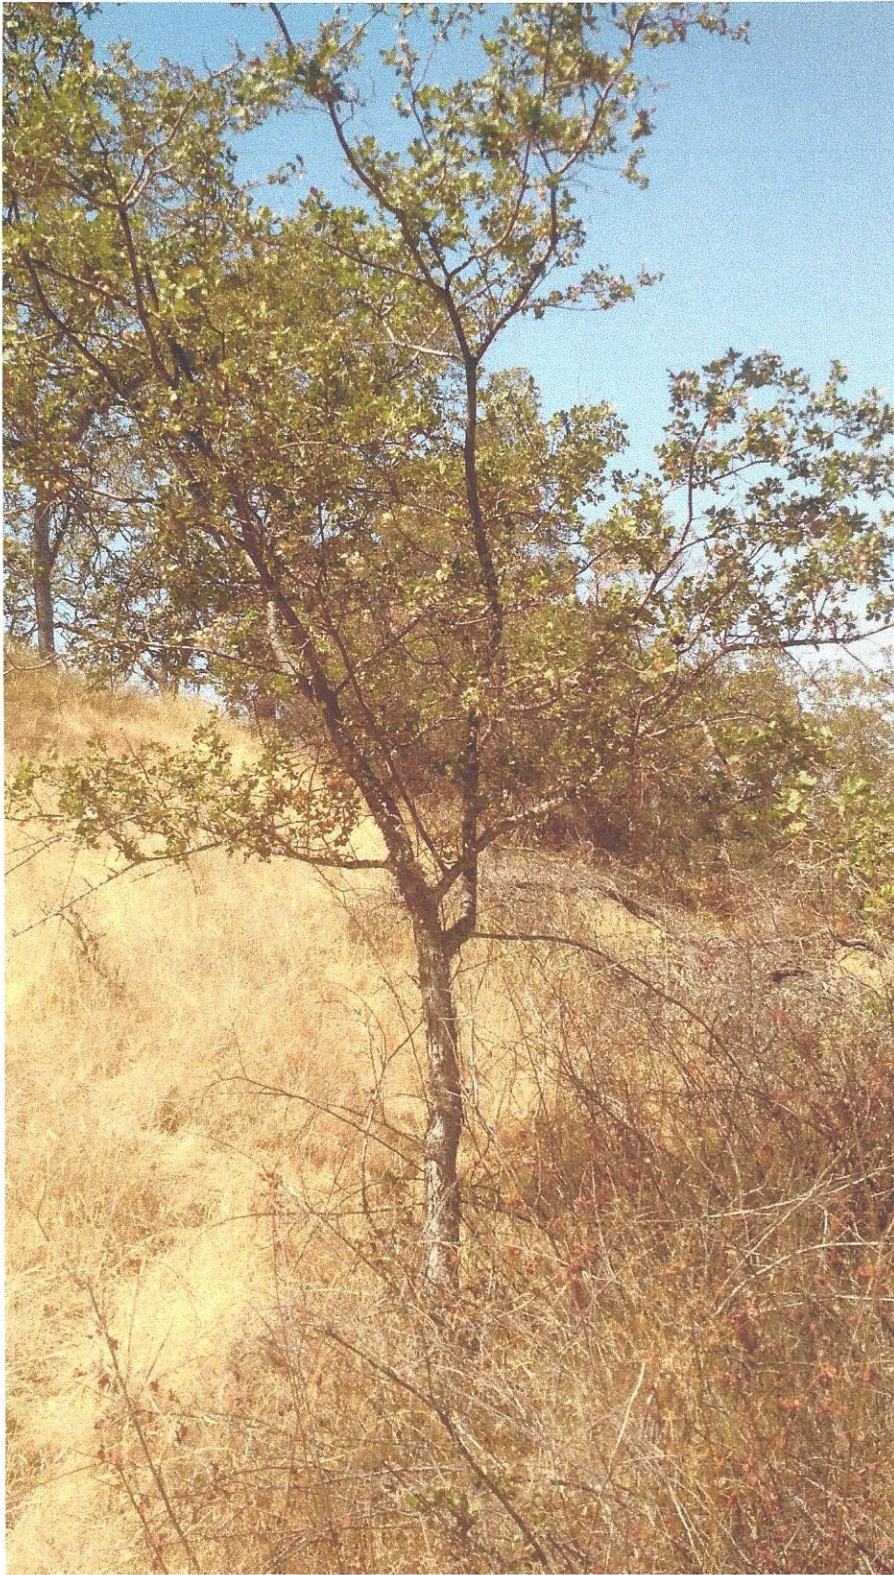
There exist in close proximity to the subject tree some healthy Blue Oak saplings, so planting in that area suggests there would be ground water available for another seedling. I recommend against the use of Coast Live Oak as not appropriate to your setting; the conditions are too harsh.

Figure No. 4: Close-proximity sapling.

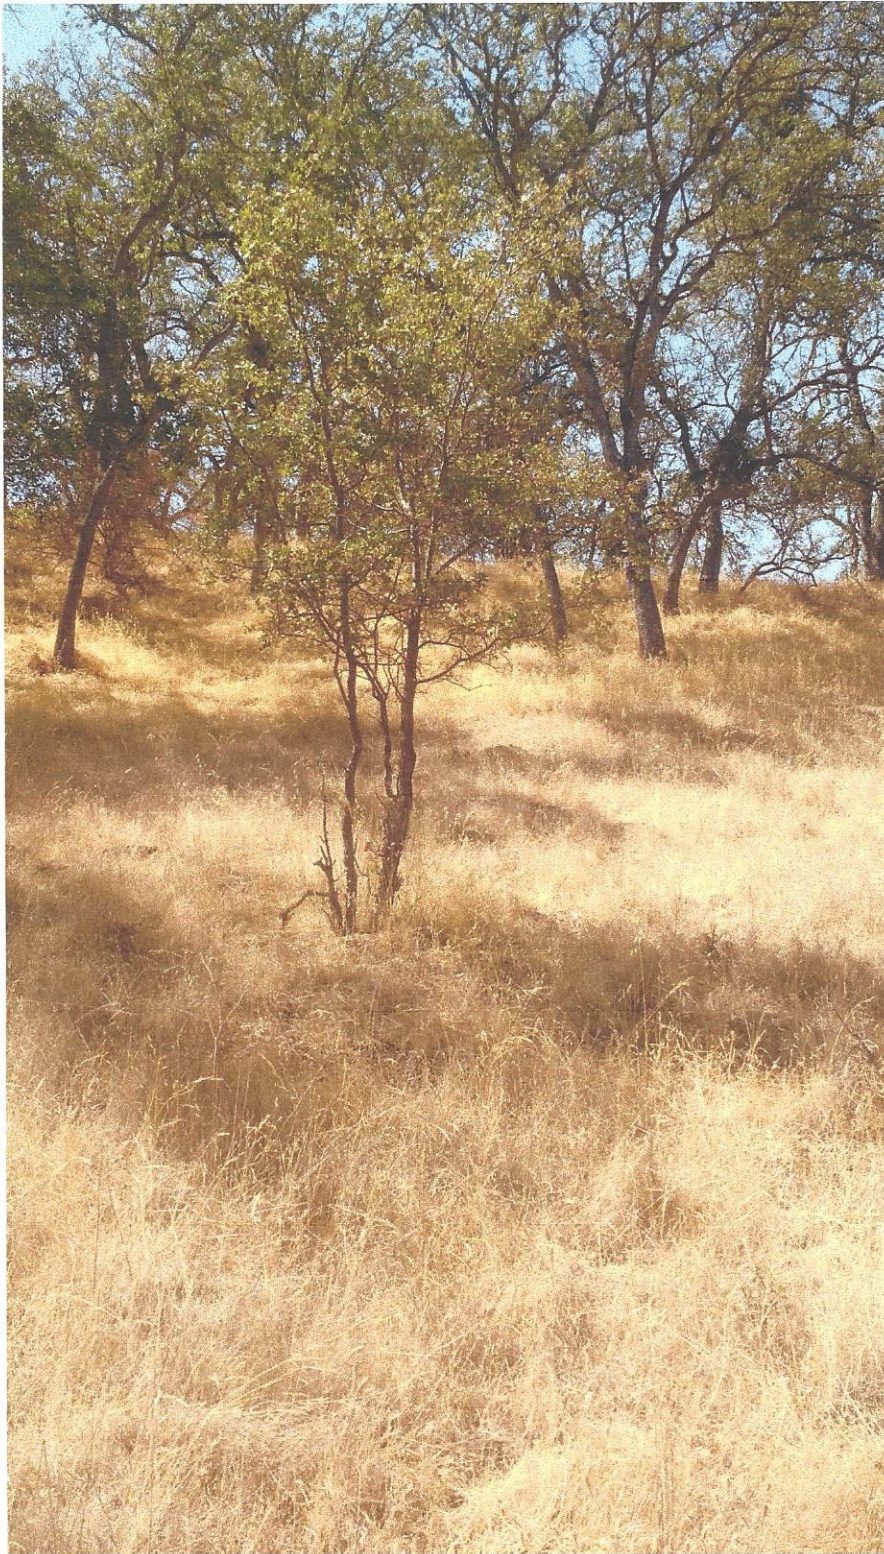
Figure No. 5: Another close-proximity sapling. Large grove in background.
