25910 Canada Way Tree Resource Assessment

Frank Ono
Arboriculture and Urban Forestry
ISA Certified Arborist #536
SAF Member #48004

November 8, 2017

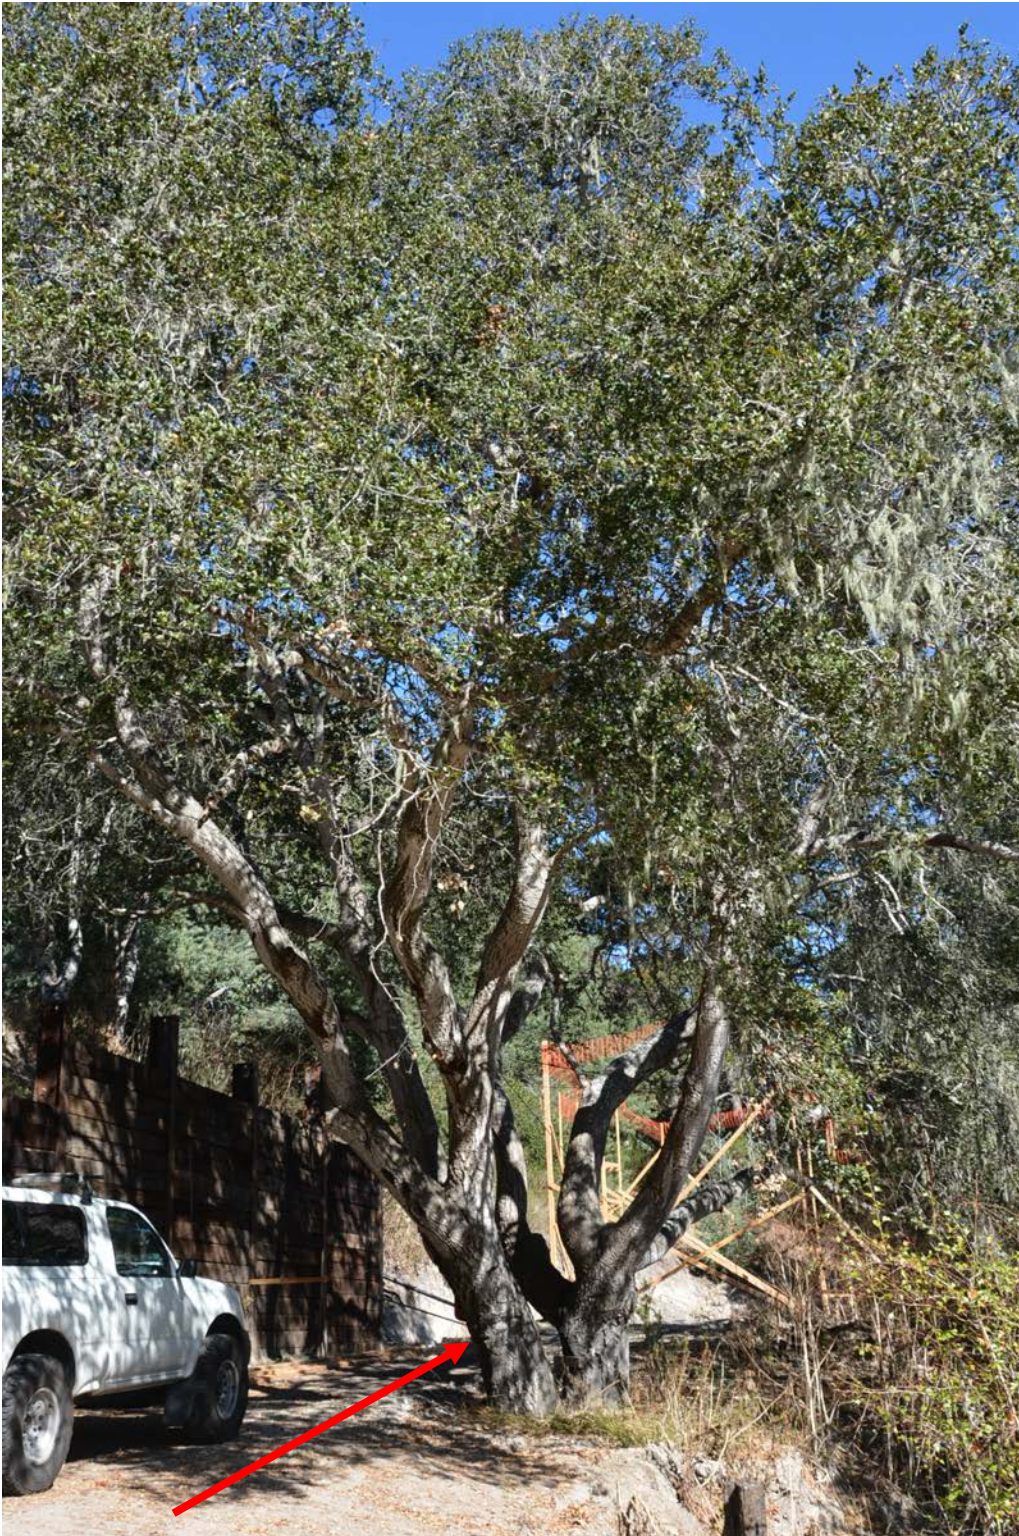
- The site is sloped with an aspect to the southeast. The property sits on a cross slope wrapping around south from the east.
- The largest tree (#181) is located at the entrance to the site and is a 26" and 24" diameter Oak tree located adjacent the driveway area. The tree appears to be in fair condition but is buried in excavation fill to an unknown depth.

- Tree #181 will need careful monitoring during trenching and grading. The project architect and qualified arborist should be on site during excavation activities to direct any minor field adjustments that may be needed. .
- Any roots that must be cut should be cut by manually digging a trench and cutting exposed roots with a saw, vibrating knife, rock saw, narrow trencher with sharp blades, or other approved root pruning equipment.
- Any roots damaged during grading or excavation should be exposed to sound tissue and cut cleanly with a saw.

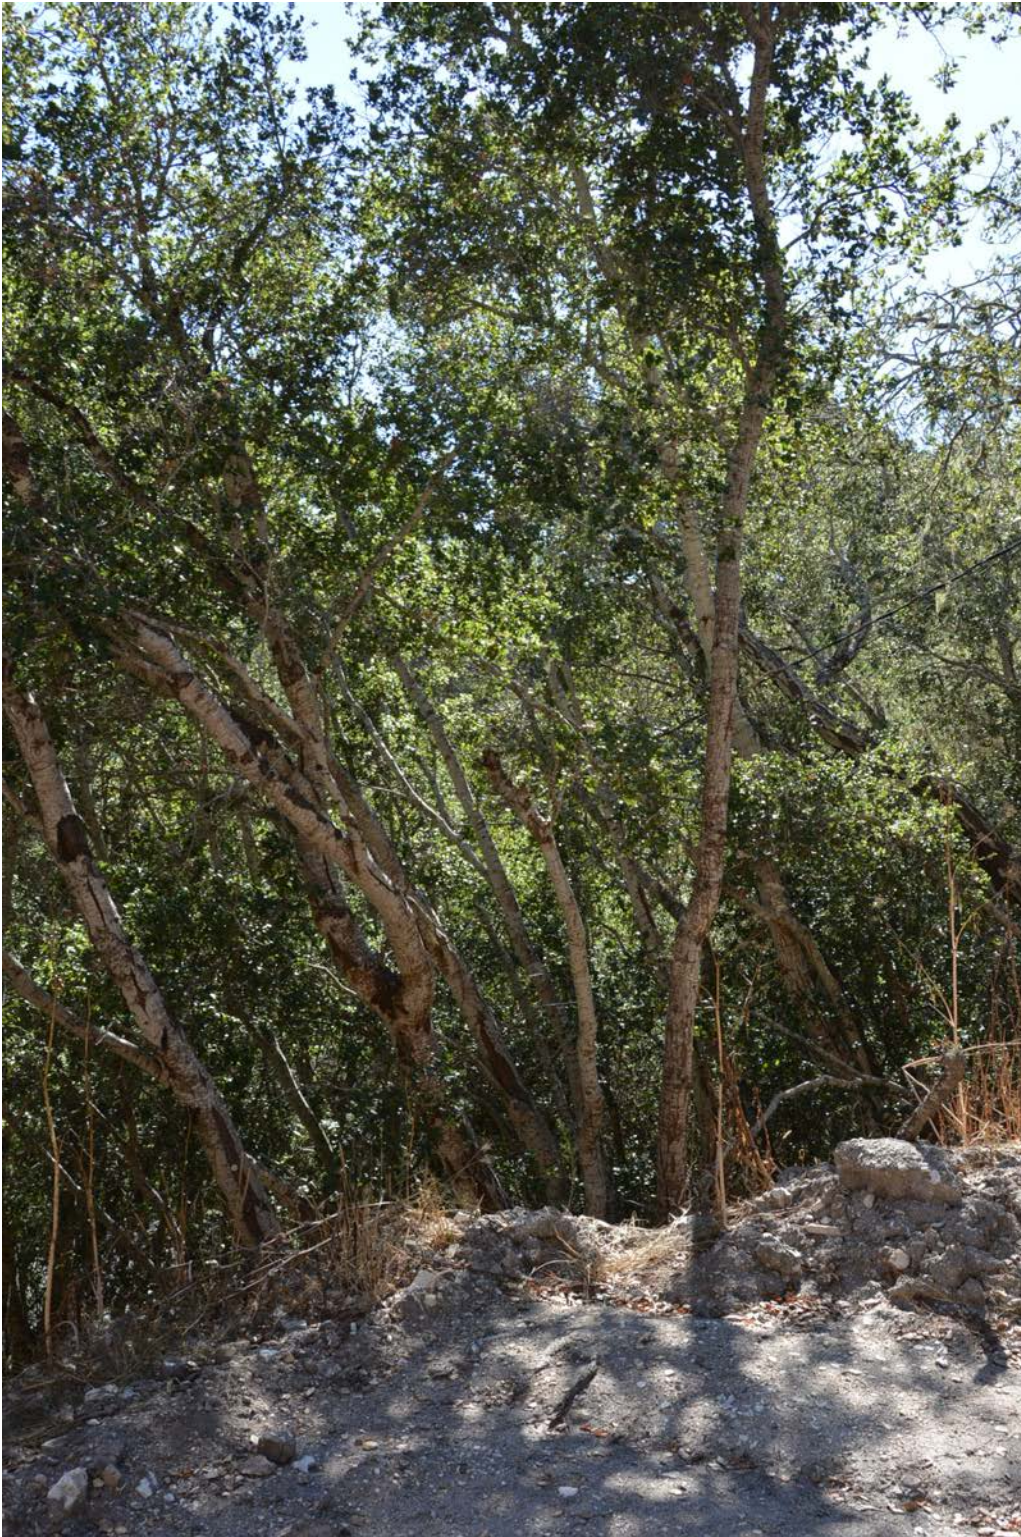
Small stand of oaks surrounded by acacia and redwood

Soils around trees need to be lowered

Development for the building walls and foundations require soil cuts within several trees' Critical Root Zones (CRZ) that will remove both support and absorption roots. Non-woody or absorption roots are instrumental for moisture and nutrient transport. Woody or support roots are necessary to provide structural support and are responsible for a trees security and ability to stand upright. Soil fill increases the natural grade requiring cutting and mixing of additional imported soil material to parent soils. Soil fill when applied is often compacted in the process, which is the susceptible for the creating of anaerobic conditions. Anaerobic conditions promote decay when roots suffocate through lack of oxygen in moist conditions. Structural roots are often compromised in both the long term as well as short term as a result of the decay. Current overfill needs to be removed from bases of Oak trees to prevent suffocating conditions and root decay.

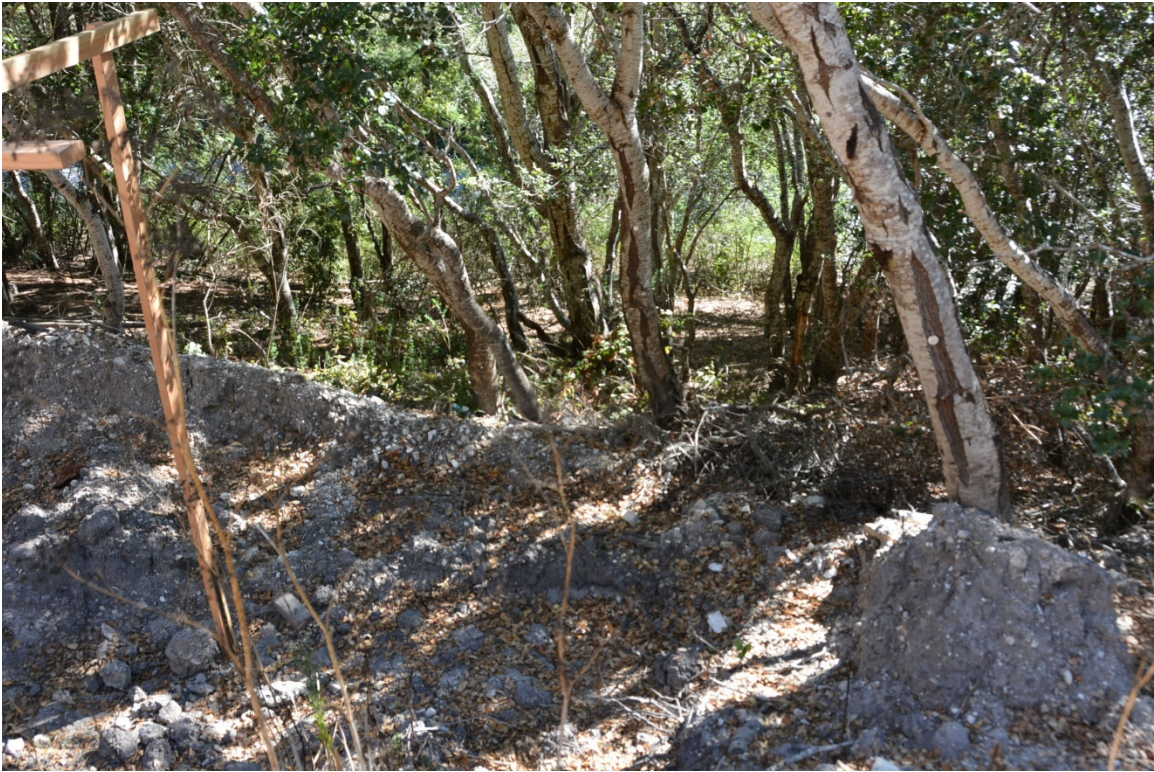
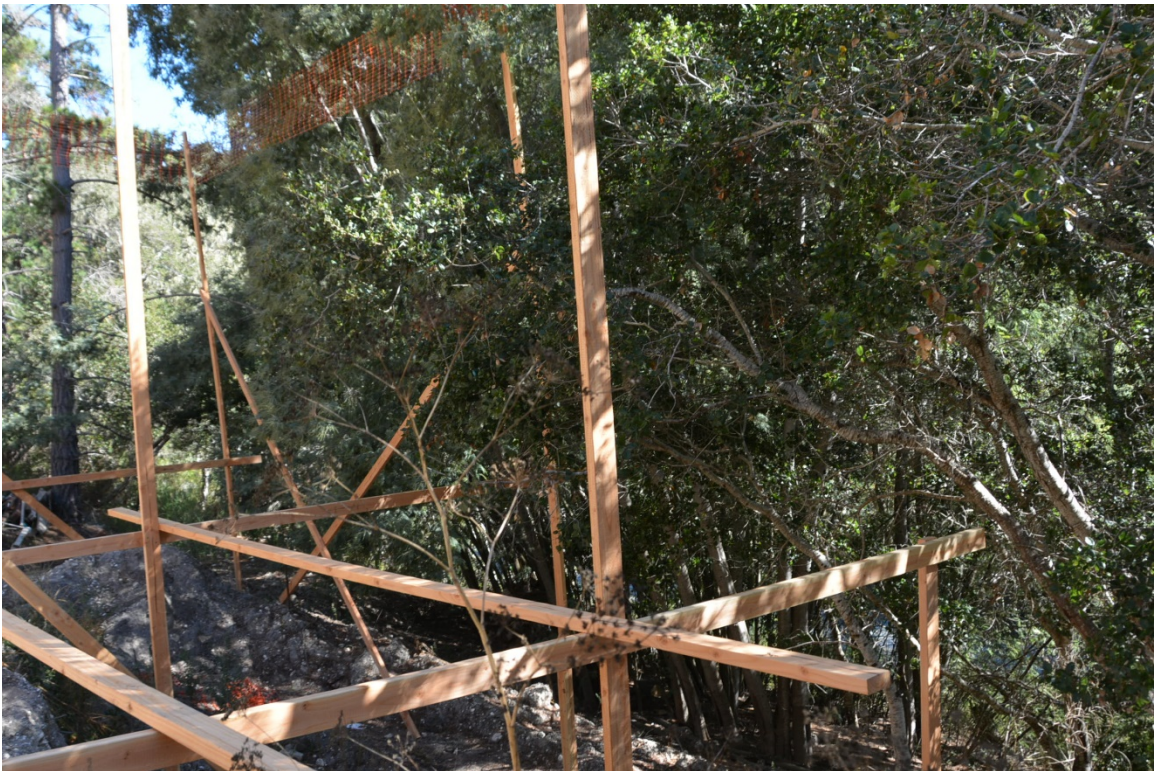
Oaks and acacia canopy in need of pruning

It is to be understood that the pruning of retained trees will be expected for this site, especially along the driveway and building construction areas. Pruning should include the larger canopied trees that have deadwood or are exhibiting some minor structural defect or minor disease that must be compensated. Those trees that require pruning and possible monitoring are the closest to the road ways, driveway and structures. Trees should be monitored on occasion for health and vigor after pruning. Should the health and vigor of any tree decline it will be treated as appropriately recommended by a certified arborist or qualified forester.

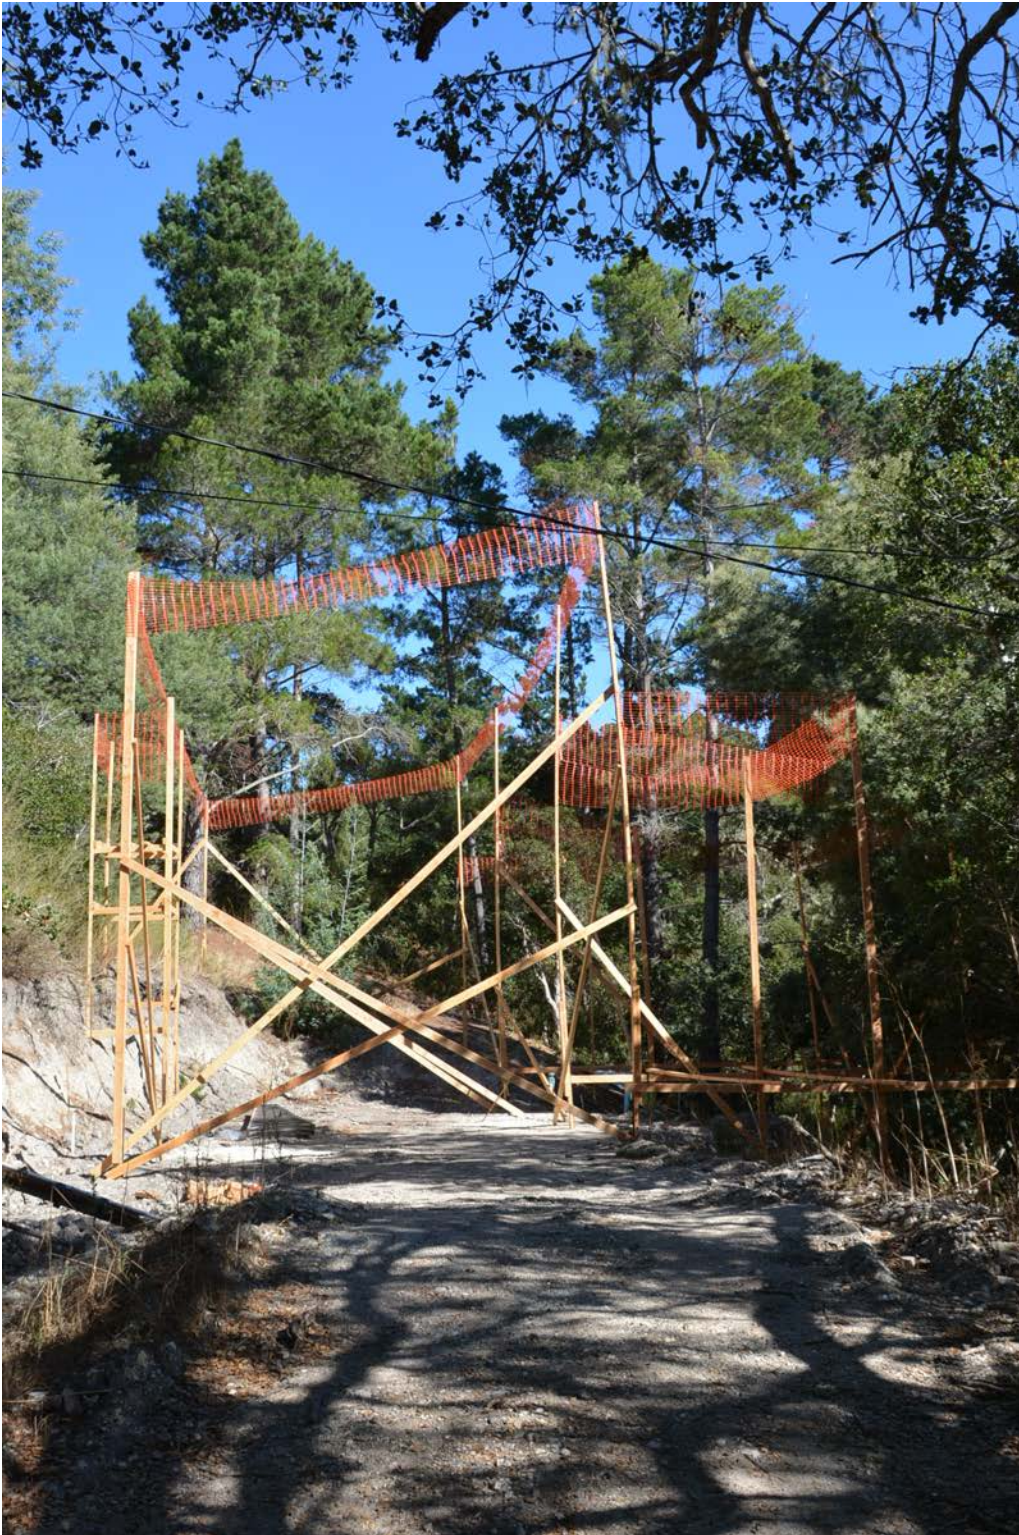
Site of proposed house
