Tree Resource Assessment
2884 Lasauen Road
Pebble Beach, CA

L1B170454

September 22, 2017

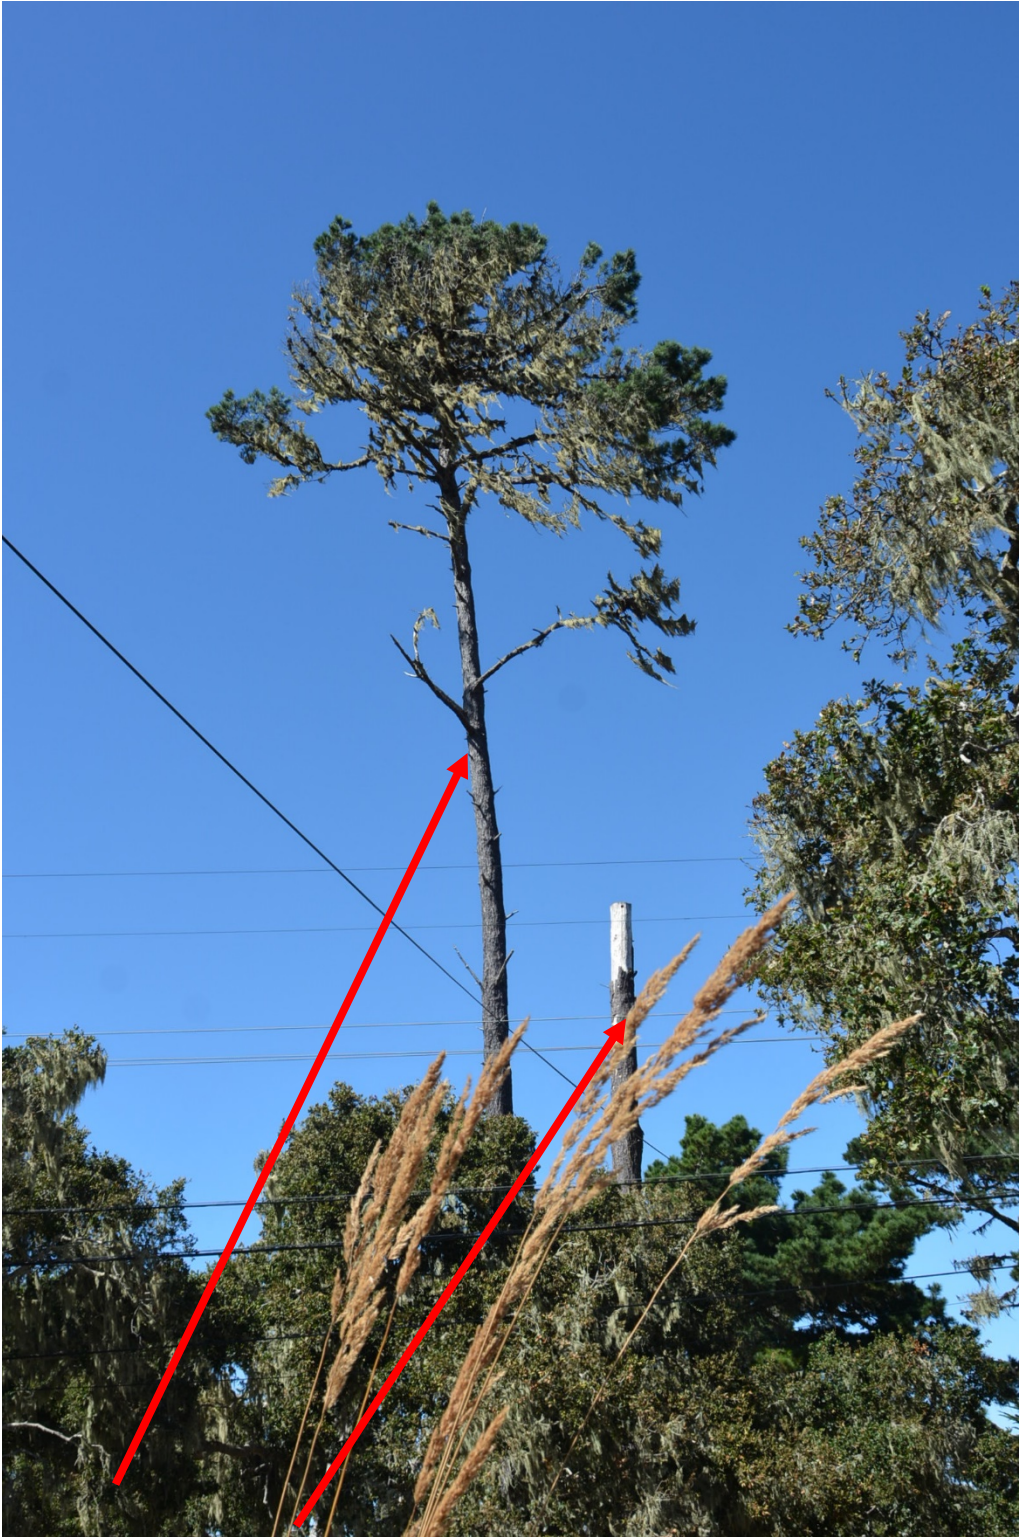
- There is one Monterey pine (#298) remaining appearing in poor condition and one partially removed pine stem (#297). Both are within the proposed building footprint and will need removal.

Tree #298 and #297

Remove Pine #298, Oak #280, and partial stem #297, due their condition or location to the proposed structure.

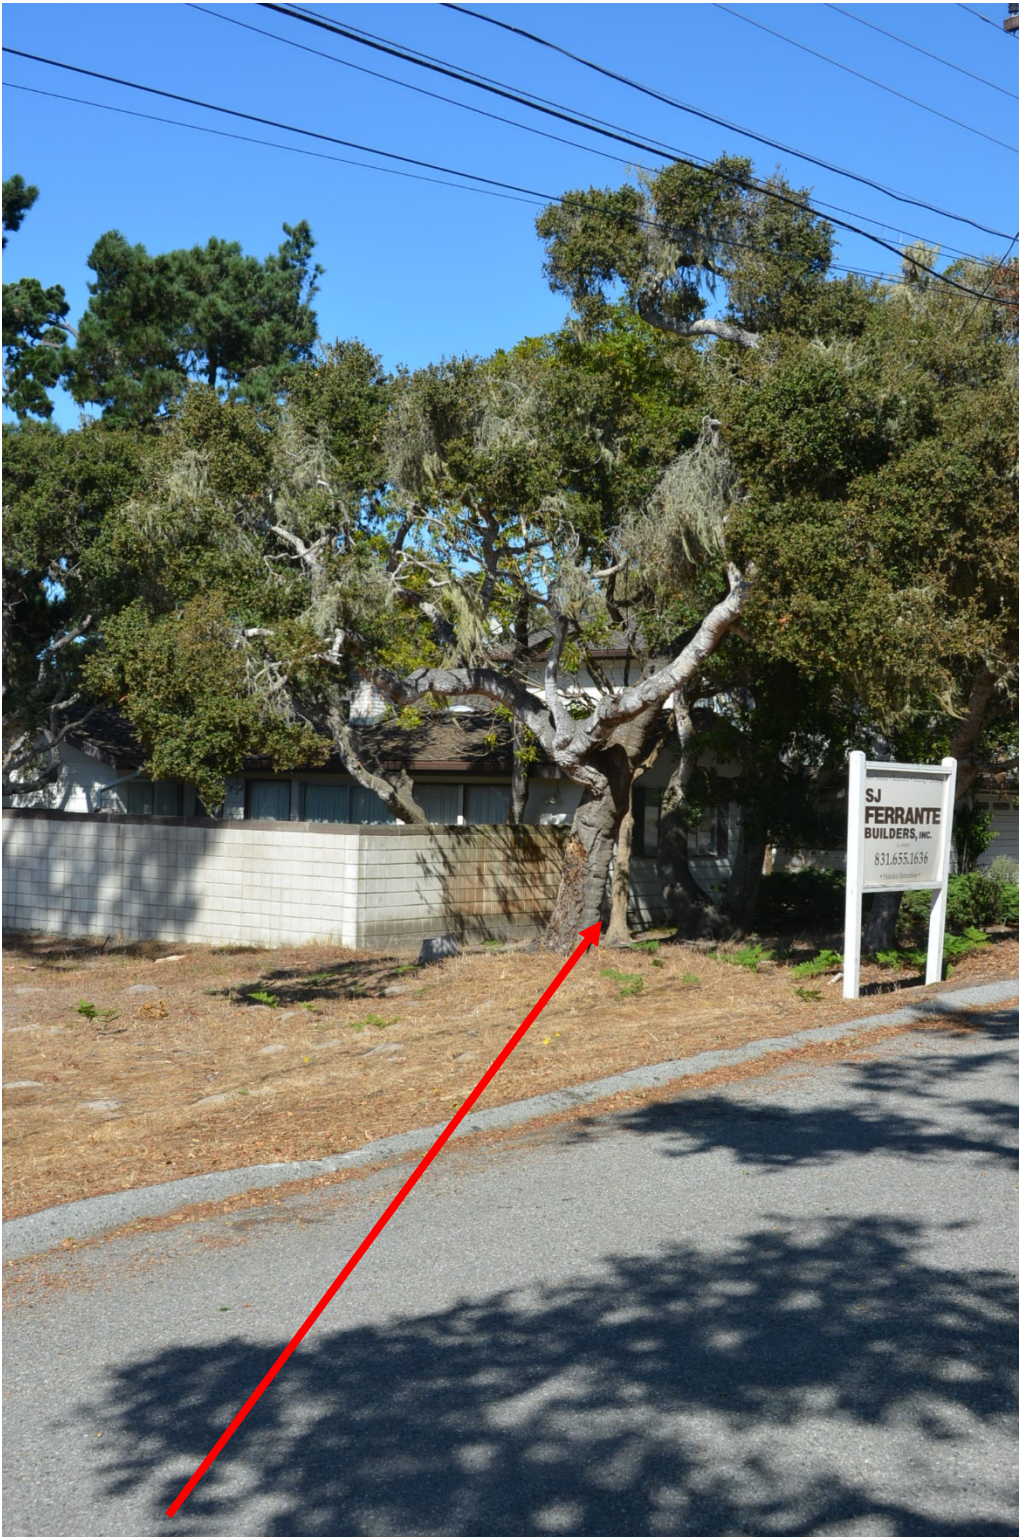
- Remaining oaks are located scattered on the property which are to be retained with the exception of those within the building foot print. One oak, shown to remain, is in poor condition #280, it should be removed as it appears will fail in the short term.

Tree #280 has a decayed stem

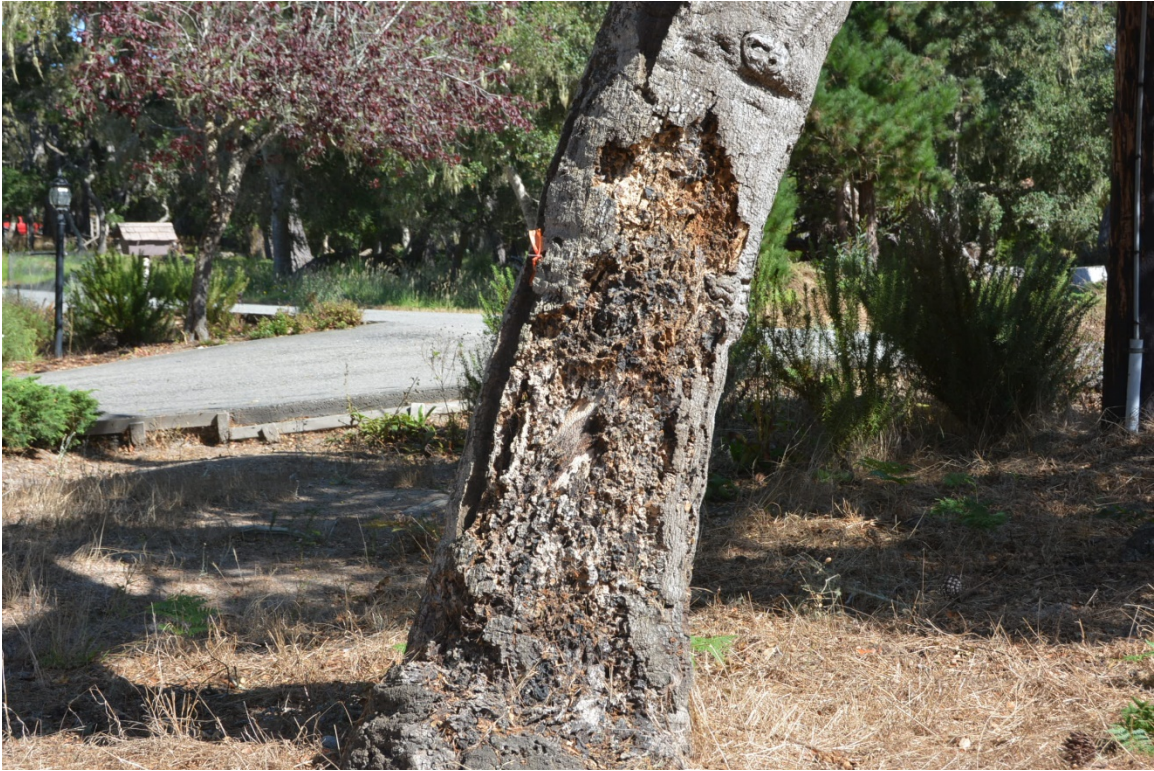
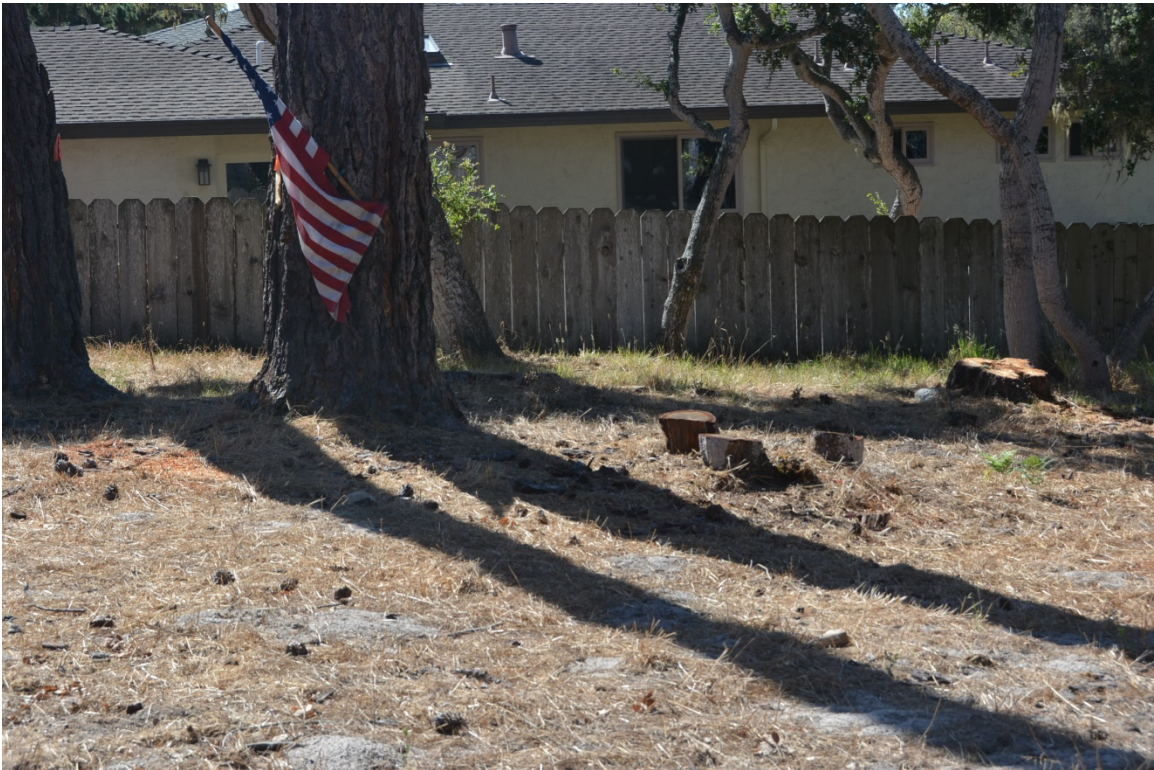
Previous tree removals
