# Exhibit E

Submitted herewith is the report of our Geotechnical Investigation for the proposed new single family residence with garage and guest house to be constructed within Parcel 1, on Rinconada Drive, APN 416-361-043, in Carmel Valley, California. One boring was drilled on February 28, 2017 and an additional boring was drilled on March 28, 2017 for geotechnical investigation purposes. Laboratory tests were subsequently made on driven soil core samples taken from the borings to determine the near surface and subsurface soil conditions and suitability for the construction of the proposed single family residence and detached guesthouse. We find that the project site is suitable for the proposed use with the recommendations made herein.

TREE RESOURCE EVALUATION  
PROJECT IMPACT ANALYSIS  
TREE PROTECTION PLAN

# Clifton and Wolske Residence Tree Assessment/Forest Management Plan

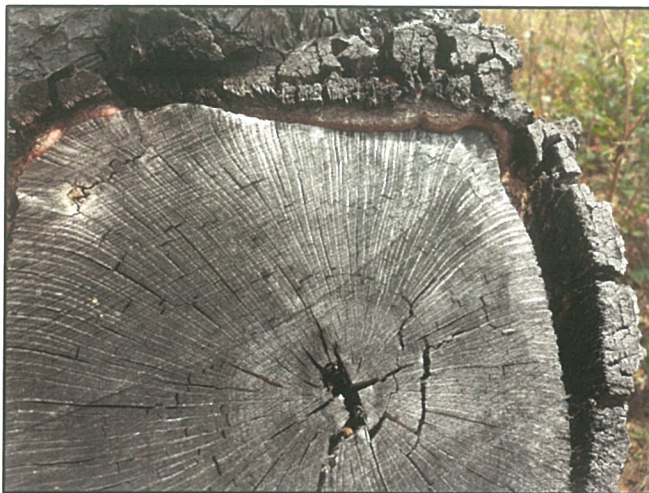
Figure 1 is a cut limb from a coast live oak near your proposed water tank site. The cut is approximately 4 feet off the ground and I estimate it to be approximately 5 or 6 years old. Note the callous developing on the upper, center portion of the cut. Figure 2 is a much older callous from a cut limb that is in excess of 15-20 years old – this older, calloused cut is located on Tree #15 (marked with a metal tag) along the access road in the general vicinity of the building site. The metal tag on Tree #15 corresponds with the “Tree Resource Evaluation and Protection Plan” prepared by Certified Arborist Maureen Hamb, April 2017. The well-formed callous seen in Figure 2 demonstrates that there was a much older episode of tree thinning (and possibly tree removal) that occurred on the subject parcel at some time in the past.

Figure 1 – Callous on limb cut approximately 5-6 years ago (photo August 2, 2017).

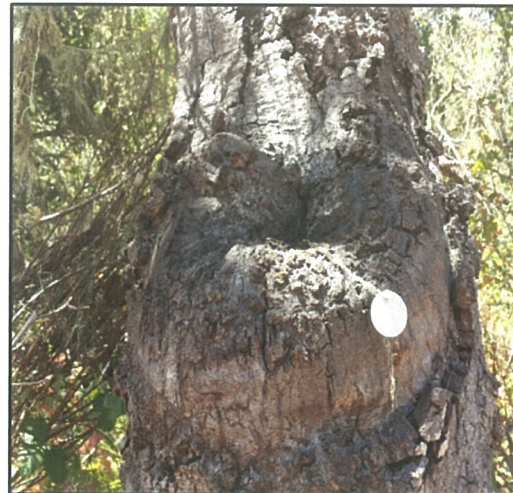
Figure 2 – Callous on limb cut more than 15 years ago on Tree #15 (photo July 25, 2017).

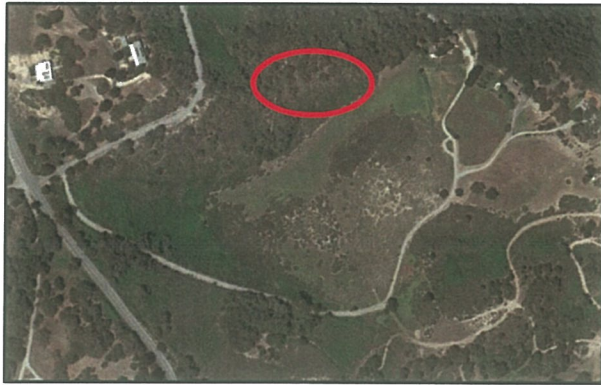
A historical search of Google Earth imagery confirmed that clearing and mowing of portions of the subject parcel occurred at some time between May 2012 and August 2013, Figures 3 and 4.

Figure 3 – Google Earth image, May 5, 2012.

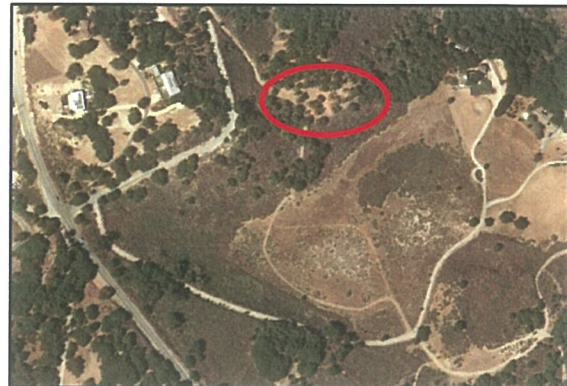
Figure 4 – Google Earth image August 25, 2013.

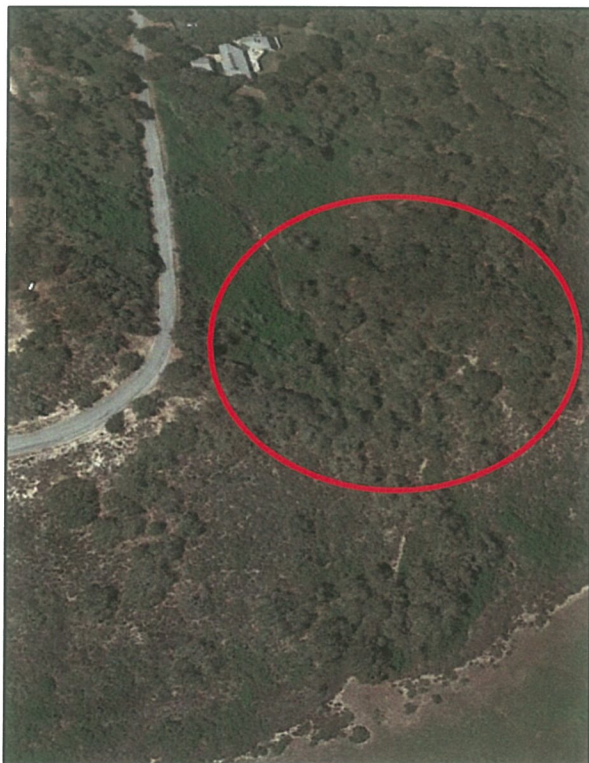
Enlargements of Figures 3 and 4 clearly exhibit vegetation removal and brush clearance that occurred at some point between the two image dates, May 5, 2012 and August 25, 2013. Clearing of oak canopy and understory vegetation, as well as road grading occurred between May 2012 and August 2013. Faint mowing lines are visible in the lower right of Figure 6, the enlargement of August 25, 2013, imagery.

Figure 5 - May 5, 2012

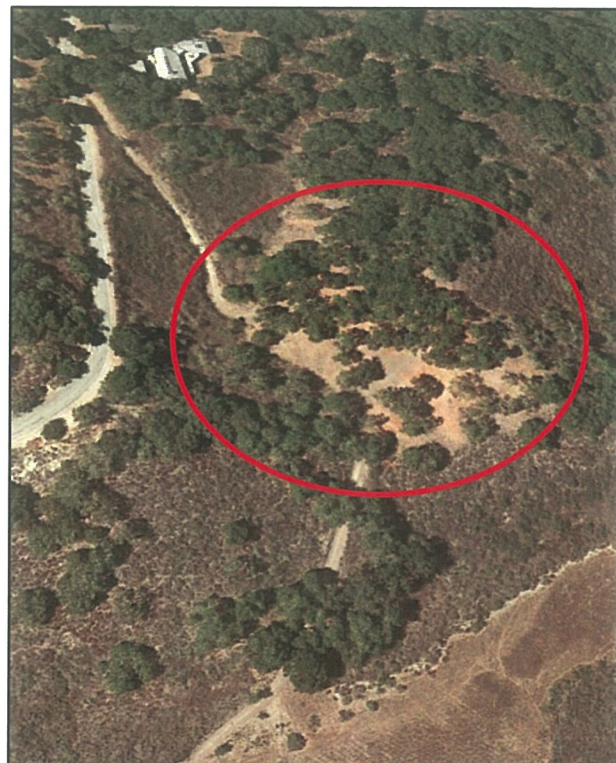
Figure 6 – August 25, 2013

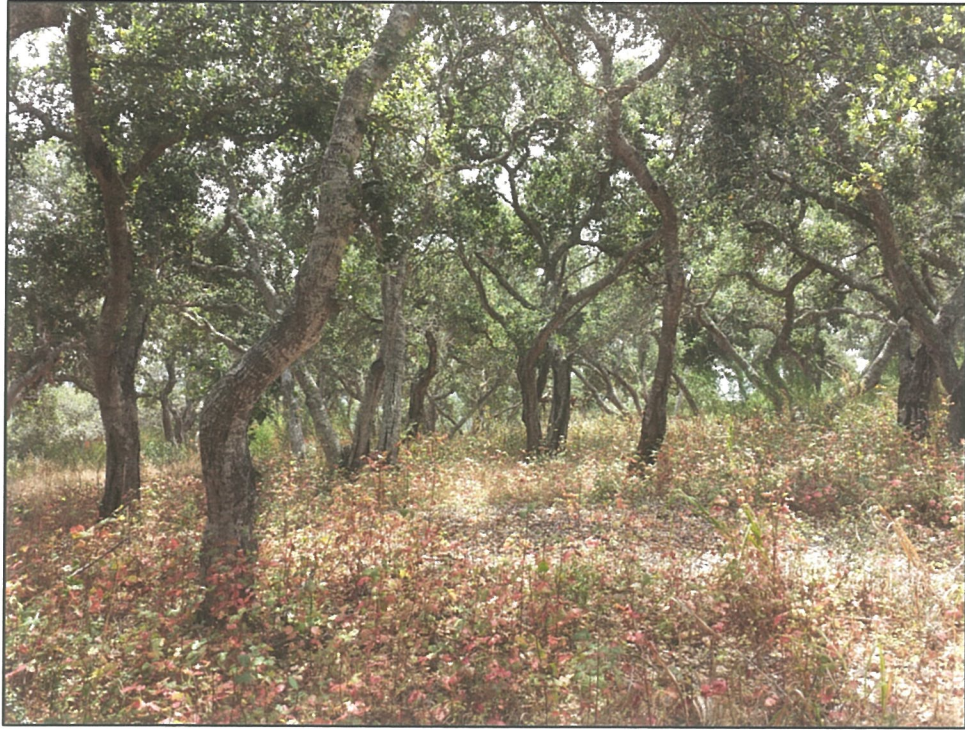
Figure 7 – Wood chip pile (lower center of photograph) in the general vicinity of tree stump #22. Photograph August 2, 2017.

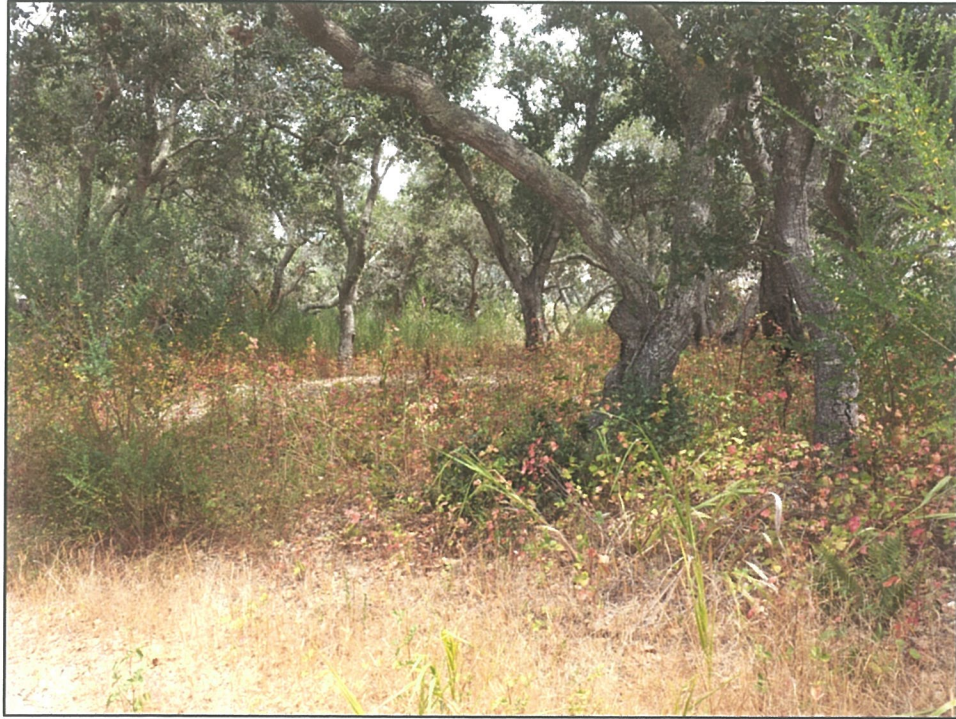
Figure 8 – Sprouts of tree stump #22 in lower center of photograph (August 2, 2017).

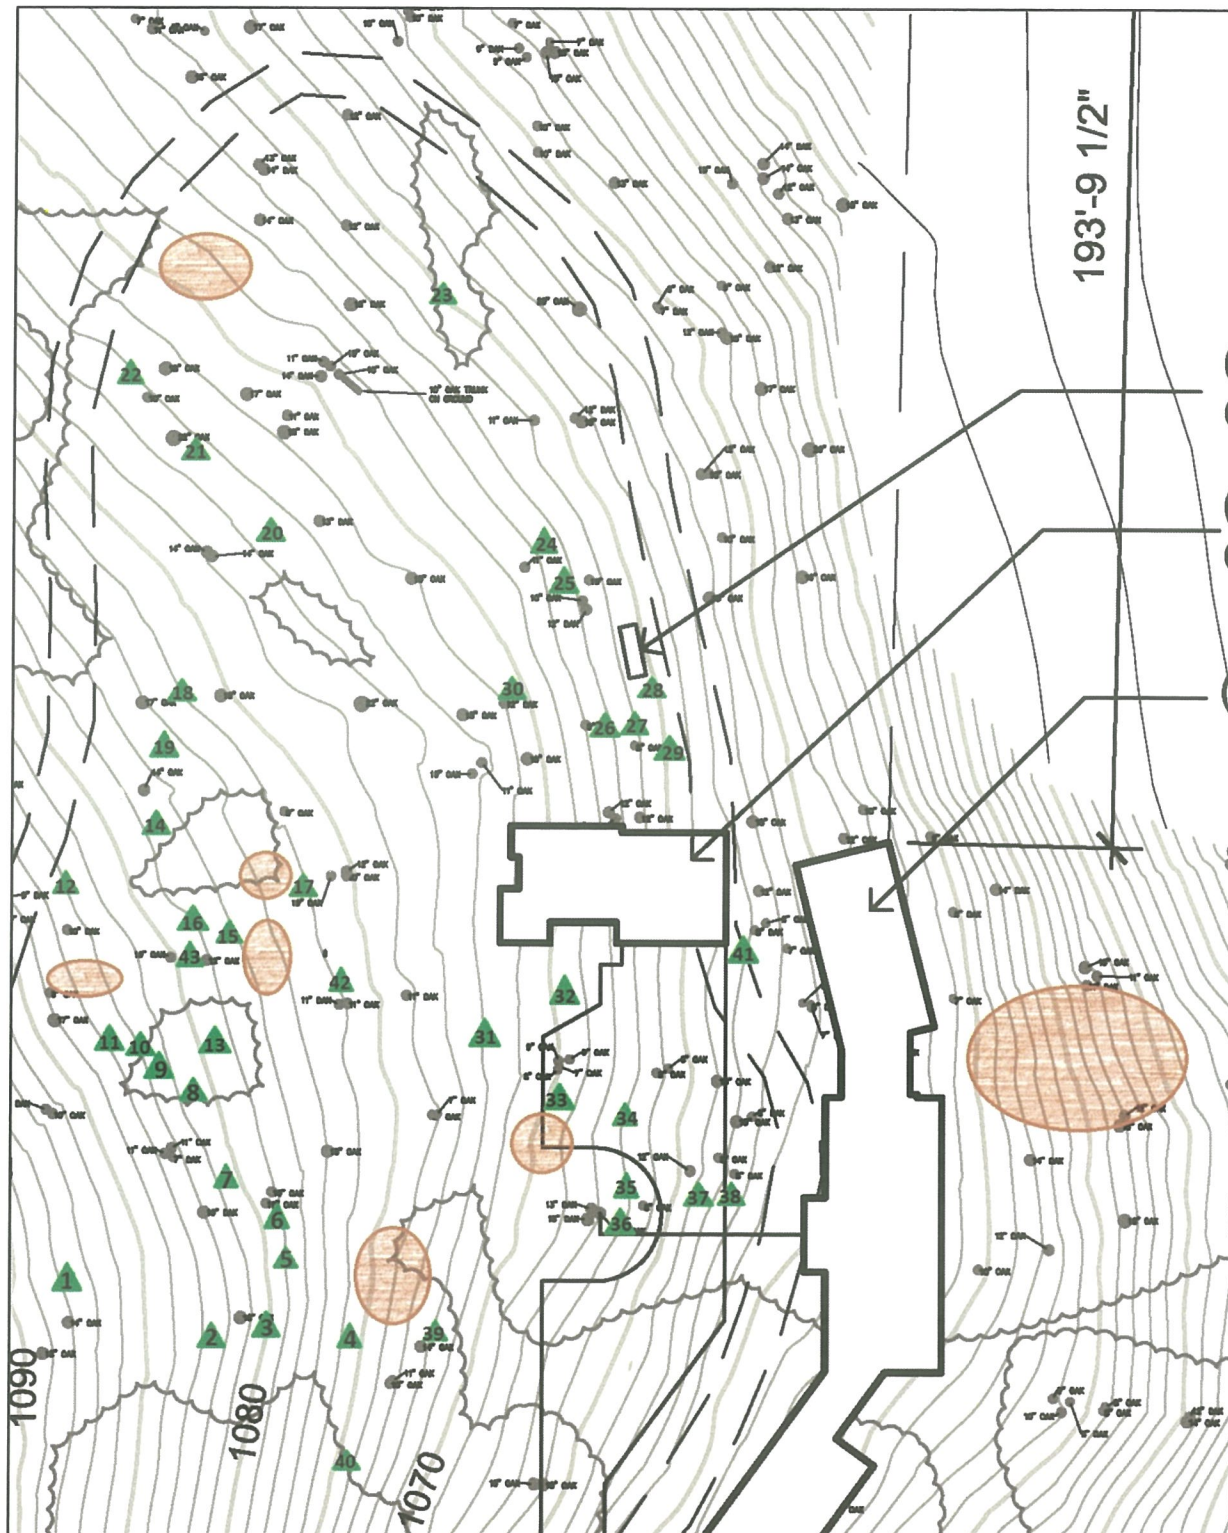
Figure 10 – The figure is an enlargement of the Plot Plan and depicts where tree removal occurred between May and December 2012. Tree stumps are numbered with green symbols and chip piles are mapped with pink ovals. 43 trees stumps were documented, with more than 150 standing trees remaining in this approximately 1-acre area.

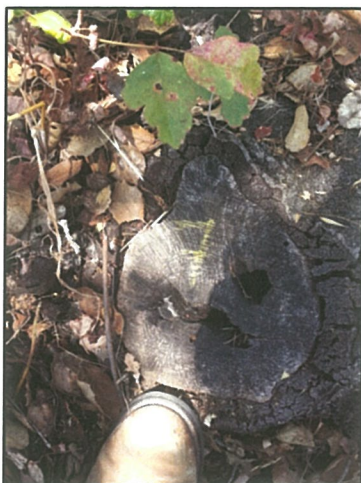
Tree 7 – multiple holes

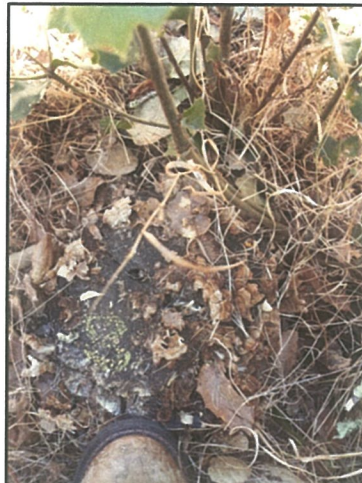
Tree 8 – decay fungus

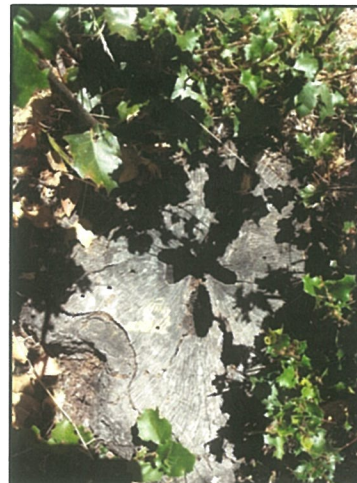
Tree 9 – big holes in center

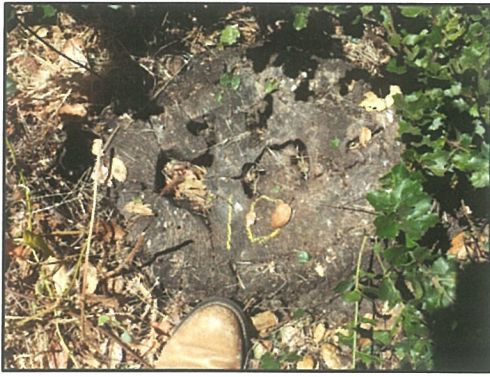
Tree 10 – large cavities in center

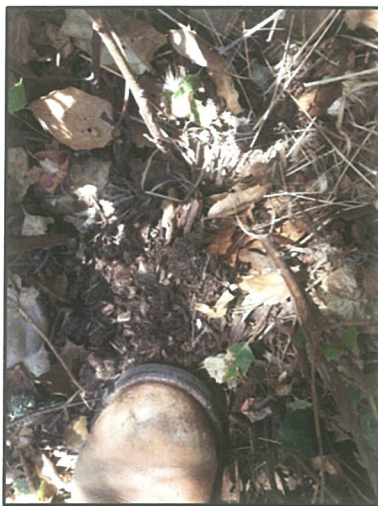
Tree 12 – small

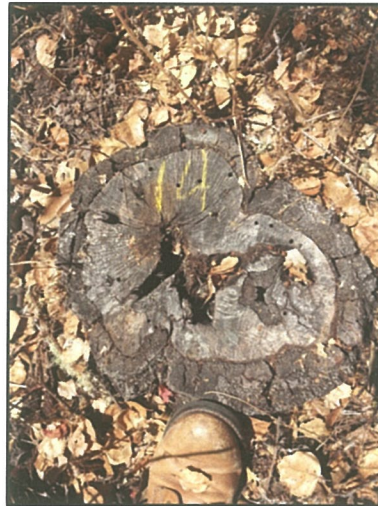
Tree 14 – heart rot and holes

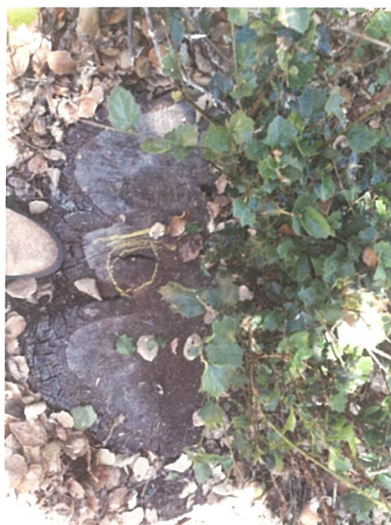
Tree 16 – stems merged

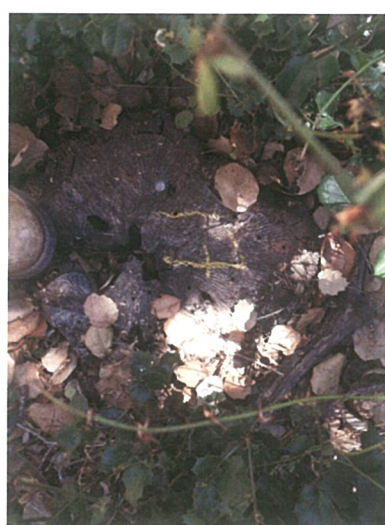
Tree 17 – heart rot and holes

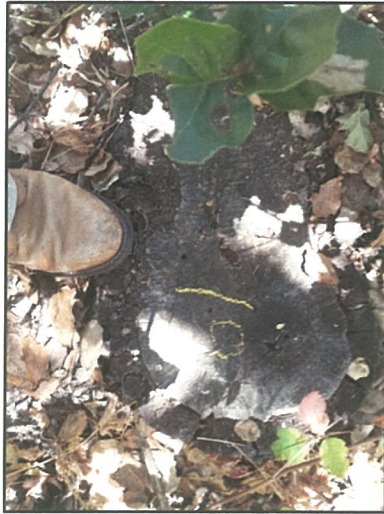
Tree 20 – holes

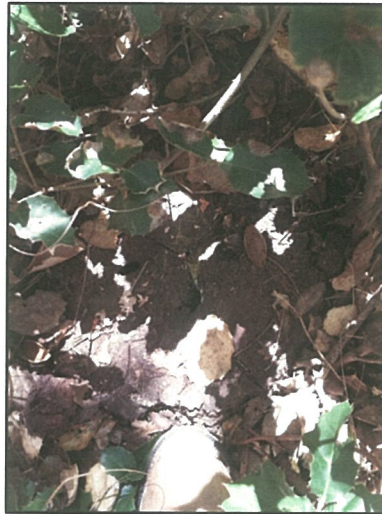
Tree 21 – holes

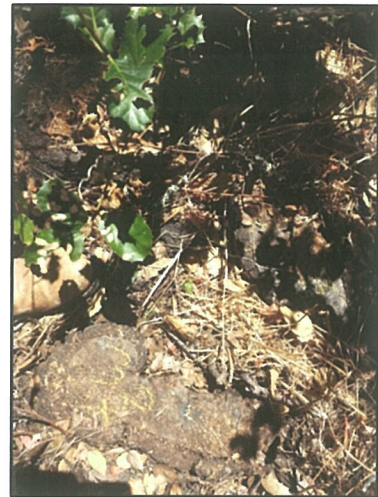
Tree 35 – termite damage

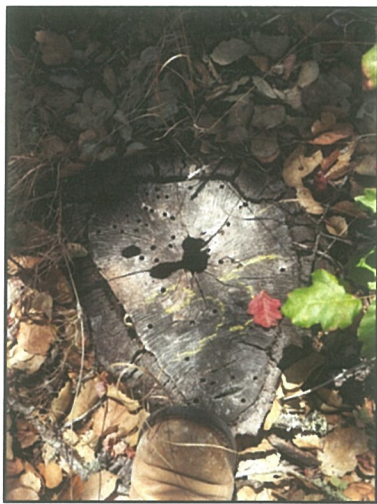
Tree 36 – decay fungus
