Tree Resource Assessment
2884 Lasauen Road
Pebble Beach, CA

L1B170454

September 22, 2017

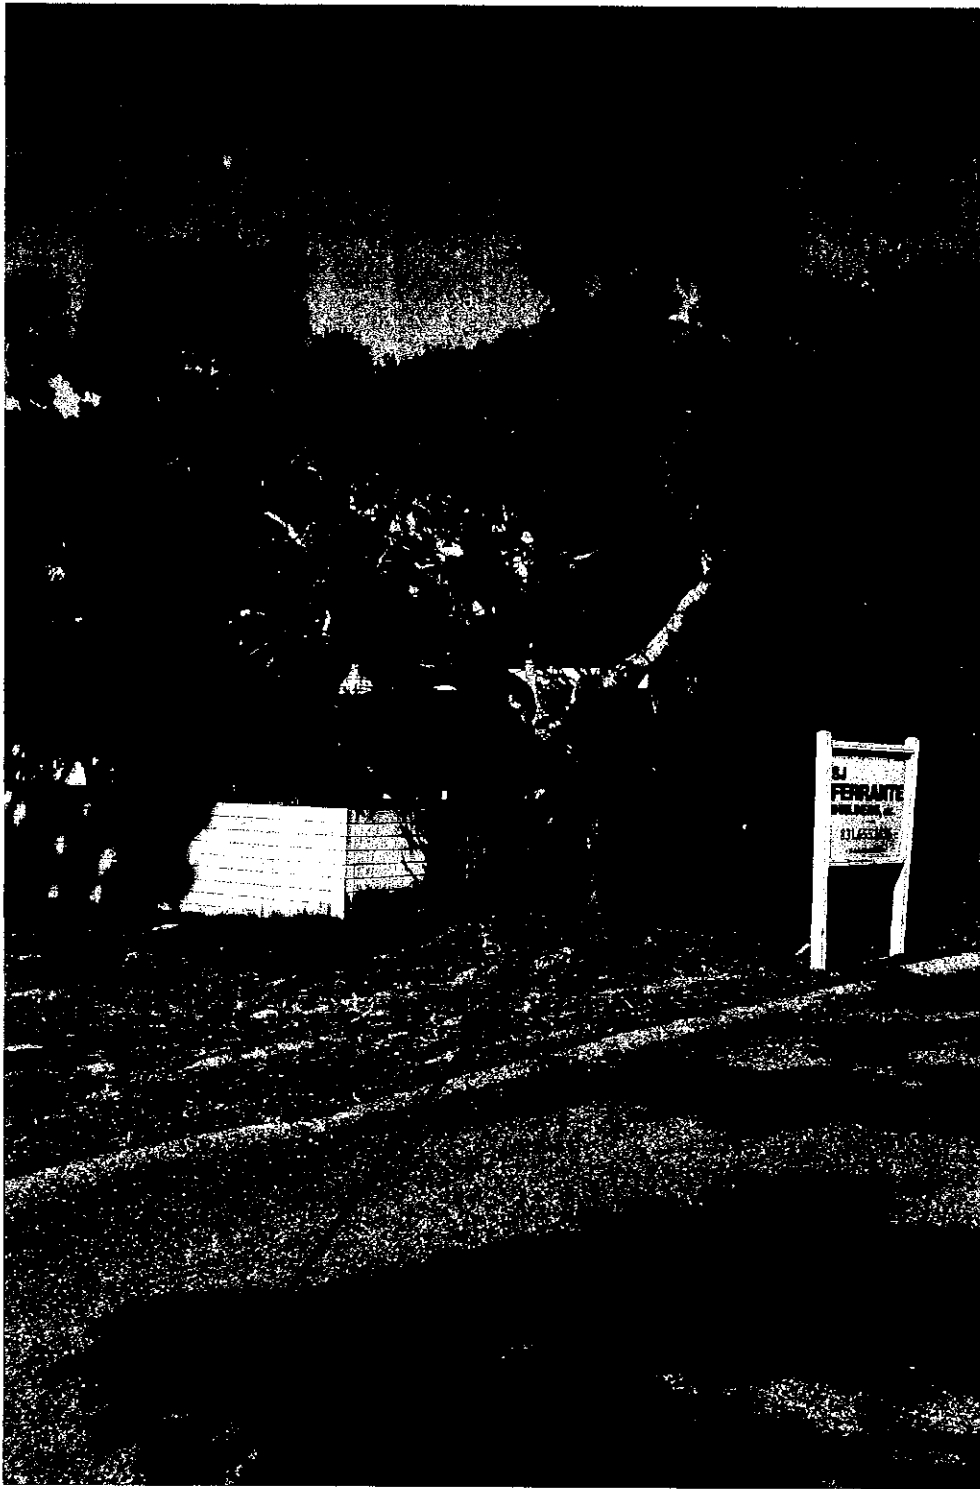
- Remaining oaks are located scattered on the property which are to be retained with the exception of those within the building foot print. One oak, shown to remain, is in poor condition #280, it should be removed as it appears will fail in the short term.

Tree #280 has a decayed stem

Remove Pine #298, Oak #280, and partial stem #297, due their condition or location to the proposed structure.

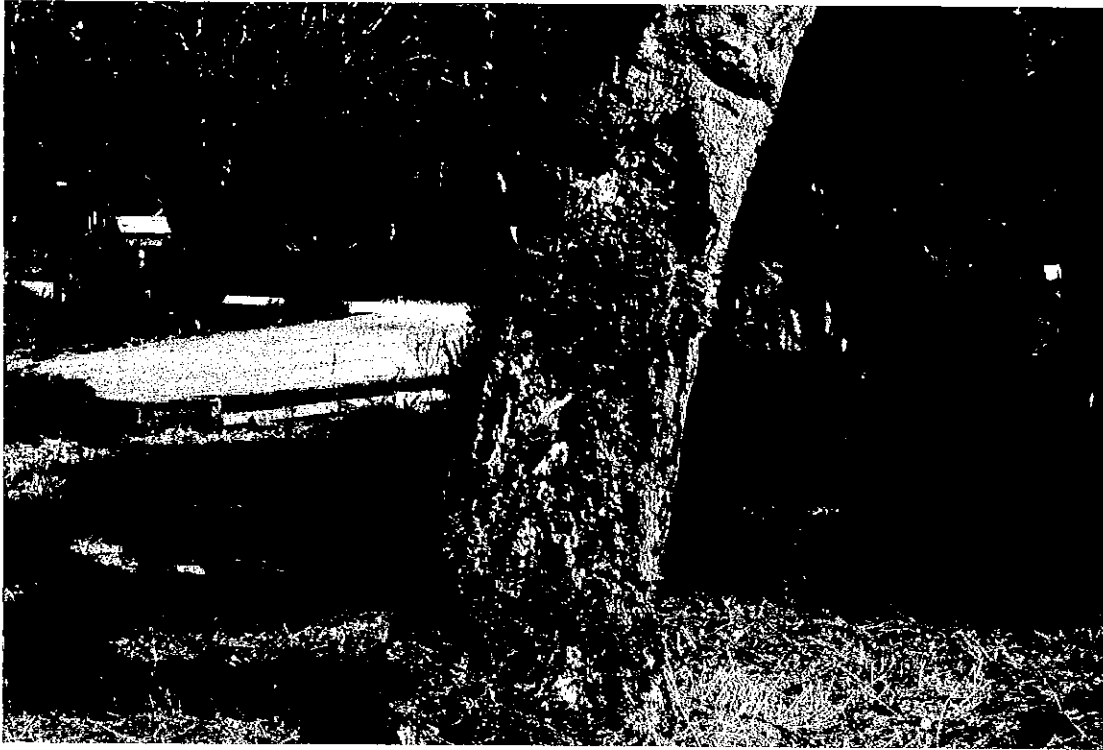
Previous tree removals
