# 29003 Robinson Canyon Road Tree Resource Assessment

Brad Cox

Frank Ono

May 9, 2016

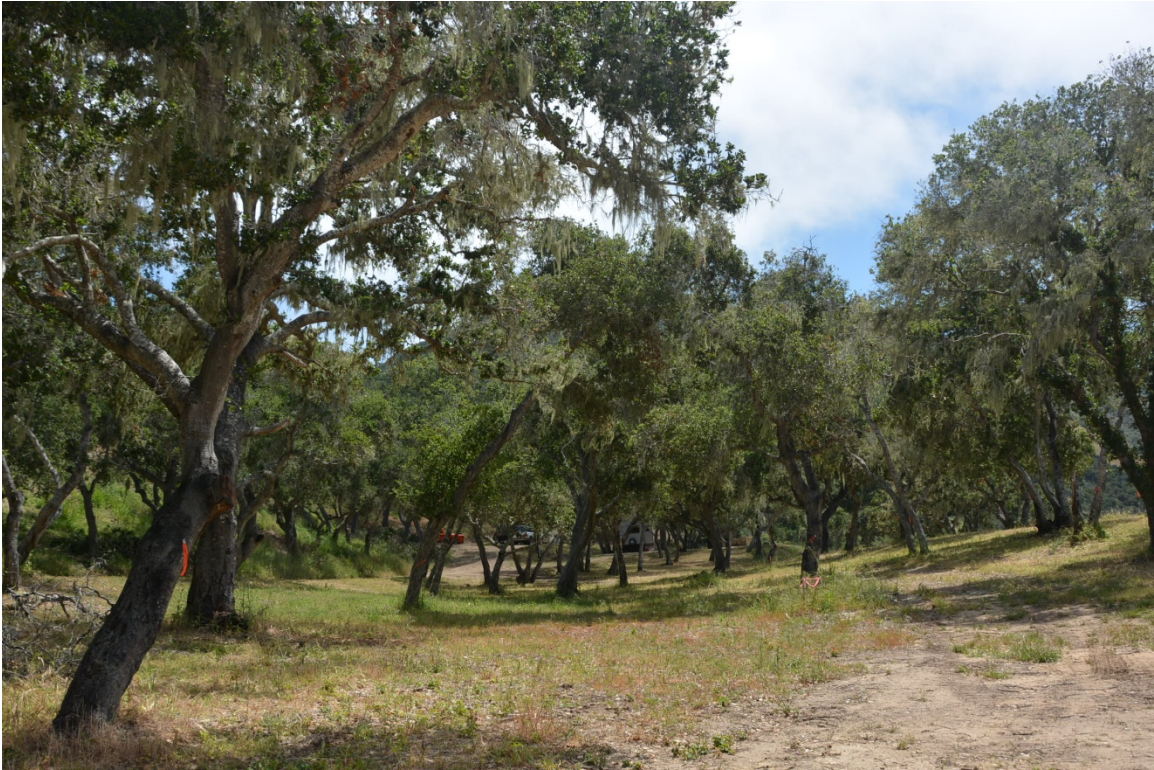
Building site view taken from west parking area, tree on left is #488

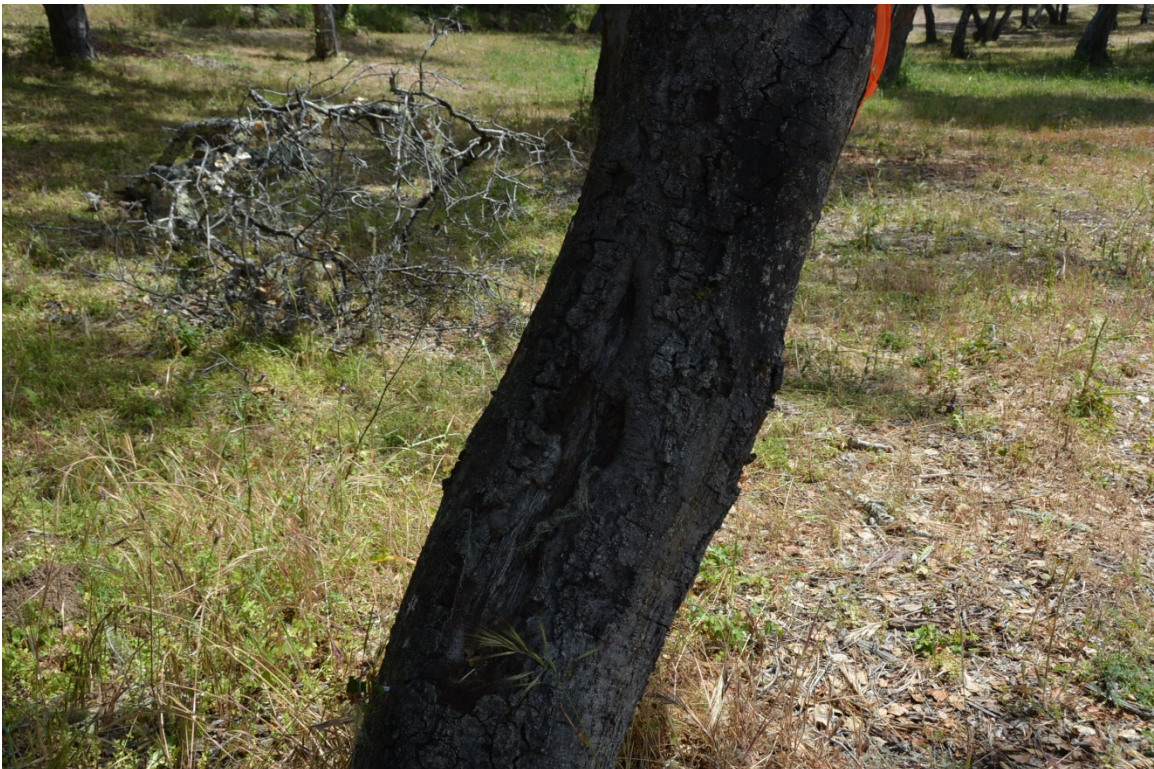
| ID# | Diameter | Structure | Health | Dominance | Comments | Remove |
|---|---|---|---|---|---|---|
| 488 | 13 | Fair | Fair | Co-dominant | Stem decay, Dead limbs | X |

Base of #488 is decayed

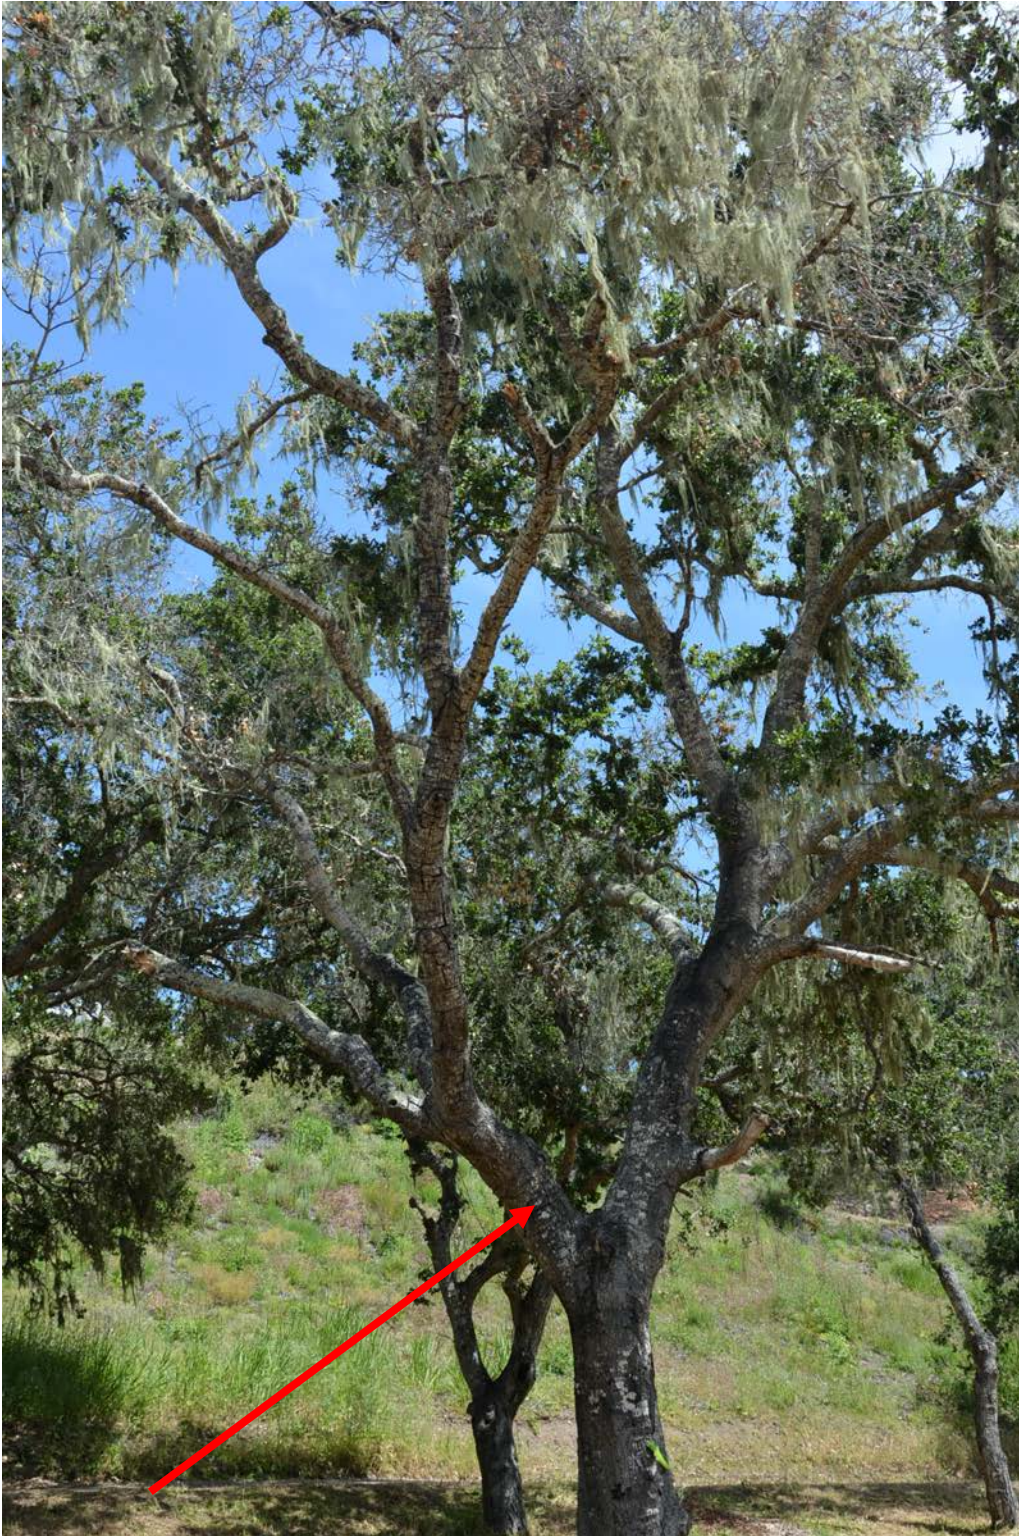
| ID# | Diameter | Structure | Health | Dominance | Comments | Remove |
|---|---|---|---|---|---|---|
| 487 | 24 | Good | Poor | Co-dominant | Hypoxylon, Dying | Maybe |

Tree #487- limb is dead and needs pruning

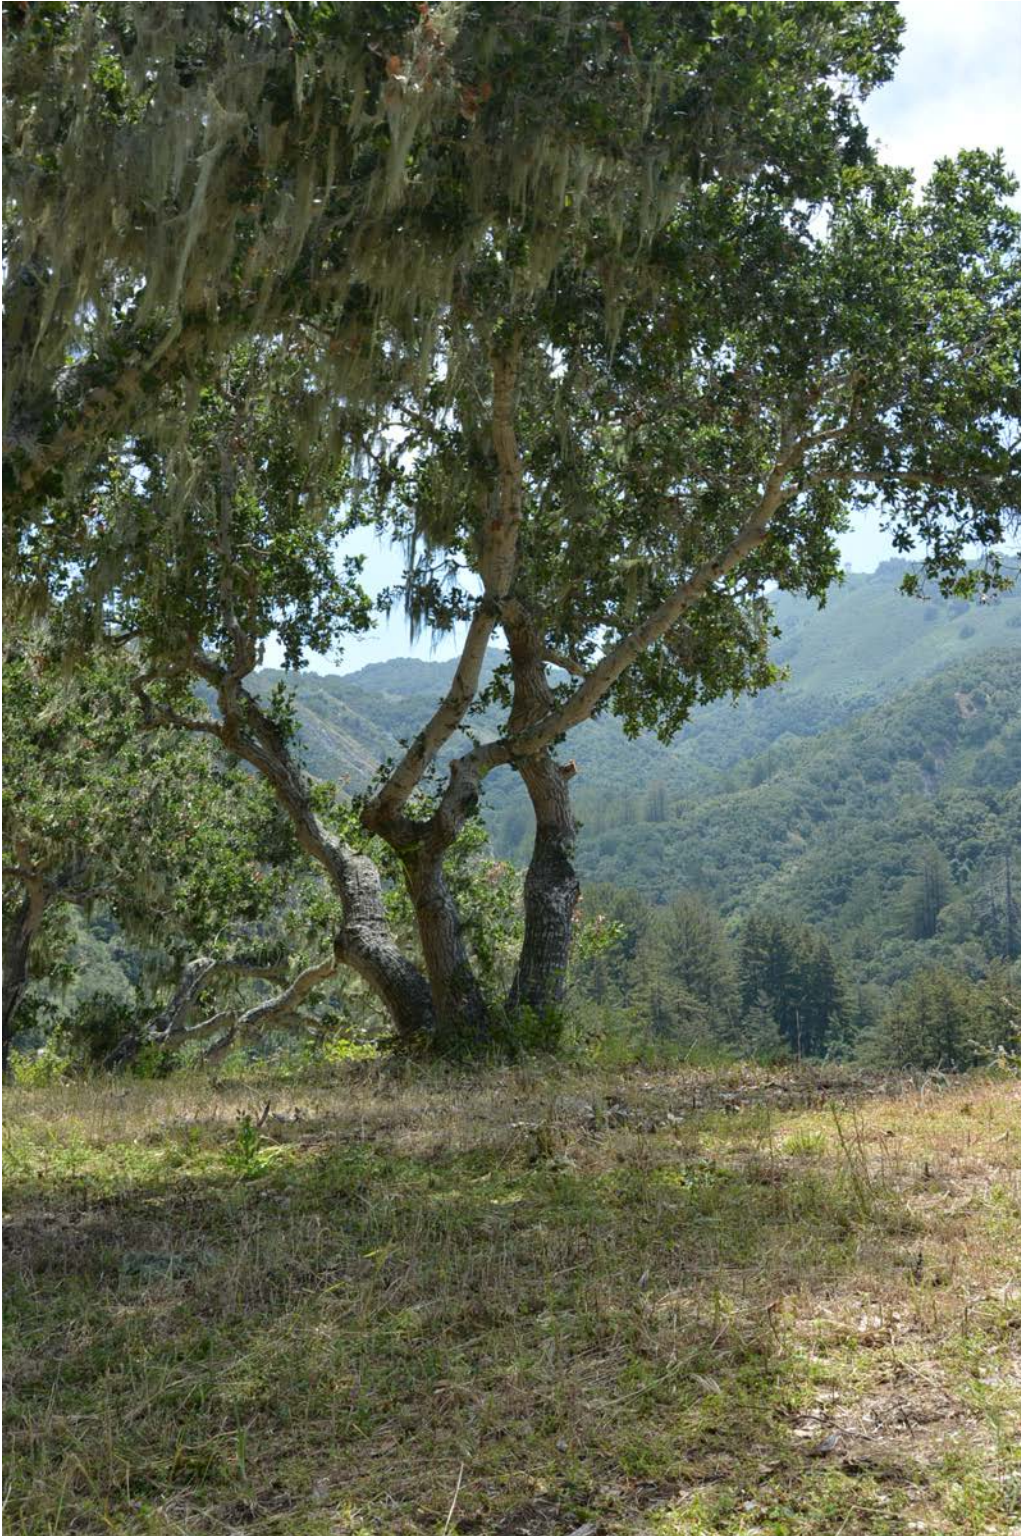
| ID# | Diameter | Structure | Health | Dominance | Comments | Remove |
|---|---|---|---|---|---|---|
| 503 | 13,13,12 | Fair | Fair | Co-dominant | Sunscald | Maybe |

Tree #503 – may need removal or trimming due to grading

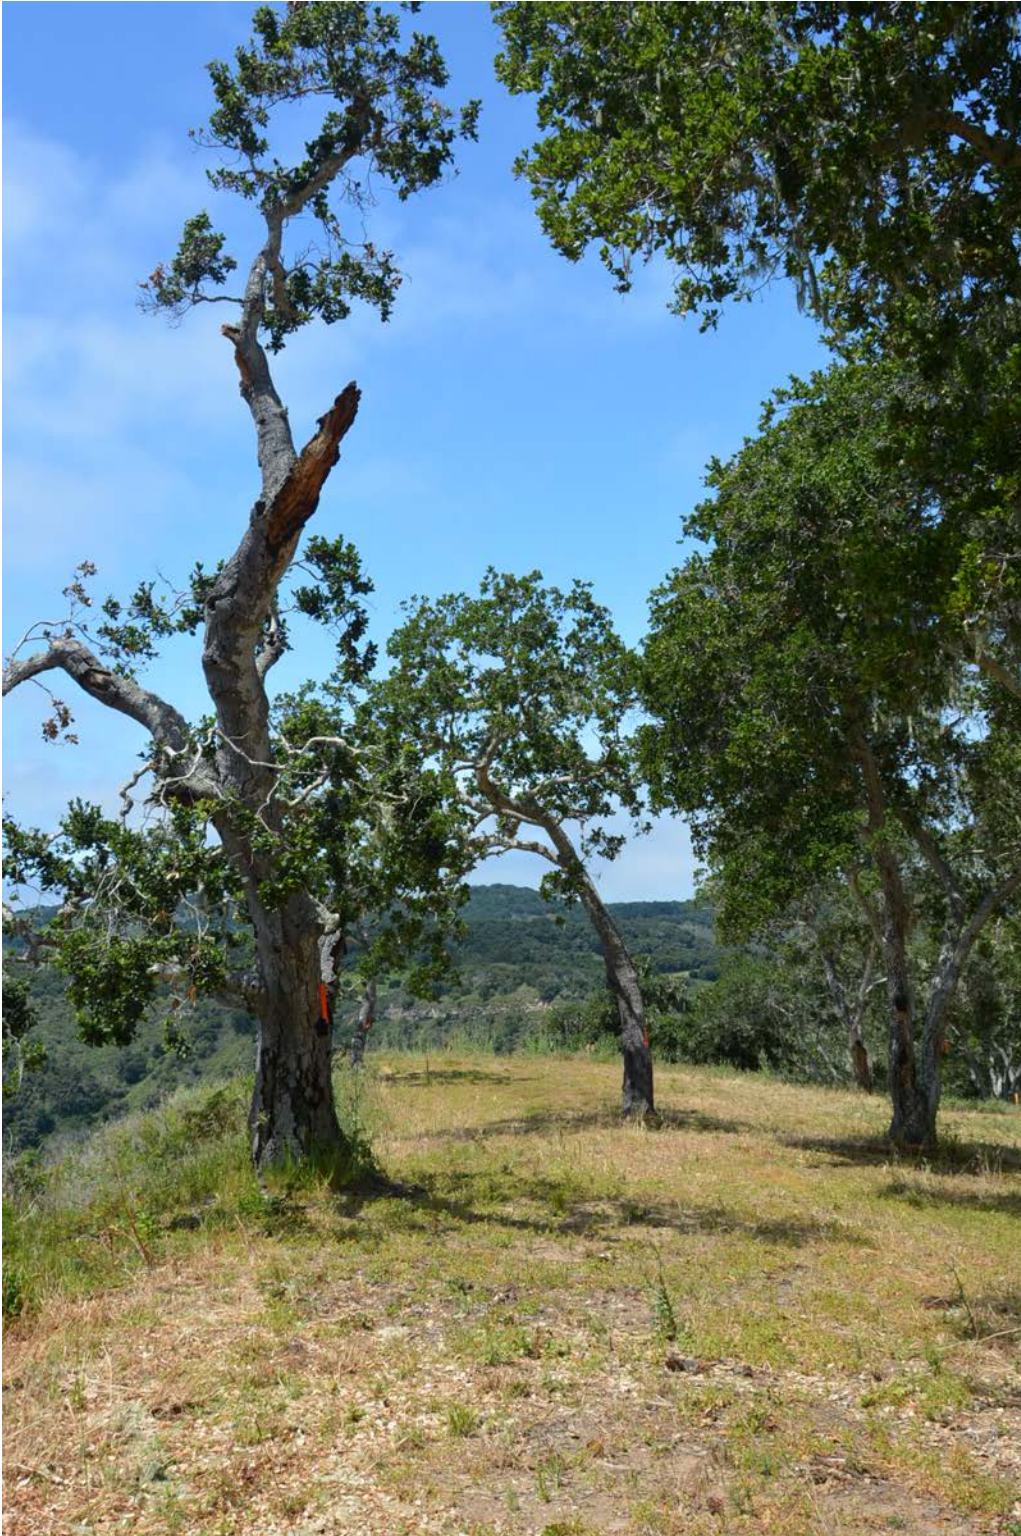
Trees#497, #497, #494

| ID# | Diameter | Structure | Health | Dominance | Comments | Remove |
|---|---|---|---|---|---|---|
| 497 | 26 | Poor | Poor | Dominant | Beetles and Termites | X |
| 494 | 14,12 | Fair | Poor | Co-dominant | Stem decay, Hypoxylon | X |

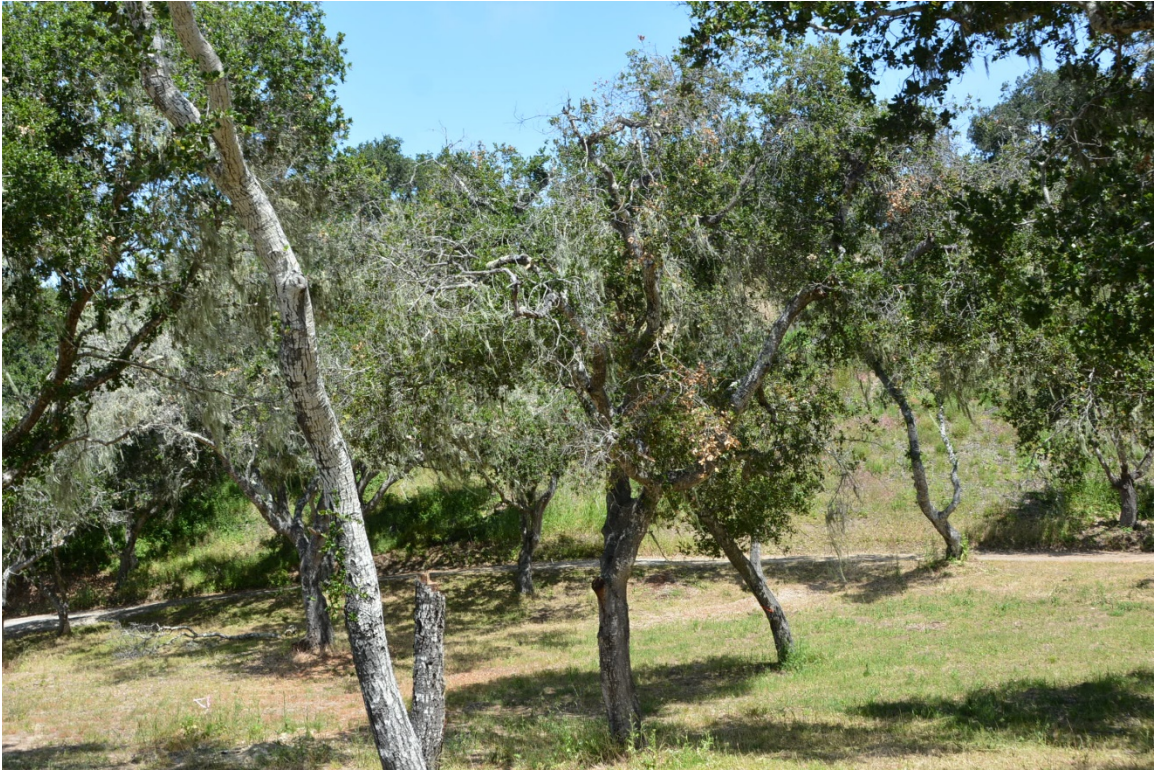
View of site where development is to occur these are trees 485-#496
