Tree Resource Assessment  
Pebble Beach Lodge Post Office  
Parking Lot Area

Pebble Beach Company

Frank Ono  
Urban Forester  
Member Society of American Foresters #48004  
ISA Certified Arborist #536  
1213 Miles Avenue  
Pacific Grove, CA 93950

June 5, 2017

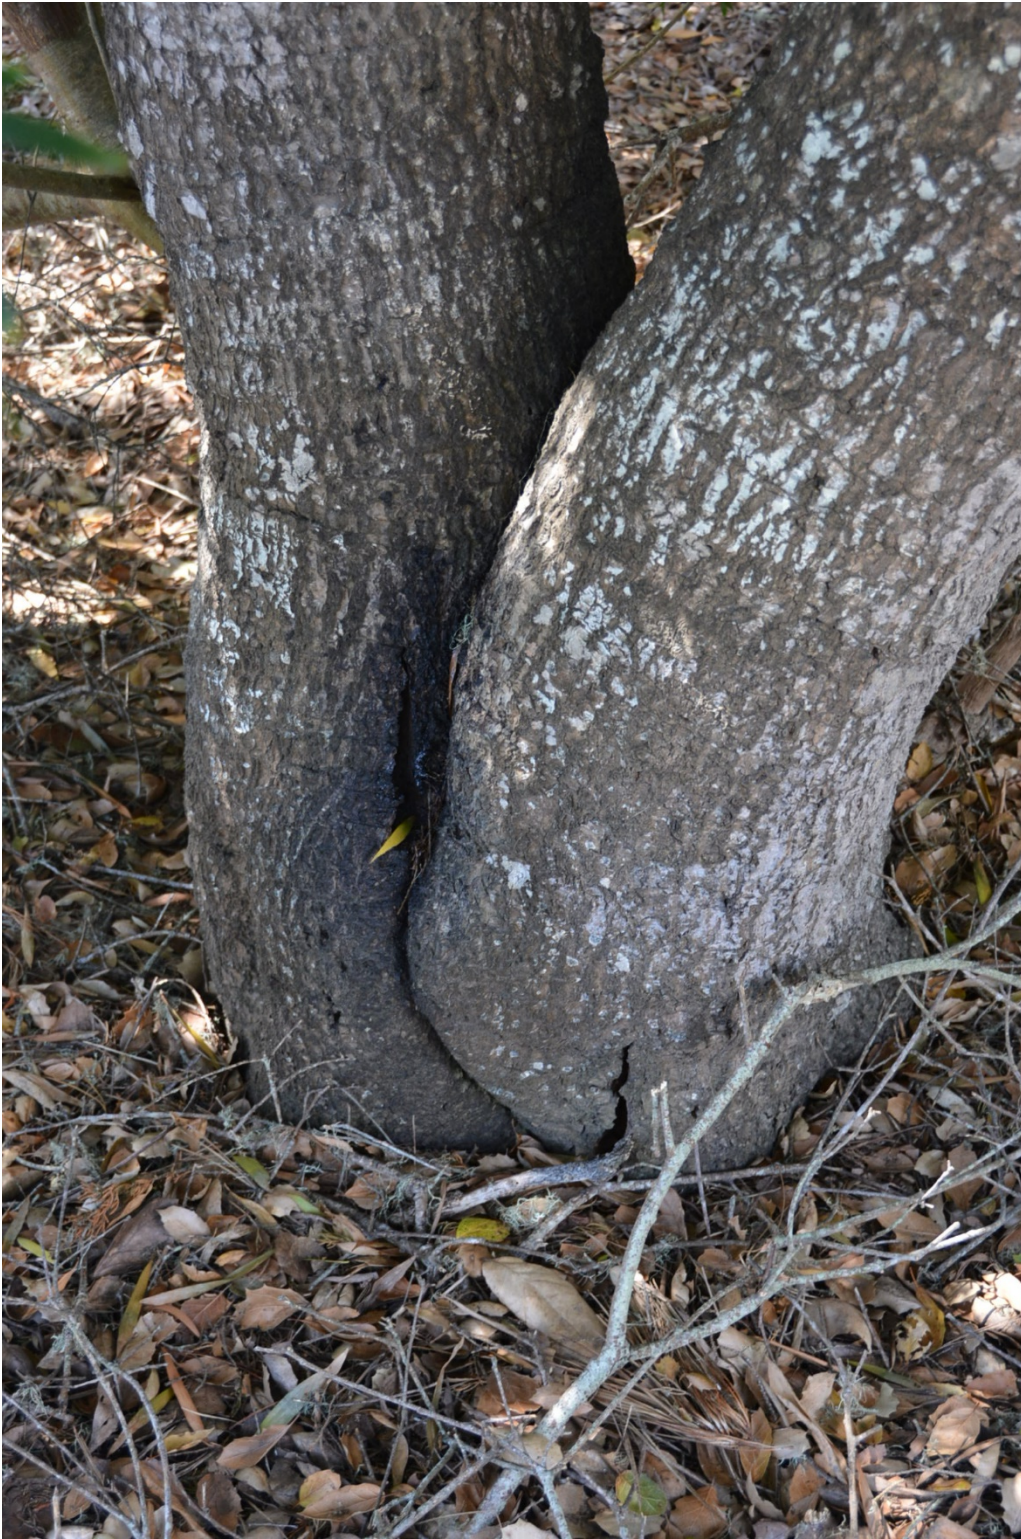
- Oak #114 (double 12" diameter) is located in the planter near parking entrance. The tree has a bleeding stem where stem are poorly attached; the tree will be affected by grading.

Tree #114 split bleeding crotch

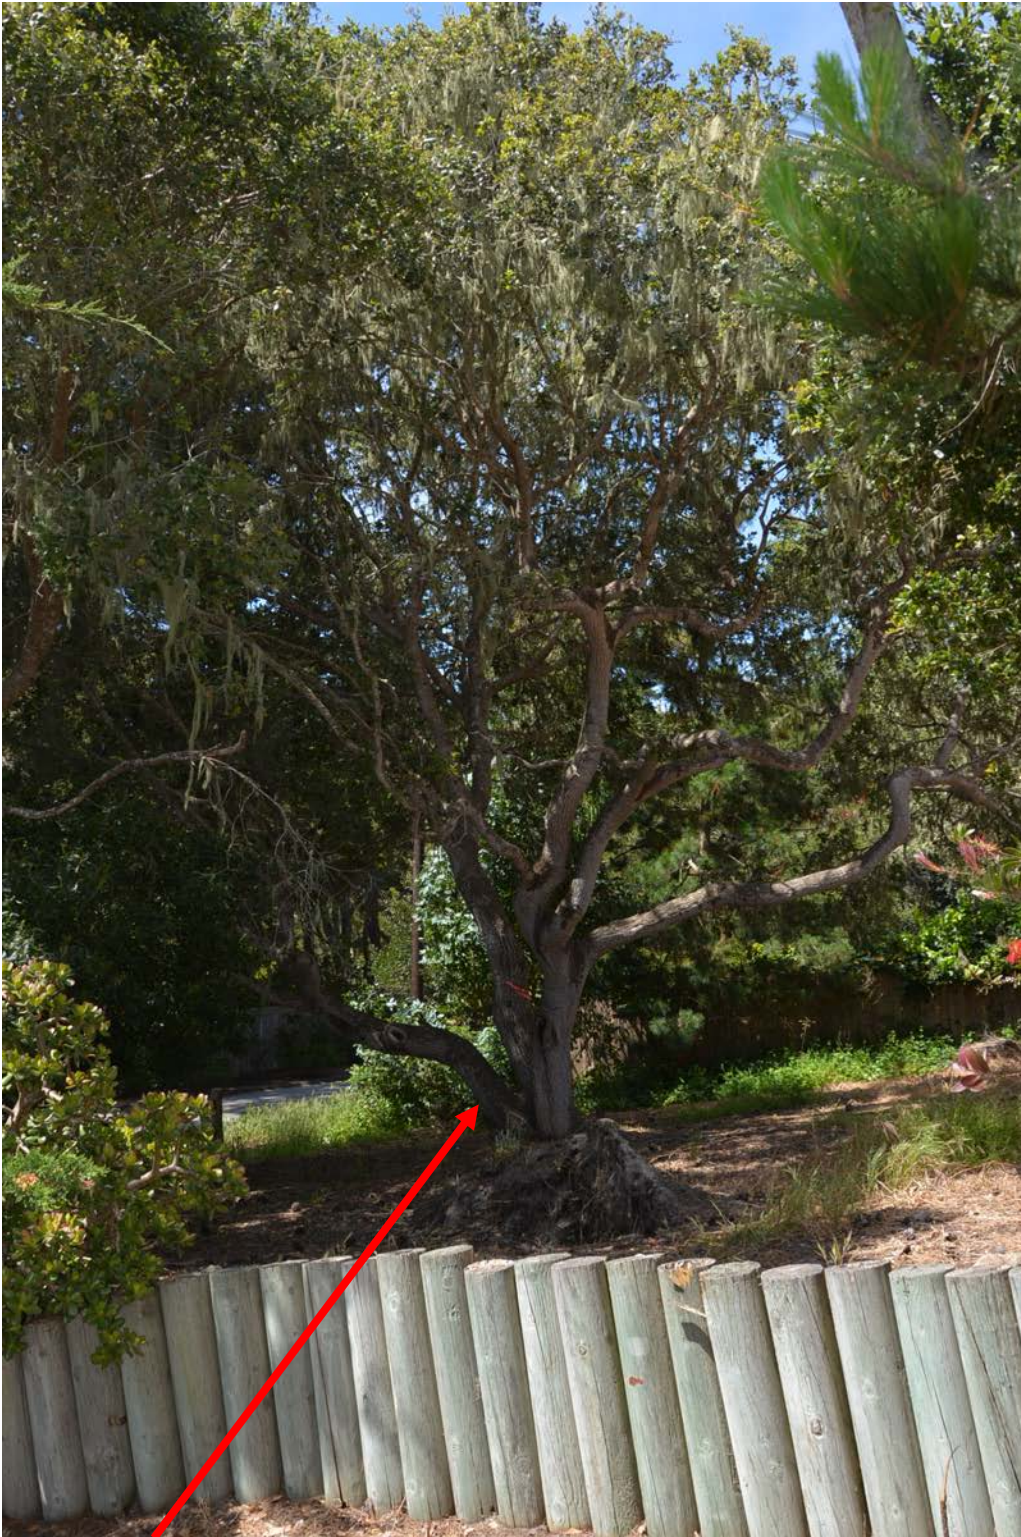
Tree #115

- Oak #115 (double 14" diameter) is in overall fair condition but located within the parking footprint area.
  - Oak #120, #121, and #122 (ranging from 16" to 12" in diameter) are located along the western property line. These trees will be affected by grading.

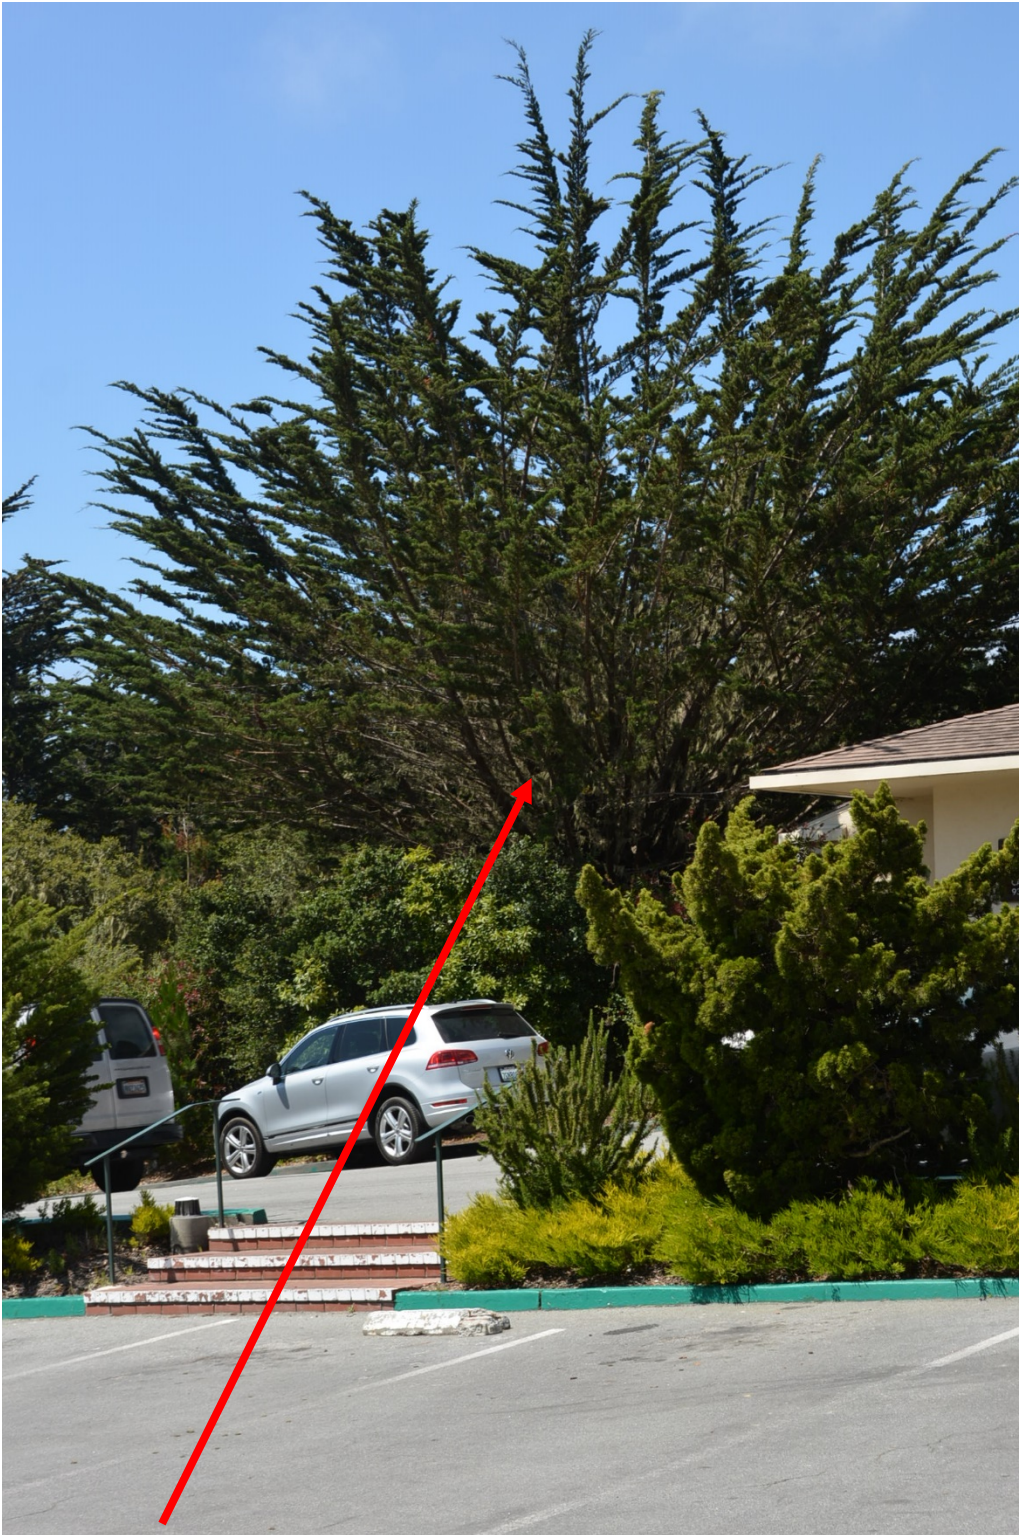
Tree #124

- The large Monterey cypress (#124) next to the Post Office Building will need removal due to its size and proximity to the building and required grading. It is a poor specimen structurally with multiple and weak stem attachments.

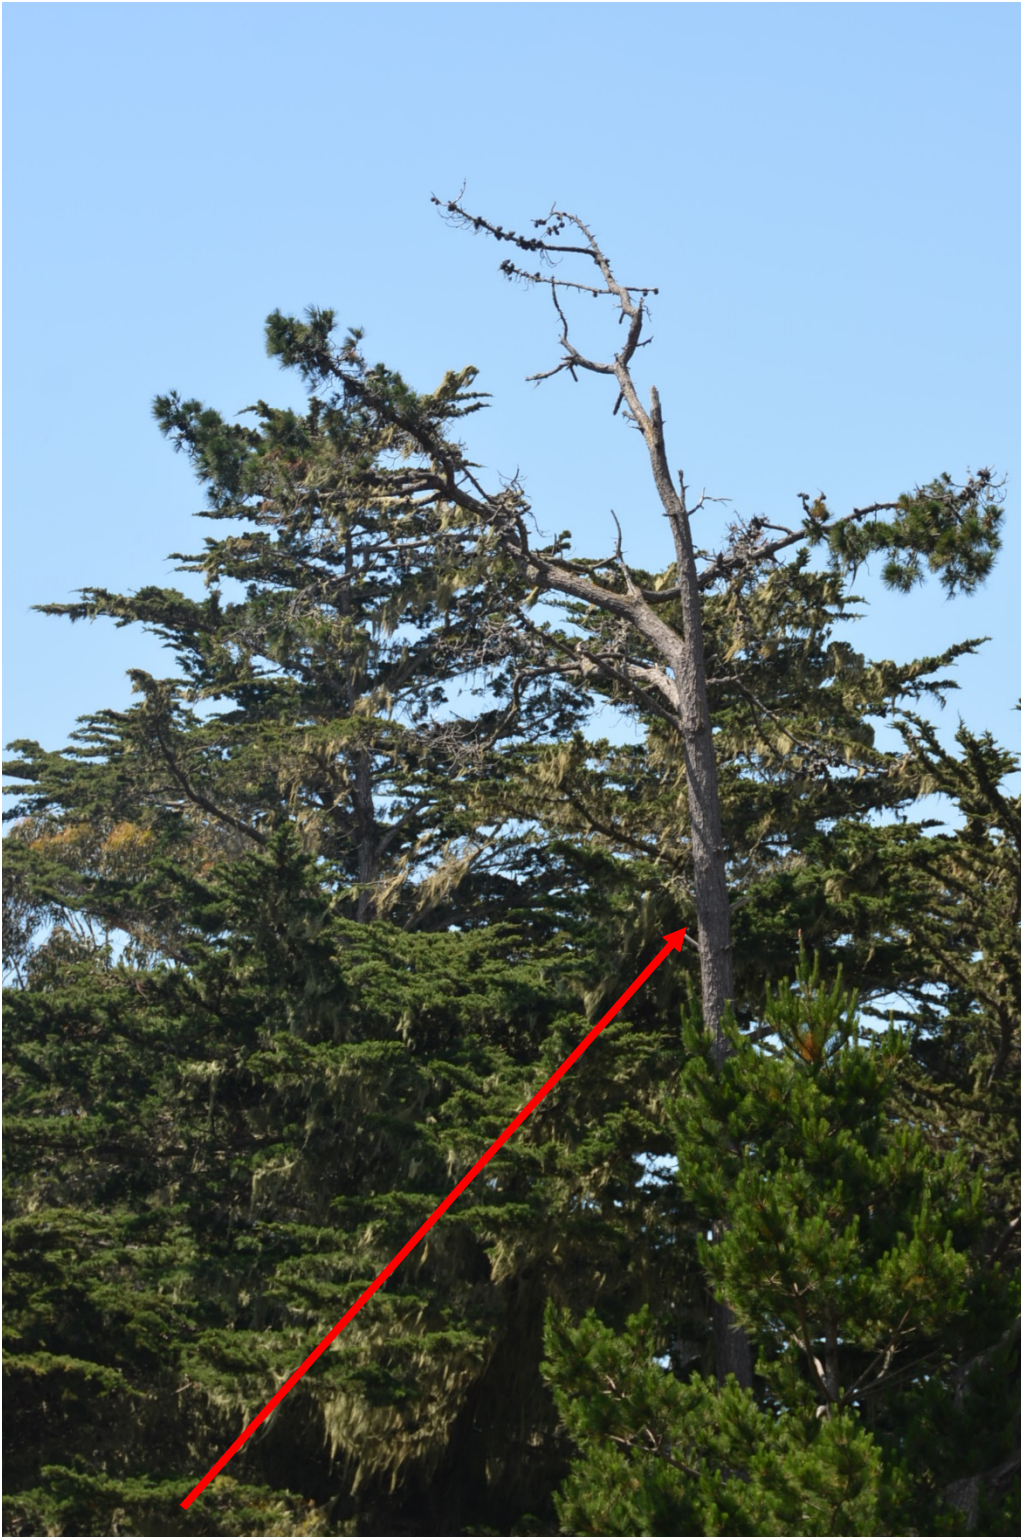
- Pine #118 (24" diameter) to be removed appears to be dying and has a thinning/dying crown.
  - Pine #119 (10" diameter) is to be retained located and within an existing planter area. It appears to be symptomatic of pine pitch canker with dying branch tips.
