Oleksy Residence
363 Calle De Los Agrinemsors
Tree Resource Assessment

October 9, 2017

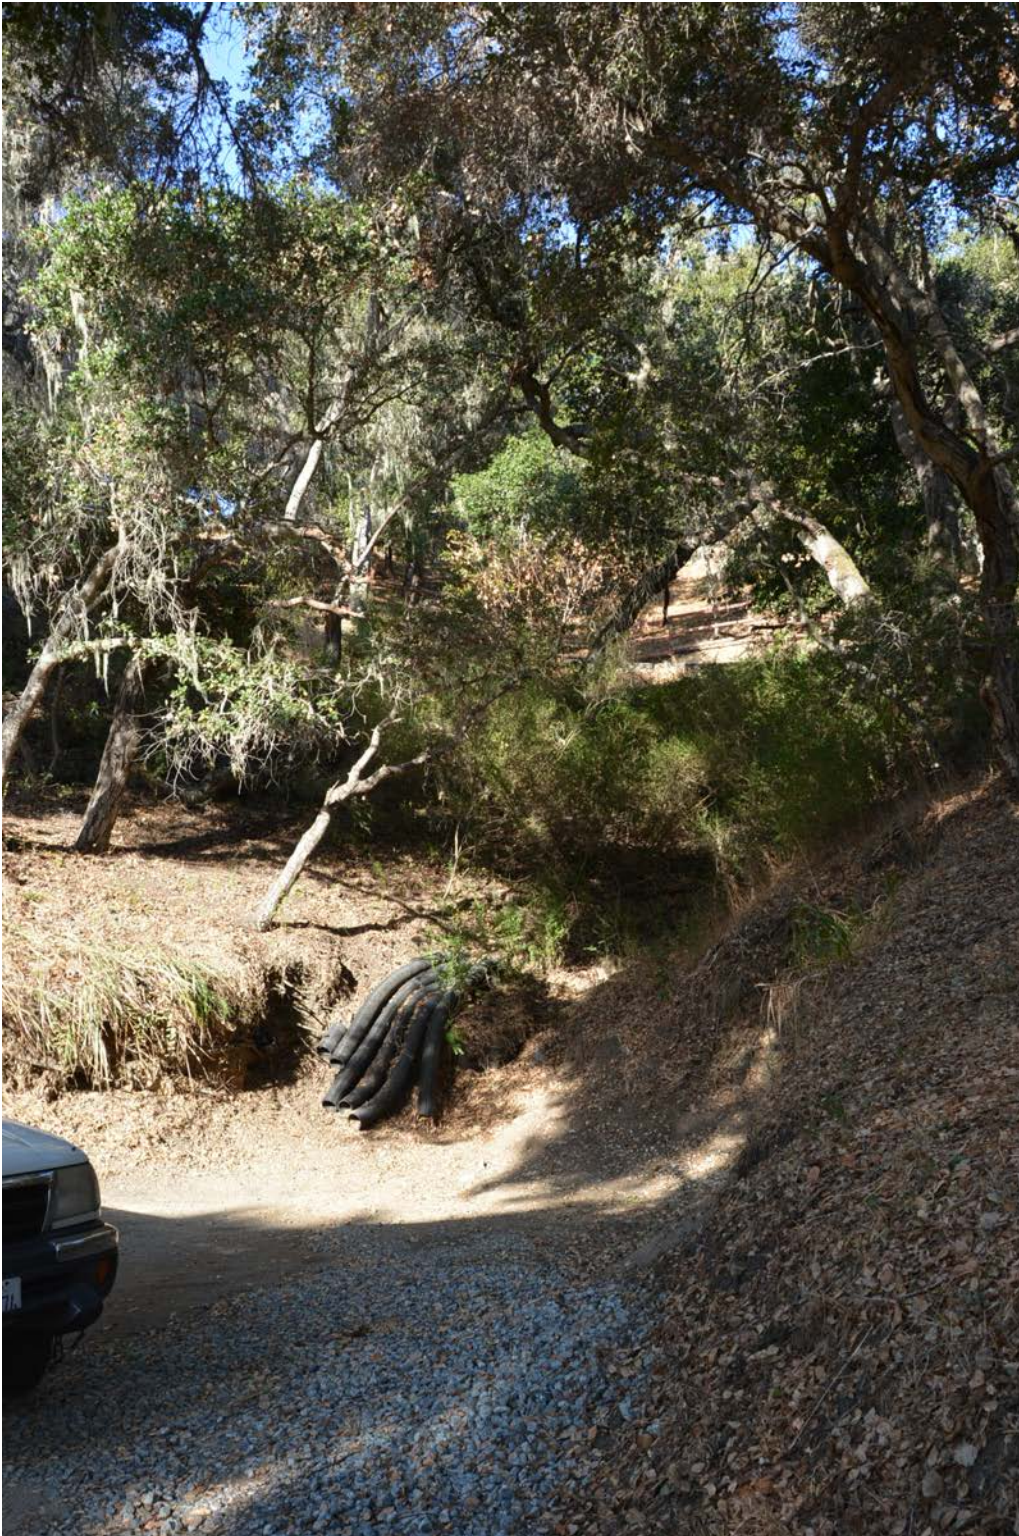
- The garage will be located below trees #328, #329, #330 and #331 which appear to be in poor condition due to fungal activity. These trees are not proposed for removal but are to be retained, because of their declining condition these may need to be monitored and addressed in a separate hazard tree assessment in the future.

Proposed garage area, these are trees #332 and 331 above the area

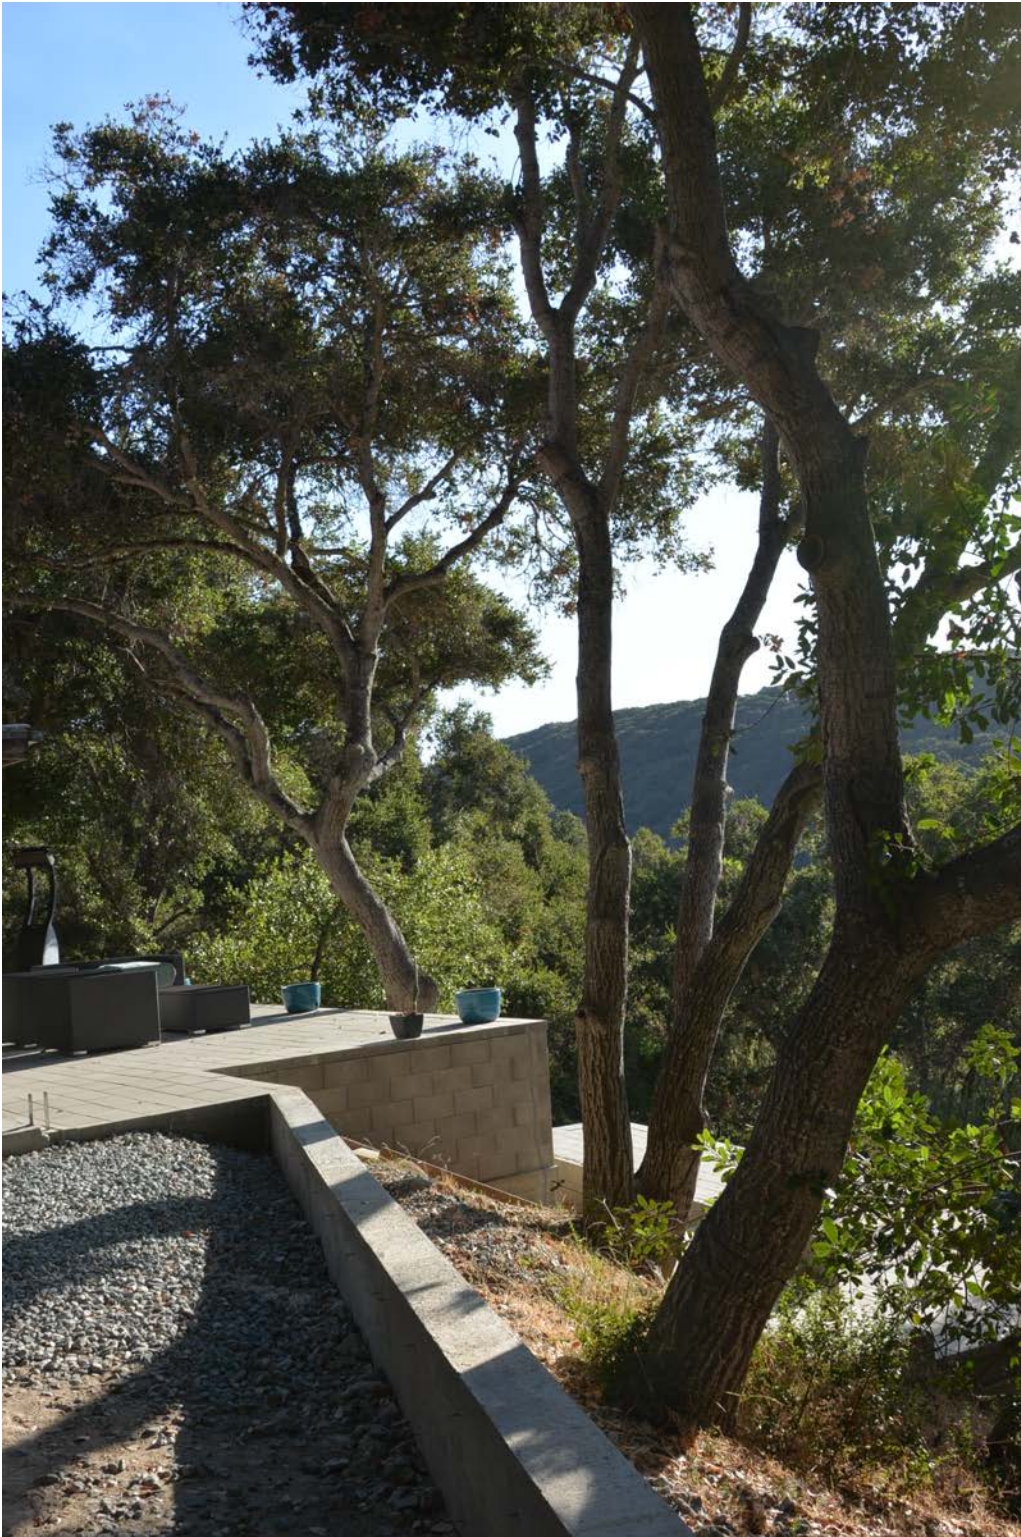
The driveway and patios near trees #344 and #345

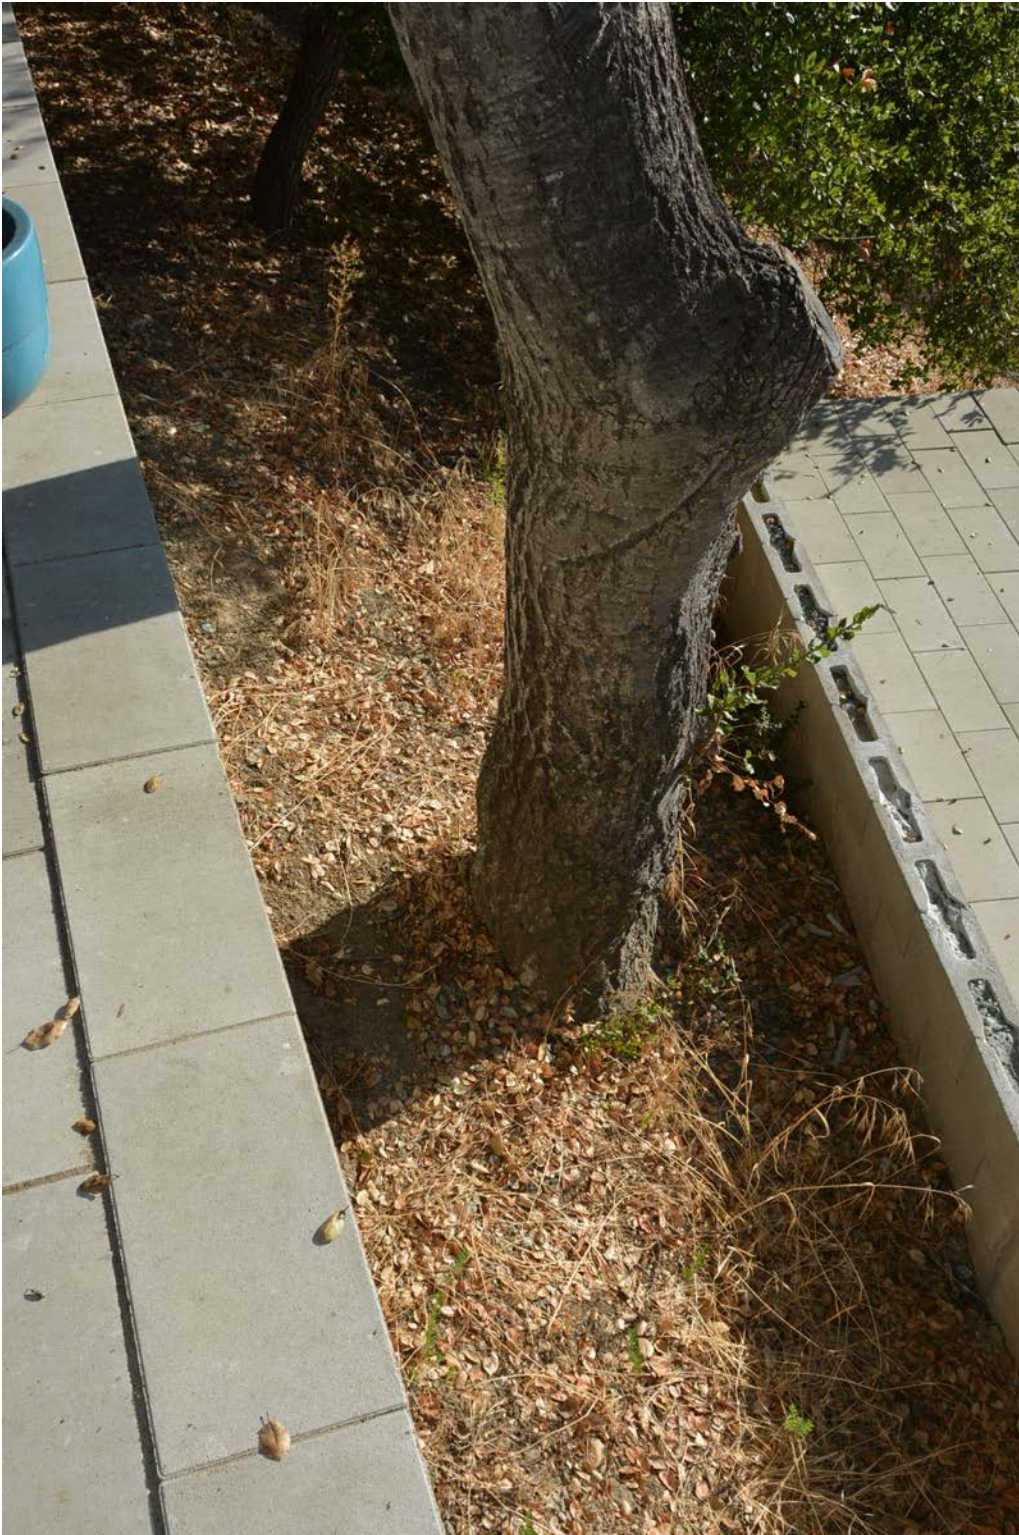
Tree #343

- The site is an urbanized area populated with oaks with a few scattered pines.
- Two patios with retaining walls have been constructed as well as a detached storage shed near several oaks trees. One of the oak trees #343 is located between the two patios. It is my understanding that no significant roots were pruned off this tree during the installation of the patios and structure. In viewing the trees it does not appear that root damage was done to the tree.

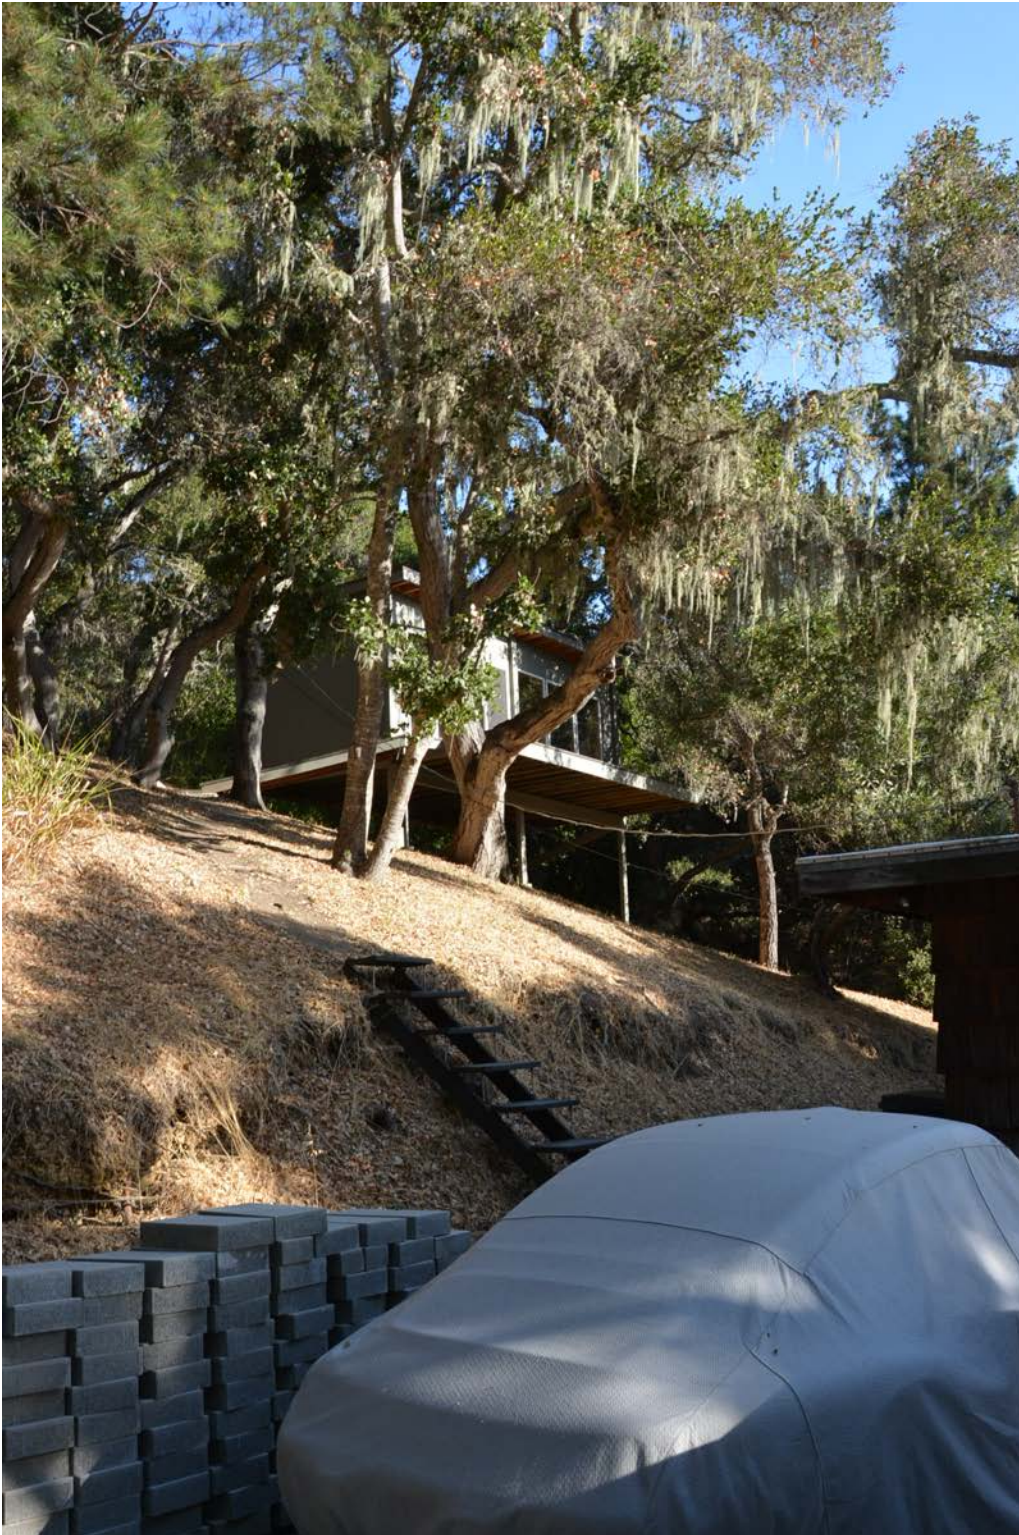
View of the studio/storage area from the driveway

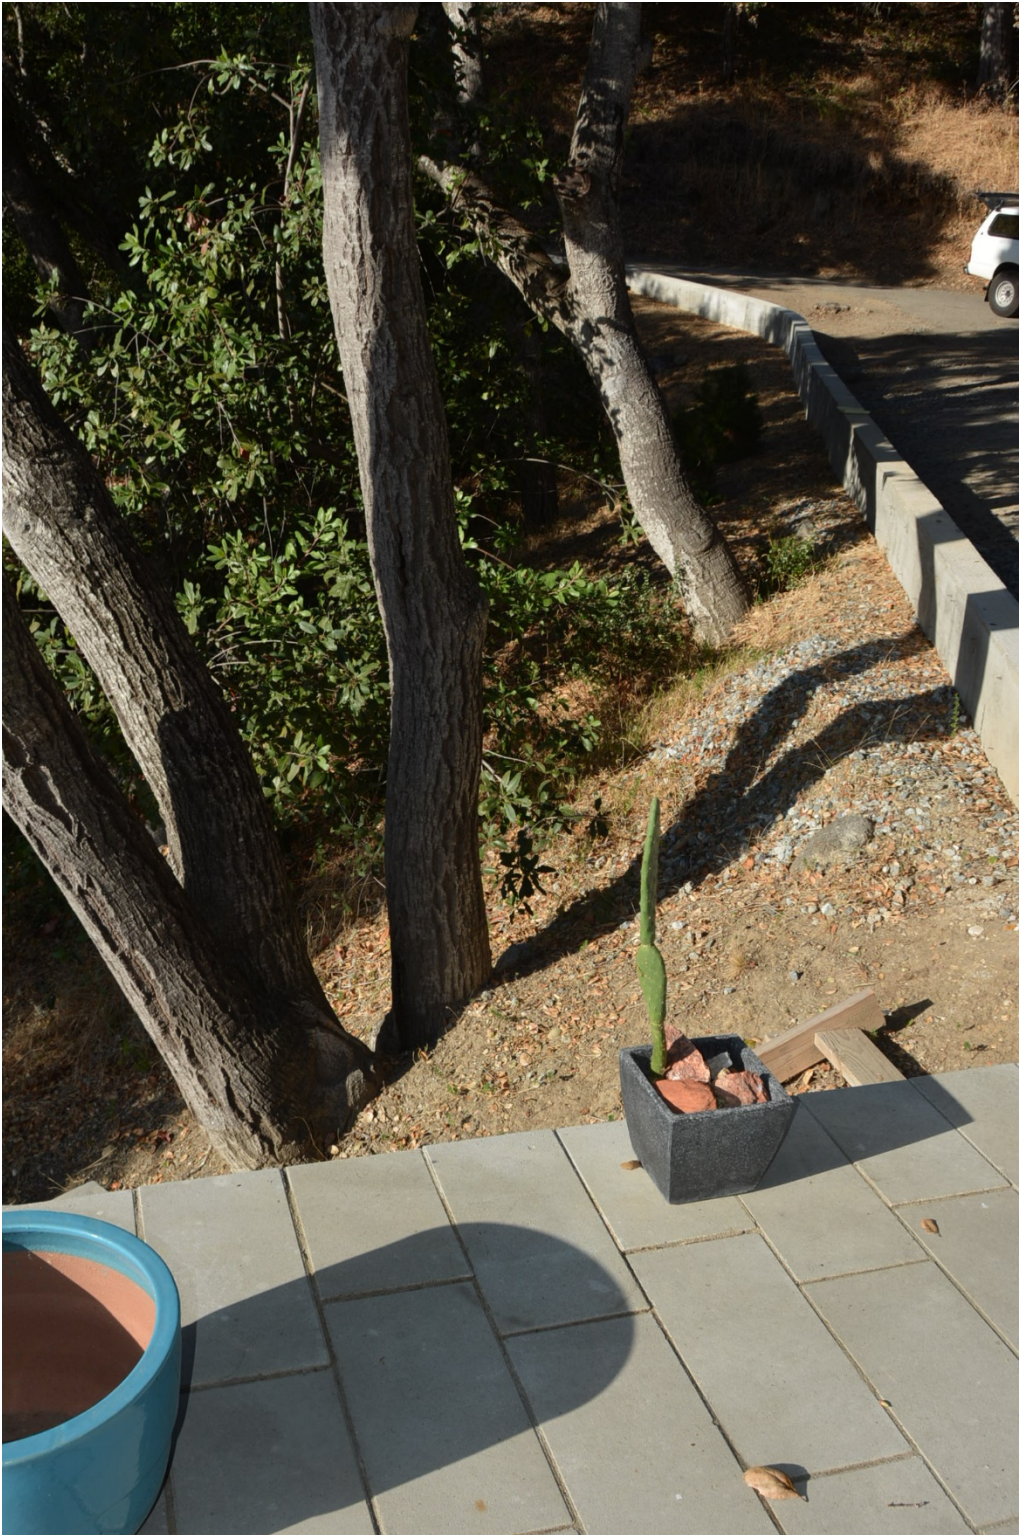
Looking from the patio toward the driveway
