***Maureen Hamb-WCISA Certified Arborist WE2280  
Professional Consulting Services***

June 18, 2018

Project: Tang/3284 San Luis Avenue  
Phase: Garage Addition Arborist Review

**Introduction/Scope of Services**

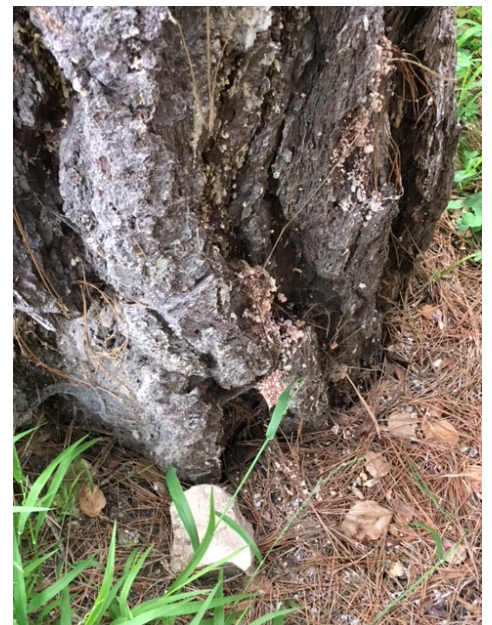
**Tree #1:** Monterey pine (*Pinus radiata*) is growing within the Monterey County road easement. The tree canopy is thin and discolored. Evidence of a significant Red Turpentine beetle infestation is visible at the base of the trunk (pictured).

The tree is growing adjacent to the proposed asphalt driveway entry. The need for removal has been discussed and approved by Robert Palomino at Monterey County Public Works Department.

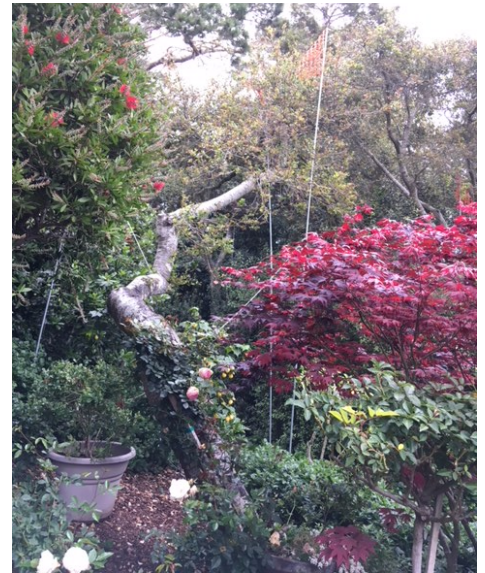
**Tree #2:** Coast live oak (*Quercus agrifolia*) a young tree with a dramatically horizontal trunk. The canopy is concentrated at the end of the tree and is thin and absent of lateral branching (pictured).

The trunk spans the footprint of the proposed garage and removal will be required. Due to the leaning structure and lack of branching, pruning cannot be completed to provide clearance for the building.
